**HORSE CREEK (WAKE FOREST COUNTRY CLUB)
2007 FINAL MONTORING REPORT
YEAR 2 OF 5
2007**

EEP Project # 409
Wake County, North Carolina

HORSE CREEK (WAKE FOREST COUNTRY CLUB) STREAM RESTORATION YEAR 2 MONITORING REPORT

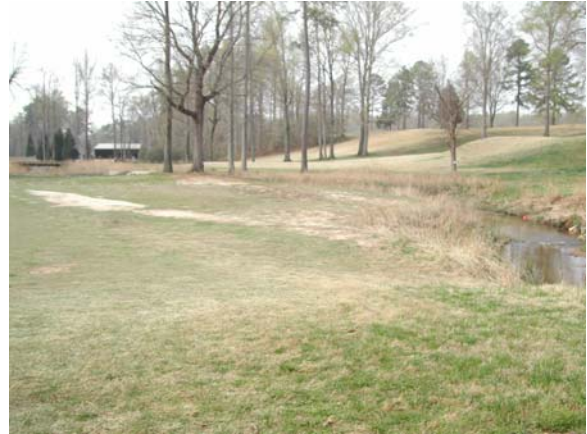
Photo 2. Representative bare floodplain problem area (approximately Station 13+00). Note the sandy deposits on the floodplain indicating a recent over-bankfull flow. Photo was taken on 3/28/2007.

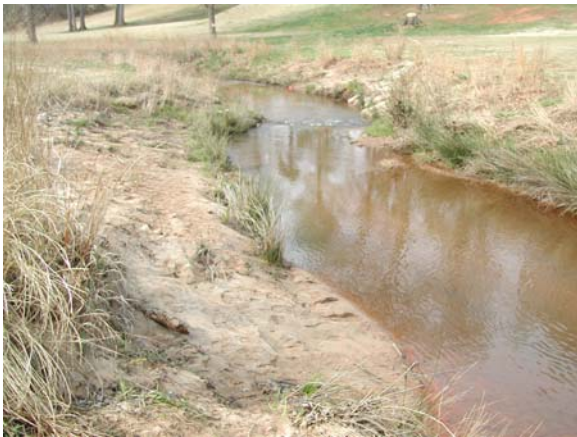
Photo 3. Sandy deposits on the below-bankfull bench (approximately Station 13+00) listed as bare bank is past monitoring reports have since been observed to be reestablishing vegetative cover and were de-listed as vegetation problem areas. Photo was taken on 3/28/2007.

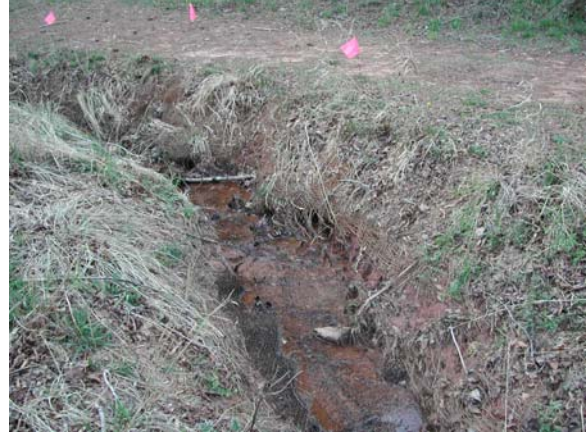
Photo 2: Representative undercut problem area (11+43 along unnamed tributary) at left toe (photo facing upstream).

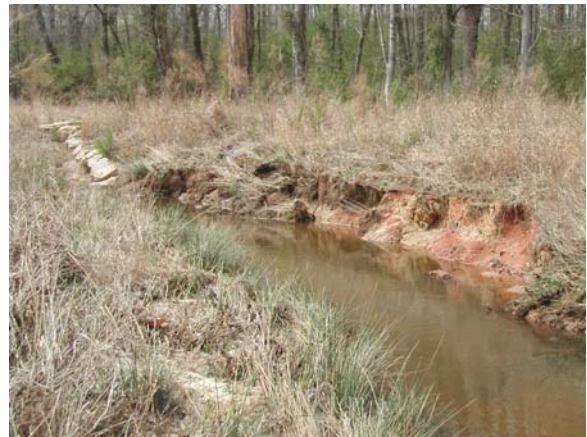
Photo 4: Representative severe bank erosion problem area on the right bank (37+86 along mainstem).

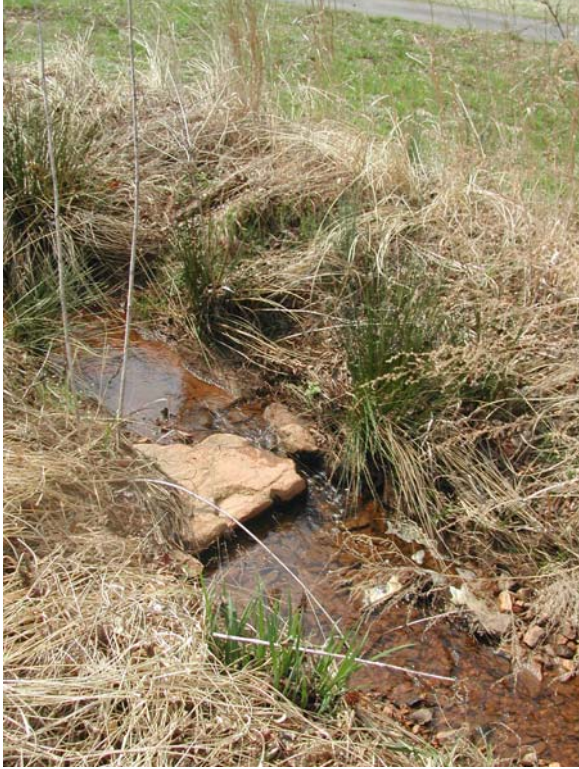
Photo 5: Representative problem crossvane (13+99 along unnamed tributary).

Crossvane	13+99 (UT)	Piping around/under structure.	5
Aggradation	14+17 (UT)	Channel narrowing to a stable state.	8
	14+66 (UT)		
Bank Erosion (both banks)	14+66 (UT)	Located at outlet pool of culvert over small drainage that enters UT to Horse creek at station 14+86. Erosion area located 35 feet upstream of confluence. Caused by soil stability and lack of protective vegetation.	
	14+74 (UT)

The UT section for Monitoring year 2 has remained stable. There is a headcut near the top of the reach to observe closely in future monitoring years. A long aggradational section toward the downstream end of the reach may need attention. In addition, there is a cross vane where water was observed piping around parts of the structure. This cross vane may need repair.

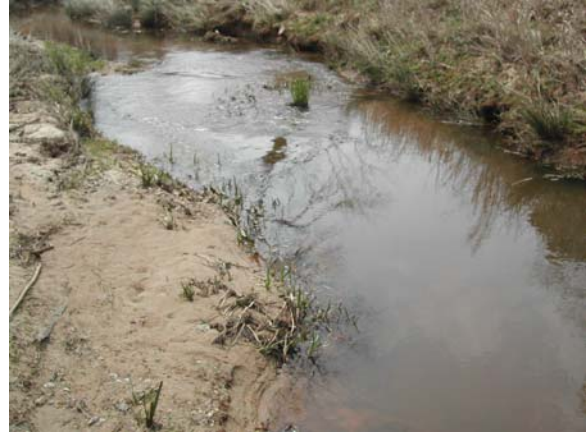
Photo 6: Representative cattail aggradation problem area (foreground, 32+58 along mainstem). Notice young cattails growing at left edge of water. Also bank erosion (background, 32+95) is visible in the upper center of the picture and a second cattail aggradation area (32+93) is located directly across channel from erosion in upper left corner of photo.

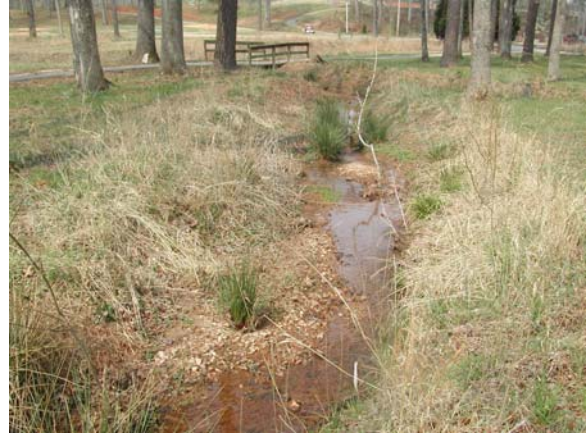
Photo 8: Representative aggradation problem area (14+17 along unnamed tributary).

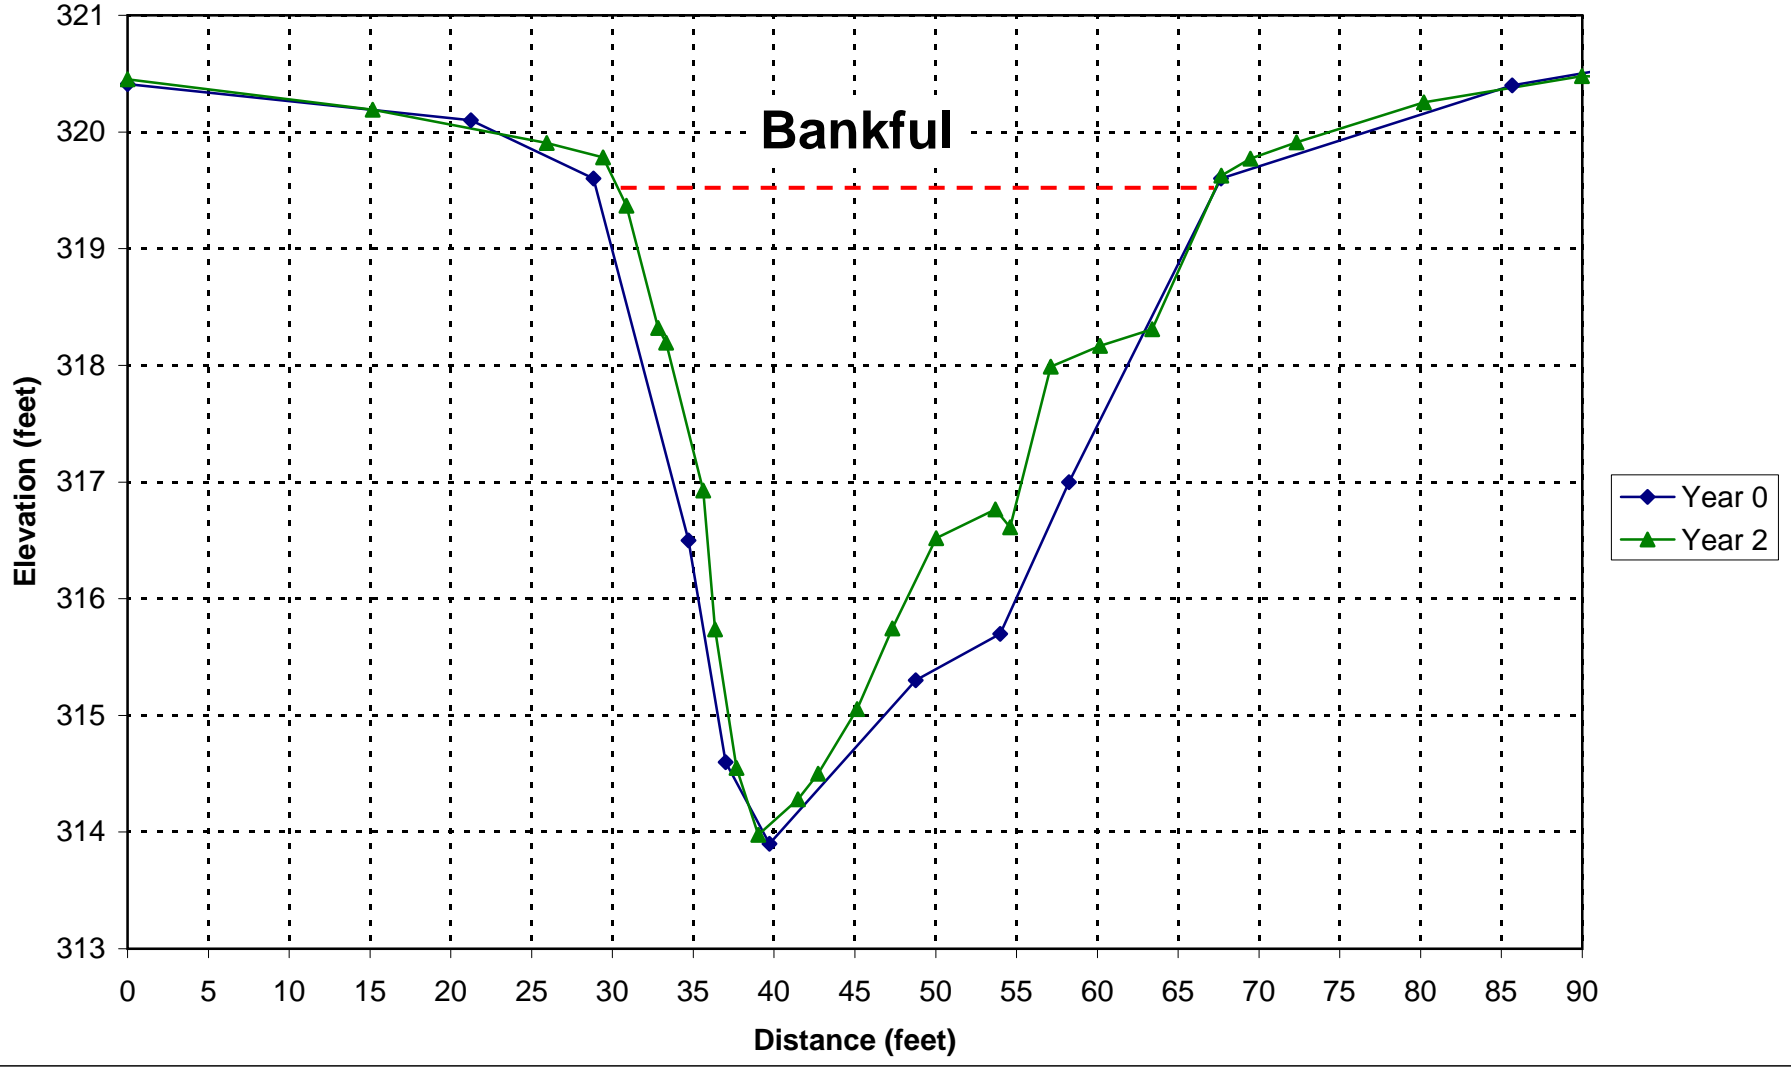
Cross Section Overlay (Years 1 & 2)
Horse Creek Mainstem
Cross Section #2 (Pool)

for a sand-bed stream. The streambed profiles of these types of streams tend to be very dynamic. The only cross section on the mainstem where any kind of change in dimension has occurred along a bank was cross section #2. It appears that there has been a notable amount of fill on the right side of this cross section between Monitoring Years 1 and 2. This result should not be alarming since this was probably just normal point bar development. Several fairly new sediment deposits were observed on the floodplain during the problem area inspection in this area. It appears that there may have been a moderate amount of downcutting in the downstream portion of the mainstem since Monitoring Year 0. This was concluded based on observations of the cross sectional and longitudinal profile annual overlays. However, it is unclear if the changes observed were caused by surveying issues or by actual downcutting. This issue will be clarified during Monitoring Year 3. In addition, at cross section #8 on the UT, it appears that a notable amount of fill occurred on the right side of the channel between Monitoring Years 0 and 1. This may be an area to keep an eye on; however, the overlay indicates no fill occurred before the Monitoring Year 2 cross sections were surveyed. This area may have stabilized at this point. The cross-section graphs are located in Appendix B4.
