**HORSE CREEK (WAKE FOREST COUNTRY CLUB)
FINAL MONTORING REPORT**

YEAR 3

EEP Project # 409

Wake County, North Carolina

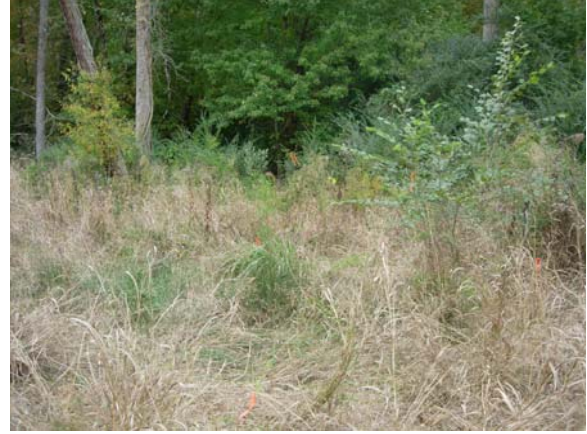
Photo 2. Representative *Ligustrum sinense* (Chinese privet) problem area (Station 33+68; privet is in background above shrub level; 9-30-2008).

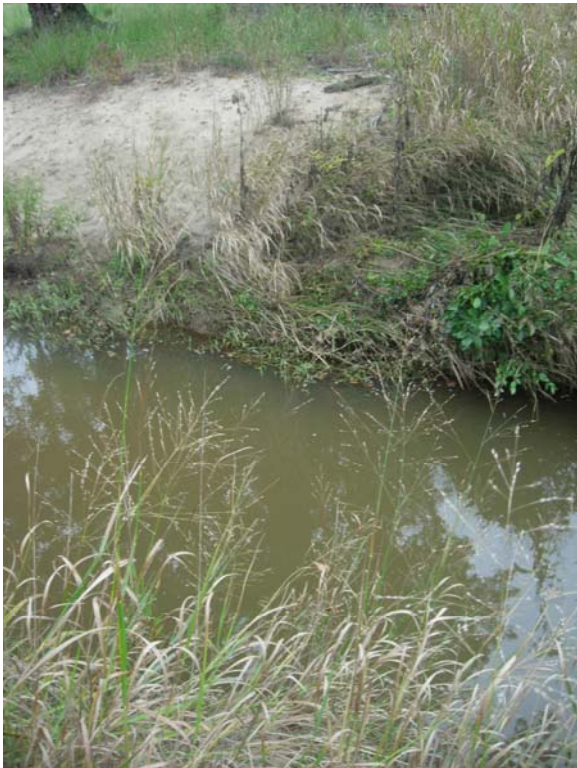
Photo 3. Representative bare bench/bank problem area (Station 16+56; view of left bank on main stem; 9-30-2008).

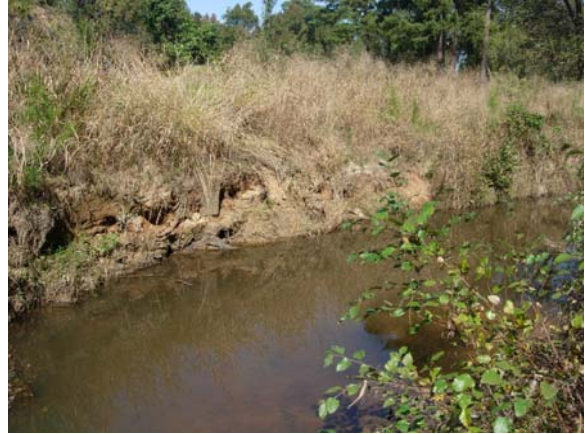
Photo 2: Representative severe bank erosion problem area (Station 29+65; view upstream of right bank along Horse Creek; 10-15-2008).

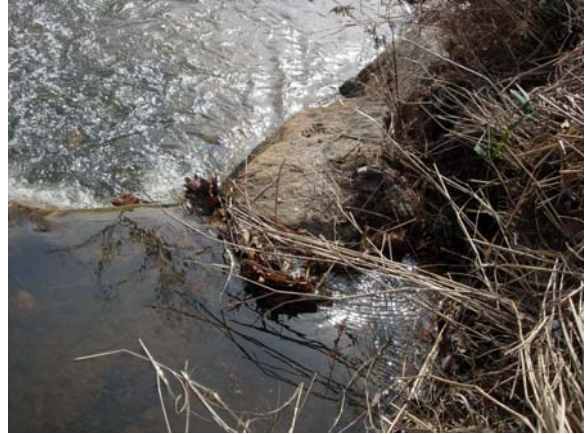
Table X, located in Appendix B3, describes the problem areas, station numbers, and respective probable causes. The most major problem along mainstem Horse Creek was the slumping of banks along the bottom third of the reach. Most bank erosion upstream of the UT Horse Creek confluence has healed over with new vegetation. Much of the bank erosion observed in the lower mainstem was rated severe. It appears that the main causes of erosion were a lack of deeply rooted vegetation at stress points, soil stability, bank angle, and/or overwidening due to possible downcutting along this section of the project. In addition, beaver dams have been a new development in Monitoring Year 3. There are four dams, located at Stations 10+98, 11+66, 22+56, and 25+14. As described in Section 3.2.1, the result has been an 30% increase in the total length of pool habitat and a 43% reduction in total length of riffle habitat. In addition, median pool length and median riffle slope have both increased, and median riffle length has decreased, presumably as a result of beaver damming. In addition, there were two problem crossvanes and two problem j-hooks noted in Monitoring Year 3. The most severe of these was a crossvane located at Station 34+07 where piping and back arm scour of the right arm (facing downstream). The crossvane located at Station 34+91 had significant piping and back arm scour of the left arm (facing downstream). The problem j-hooks are located at Stations 36+28 and 37+07 and had piping of water/scour around a piece of the structure.

Photo 4: Representative cross-vane problem area, Horse Creek (Station 34+91 view downstream of piping on right arm; 2-15-2008).

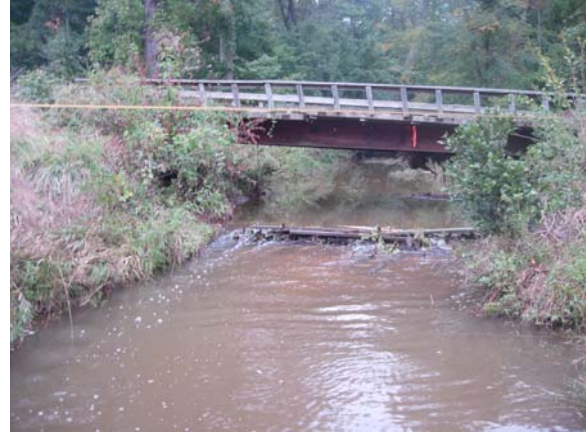
Cross-Section 1: View upstream. Horse Creek (9-30-2008). Note beaver dam at Station 10+98.

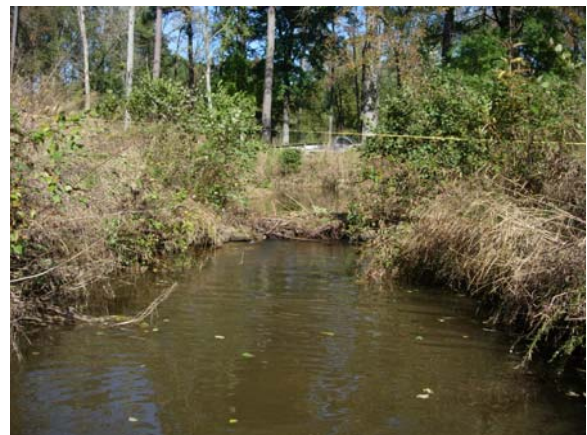
Cross-Section 3: View upstream. Horse Creek (10-28-2008). Note beaver dam at Station 25+14.
