**HORSE CREEK (WAKE FOREST COUNTRY CLUB)
FINAL MONITORING REPORT
YEAR 4 OF 5
2009**

EEP Project # 409
Wake County, North Carolina

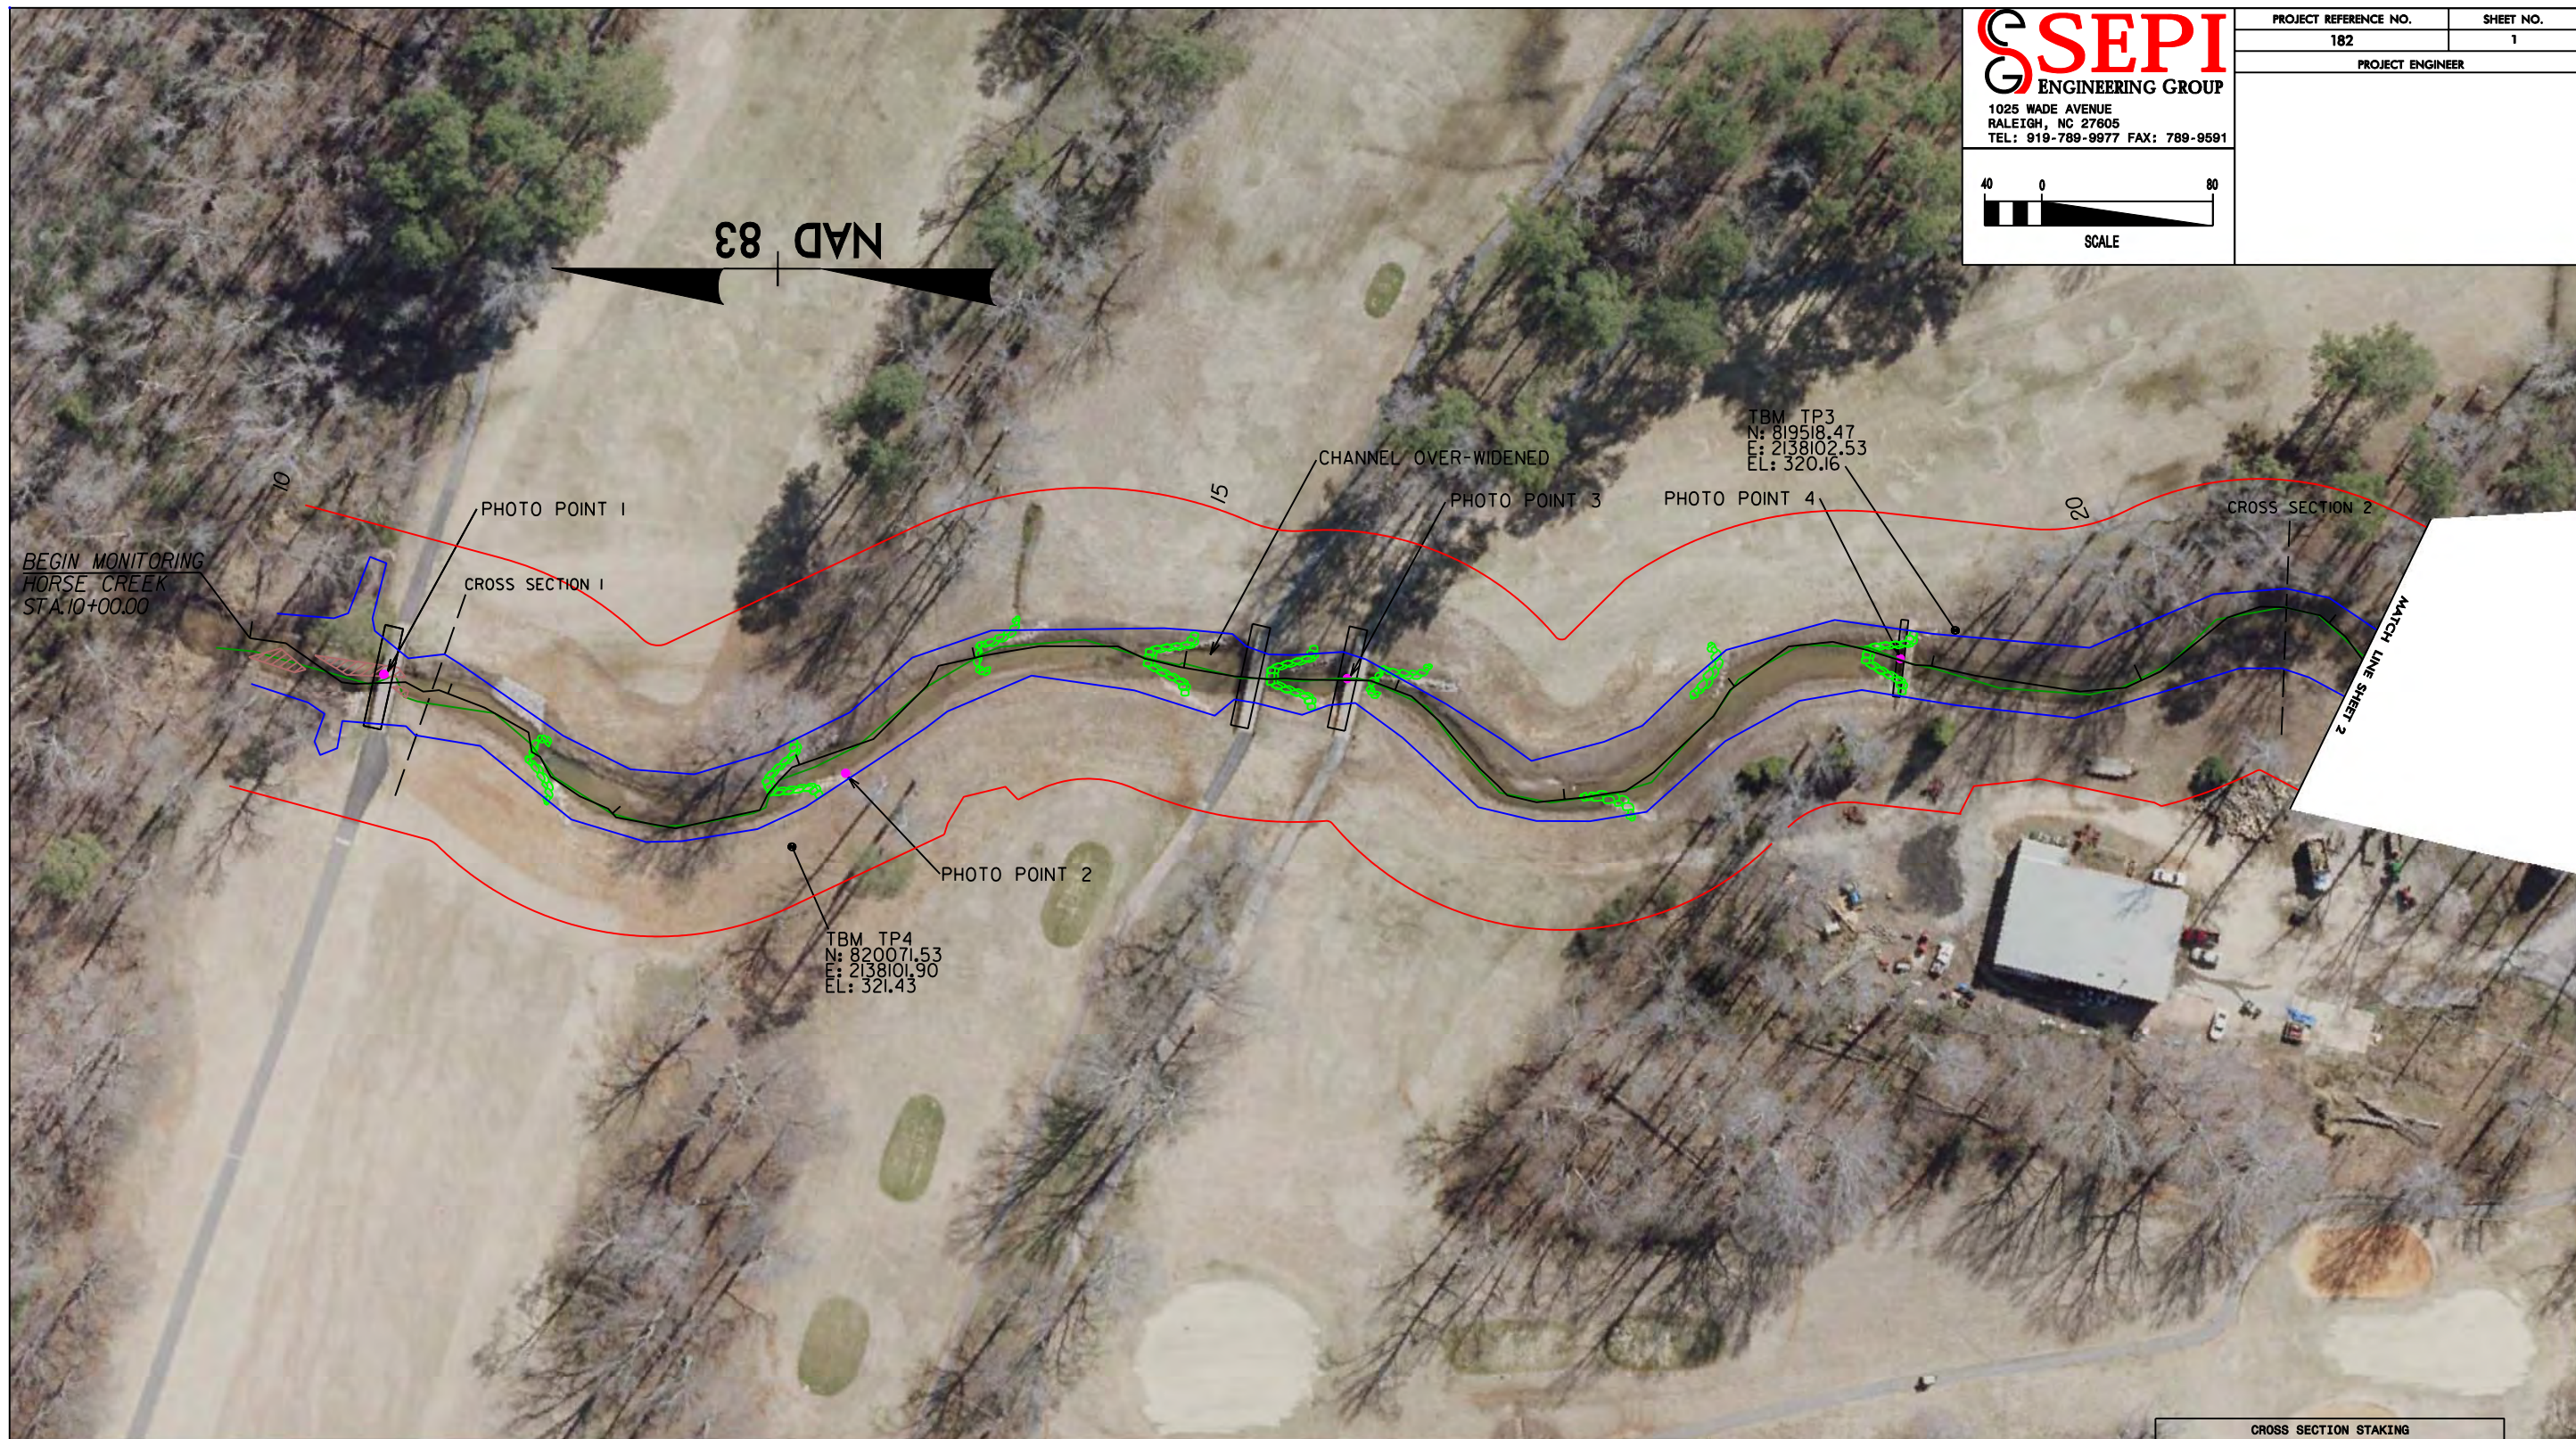
LOCATION:	HORSE CREEK	
	CURRENT CONDITIONS PLAN VIEW	
	FINAL STREAM - YEAR 4	
PROJ #:	182	COUNTY: WAKE
PREPARED BY:	IPJ	
CHECKED BY:	PDB	DATE: 3/01/2010

Year 4 monitoring showed that the Horse Creek mainstem has significant instabilities in the form of bank erosion in the form of slumping. The bank slumping areas were concentrated downstream of Station 28+00. The actual cause of these erosional areas is unknown, but it appears to be related to the combination of steep banks, a lack of soil stability, and/or a lack of deeply rooted vegetation in these areas. Overall, 9% of banks were impacted by bank erosion along the Horse Creek mainstem. Also, there were problems regarding structures. Two cross

vanes and two J-hooks that have piping and/or backarm scour that may warrant review to see if repair is needed. All four of these problem structures are located between Station 34+00 and 37+00. The Beaver dams along the mainstem, noted during Monitoring Year 4, were noted to no longer be present as of August 17, 2009.

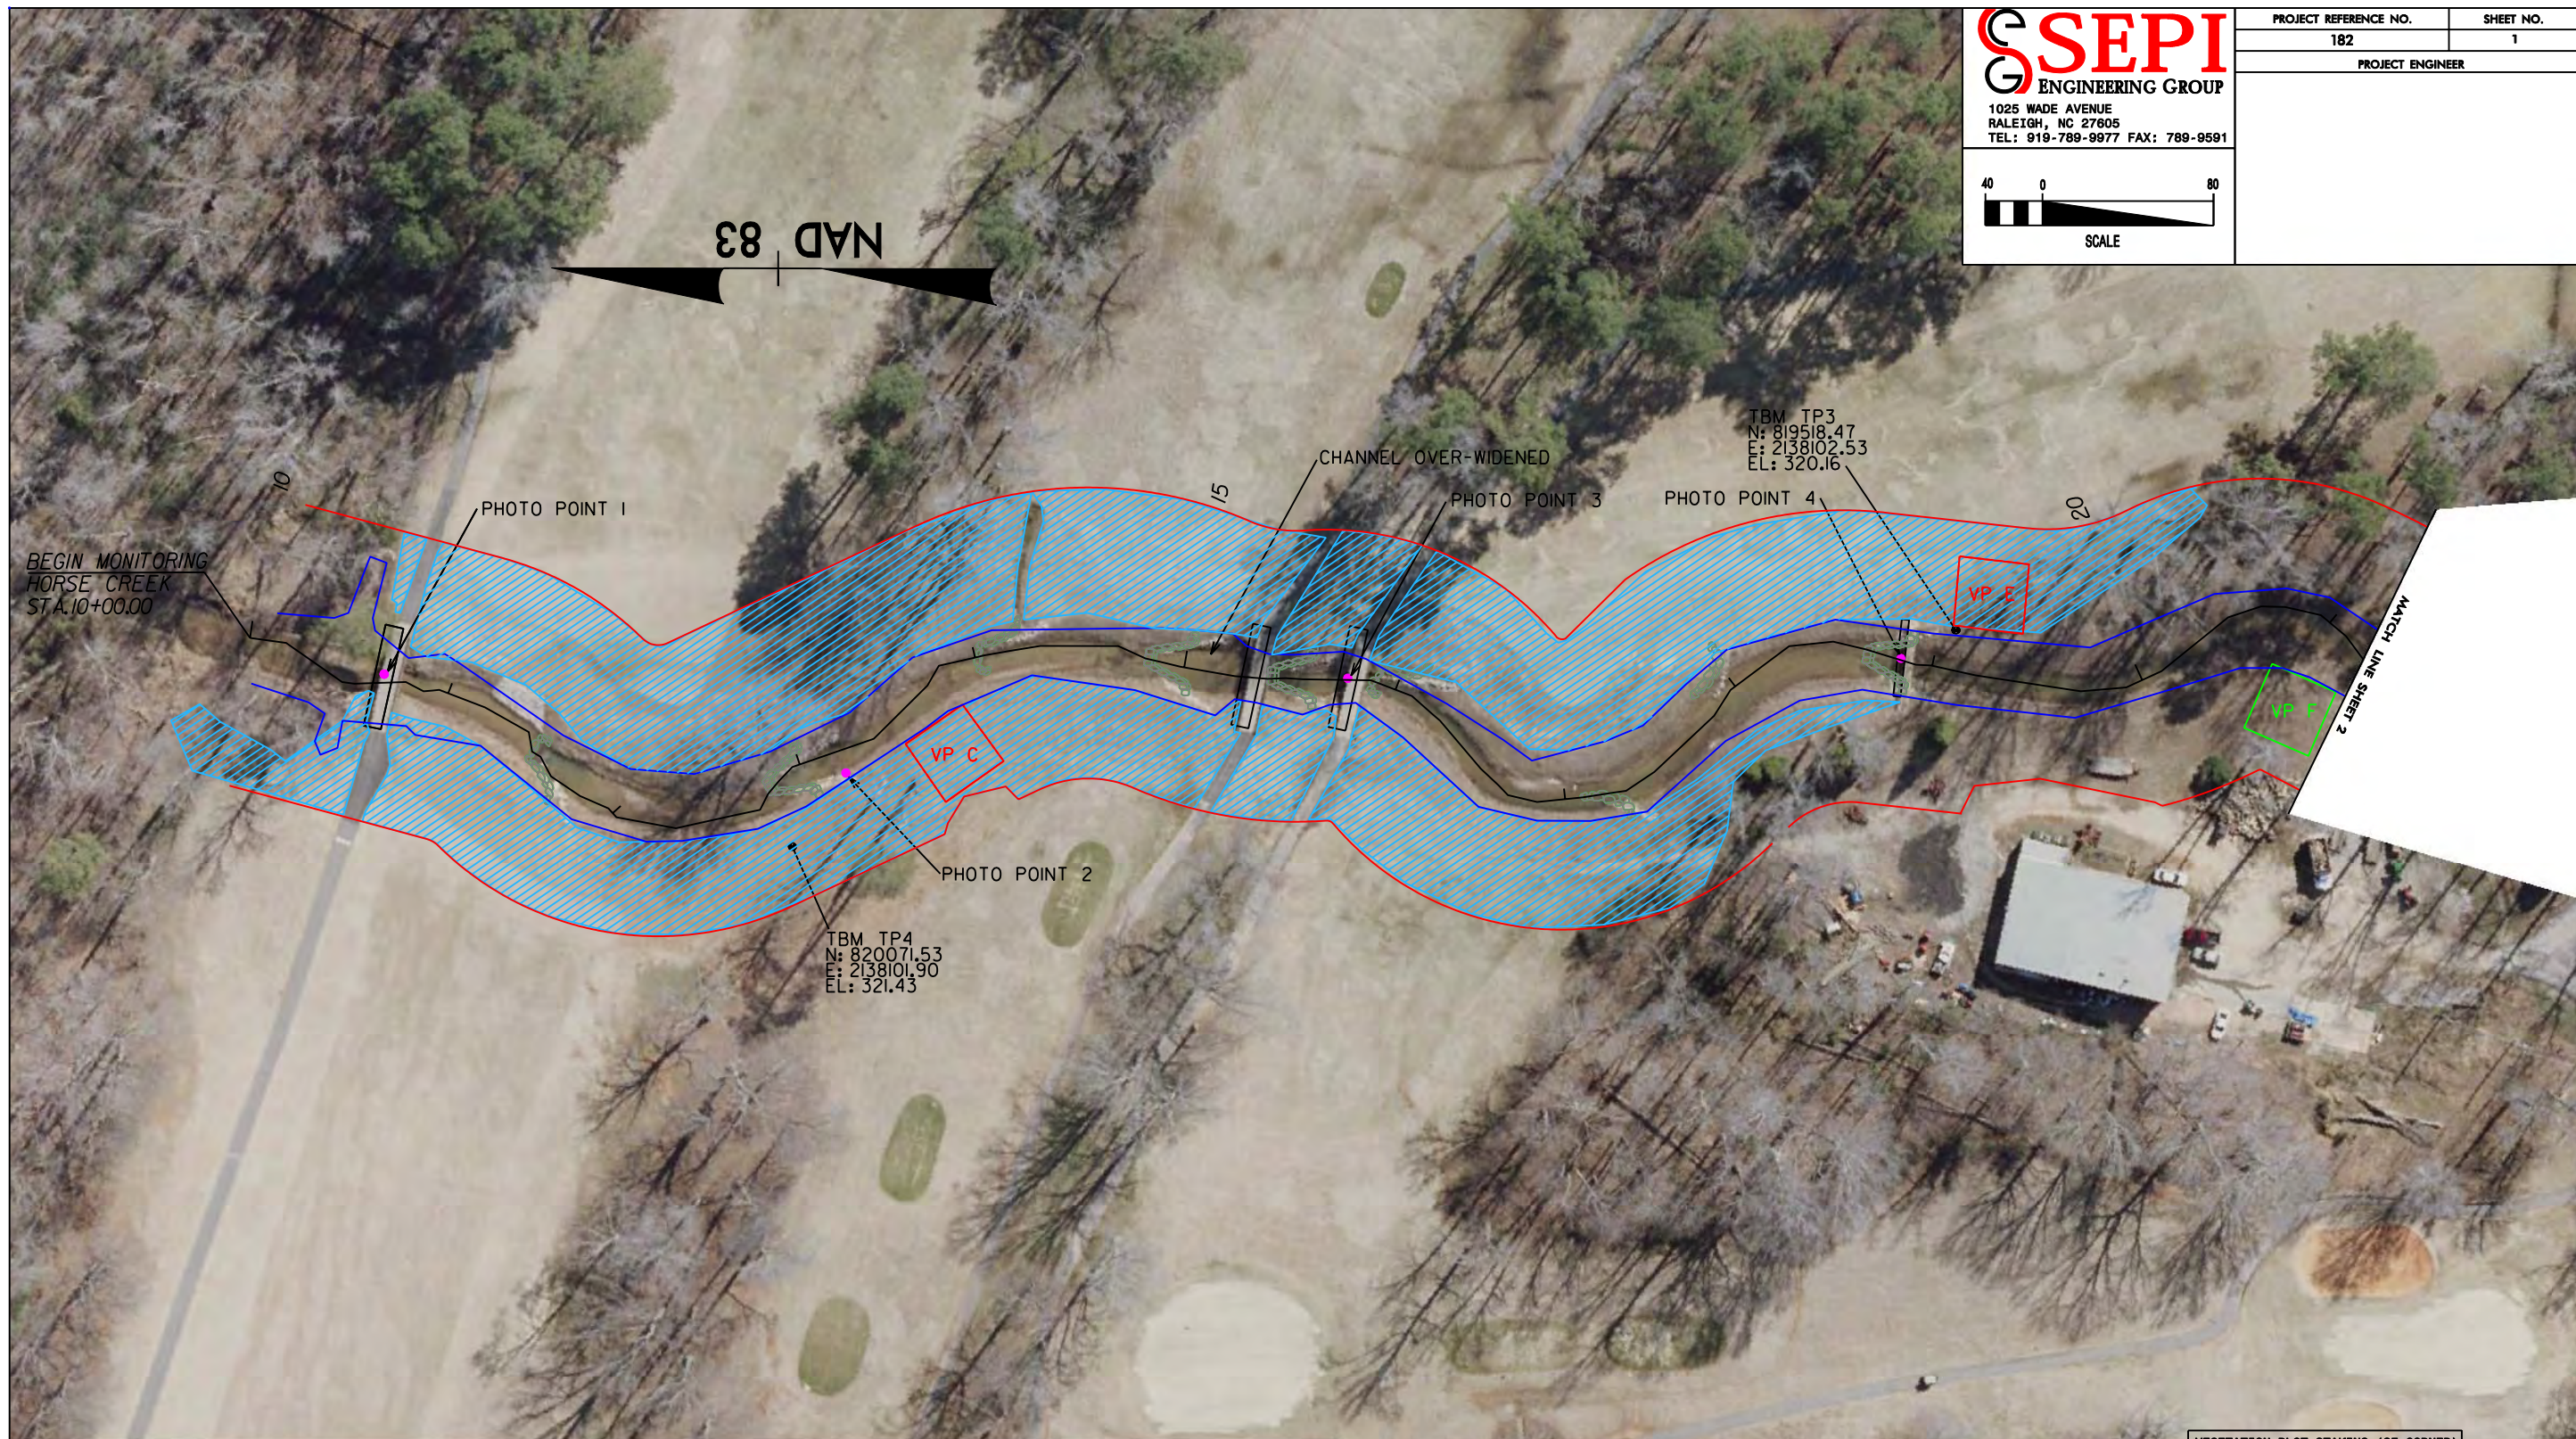
LOCATION:	HORSE CREEK	
	CURRENT CONDITIONS PLAN VIEW	
	FINAL VEGETATION- YEAR 4	
PROJ #:	182	COUNTY: WAKE
MONITORED BY:	IPJ	
CHECKED BY:	PDB	DATE: 3/01/2010

The most notable vegetation problems were long sections of floodplain that had been mowed as part of regular fairway maintenance before the country club closed. These areas are located along the upper two thirds of the Horse Creek mainstem and along the entire UT section (see Vegetation Problem Area Plan Views; Appendix A). These areas have started to fill in with vegetation since closing of the golf course (fall of 2007), but still appear to lack diversity. In addition, the lower portion of Horse Creek has intact stands of invasive Chinese privet (*Ligustrum sinense*) which appear to be spreading North along the project. The vegetation plots (VP) impacted by past-mowing (i.e., VP C, E, I, and O) have stem densities below 260 stems/acre (Monitoring Year 5 goal). However, planted stems across all plots were measured at 468 stems/acre. Therefore, planted stem densities of less than the Monitoring Year 5 goal should not be interpreted as an indication of the planted species being completely inappropriate, or the growing conditions being severely inhospitable. In fact, the evidence of naturalization of volunteer stems suggests the growing conditions are suitable for good herbaceous and woody vegetative growth without supplemental plantings. However, supplemental plantings should not be ruled out for several areas.
