**HORSE CREEK (WAKE FOREST COUNTRY CLUB)
FINAL MONITORING REPORT
YEAR 5 OF 5
2010**

EEP Project #409
Wake County, North Carolina

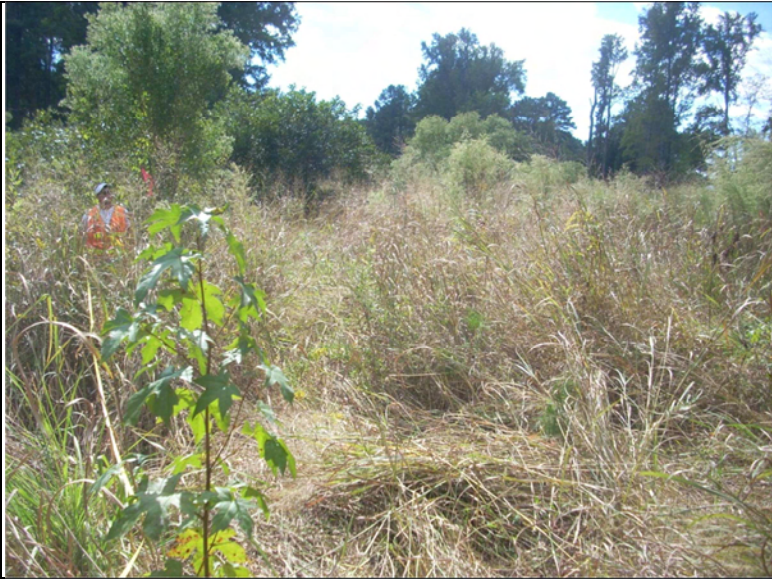
Photo 1: Vegetation Plot C (10-4-2010)

The vegetation plots (VP) impacted by past-mowing (i.e., VP C, E, I, and O) have stem densities below 260 stems/acre (Monitoring Year 5 goal). Planted stems across all plots were measured at 243 stems / acre. Although planted stem densities were less than the Monitoring Year 5 goal, overall stem densities including native volunteers exceeded 260 stems / acre. Growing conditions appear to support locally adapted species. However, supplemental plantings will benefit several regions.

A supplemental invasive exotic species assessment was performed during September 22 and 23, 2009. The site has been treated for exotics and invasives during the 2010 growing season and will continue to be treated during the 2011 growing season. Supplemental planting is scheduled for late 2011.
