**FINAL  
MY4 (2023) MONITORING REPORT**

**WARREN WILSON COLLEGE STREAM MITIGATION SITE**

Buncombe County, North Carolina

NCDMS Project ID No. 100019

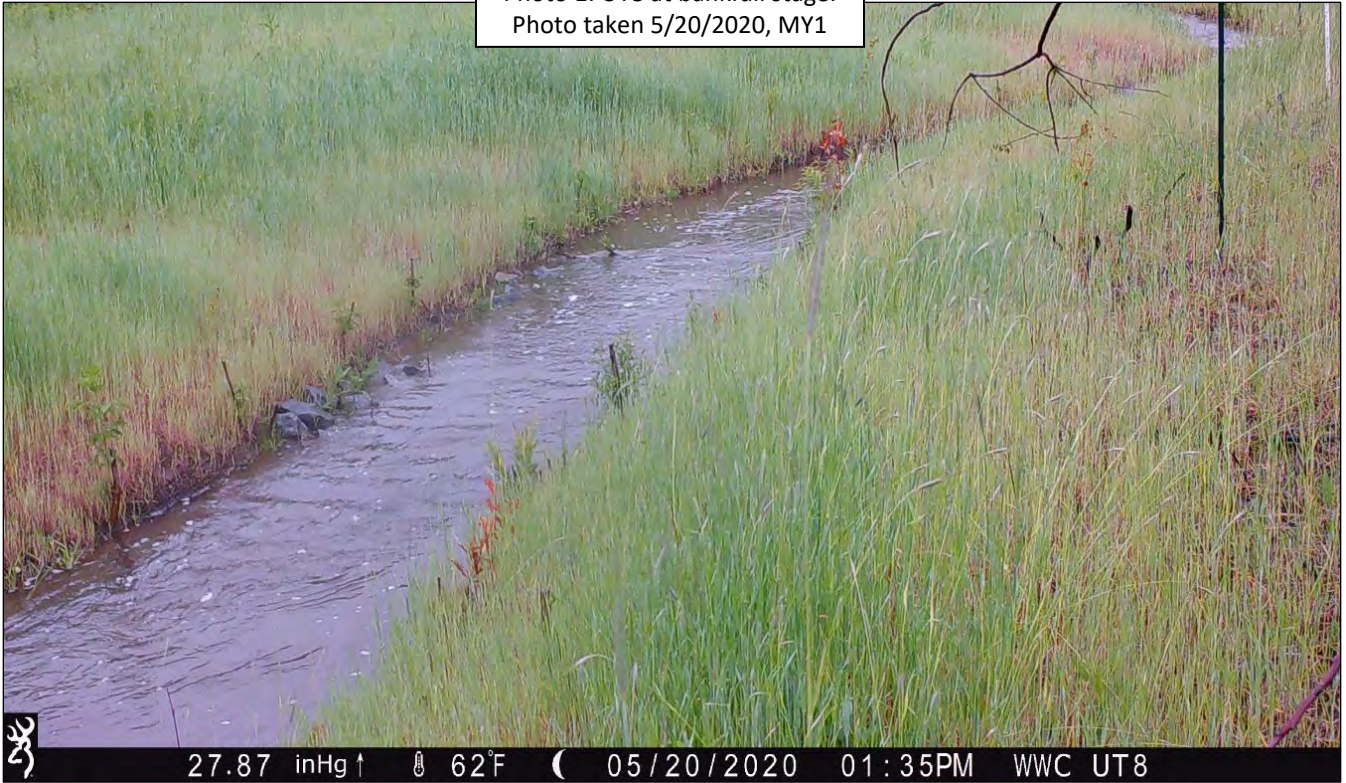
Photo 1: UT8 at bankfull stage.  
Photo taken 5/20/2020, MY1

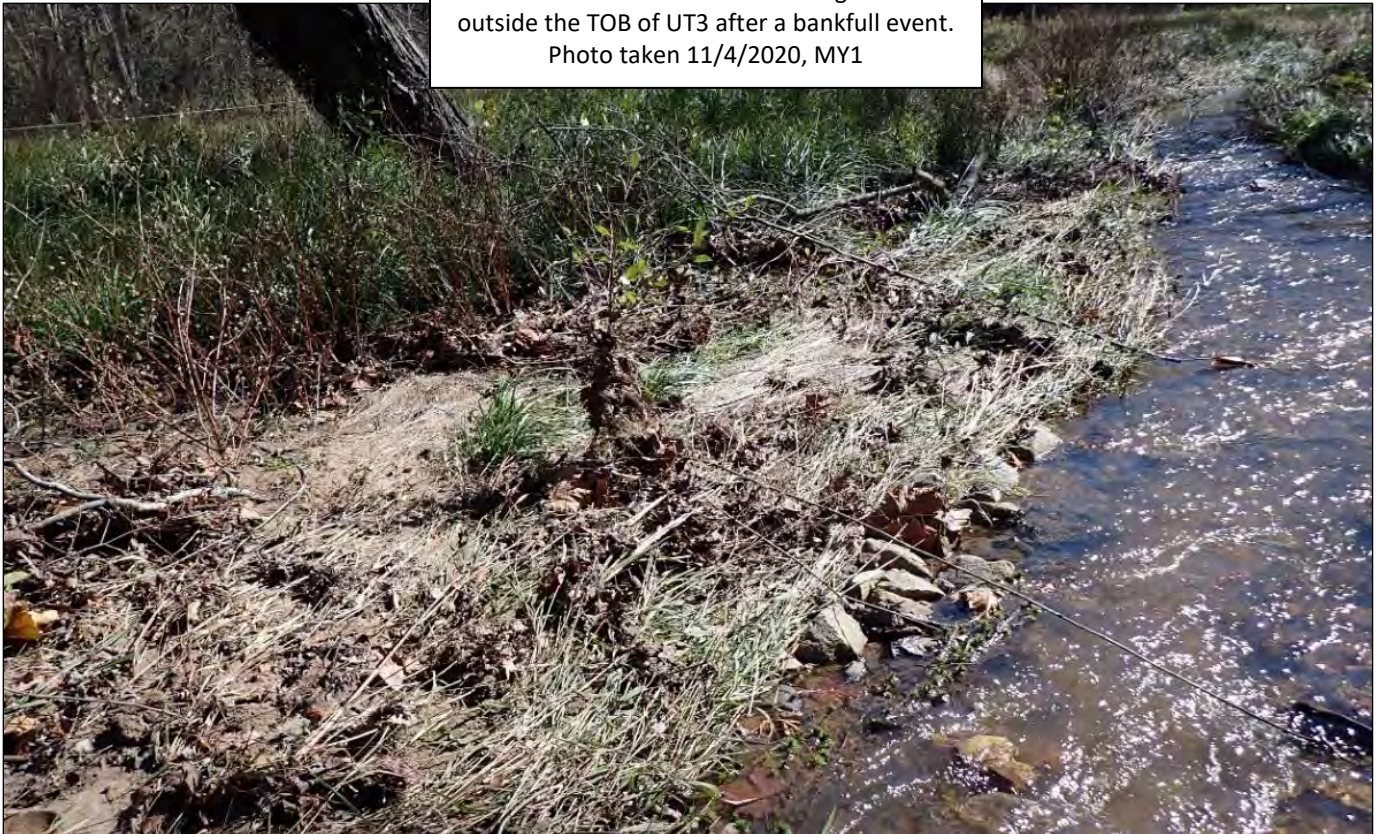
Photo 2: Wrack and laid-back vegetation  
outside the TOB of UT3 after a bankfull event.  
Photo taken 11/4/2020, MY1

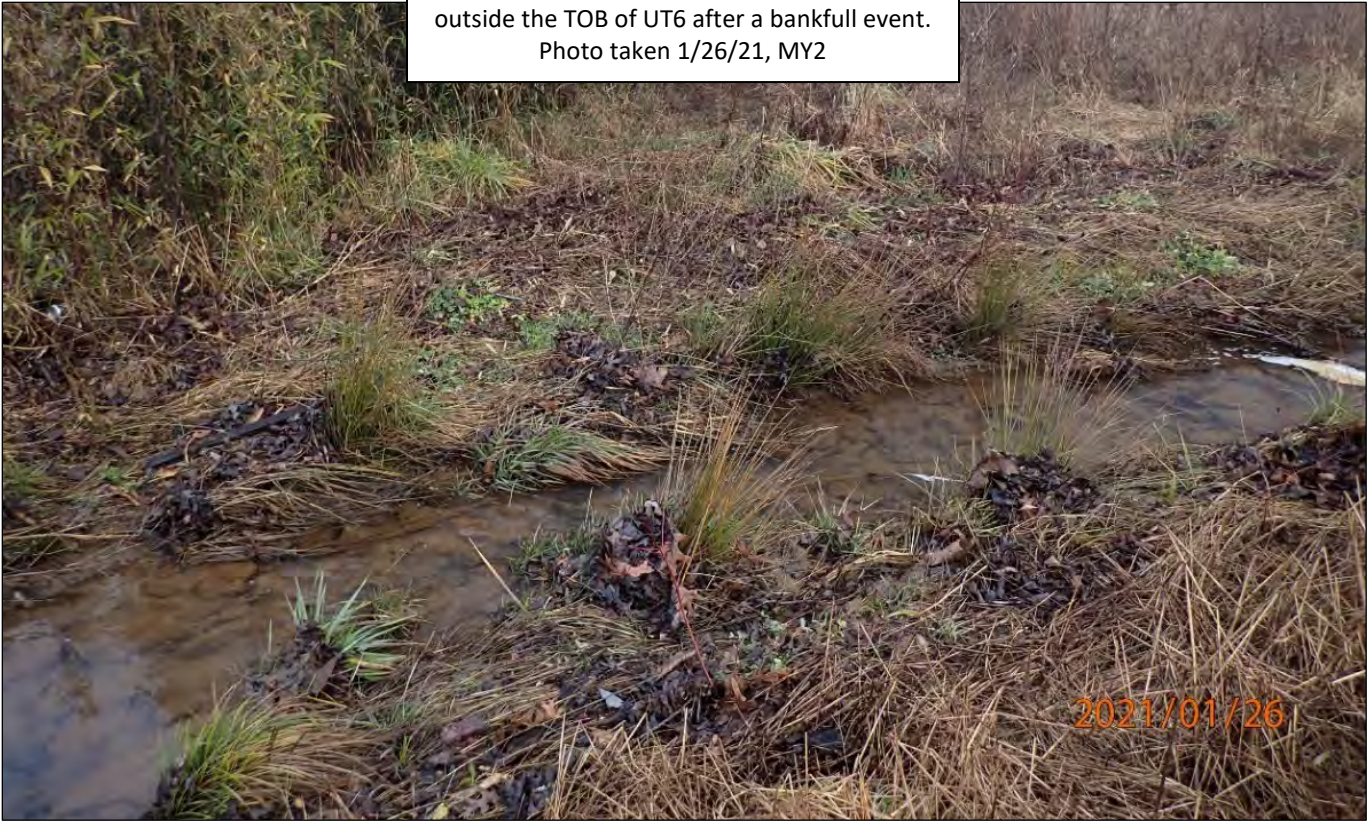
Photo 3: Wrack and laid-back vegetation  
outside the TOB of UT6 after a bankfull event.  
Photo taken 1/26/21, MY2

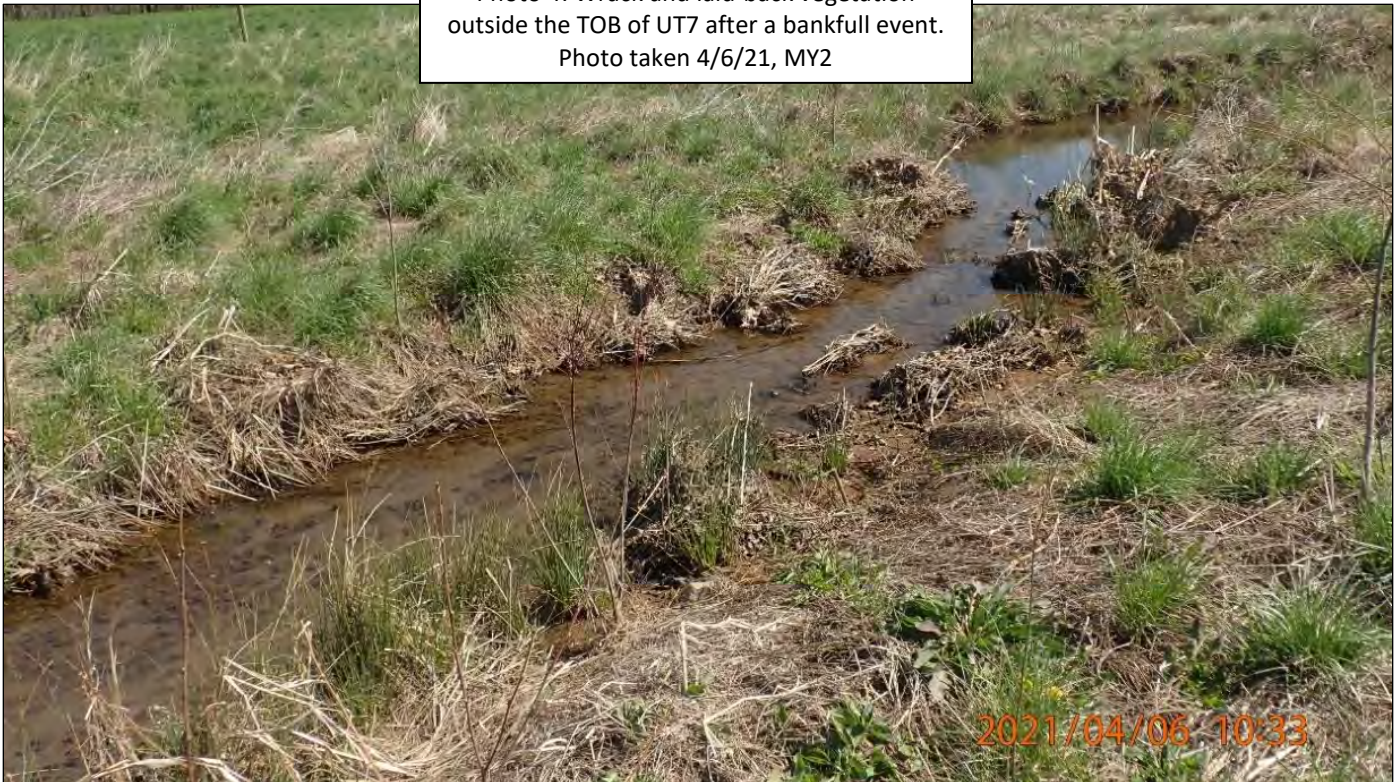
Photo 4: Wrack and laid-back vegetation  
outside the TOB of UT7 after a bankfull event.  
Photo taken 4/6/21, MY2

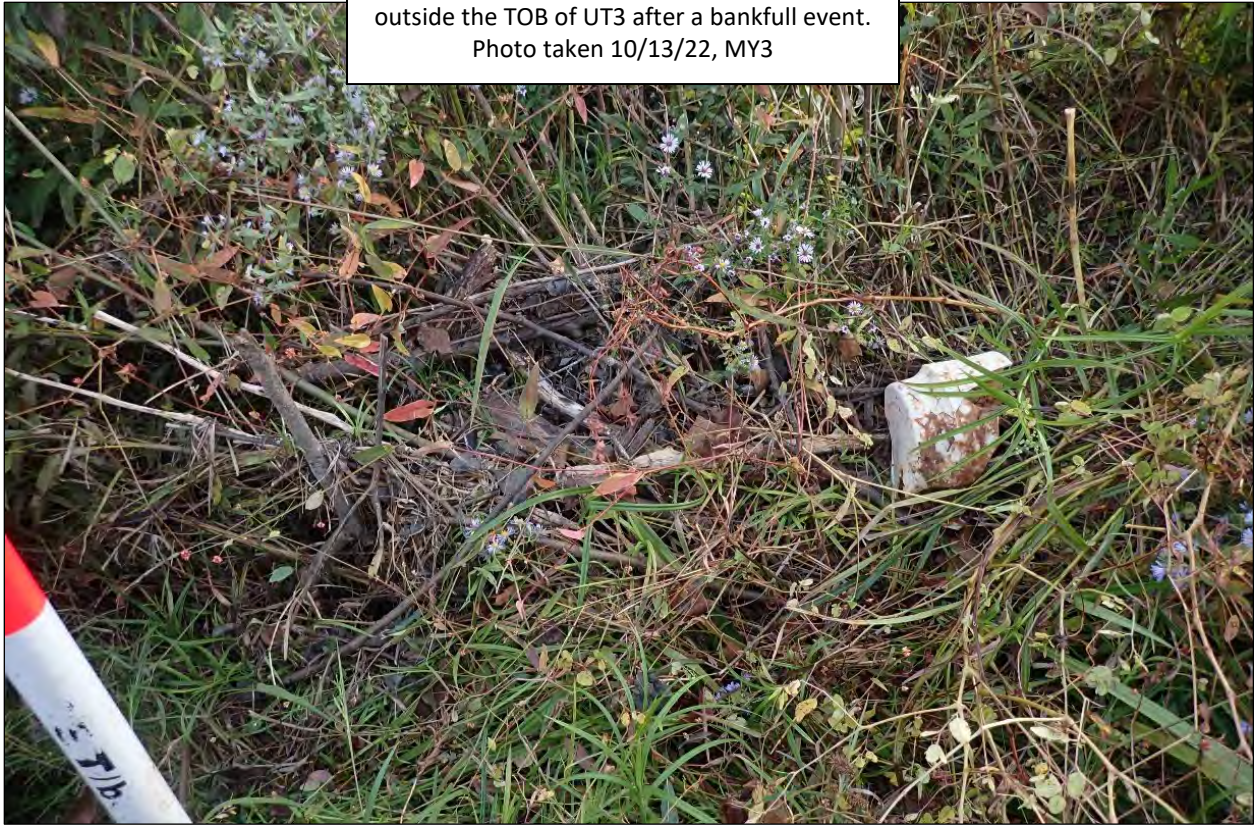
Photo 5: Wrack and laid-back vegetation  
outside the TOB of UT3 after a bankfull event.  
Photo taken 10/13/22, MY3

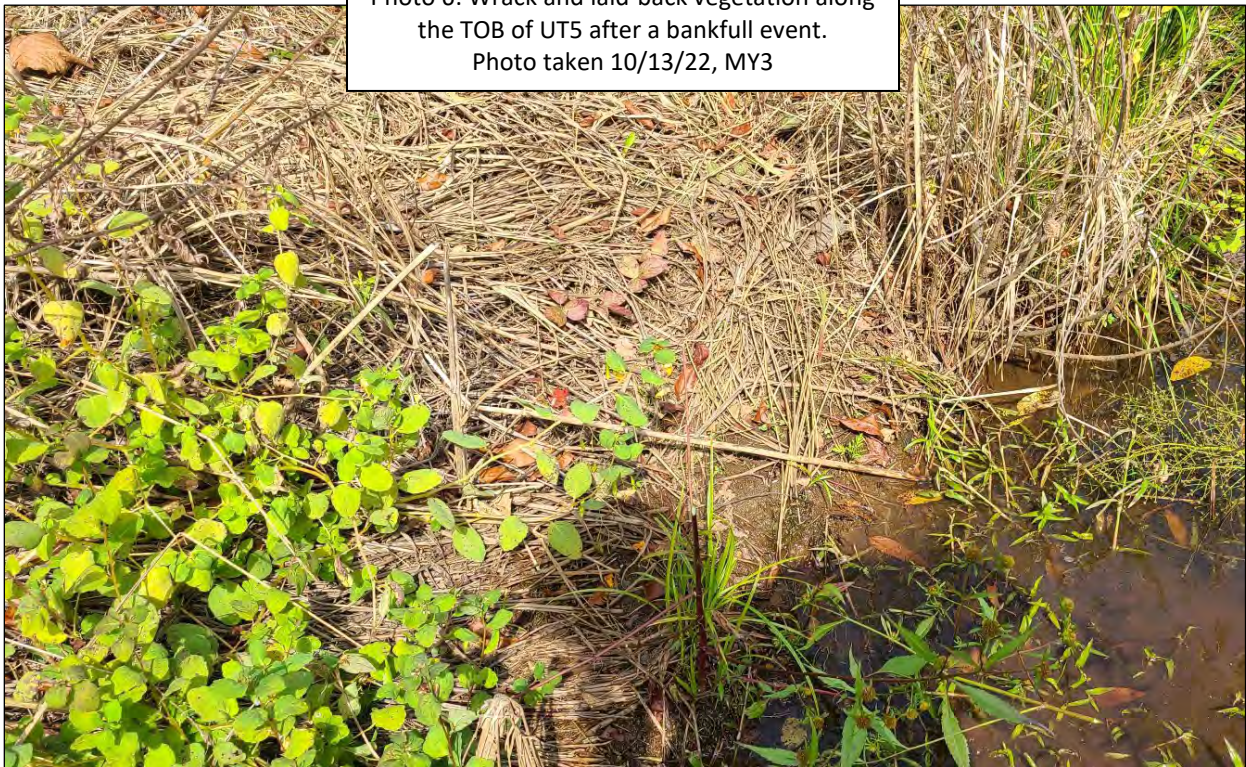
Photo 6: Wrack and laid-back vegetation along  
the TOB of UT5 after a bankfull event.  
Photo taken 10/13/22, MY3

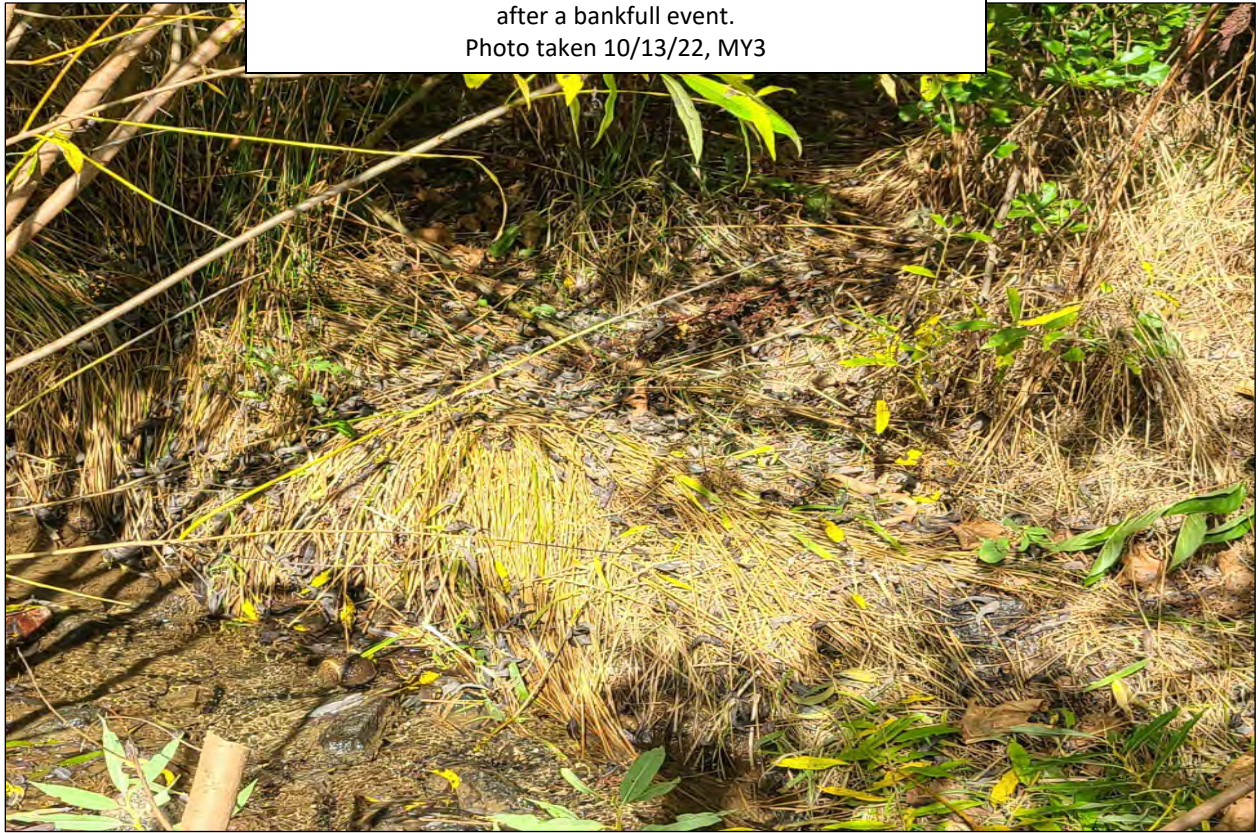
Photo 7: Wrack and laid-back vegetation along the TOB of UT8  
after a bankfull event.  
Photo taken 10/13/22, MY3

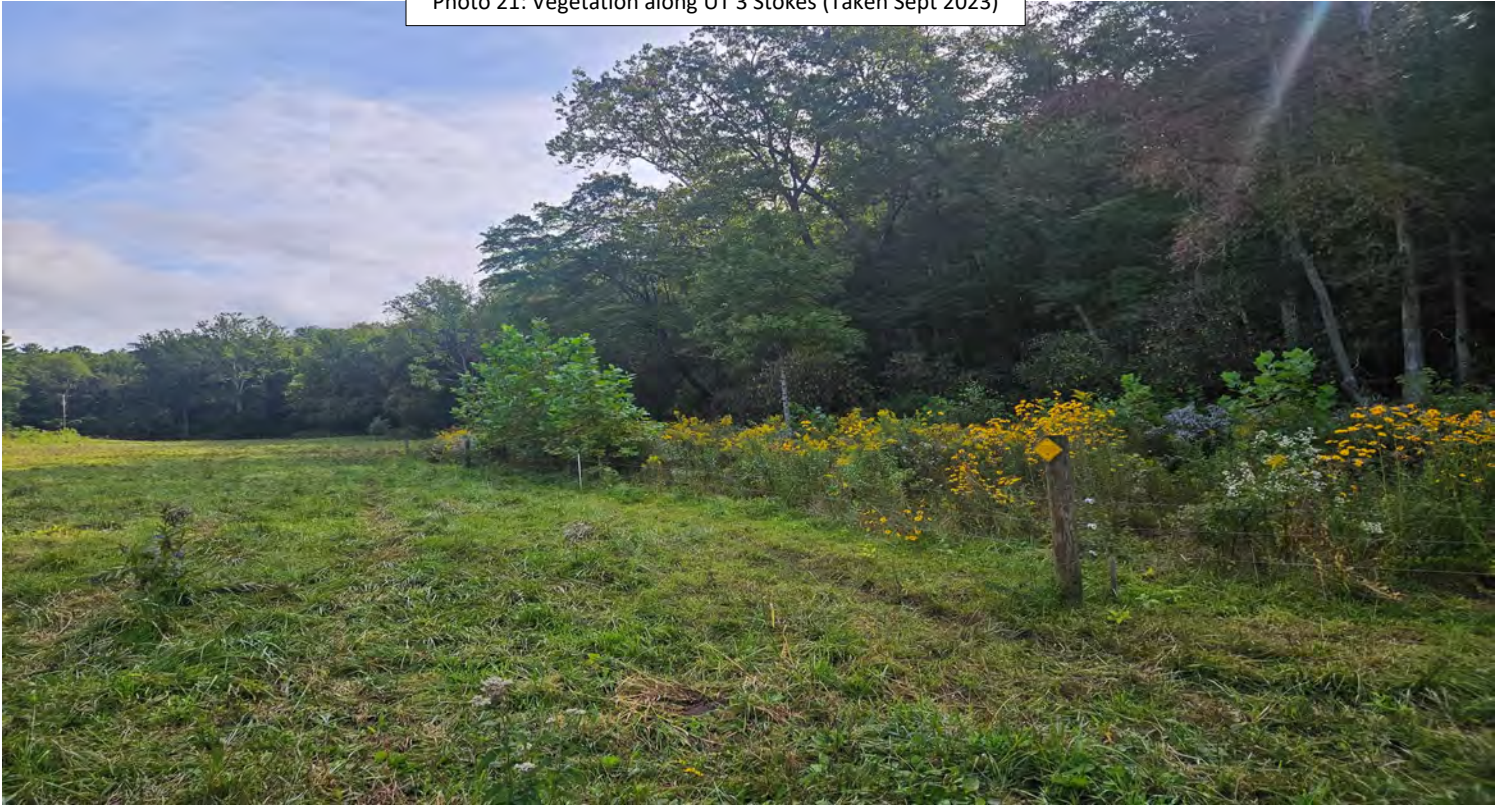
Photo 21: Vegetation along UT 3 Stokes (Taken Sept 2023)

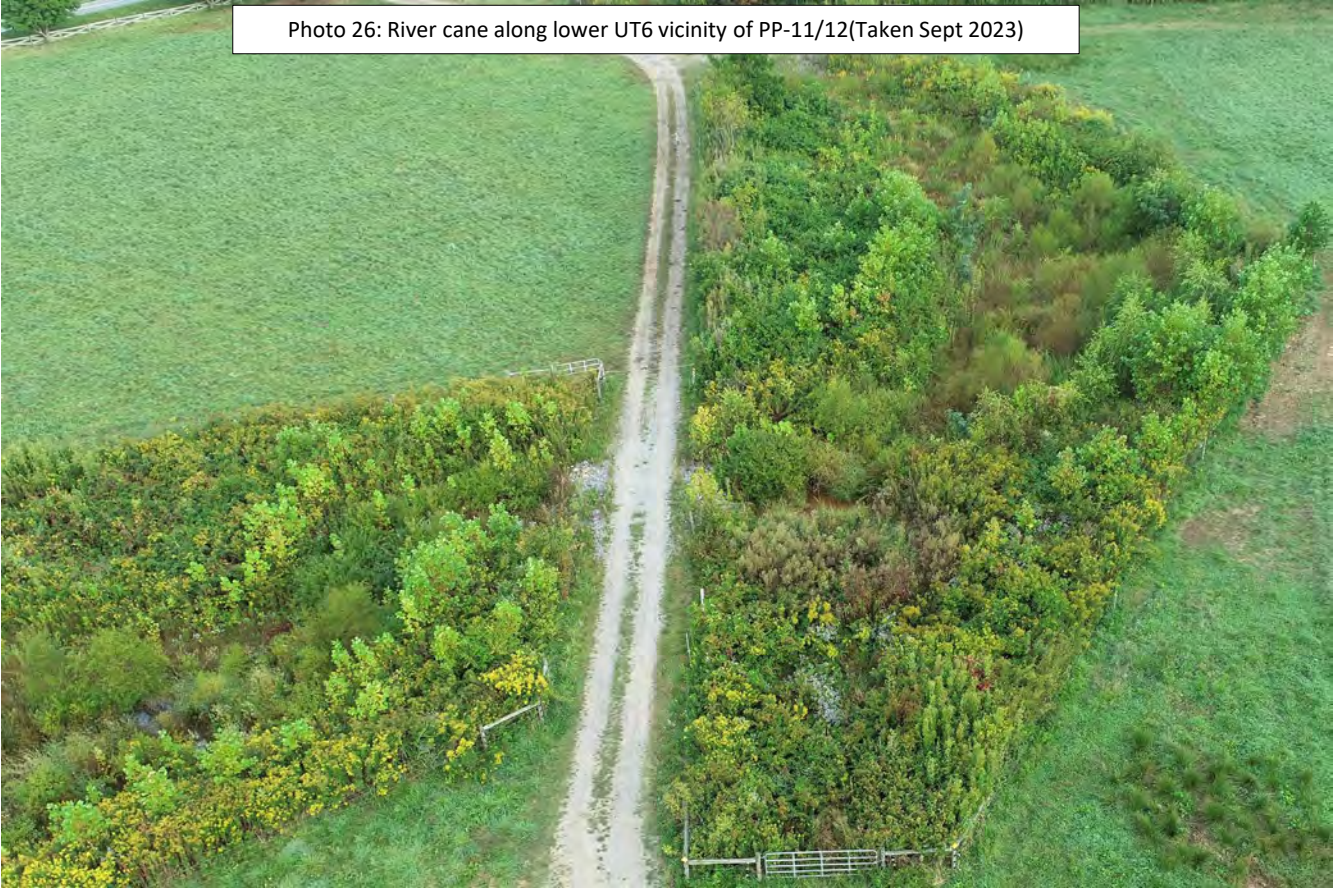
Photo 26: River cane along lower UT6 vicinity of PP-11/12(Taken Sept 2023)

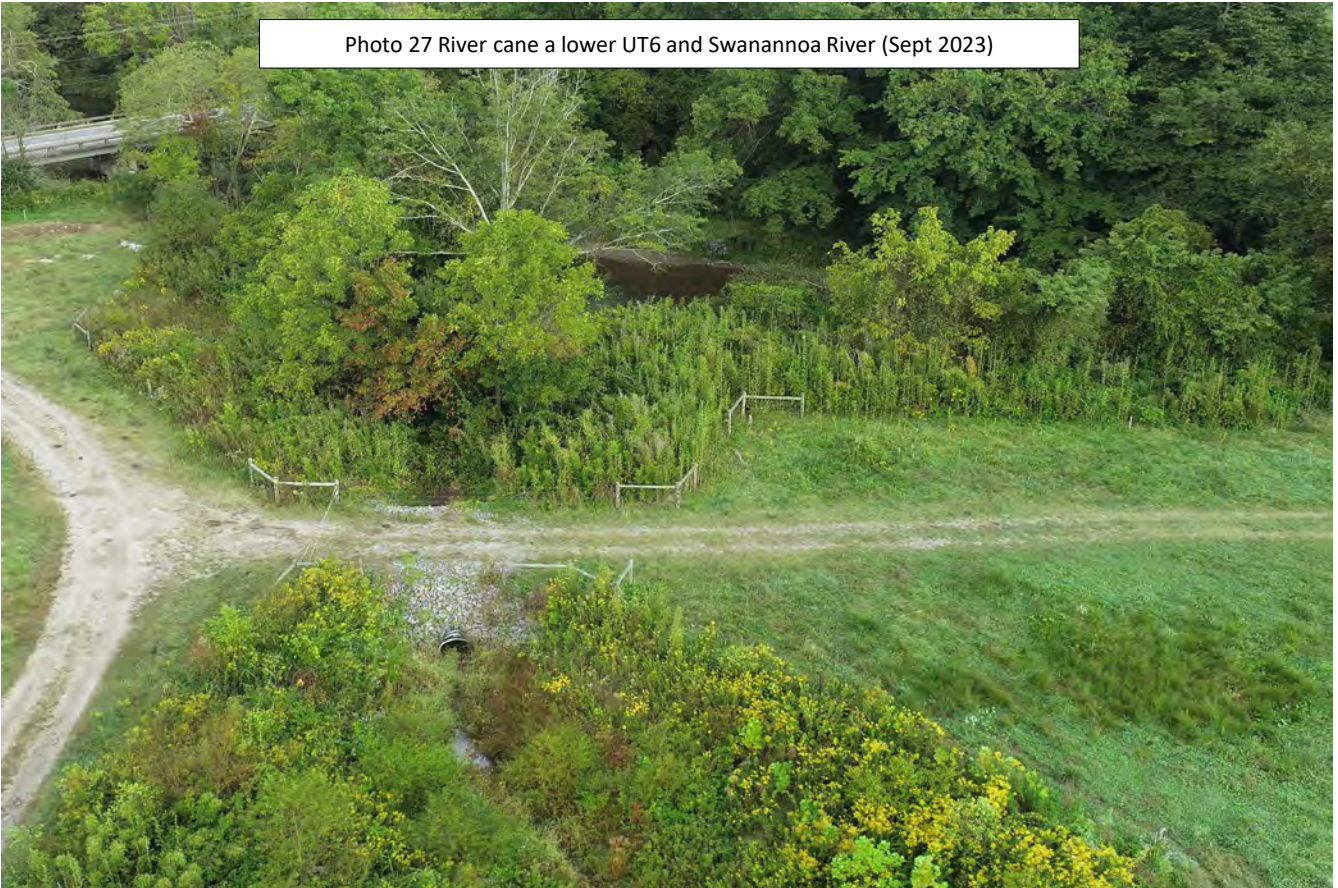
Photo 27 River cane a lower UT6 and Swanannoa River (Sept 2023)
