FINAL
MONITORING REPORT (MY1)

WARREN WILSON COLLEGE STREAM MITIGATION SITE
Buncombe County, North Carolina

NCDMS Project ID No. 100019
Full Delivery Contract No. 7188
USACE Action ID No. SAW-2017-01557
NCDWR No. 20171158
RFP No. 16-006991 (Issued: 9/16/16)

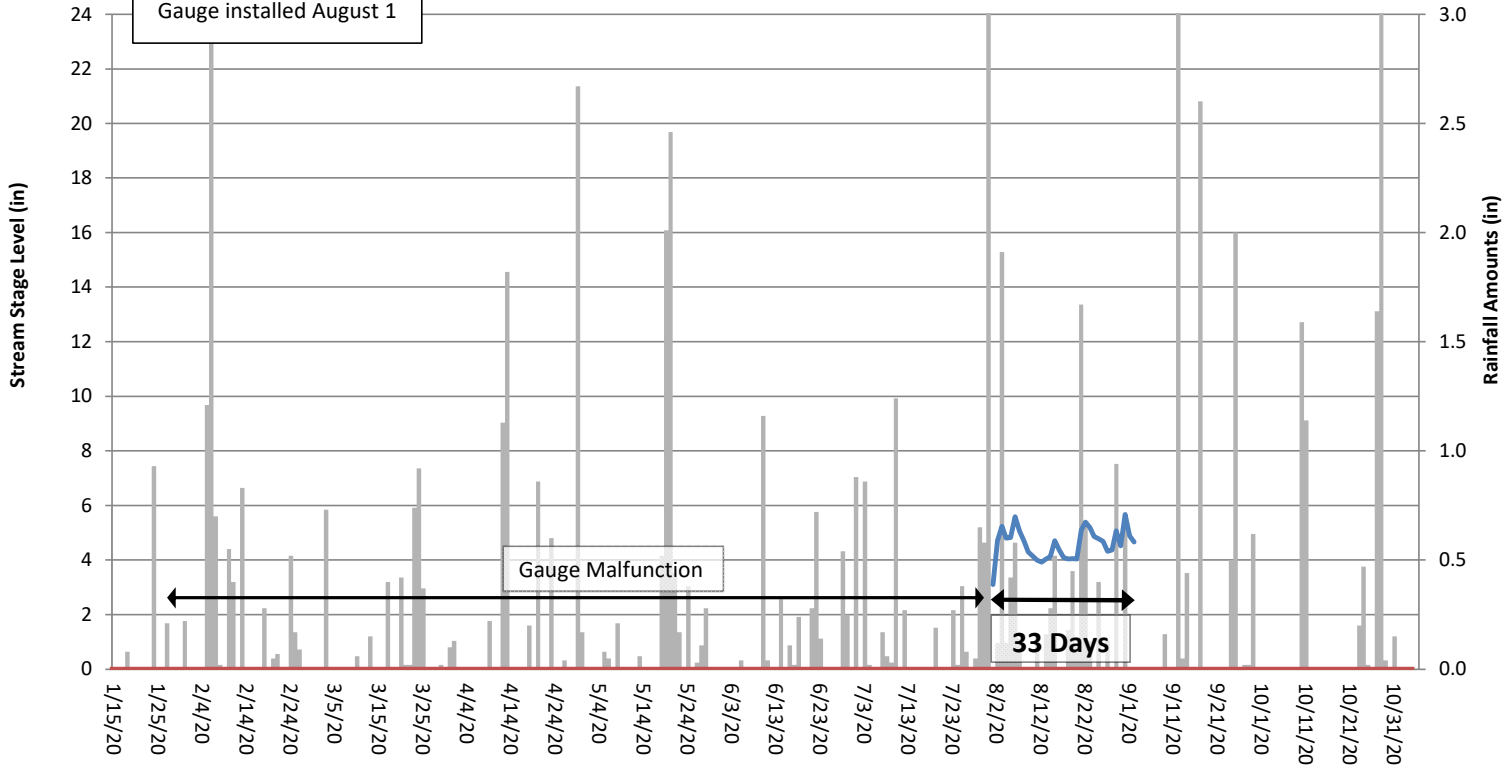
Warren Wilson Creek UT6 Stream Flow Gauge Year 1 (2020 Data)

*The gauge was installed August 1, 2020. Based on precipitation data, adjacent groundwater gauge data (Gauge 9), and other Site stream gauge data, it is expected to have flowed consecutively for much of the year 1 (2020) monitoring period.

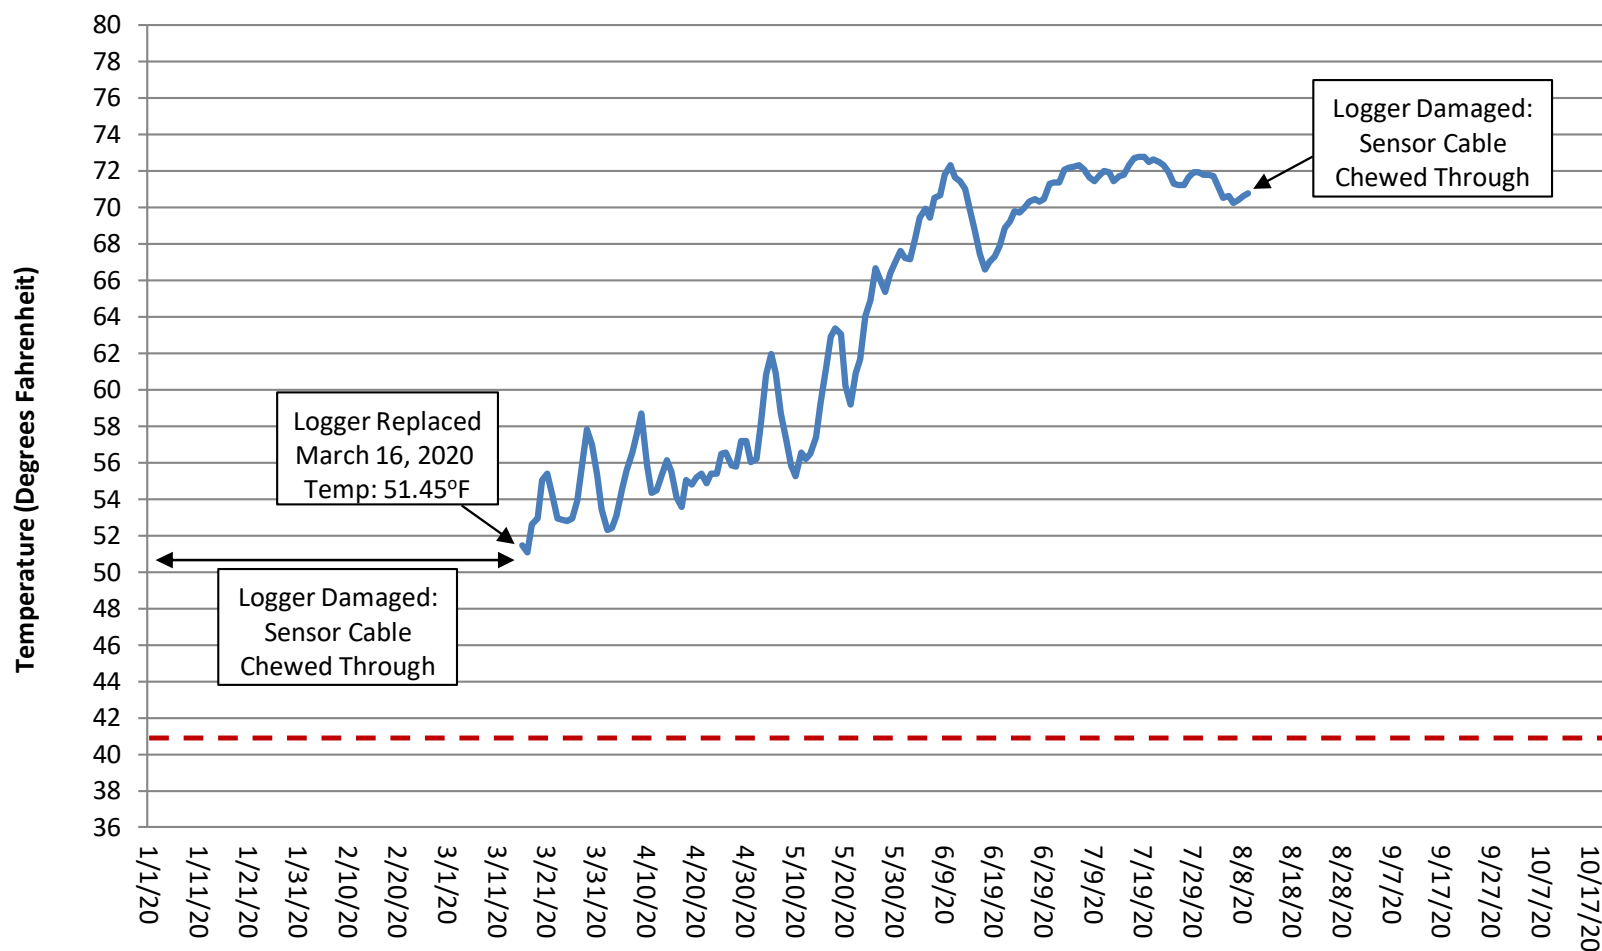
Figure E-1. Year 1 (2020) Soil Temperature Data

*Based on observed/documentated bud burst and data collected from a soil temperature data logger located on the Site (Figure E-1, Appendix E).
