FINAL
MONITORING REPORT (MY2)

WARREN WILSON COLLEGE STREAM MITIGATION SITE

Buncombe County, North Carolina

Data Collection: January - October 2021
Submission: January 2022

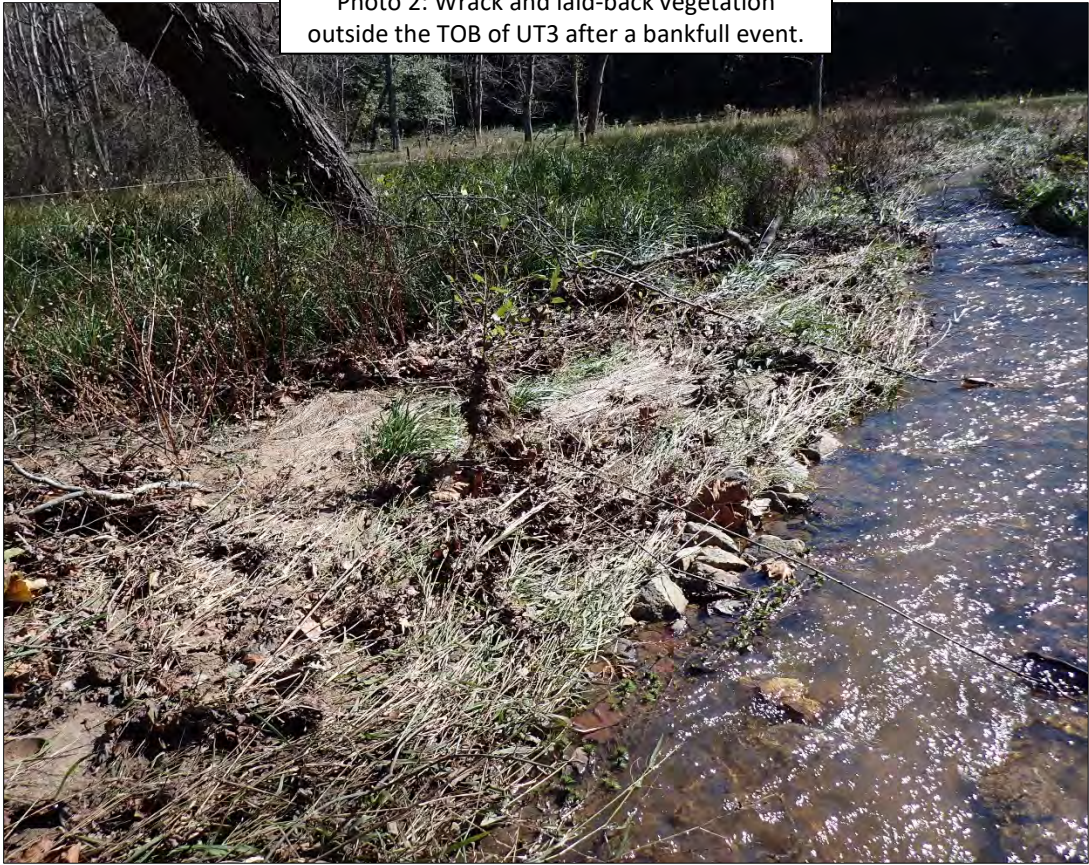
Photo 2: Wrack and laid-back vegetation outside the TOB of UT3 after a bankfull event.

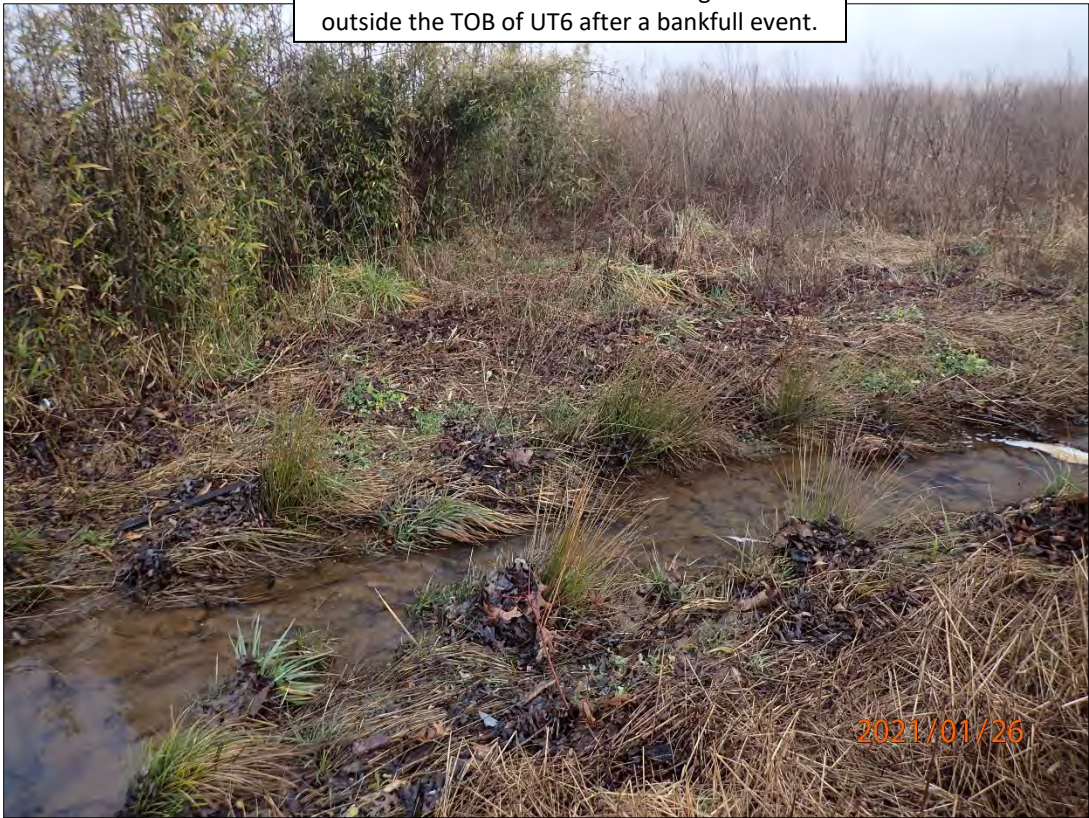
Photo 3: Wrack and laid-back vegetation outside the TOB of UT6 after a bankfull event.

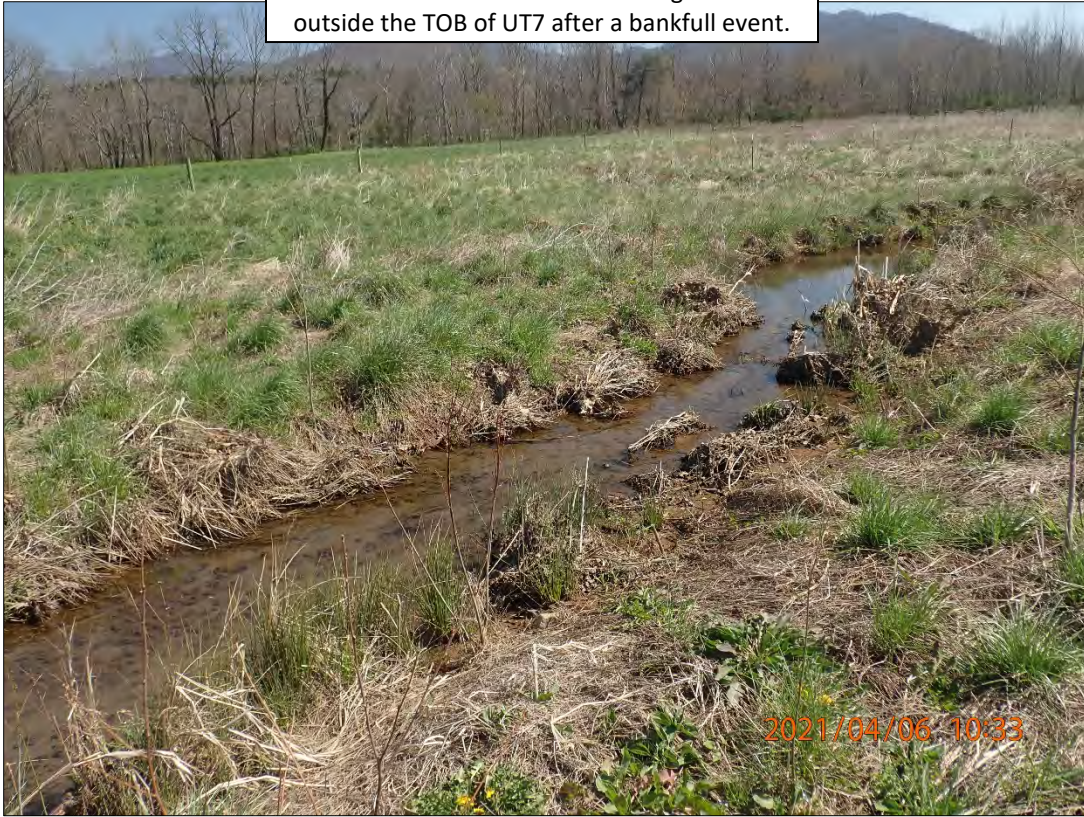
Photo 4: Wrack and laid-back vegetation outside the TOB of UT7 after a bankfull event.
