FINAL MONITORING REPORT (MY3)

WARREN WILSON COLLEGE STREAM MITIGATION SITE

Buncombe County, North Carolina

NCDMS Project ID No. 100019 Full Delivery Contract No. 7188 USACE Action ID No. SAW-2017-01557 NCDWR No. 20171158 RFP No. 16-006991 (Issued: 9/16/16)

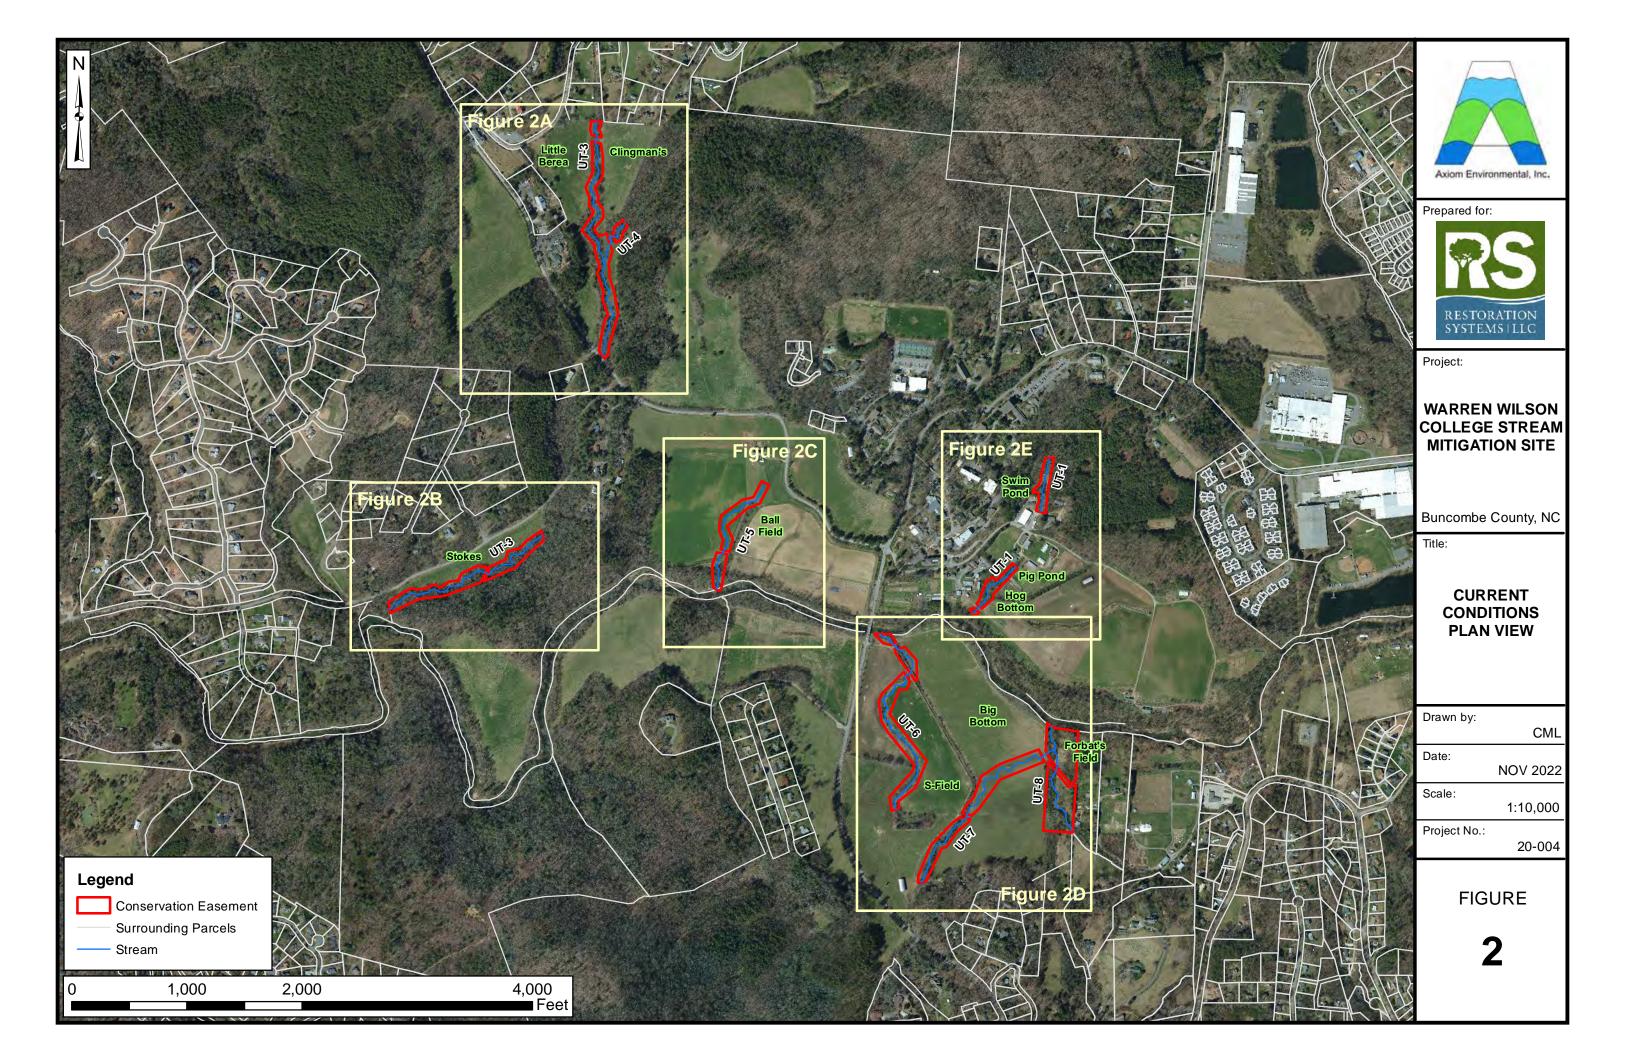
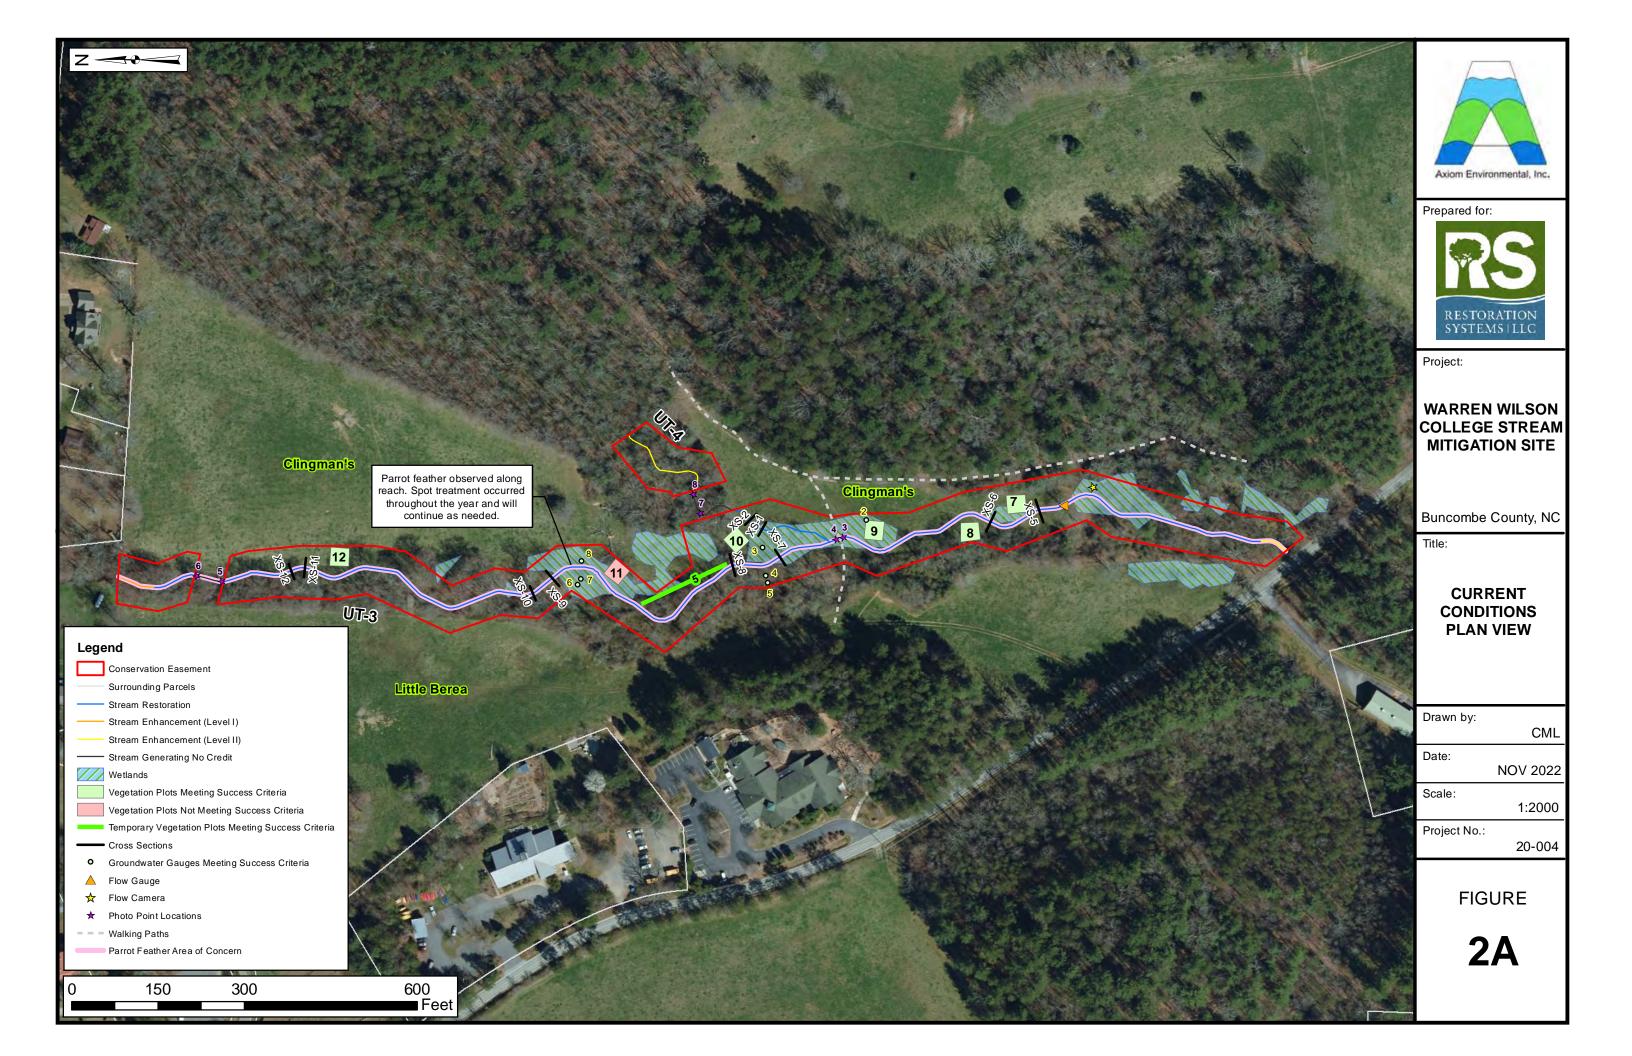
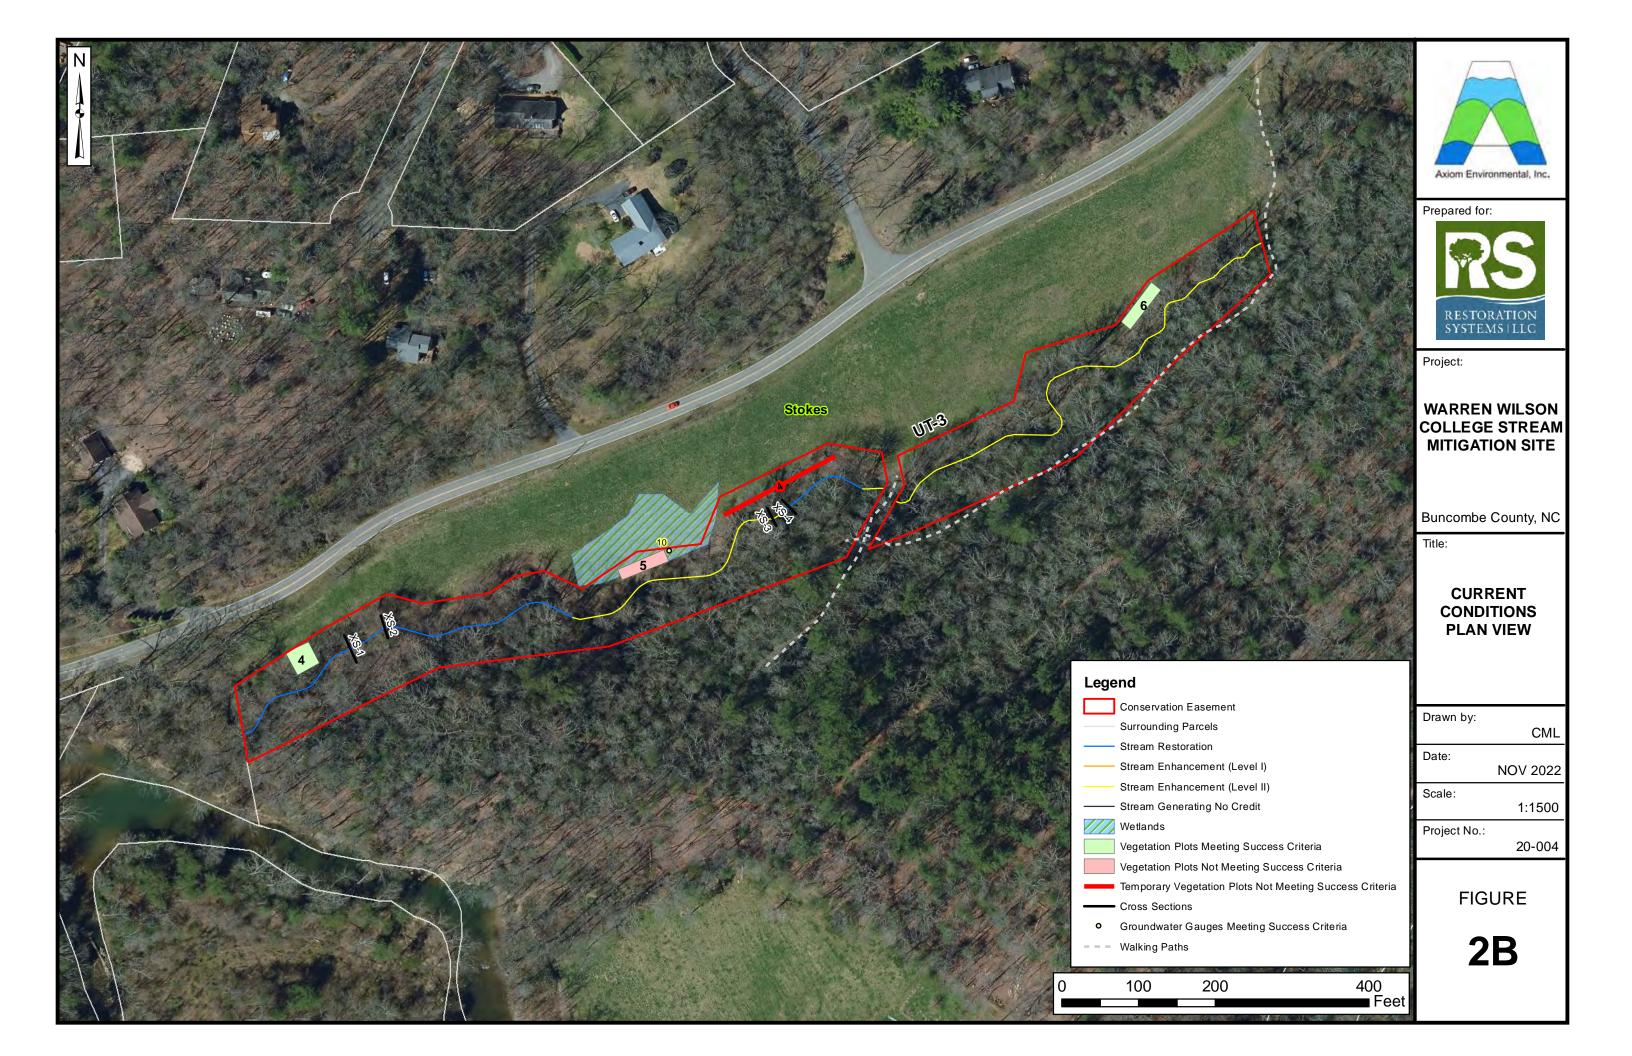
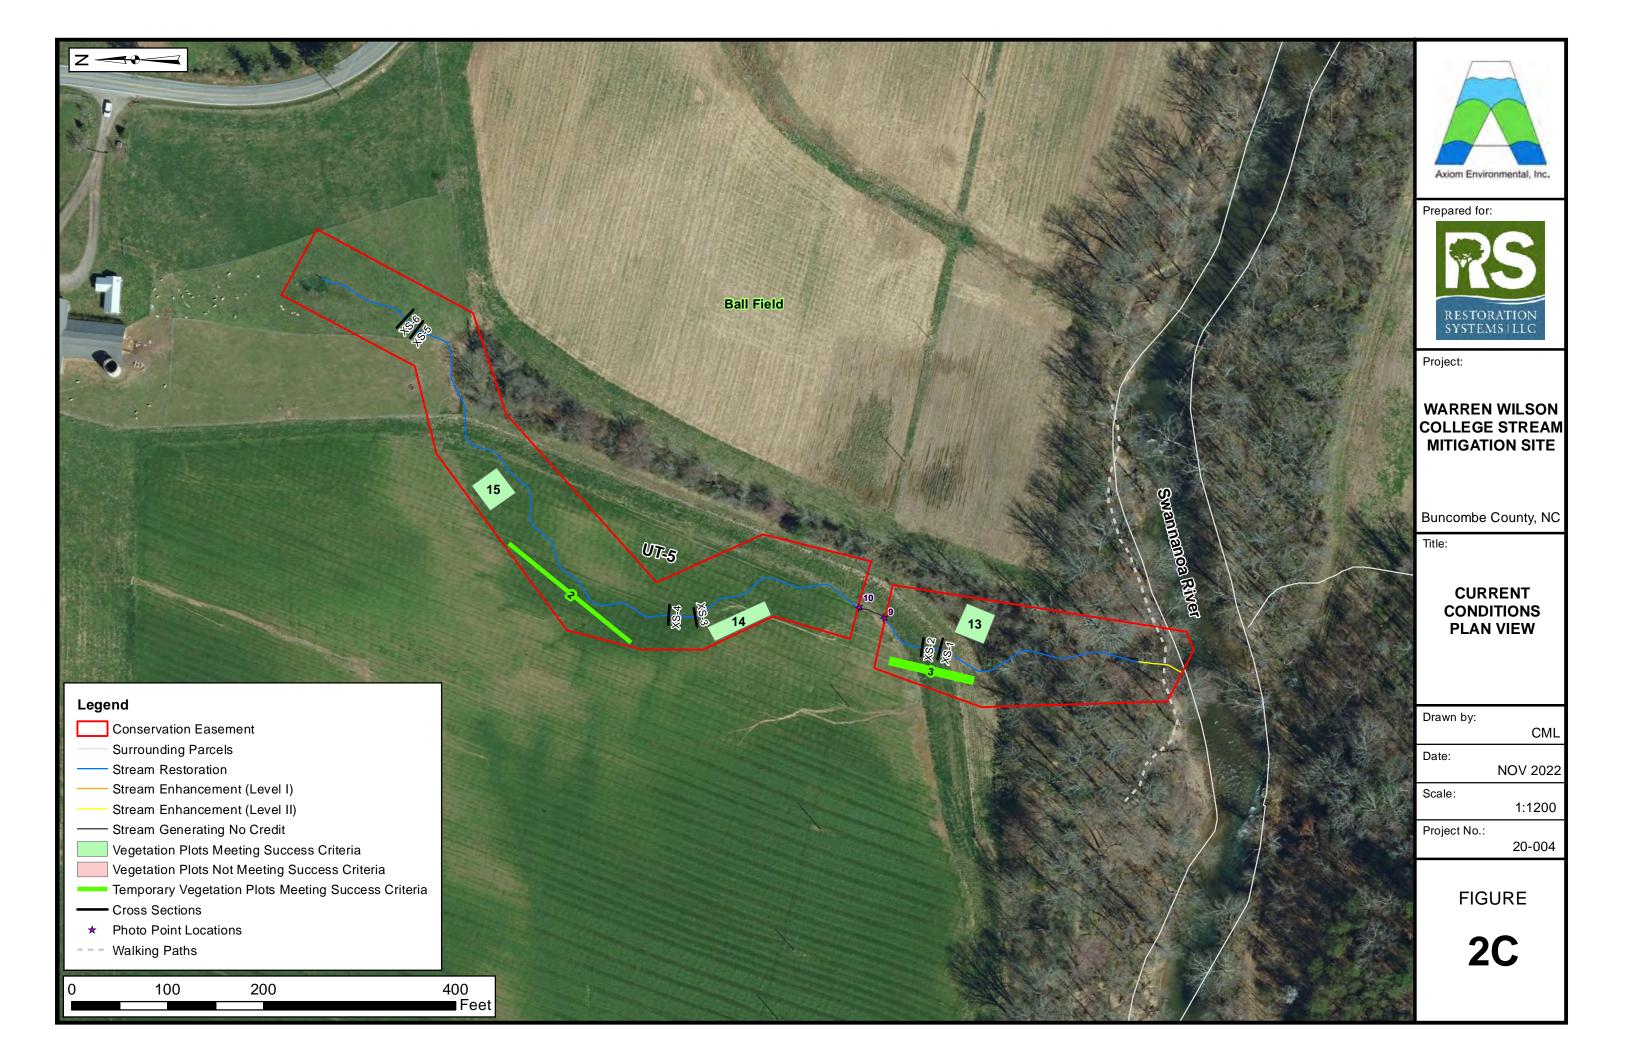
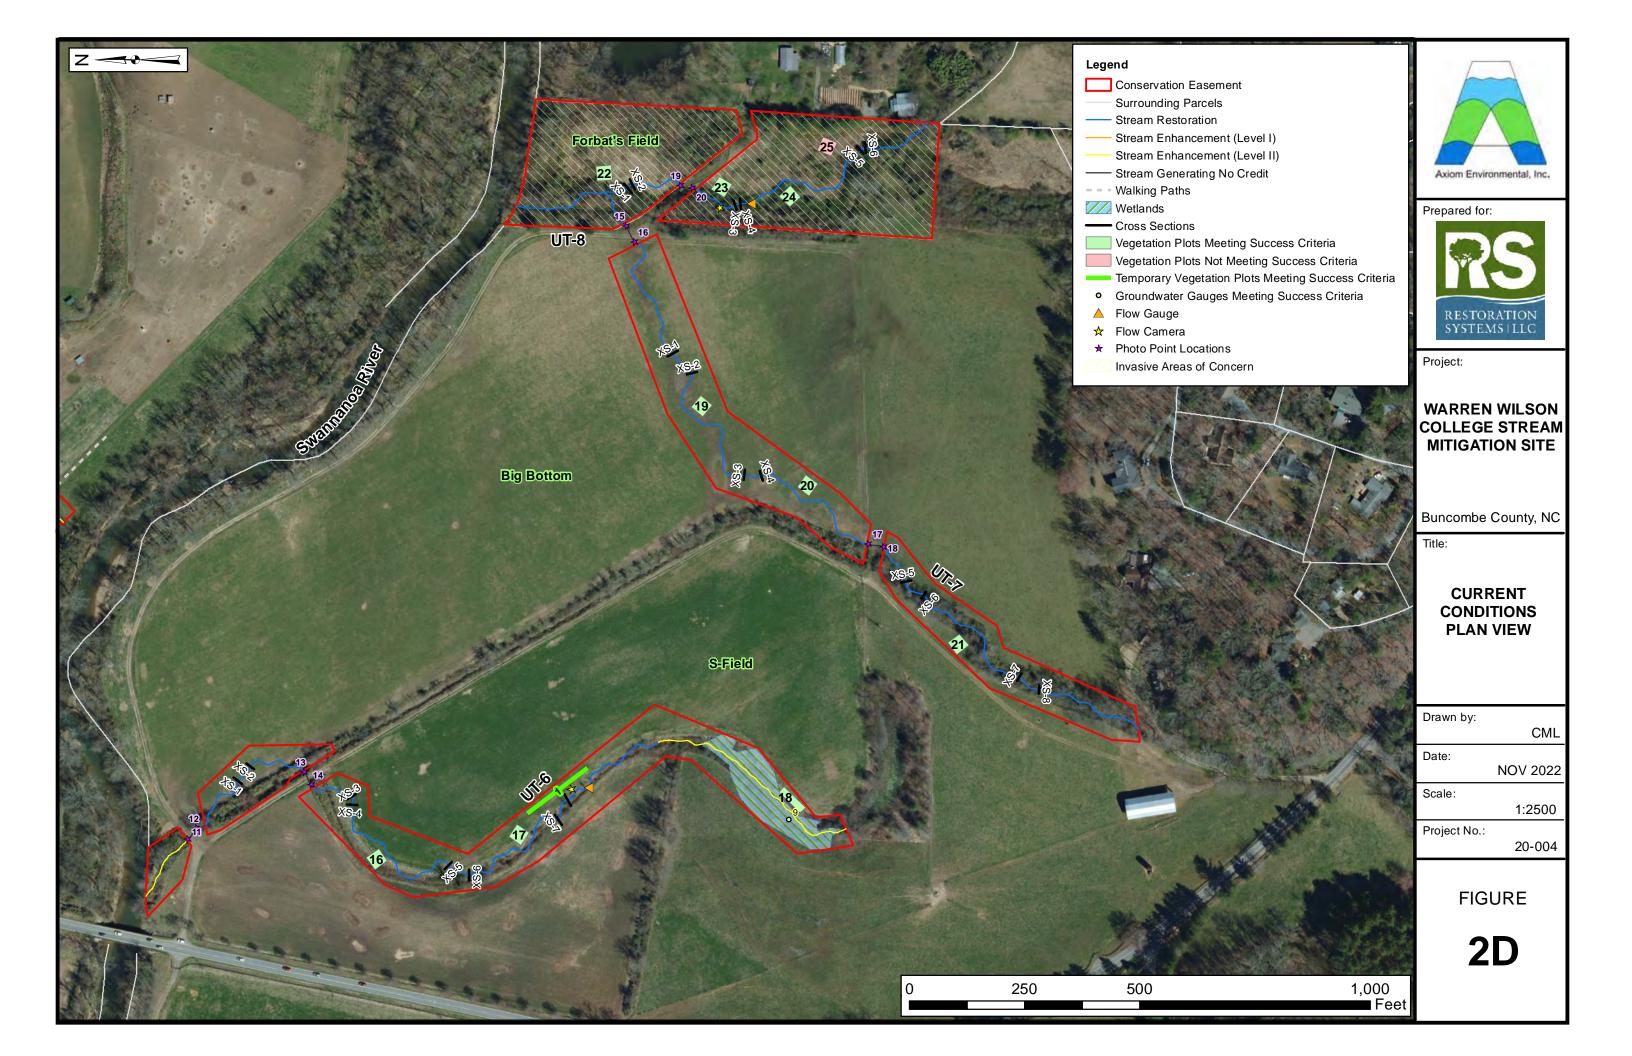
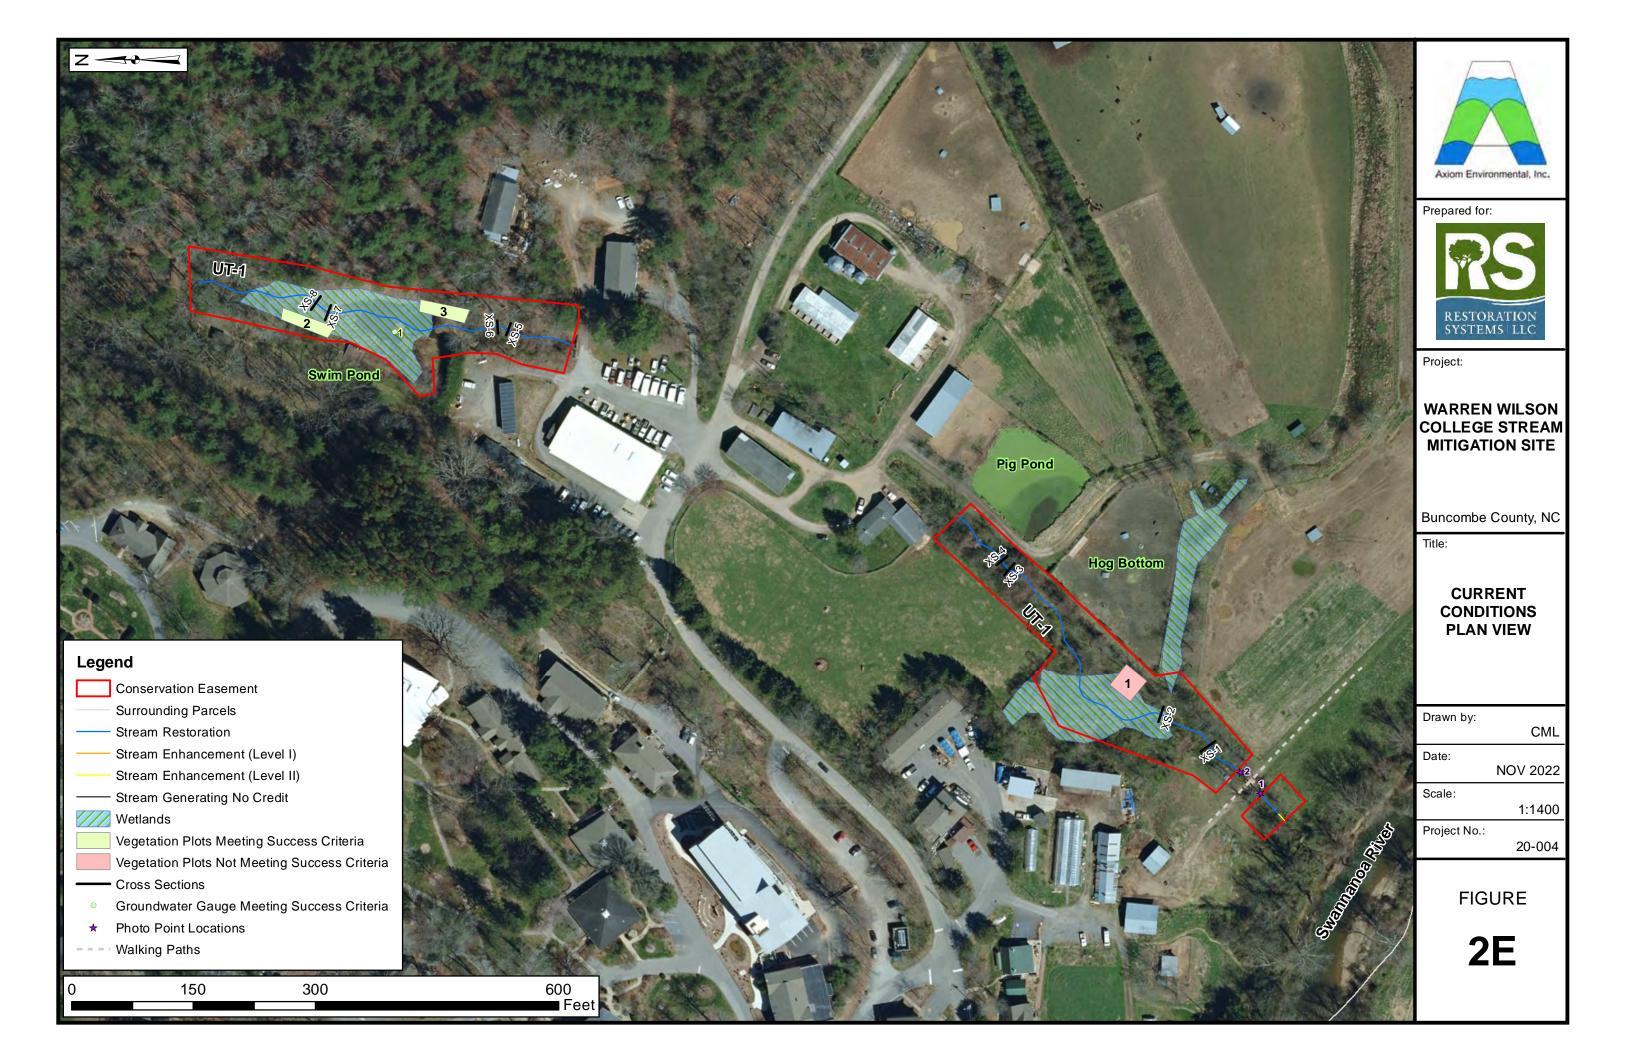
Figures 2 & 2A-2E. Current Conditions Plan View Tables 5A-5G. Visual Stream Morphology Stability Assessment Table 6. Vegetation Condition Assessment Vegetation Plot Photographs

During year (2022) monitoring, parrot feather (*Myriophyllum aquaticum*) was observed spread throughout the upper reach of UT-3 (Figure 2A, Appendix B). Additionally, multiflora rose (*Rosa multiflora*), Chinese privet (*Ligustrum sinense*), Chinese bittersweet (*Celastrus orbiculatus*), cattail (*Typha spp.*), Johnson grass (*Sorghum halepense*), air potato (*Dioscorea bulbifera*), and Japanese knotweed (*Reynoutria japonica*) were observed elsewhere throughout the Site but were especially dense along UT-8 (Figure 2D, Appendix B). All invasives were treated on June 27-28 and September 15, 2022, and will continue to be treated as necessary.
