**Big Warrior Creek Stream Restoration
2006 Monitoring Report
Monitoring Year Two**

Ecosystem Enhancement Program Project Number 00412

Submitted: January 19, 2007

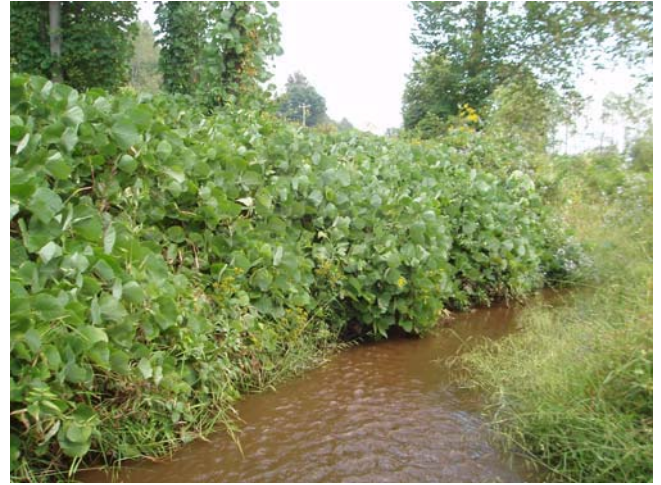
Table A6a. Vegetative Problem Areas – Big Warrior Creek				
Big Warrior Creek				
EEP Project Number 00412				
Feature #	Feature/Issue	Station #/Range	Probable Cause	Photo #
BWVPA1	Bare bank	2+00 to 8+00	Bank erosion	BWVPA1
BWVPA2	Invasive/exotic plant	12+00 to 20+10	Invasive/exotic plant	BWVPA2
BWVPA3	Bare bank	29+70	Bank erosion	BWVPA3
BWVPA4	Invasive/exotic plant	33+00 to 35+00	Invasive/exotic plant	BWVPA4
BWVPA5	Bare bank	43+15	Bank erosion	BWVPA5
BWVPA6	Invasive/exotic plant	43+15	Invasive/exotic plant	BWVPA6
BWVPA7	Bare floodplain, gully erosion	49+00 to 50+00	Poor soil	BWVPA7
BWVPA8	Invasive/exotic plant	63+50	Invasive/exotic plant	BWVPA8

Other problem areas include bare banks and floodplains along the mainstem (BWVPA1 through BWVPA8) and Mountain Creek (MCVPA1 through MCVPA8). No problem areas were documented along the Unnamed Tributary. These problems are likely resulting from poor site soils or soils that were compacted during construction. URS recommends soil amendments and reseeding in these areas.

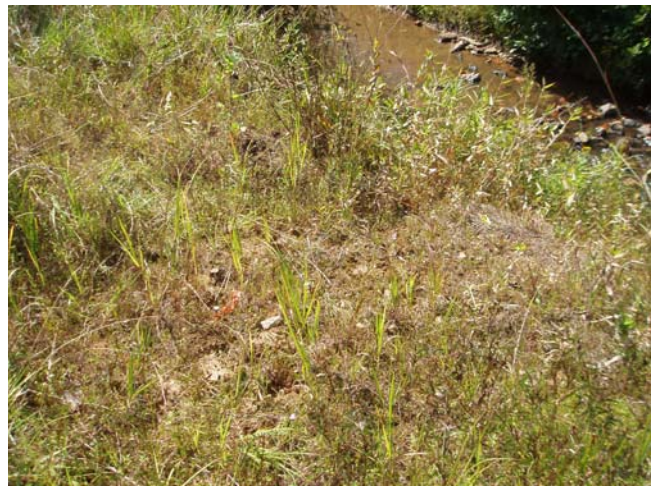
Table A6b. Vegetative Problem Areas – Mountain Creek				
Big Warrior Creek				
EEP Project Number 00412				
Feature #	Feature/Issue	Station #/Range	Probable Cause	Photo #
MCVPA1	Bare bank	5+00	Bank erosion	MCVPA1
MCVPA2	Bare bank	6+20	Bank erosion	MCVPA2
MCVPA3	Bare bank	13+60	Bank erosion	MCVPA3
MCVPA4	Bare bank	15+00	Bank erosion	MCVPA4
MCVPA5	Bare floodplain	17+00 to 17+60	Overflow	MCVPA5
MCVPA6	Bare bank	17+00	Bank erosion	MCVPA6
MCVPA7	Bare bank	17+60	Bank erosion	MCVPA7
MCVPA8	Bare bank	19+00	Bank erosion	MCVPA8

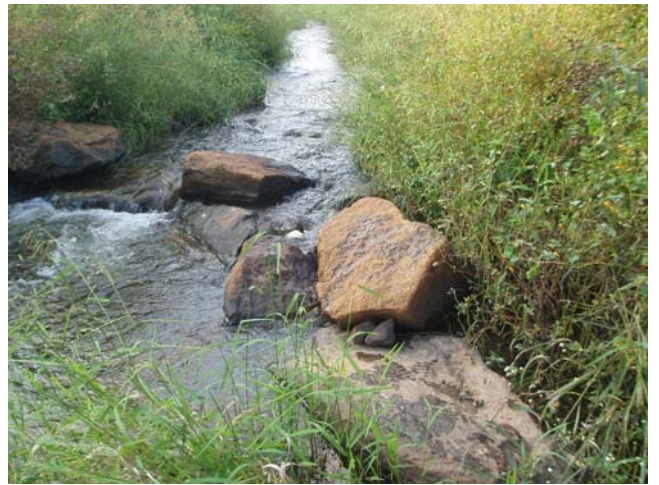
BWPA9 facing downstream

Table B1a. Stream Problem Areas – Big Warrior Creek				
Big Warrior Creek				
EEP Project Number 00412				
Feature #	Feature Issue	Station	Suspected Cause	Photo #
BWPA1	Structure failure	5+00	Rocks obstructing flow, causing flow diversion into banks	BWPA1
BWPA2	Structure failure	11+00	Scour	BWPA2
BWPA3	Structure failure	16+00	Rocks obstructing flow, causing flow diversion into banks	BWPA3
BWPA4	Structure failure	17+60	Scour	BWPA4
BWPA5	Bank erosion, failure of log toe protection	20+80	Scour	BWPA5
BWPA6	Bank erosion	34+50	Scour	BWPA6
BWPA7	Bank erosion	34+75	Scour	BWPA7
BWPA8	Bank erosion	34+90	Scour	BWPA8
BWPA9	Aggradation, mid-channel bar formation	43+00	Inadequate sediment transport	BWPA9
BWPA10	Structure failure	42+60	Rocks obstructing flow, causing flow diversion into banks	BWPA10
BWPA11	Aggradation, lateral bar formation	44+70	Lateral migration of channel	BWPA11
BWPA12	Bank erosion	49+75	Lateral migration of channel	BWPA12
