**Big Warrior Creek Stream Restoration
2007 Final Monitoring Report
Monitoring Year Three**

Ecosystem Enhancement Program Project Number 00412

Prepared by: URS Corporation – North Carolina
1600 Perimeter Park Drive, Suite 400
Morrisville, NC 27560

Submitted: February 26, 2007

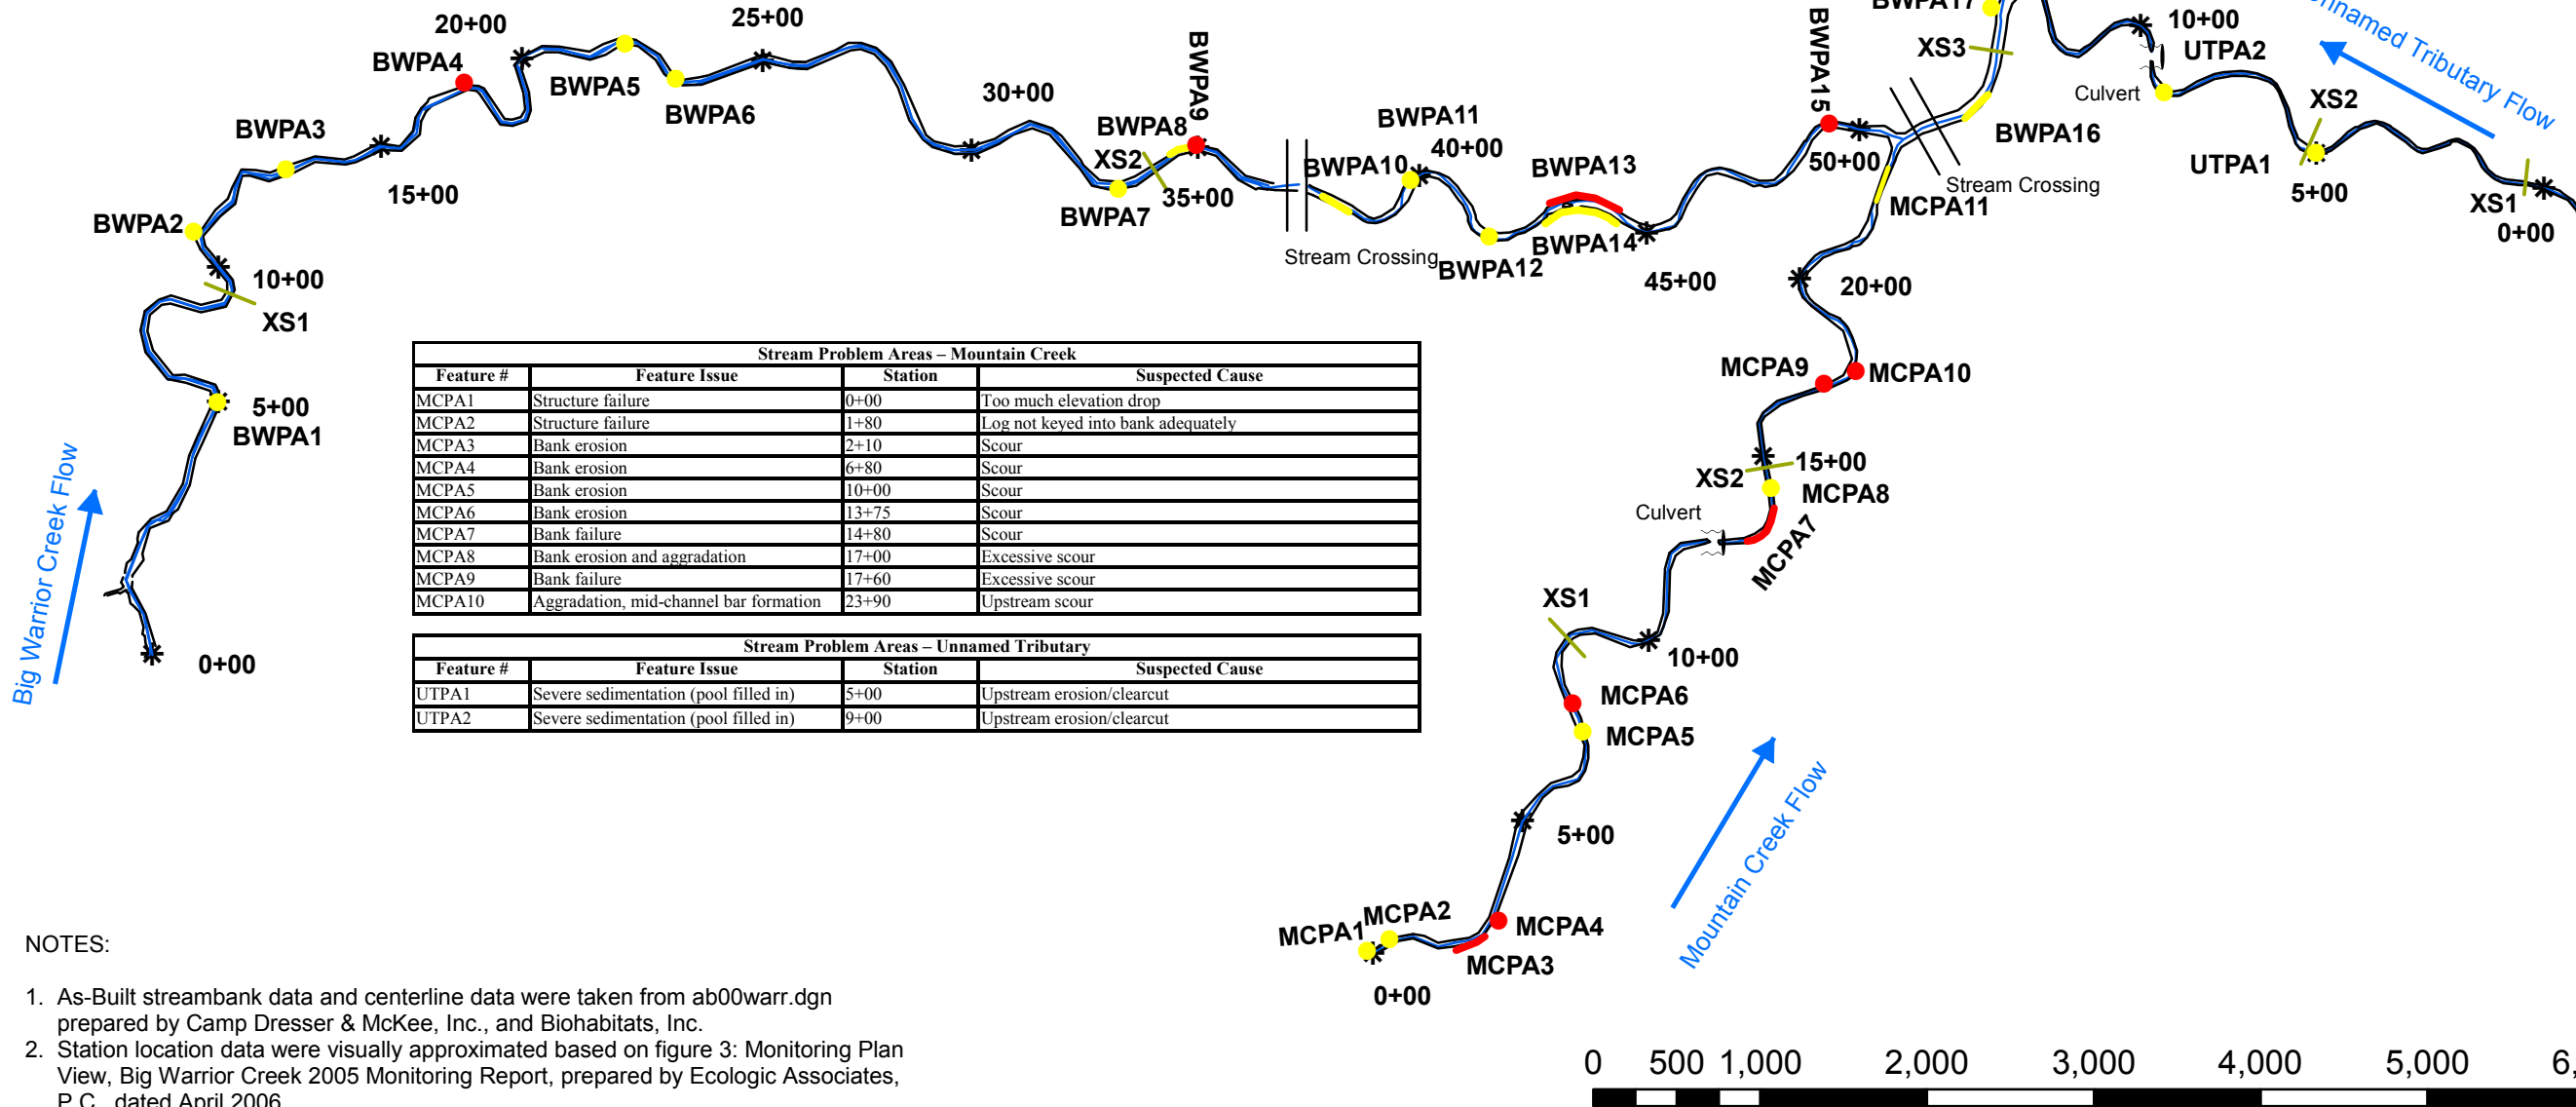
Stream
 Current Condition
 Plan View

There were a total of 37 stream problem areas identified for the project, 25 on the mainstem, 10 on Mountain Creek, and two on the Unnamed Tributary. Thirteen problem areas were classified as areas of high concern, and URS recommends repair or maintenance on these areas. The remaining 24 should be watched closely to see if they improve or worsen.

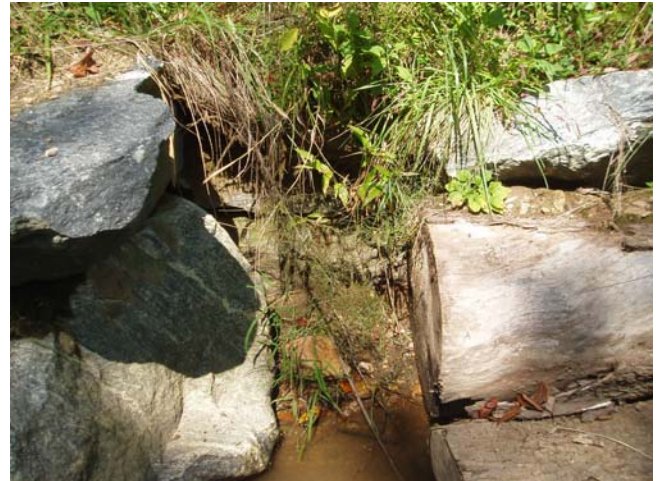
MCPA1 facing downstream at right bank

The stream problem areas consisted primarily of bank erosion, structure failure, and bed aggradation. The structure at the beginning of Mountain Creek, MCPA1 continues to be a problem area. Water is piping behind and around the structure, and it is constructed at a large elevation drop. If this structure fails, it is likely to induce a headcut that will work up the unrestored section of Mountain Creek. Many of the rootwads were causing scour on the downstream side. A common problem was also observed with many of the J-hook vanes, as shown in photos BWPA3 and BWPA10. These structures were often constructed with three rocks placed high above the invert of the bed, which caused an obstruction of flow, and the water to be diverted into the banks. This problem was further exacerbated by the fact that the rocks trap debris and create a larger obstruction.
