Big Warrior Creek Stream Restoration 2008 Final Monitoring Report Monitoring Year Four

Ecosystem Enhancement Program Project Number 000412

Submitted: February 17, 2009

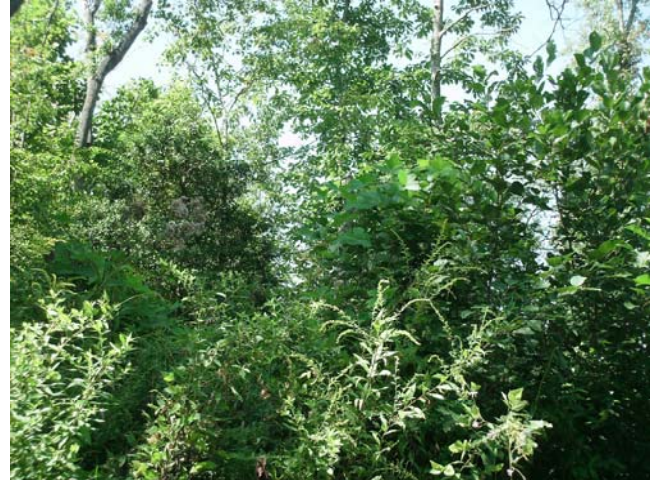
BWVPA2 facing left bank

BWVPA4 facing left bank

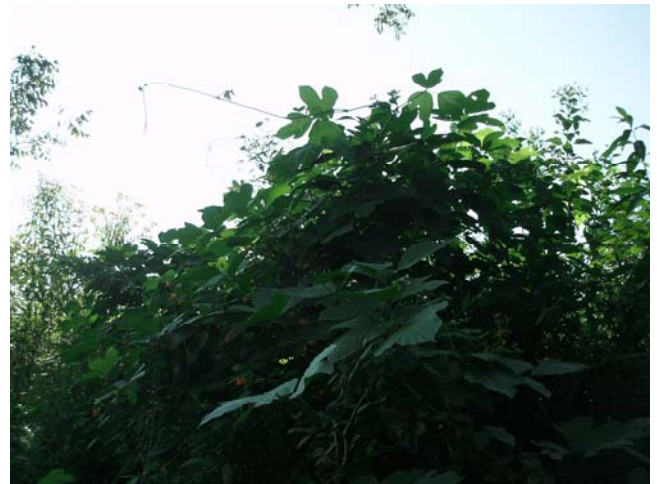
BWVPA6 facing right bank

BWVPA8 facing upstream

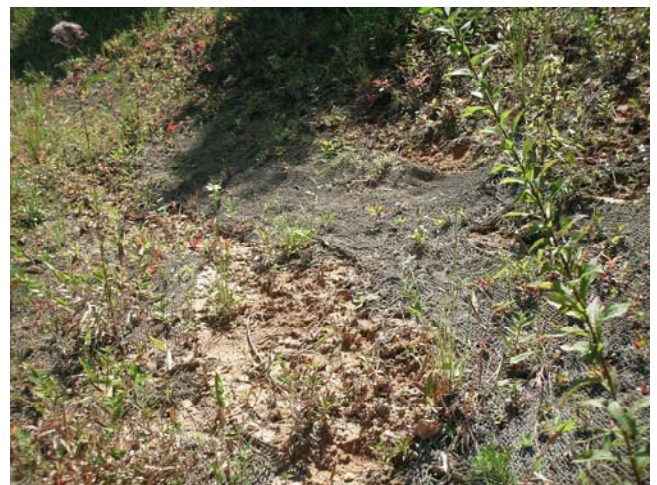
BWVPA9 facing left bank

BWVPA10 facing upstream

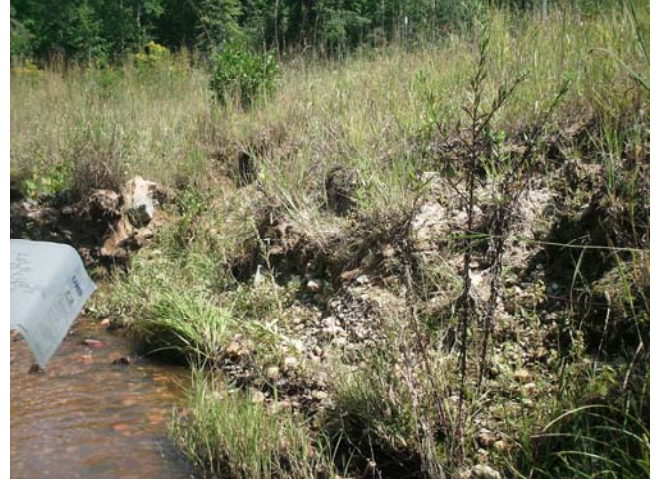
MCVPA2 facing upstream

MCVPA3 facing right bank

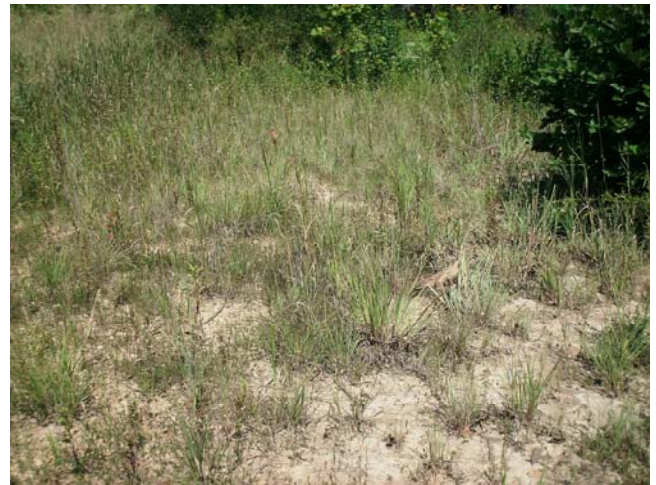
MCVPA4 facing left bank

MCVPA6 facing right bank

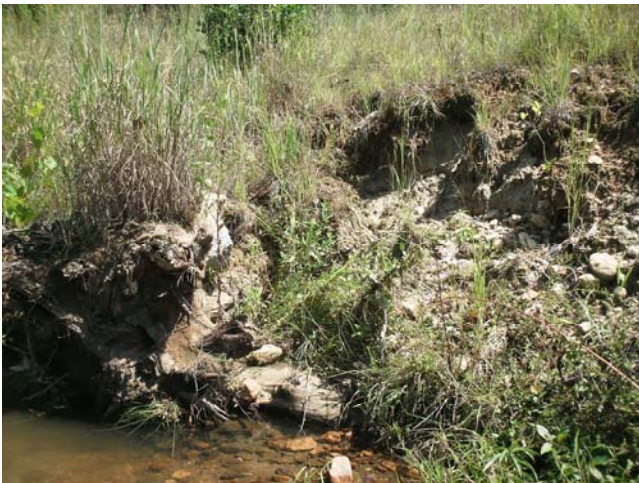
MCVPA8 facing right bank

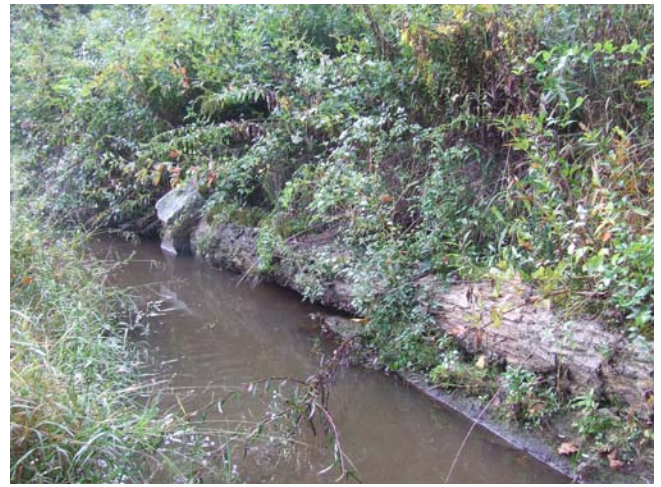
BWPA2 facing right bank

BWPA6 facing downstream

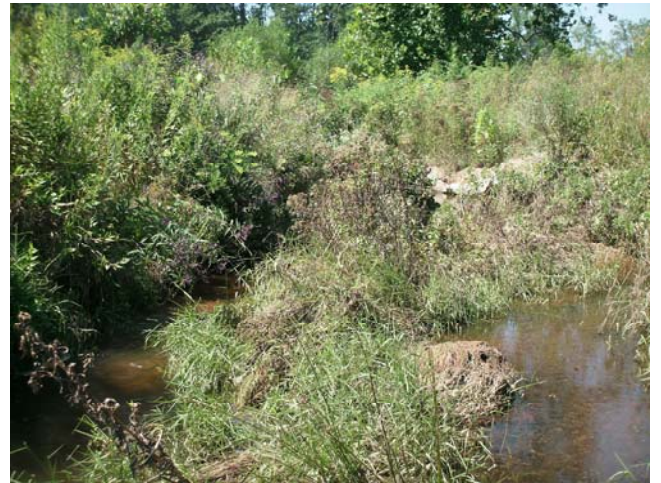
BWPA12 facing downstream

BWPA13/14 facing downstream

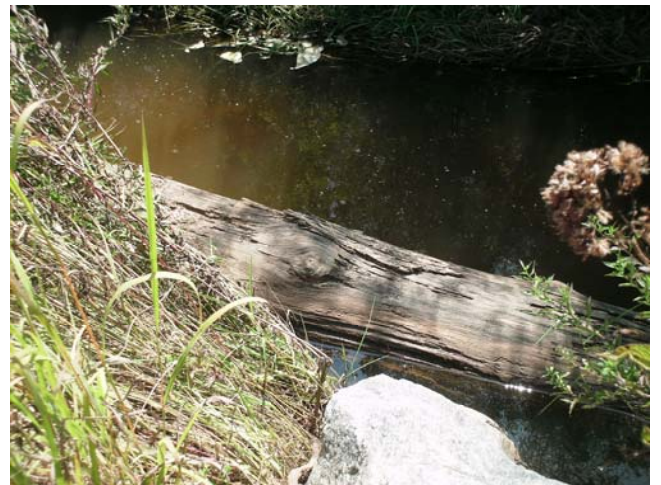
BWPA13/14 facing downstream

BWPA15 facing left bank

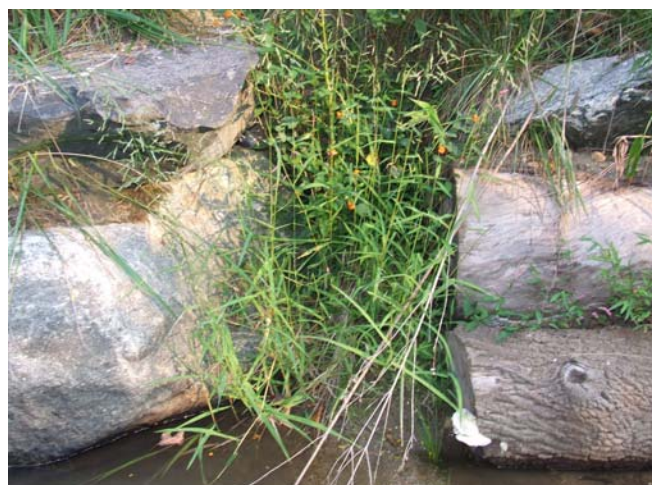
The stream problem areas consisted primarily of bank erosion, structure failure, and bed aggradation. The structure at the beginning of Mountain Creek, MCPA1 continues to be a problem area. Water is piping behind and around the structure, and it is constructed at a large elevation drop. If this structure fails, it is likely to induce a headcut that will work up the unrestored section of Mountain Creek. However, there have been no significant changes between 2007 (MY3) and 2008 (MY4) at this structure.

MCPA1 facing right bank

MCPA2 facing right bank

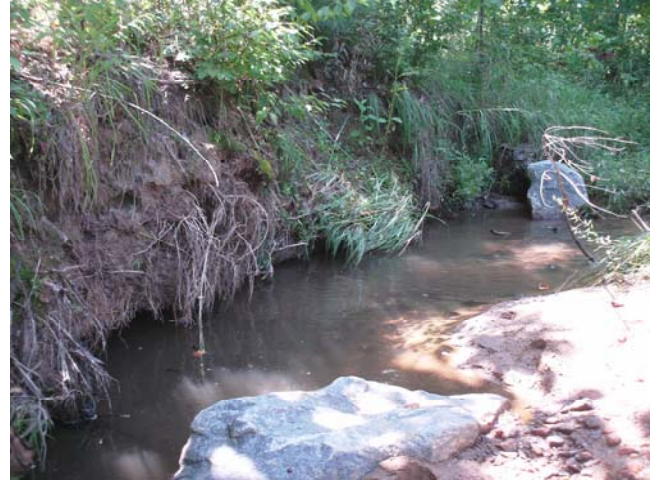
MCPA3 facing downstream

MCPA4 facing downstream

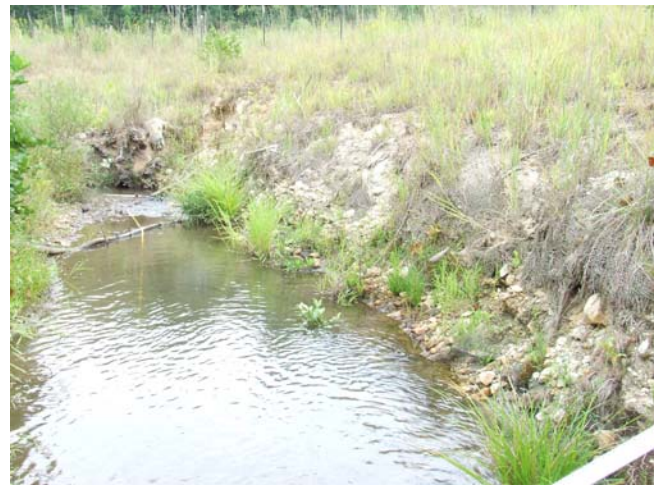
MCPA5 facing downstream (9/12/07)

MCPA6 facing downstream (9/12/07)

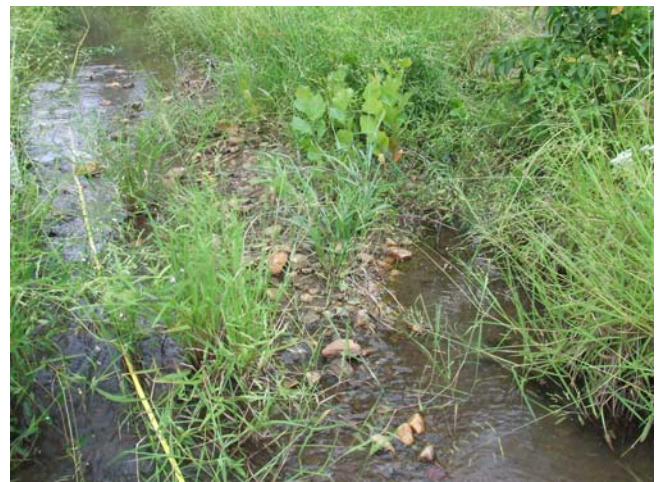
MCPA7 facing right bank (9/12/07)

MCPA8 facing downstream (9/12/07)
