**Big Warrior Creek Stream Restoration
2009 Final Monitoring Report
Monitoring Year Five**

Ecosystem Enhancement Program Project Number 00412

Submitted: April 23, 2010

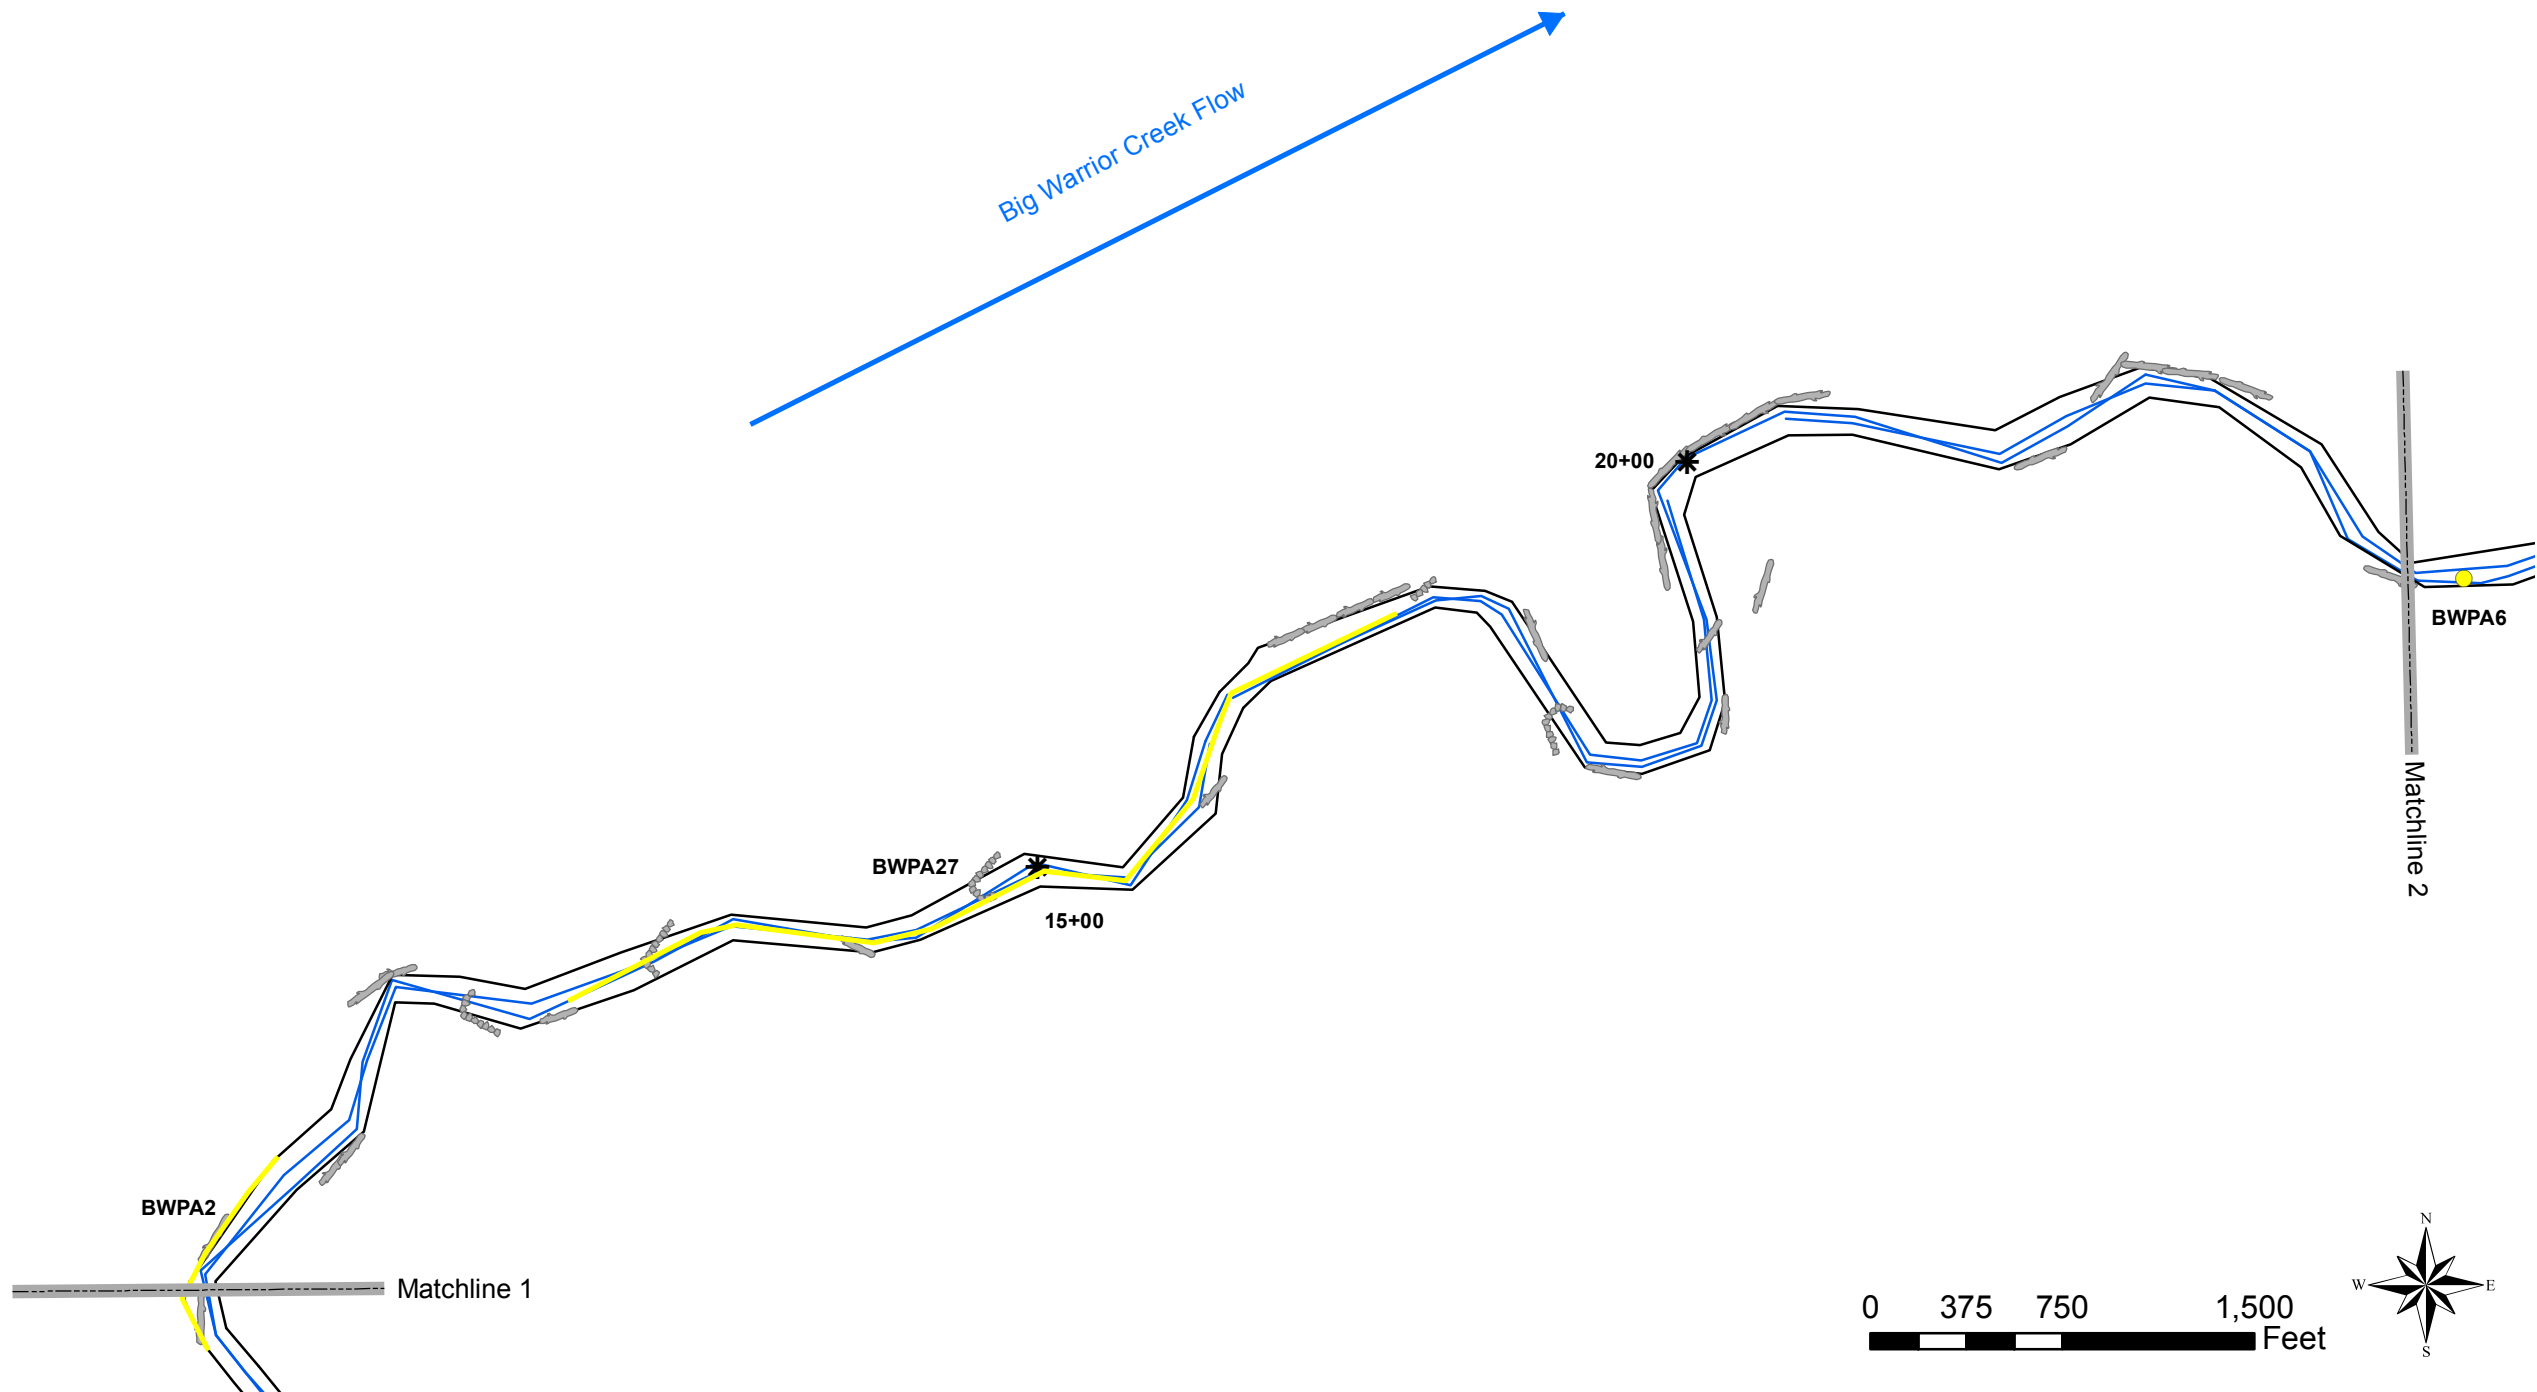
**Stream
 Current Condition
 Plan View**

Big Warrior Creek Stream Problem Areas		
EEP Project Number 00412		
Big Warrior Creek		
Feature #	Feature Issue	Station #/Range
BWPA2	Structure failure	10+70 to 11+00
BWPA6	Structure degradation	23+60
BWPA27	Beaver dam and backwater	14+00 to 19+00

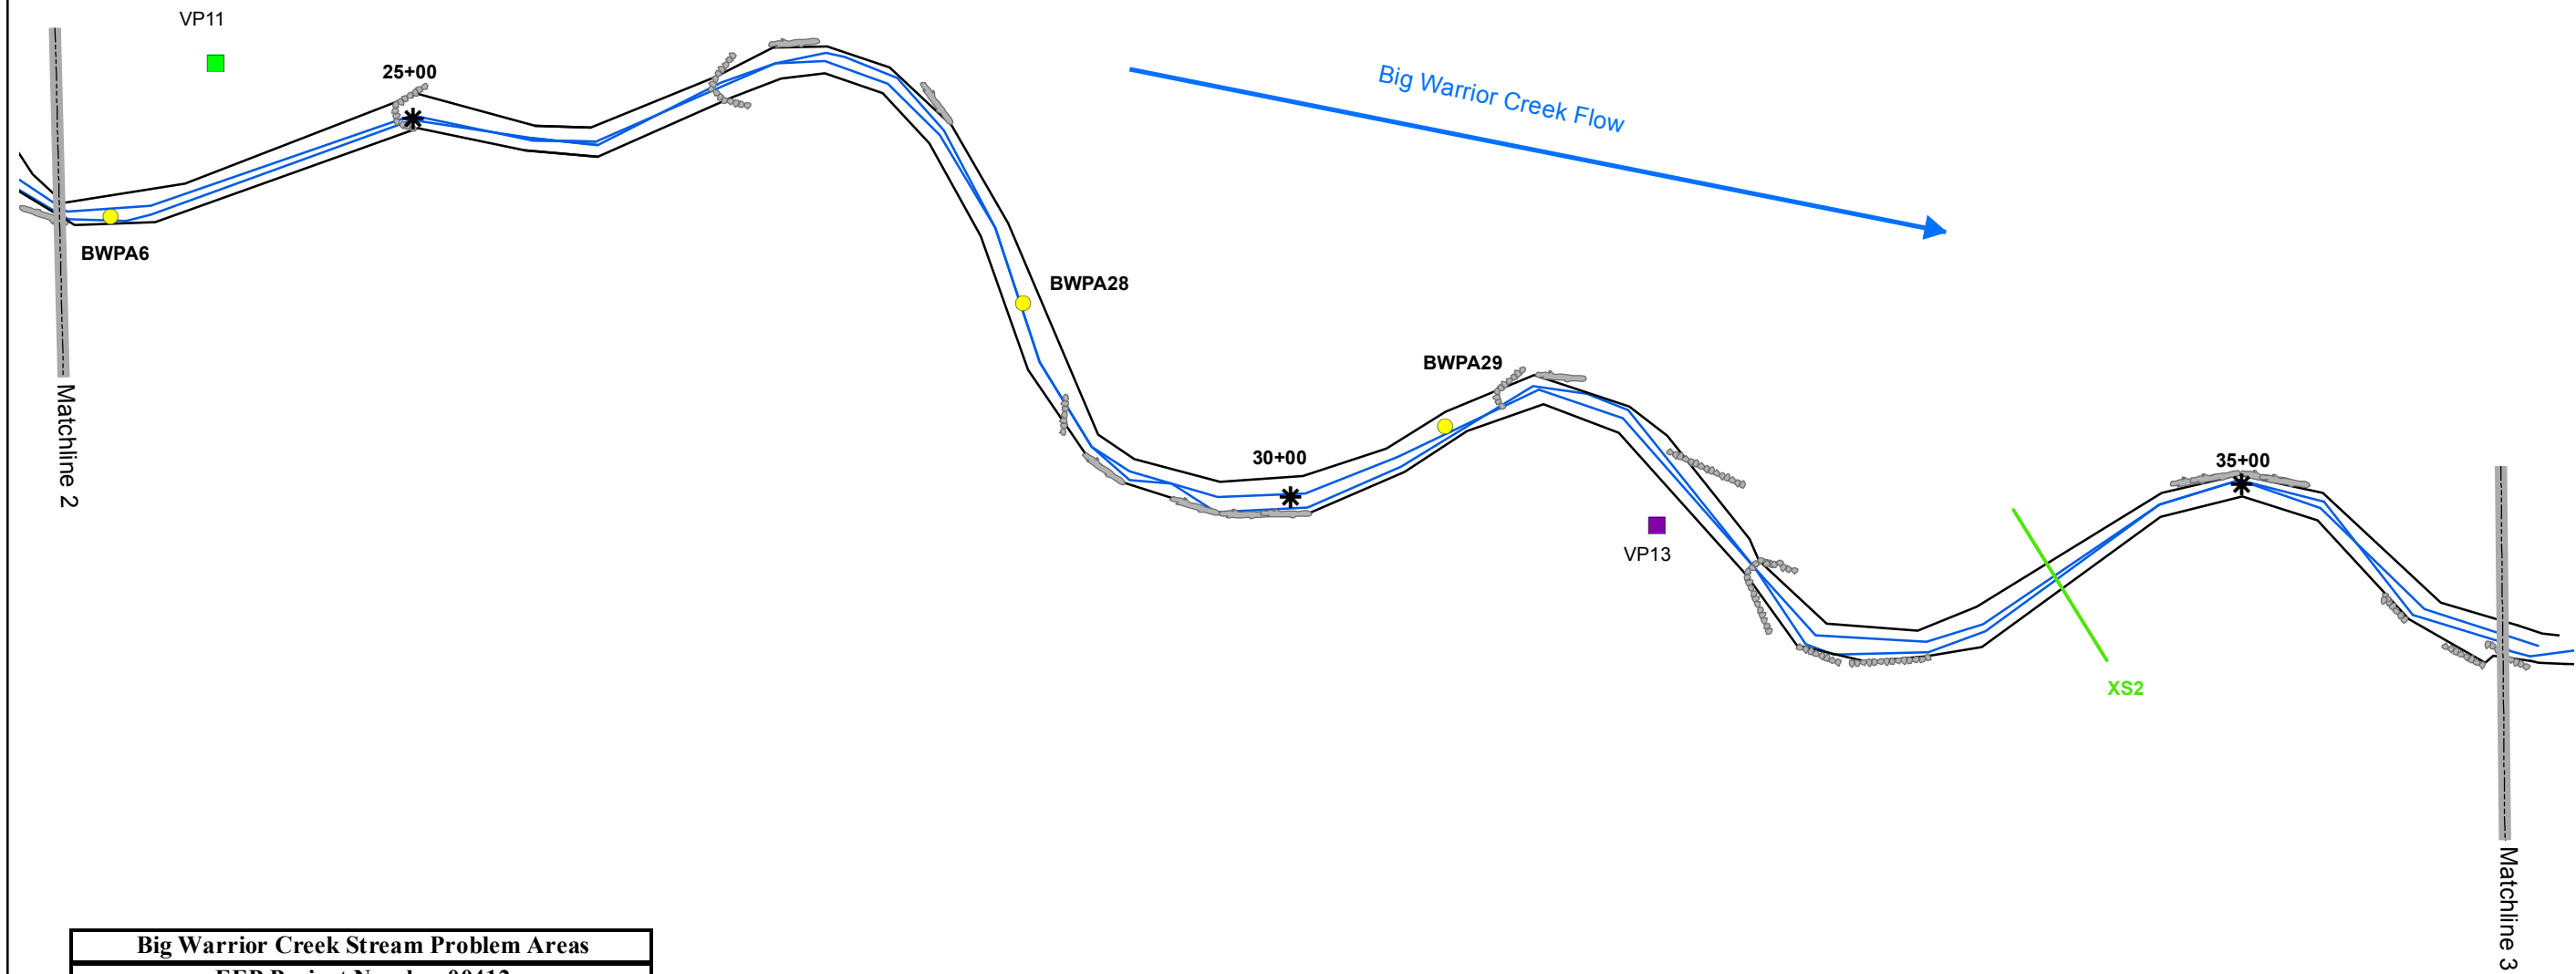
**Stream
 Current Condition
 Plan View**

Big Warrior Creek Stream Problem Areas		
EEP Project Number 00412		
Big Warrior Creek		
Feature #	Feature Issue	Station #/Range
BWPA6	Structure degradation	23+60
BWPA28	Beaver dam	27+50
BWPA29	Beaver dam	30+50

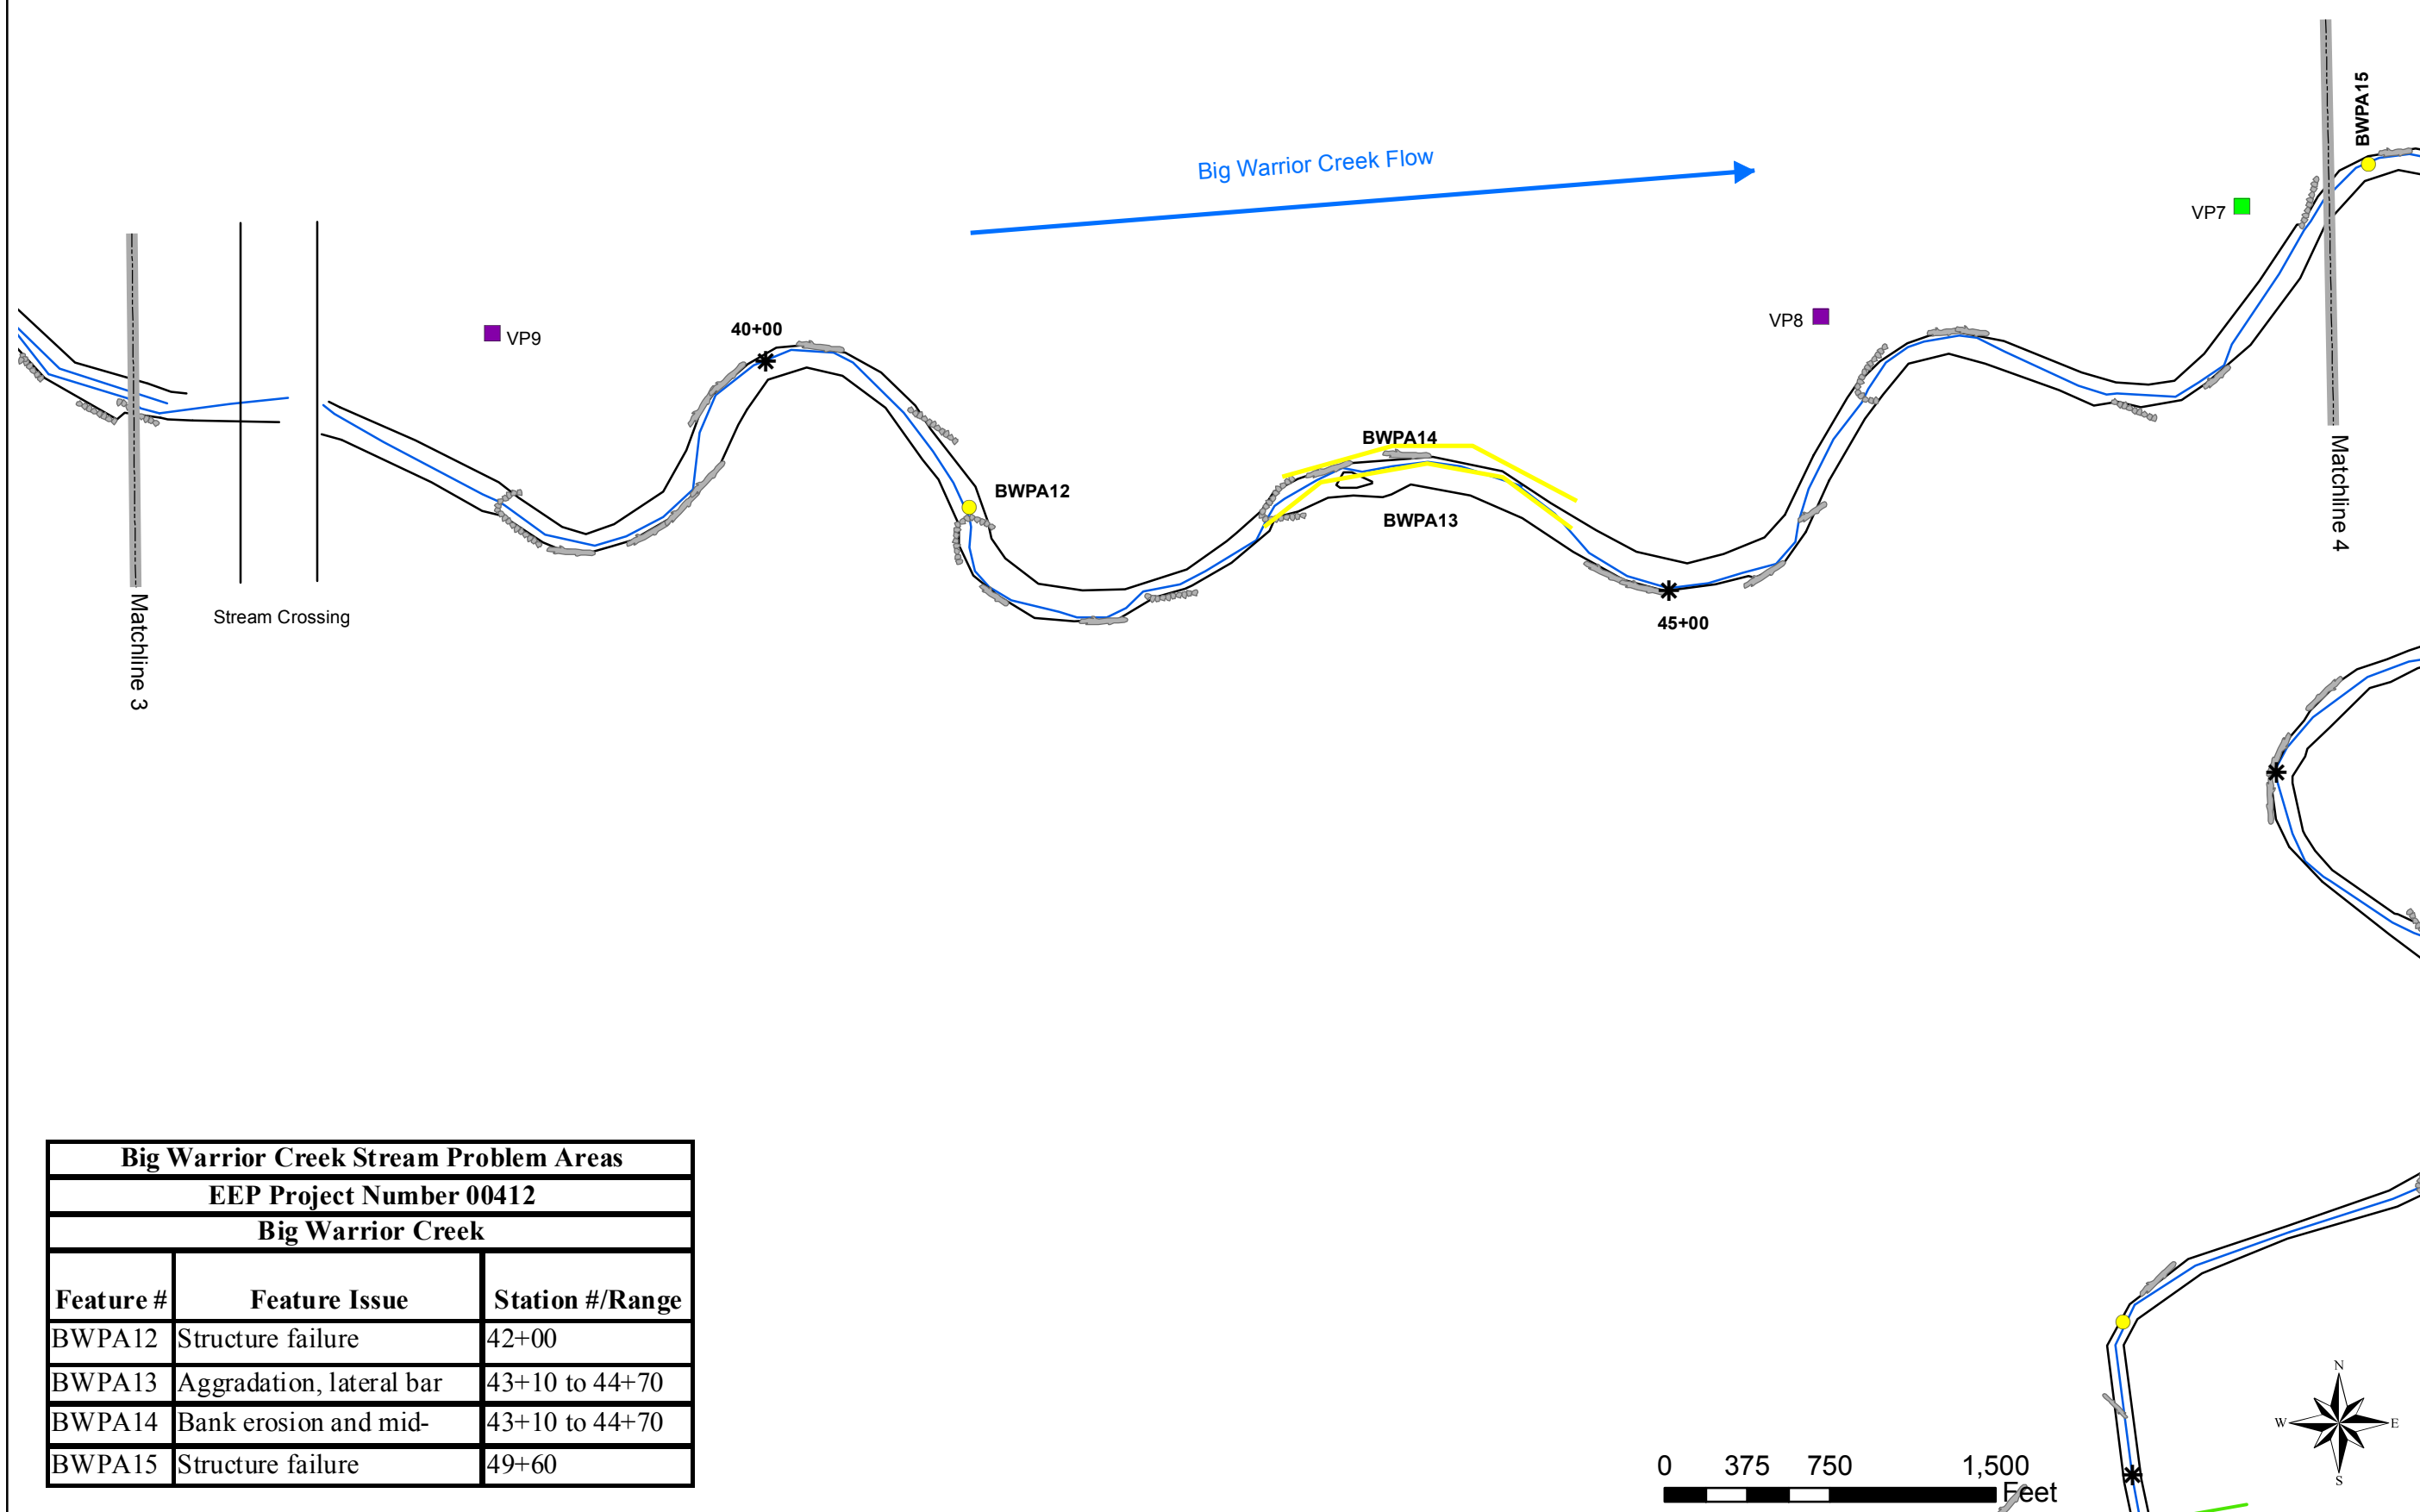
Stream
 Current Condition
 Plan View

Big Warrior Creek Stream Problem Areas		
EEP Project Number 00412		
Big Warrior Creek		
Feature #	Feature Issue	Station #/Range
BWPA12	Structure failure	42+00
BWPA13	Aggradation, lateral bar	43+10 to 44+70
BWPA14	Bank erosion and mid-	43+10 to 44+70
BWPA15	Structure failure	49+60

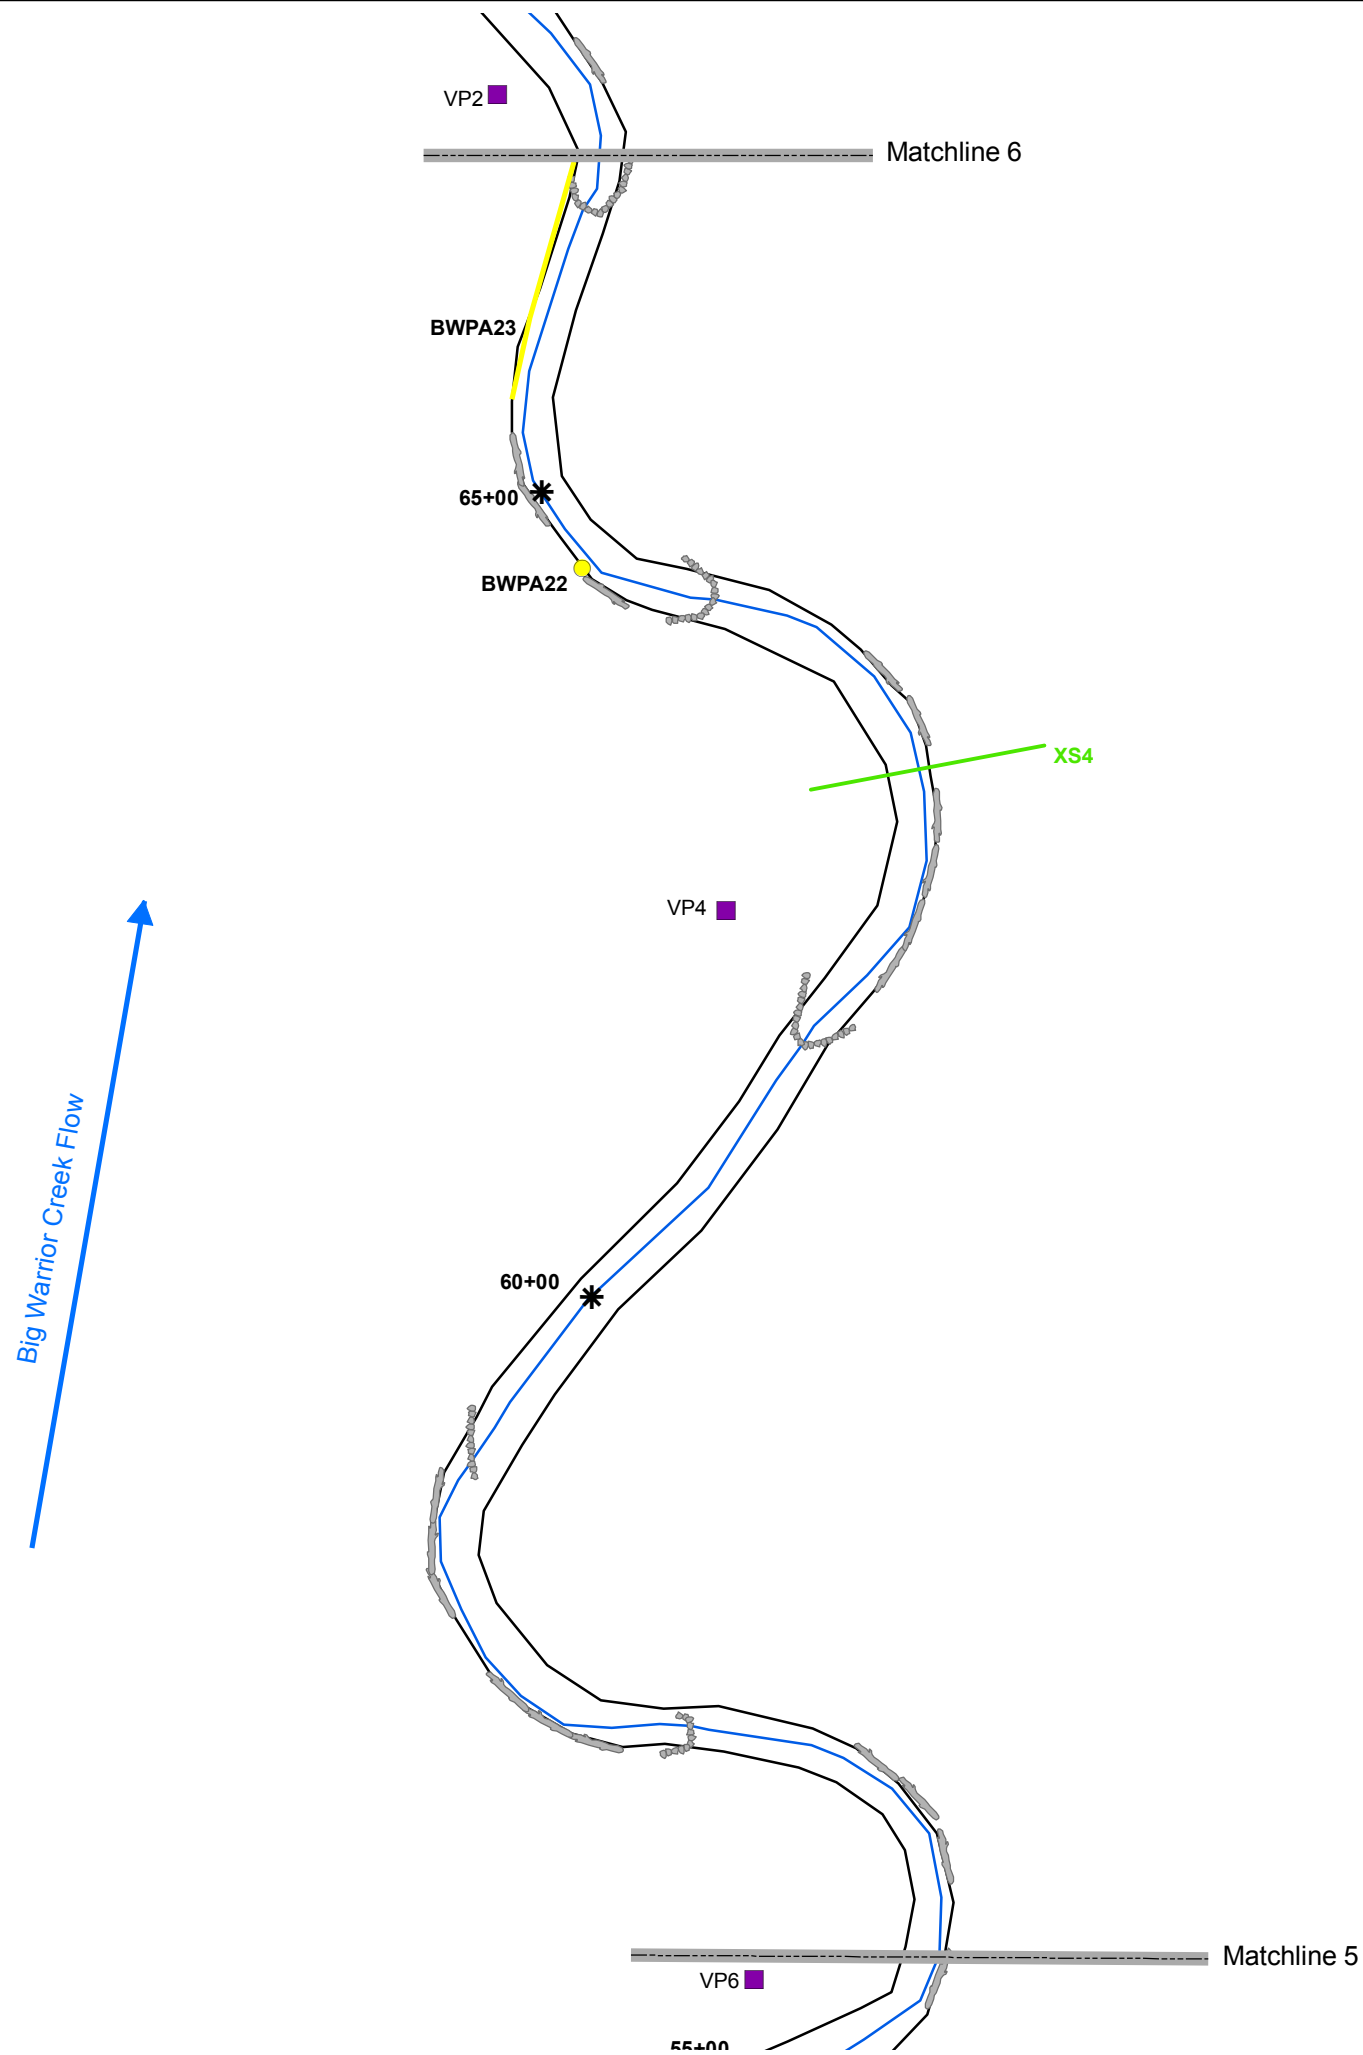
Big Warrior Creek Stream Problem Areas		
EEP Project Number 00412		
Big Warrior Creek		
Feature #	Feature Issue	Station #/Range
BWPA22	Structure degradation	64+90
BWPA23	Bank erosion	65+10 to 66+00

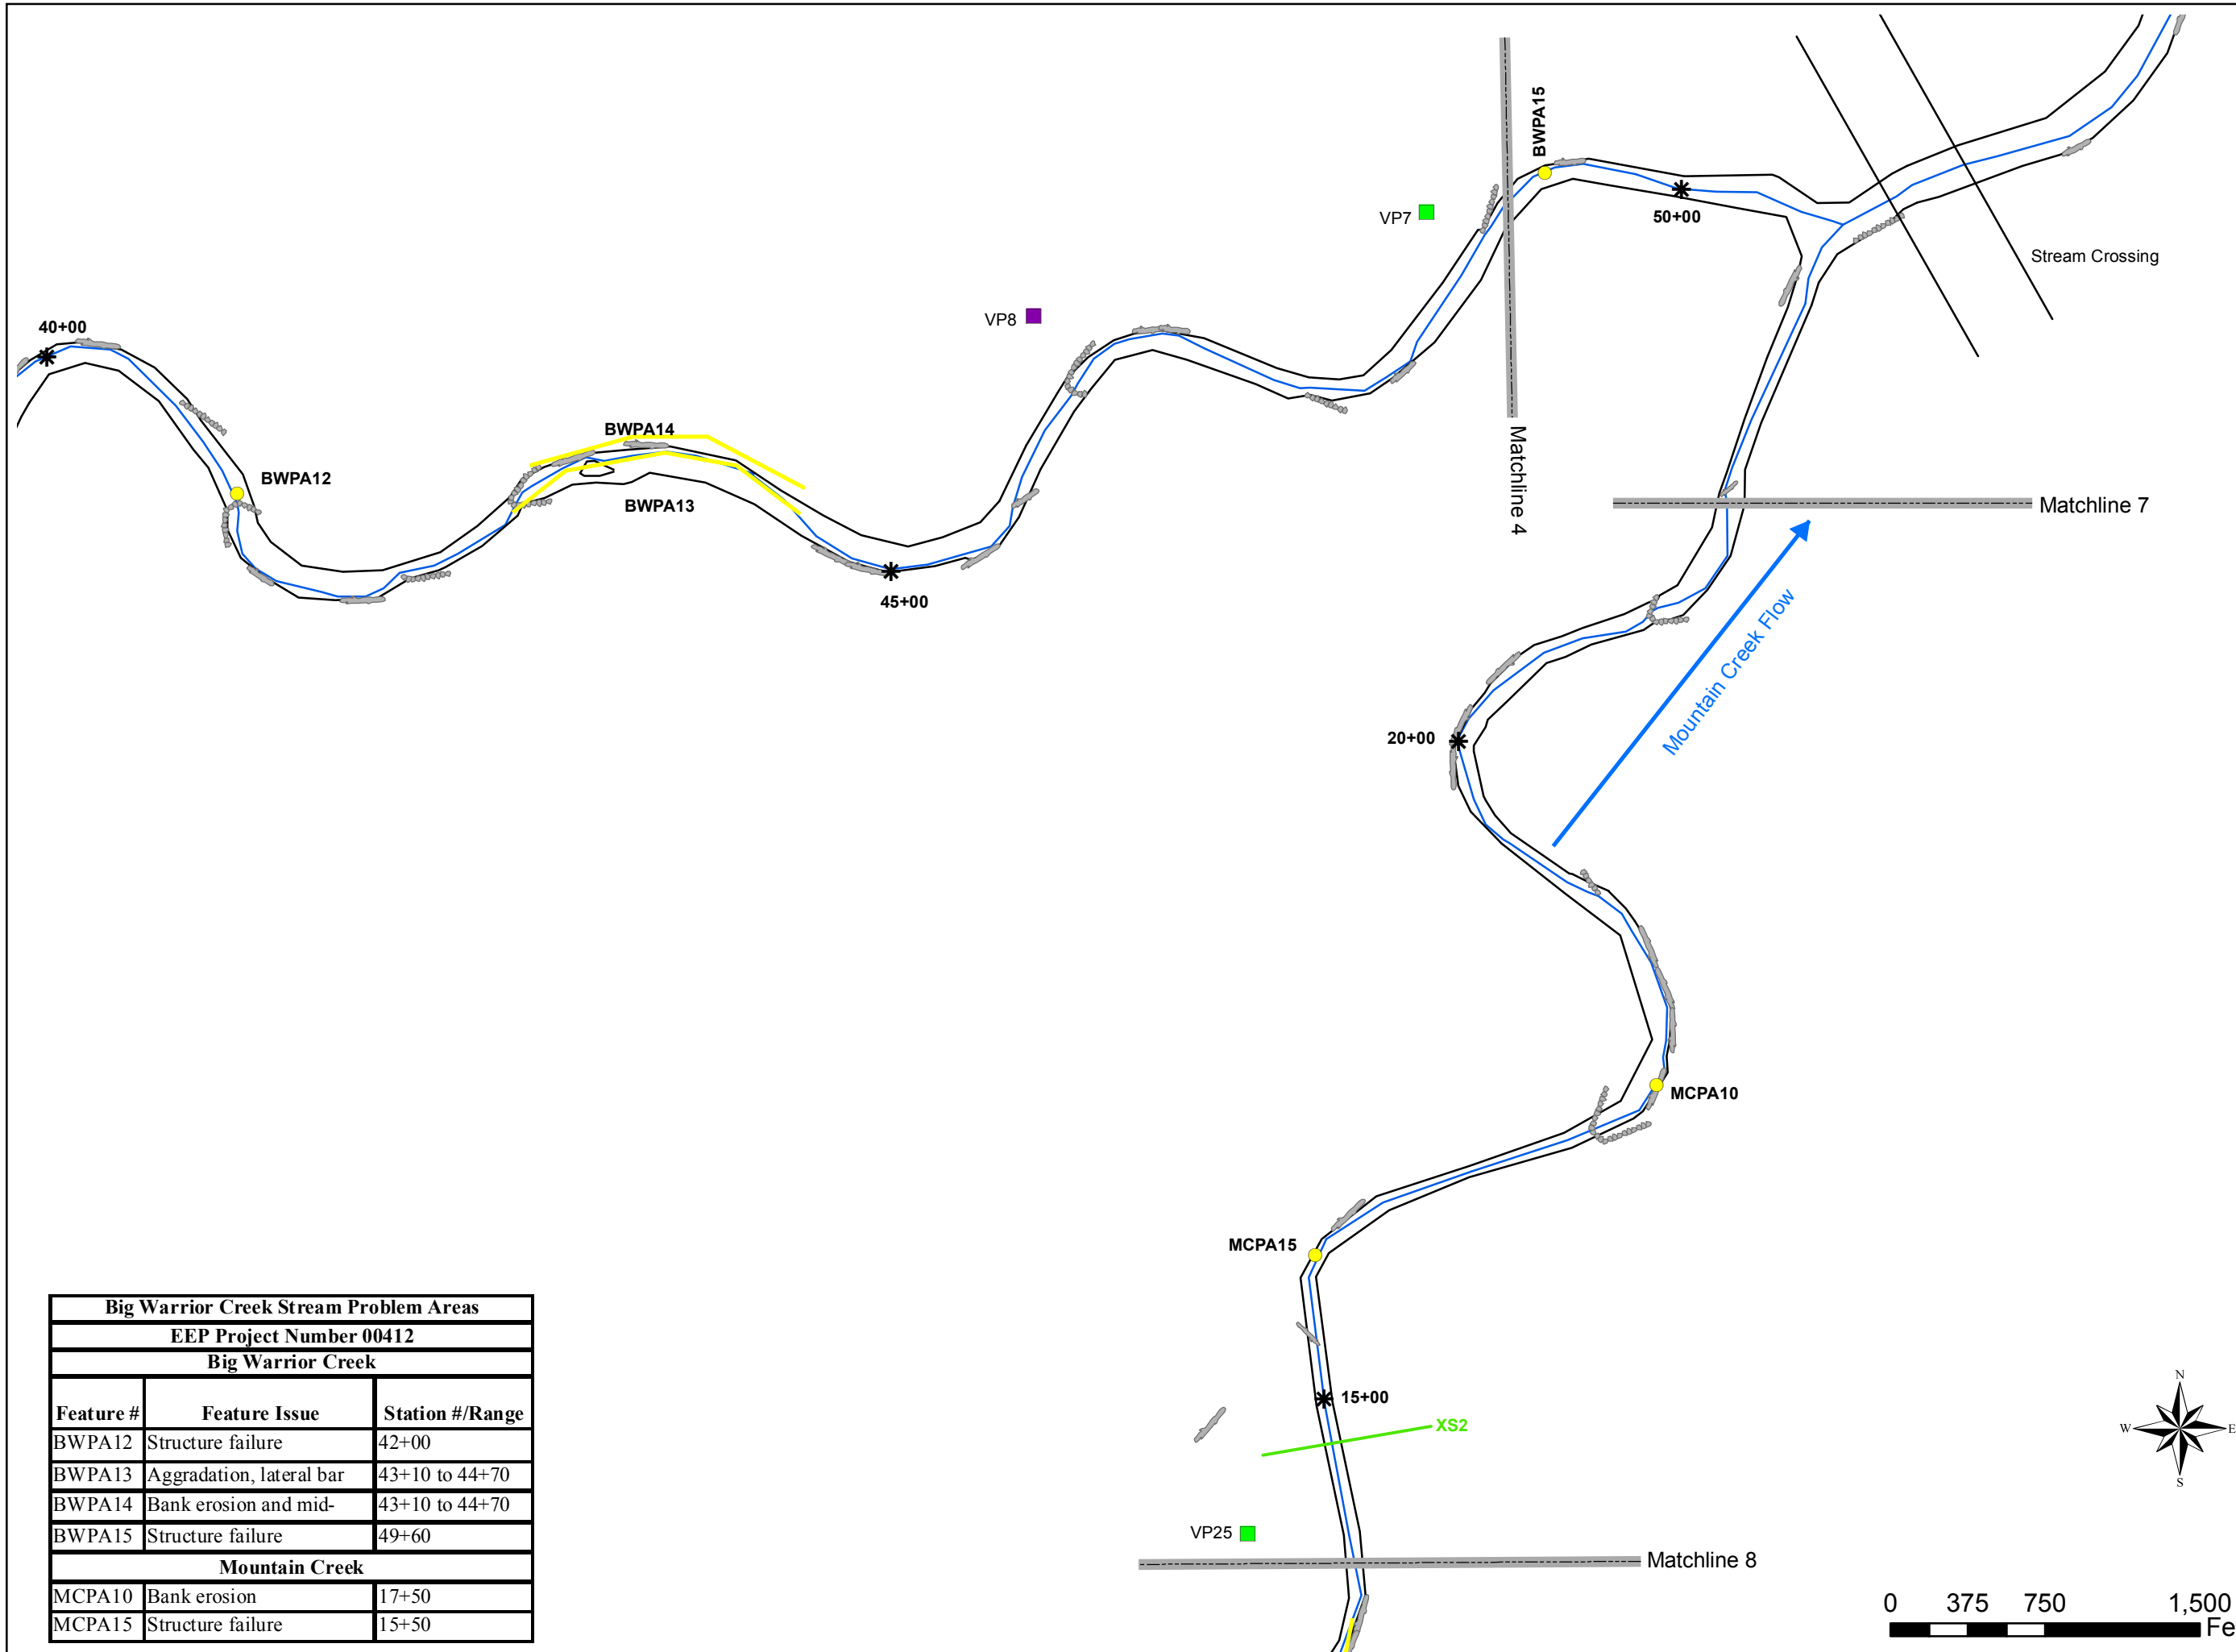
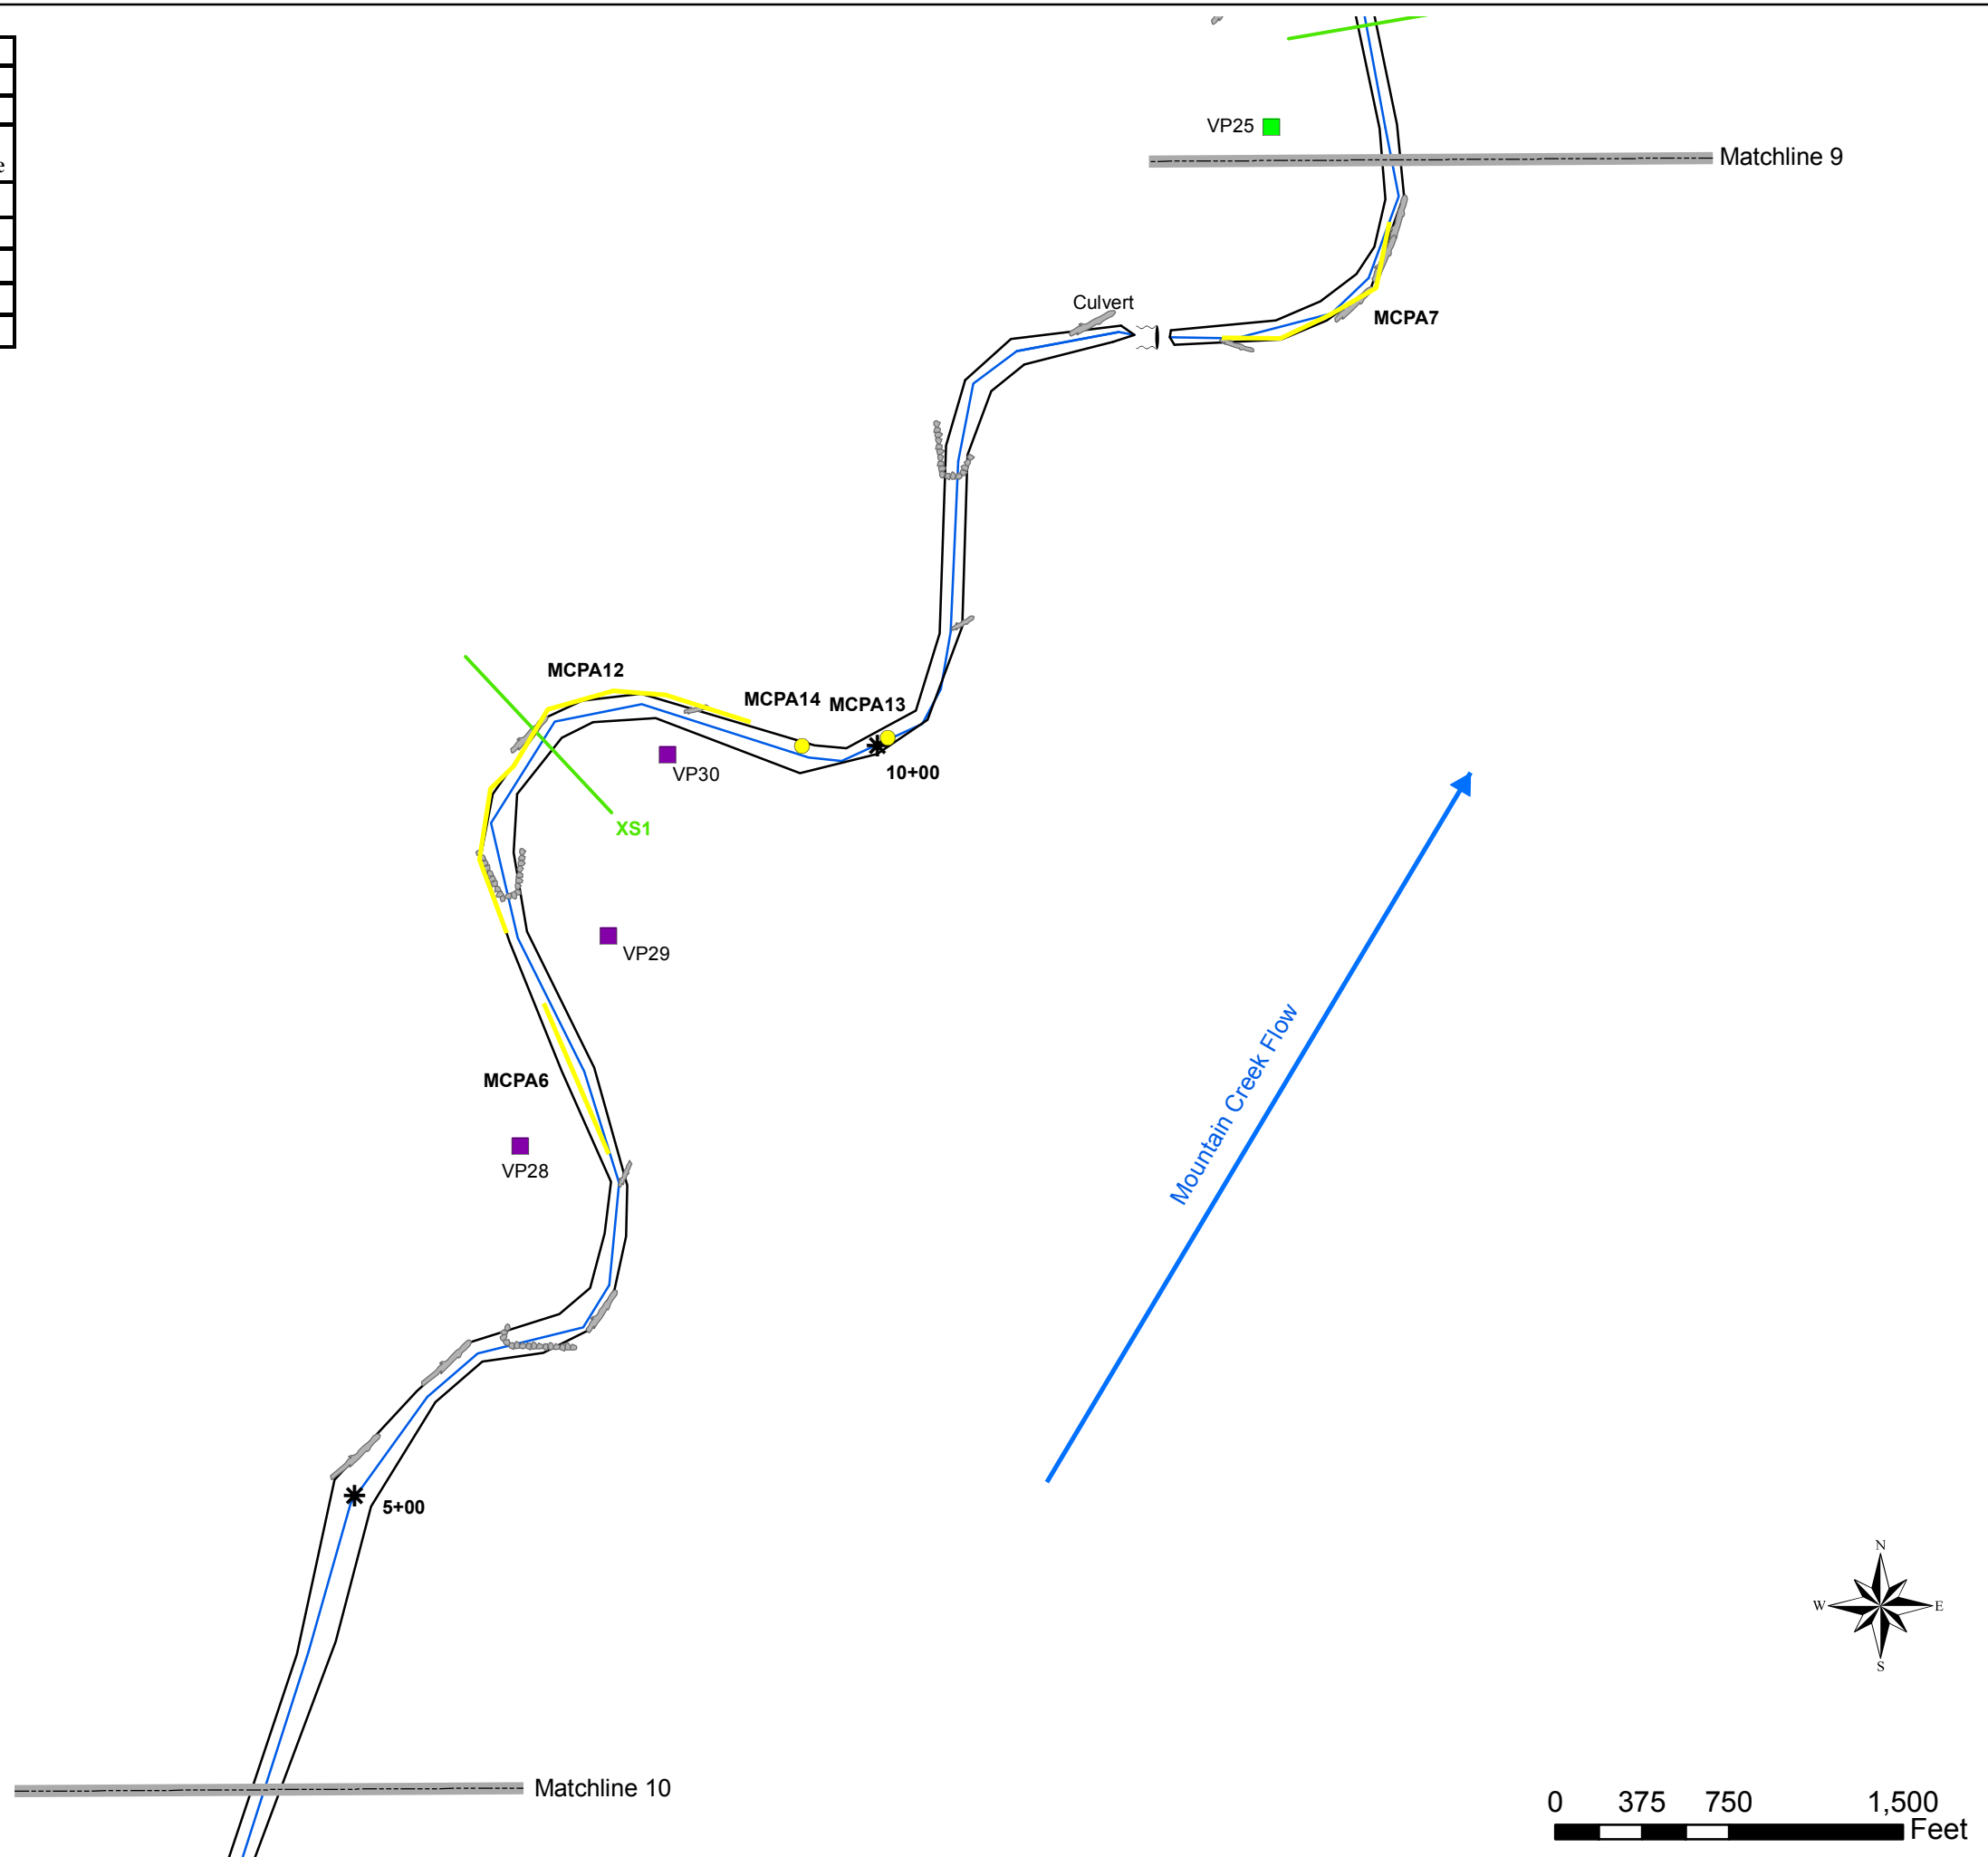
Big Warrior Creek Stream Problem Areas		
EEP Project Number 00412		
Big Warrior Creek		
Feature #	Feature Issue	Station #/Range
BWPA12	Structure failure	42+00
BWPA13	Aggradation, lateral bar	43+10 to 44+70
BWPA14	Bank erosion and mid-	43+10 to 44+70
BWPA15	Structure failure	49+60
Mountain Creek		
MCPA10	Bank erosion	17+50
MCPA15	Structure failure	15+50

Big Warrior Creek Stream Problem Areas		
EEP Project Number 00412		
Mountain Creek		
Feature #	Feature Issue	Station #/Range
MCPA6	Bank erosion and mid-	7+20 to 7+60
MCPA7	Bank failure	13+00 to 14+50
MCPA12	Structure failure / lateral	8+00 to 9+50
MCPA13	Aggradation	9+70
MCPA14	Structure failure	10+00
