**Big Warrior Creek Stream Restoration
2009 Final Monitoring Report
Monitoring Year Five**

Ecosystem Enhancement Program Project Number 00412

Submitted: April 23, 2010

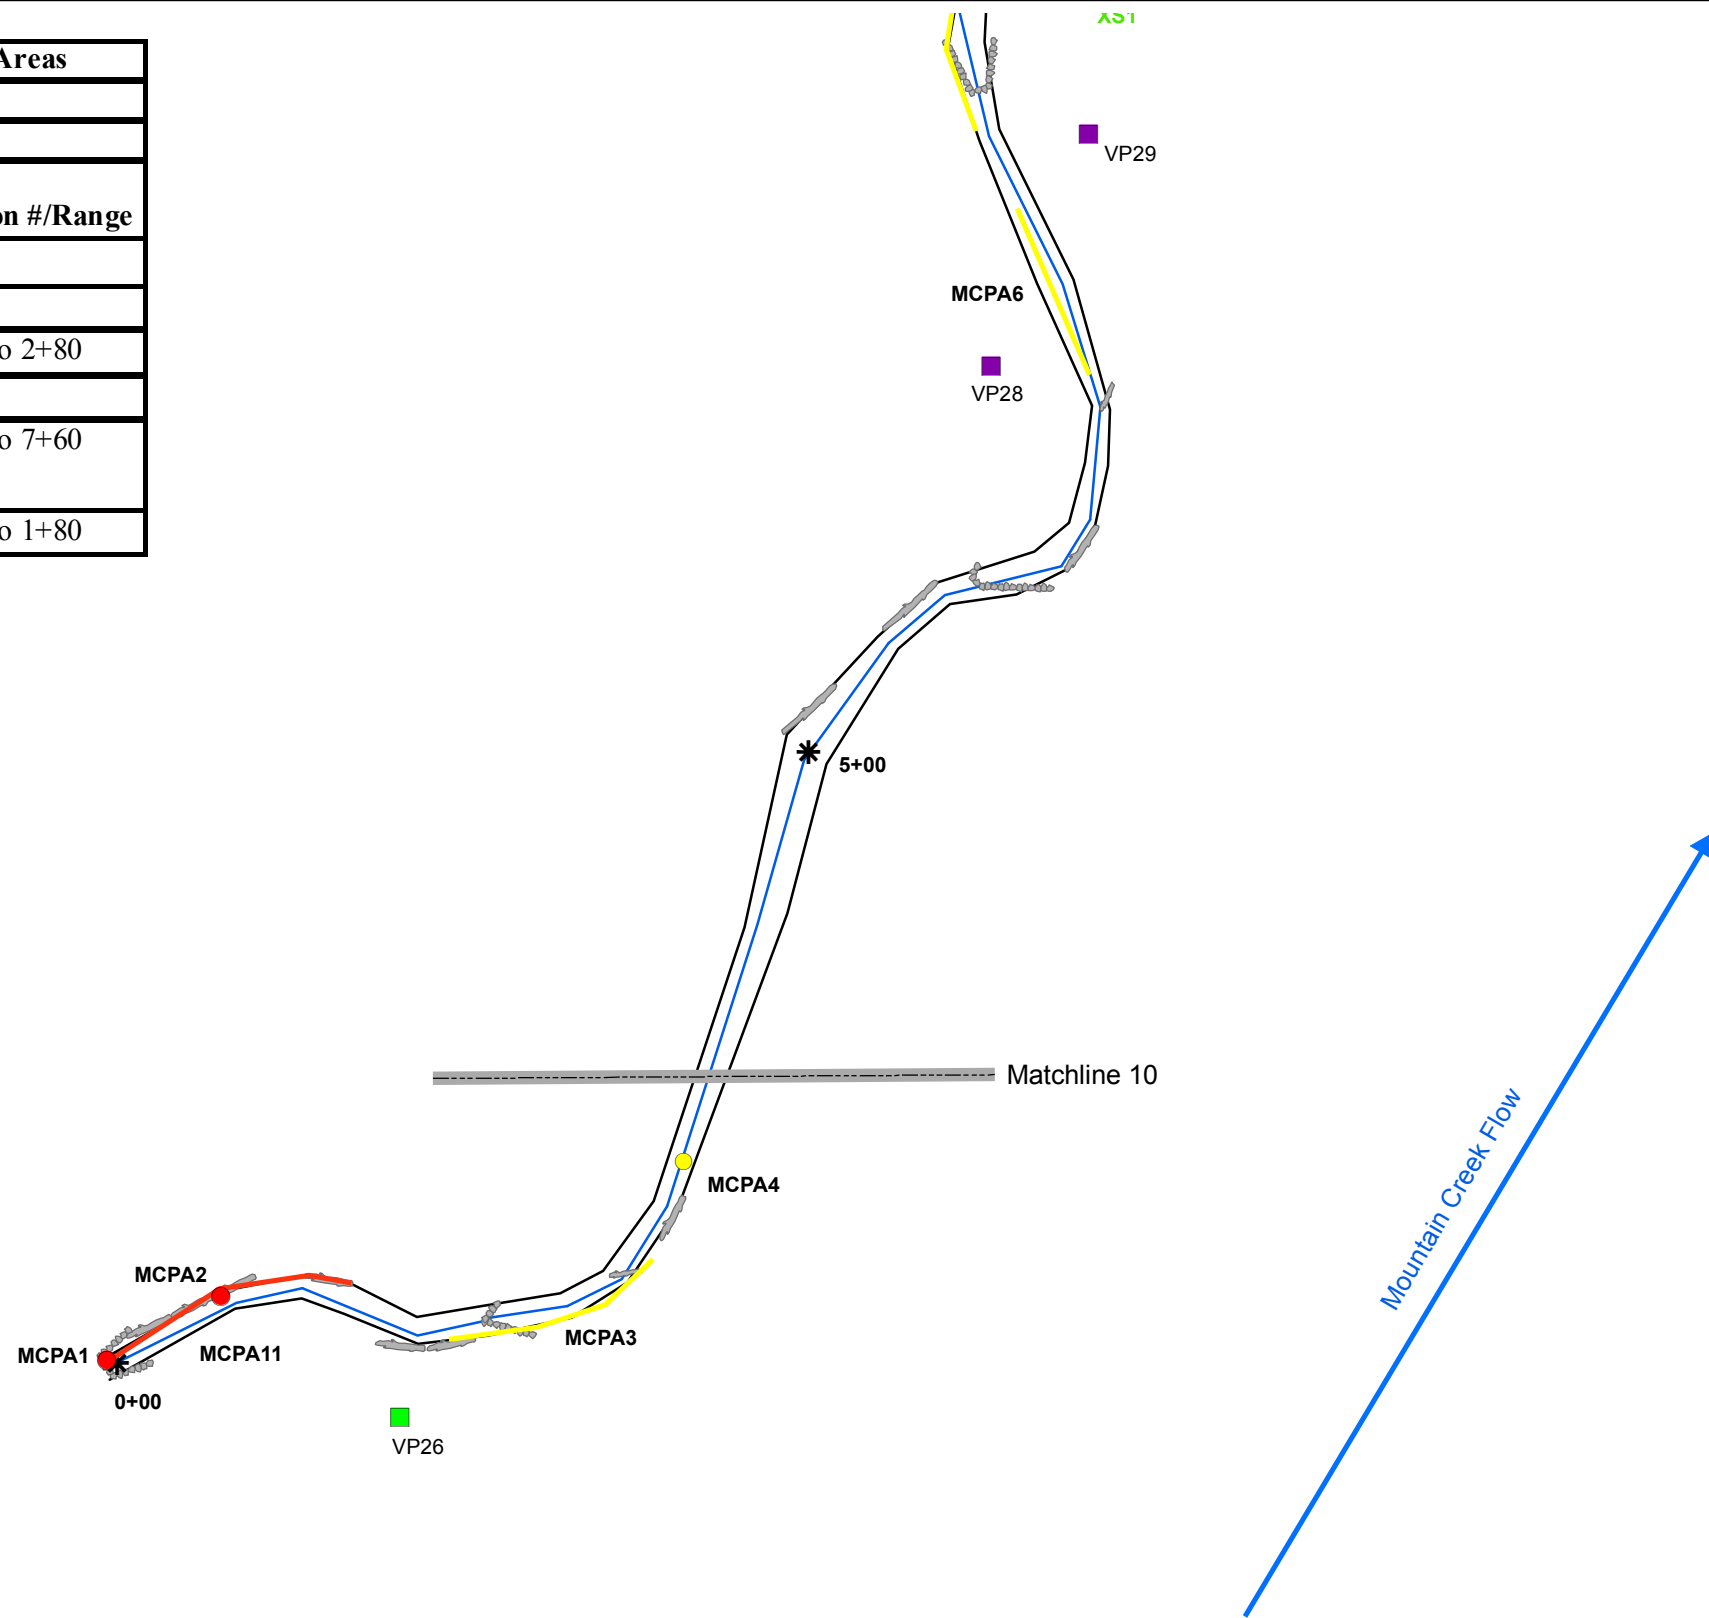
**Stream
 Current Condition
 Plan View**

Big Warrior Creek Stream Problem Areas		
EEP Project Number 00412		
Mountain Creek		
Feature #	Feature Issue	Station #/Range
MCPA1	Structure failure	0+00
MCPA2	Structure failure	1+80
MCPA3	Bank erosion	1+90 to 2+80
MCPA4	Structure failure	3+00
MCPA6	Bank erosion and mid-channel bar formation	7+20 to 7+60
MCPA11	Bank erosion	0+00 to 1+80

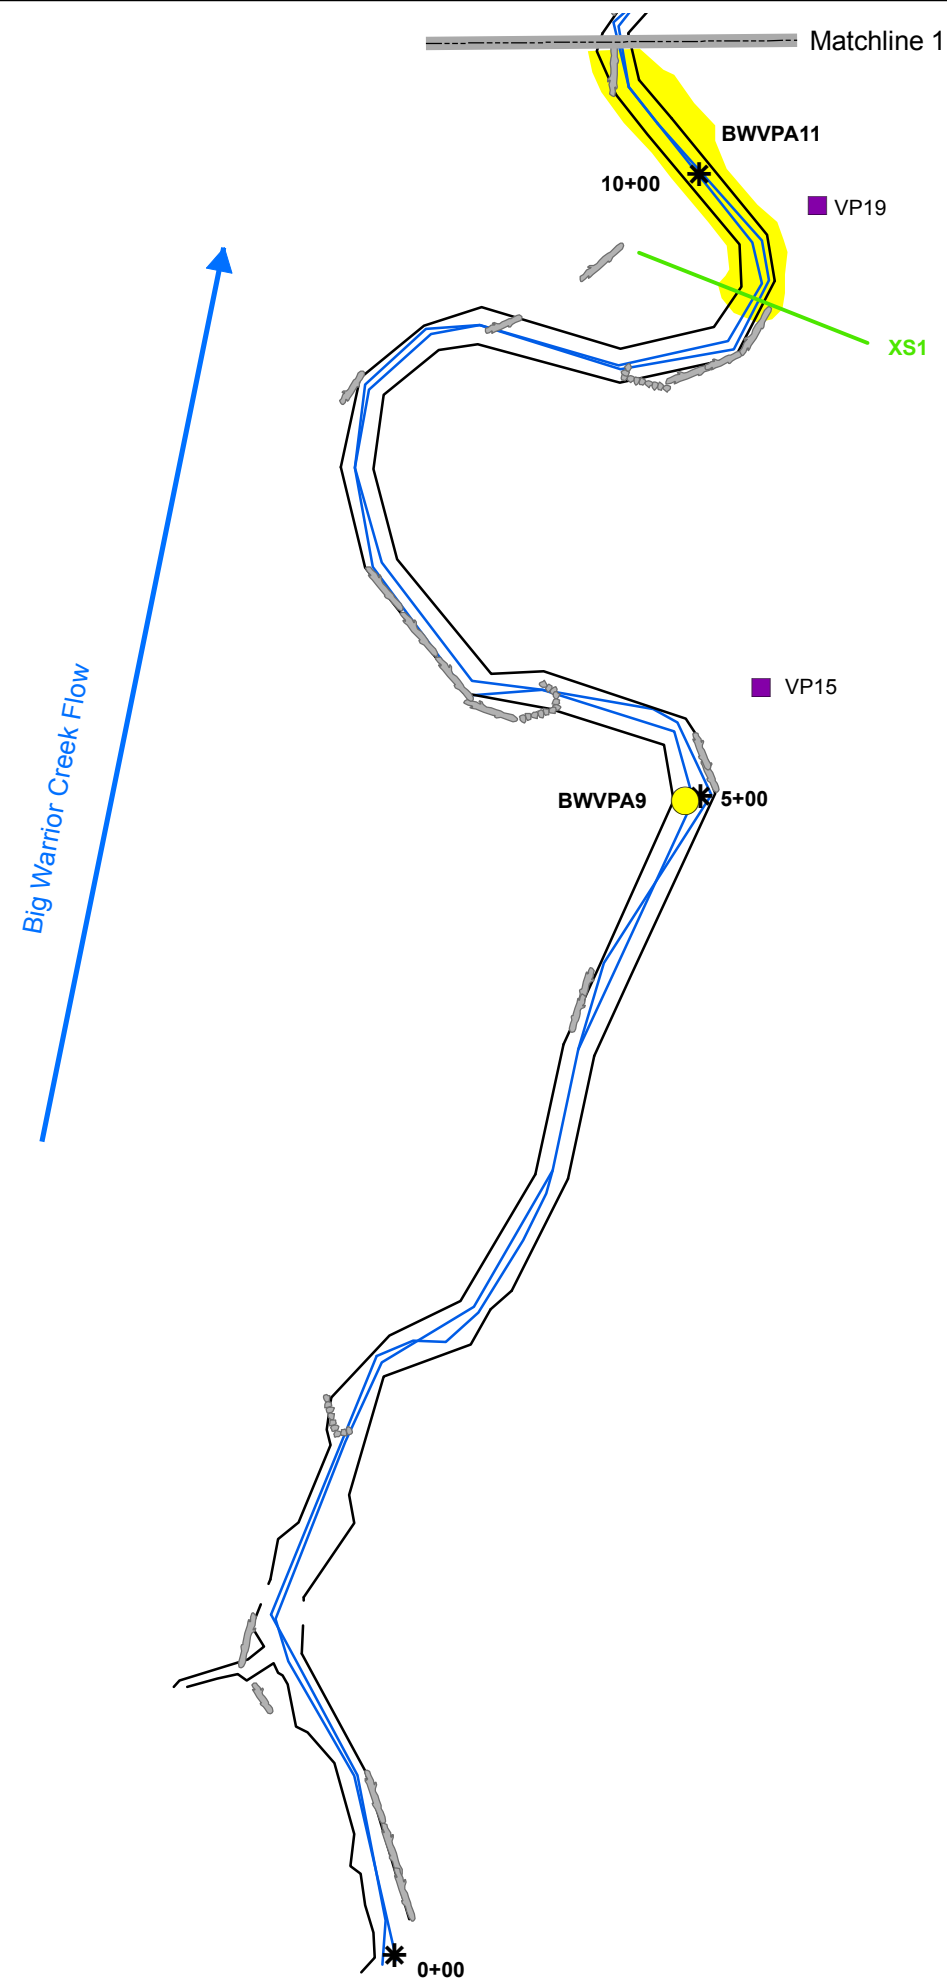
Big Warrior Creek Vegetative Problem Areas		
EEP Project Number 00412		
Big Warrior Creek		
Feature #	Feature/Issue	Station #/Range
BWVPA9	Invasive/exotic plant	5+00
BWVPA11	Beaver damage to planted stems	9+90 to 11+00

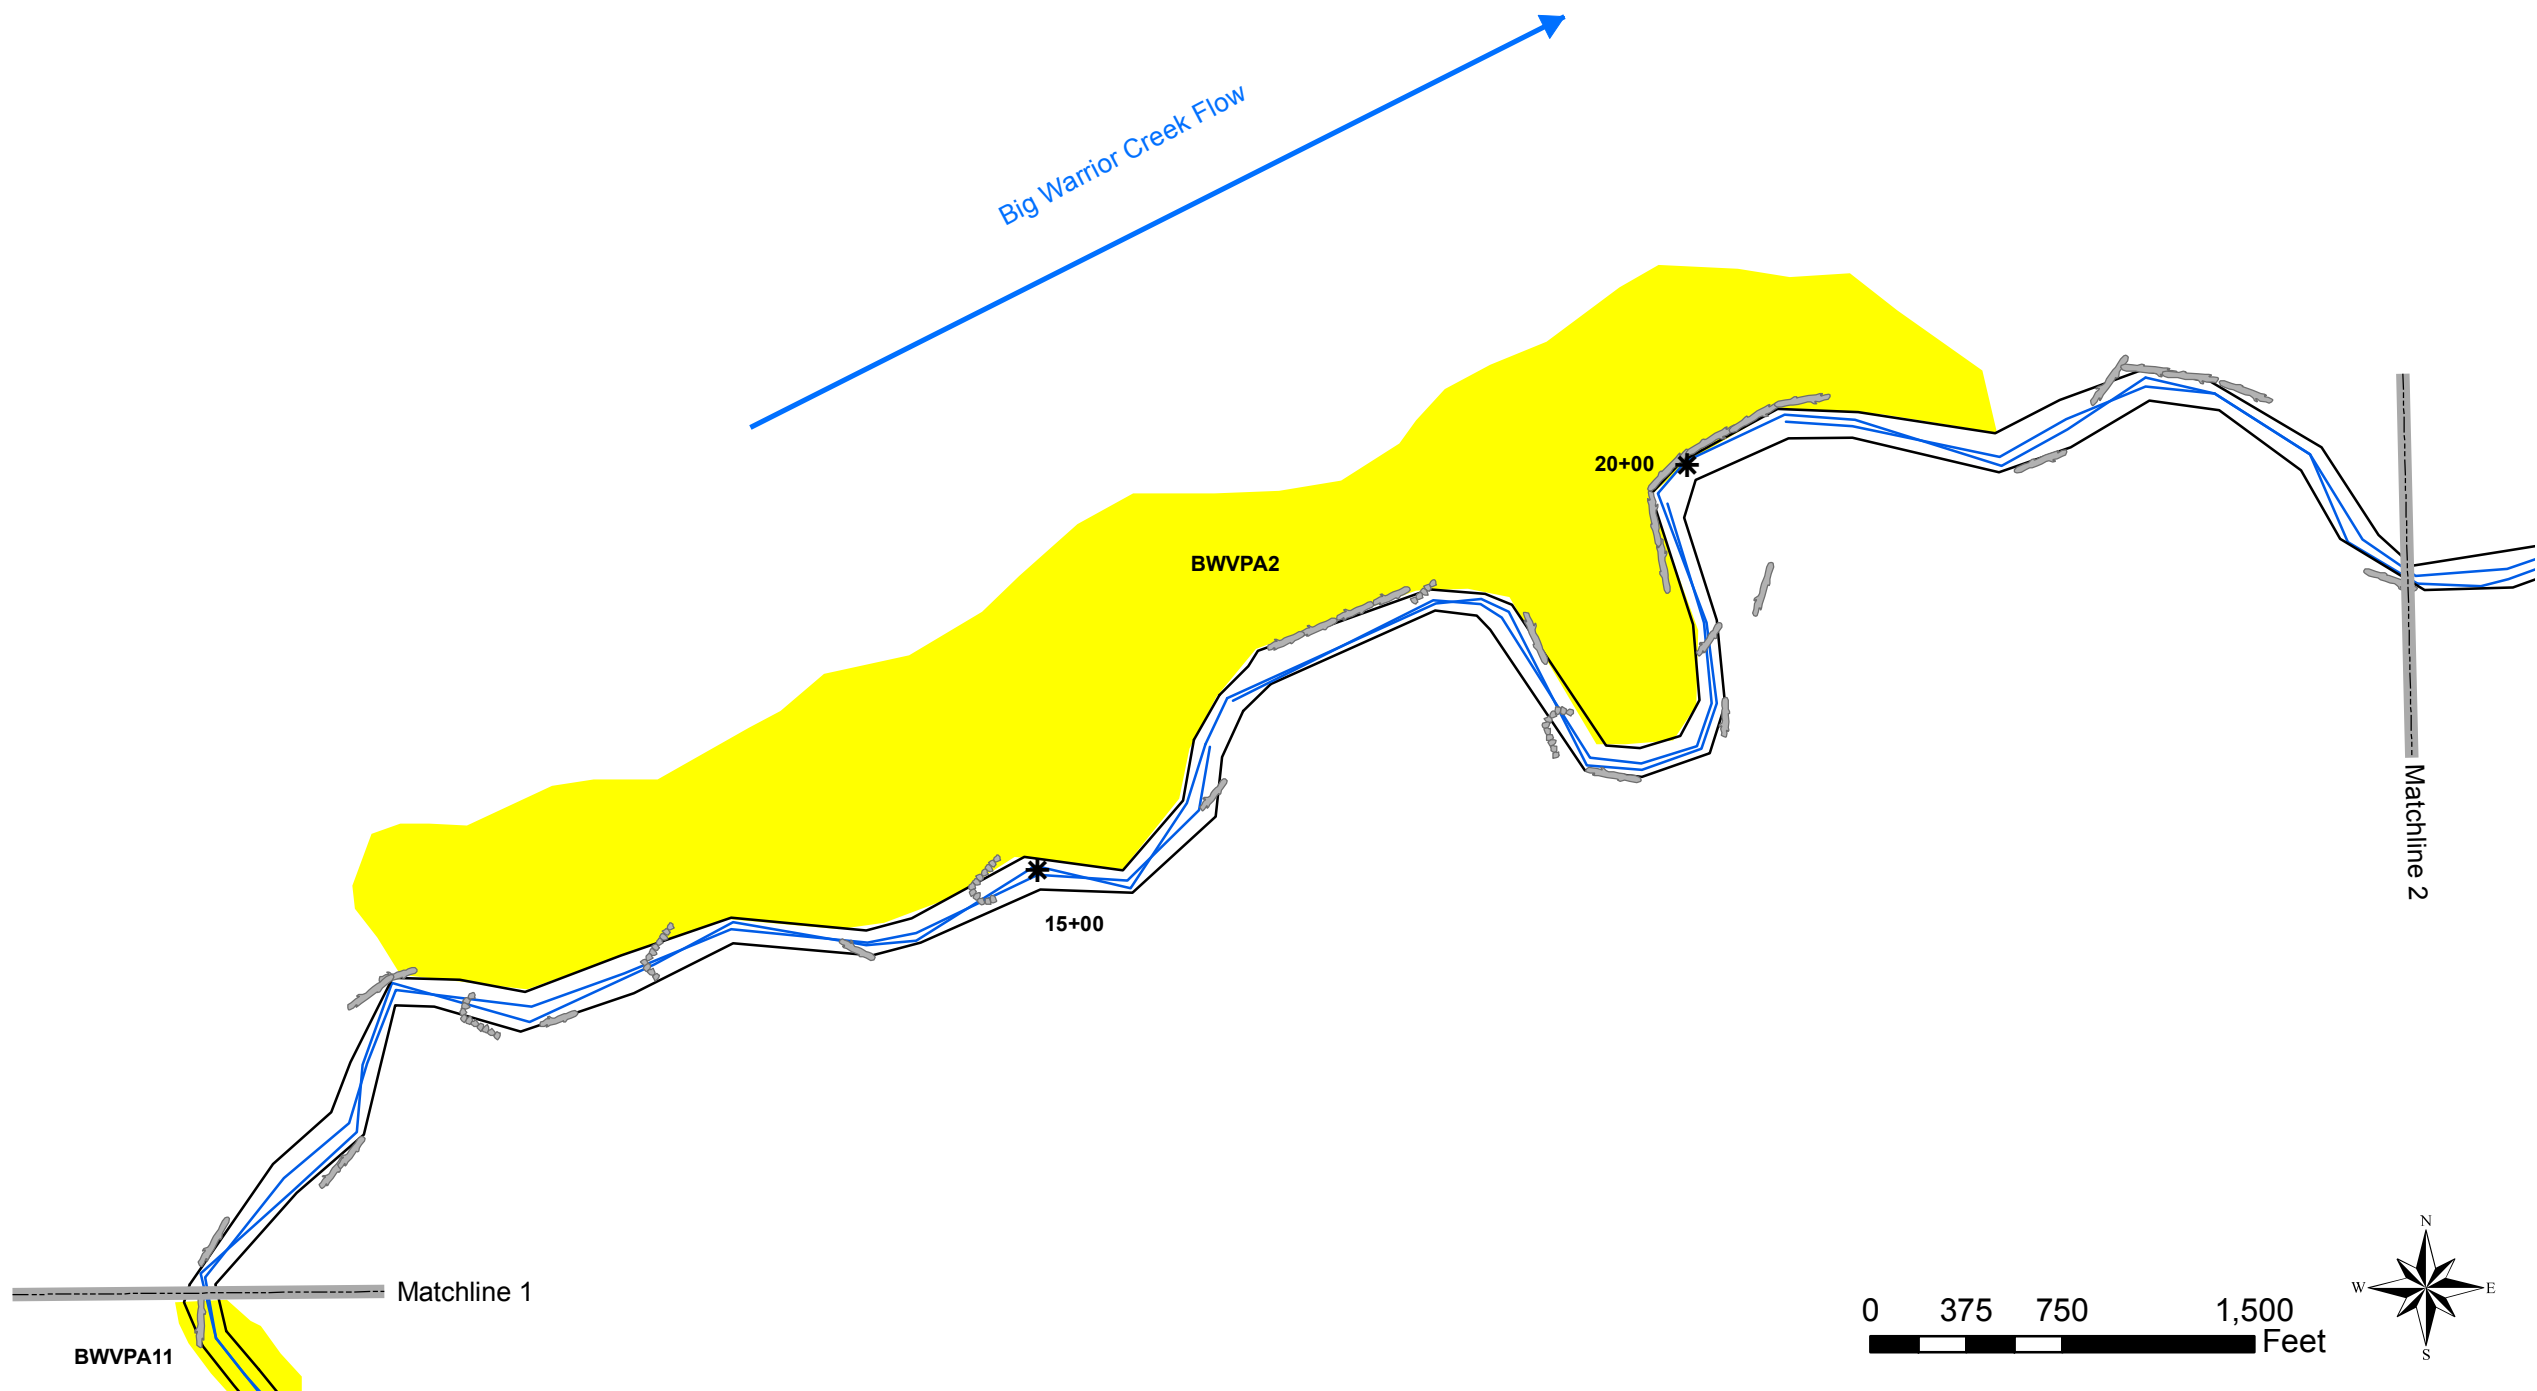
**Vegetation
 Current Condition
 Plan View**

EEP Project Number 00412			
Big Warrior Creek			
Feature #	Feature/Issue	Station #/Range	Suspected Cause
BWVPA2	Invasive/exotic plant	12+00 to 20+10	Kudzu
BWVPA11	Beaver damage to planted stems	9+90 to 11+00	Beaver activity

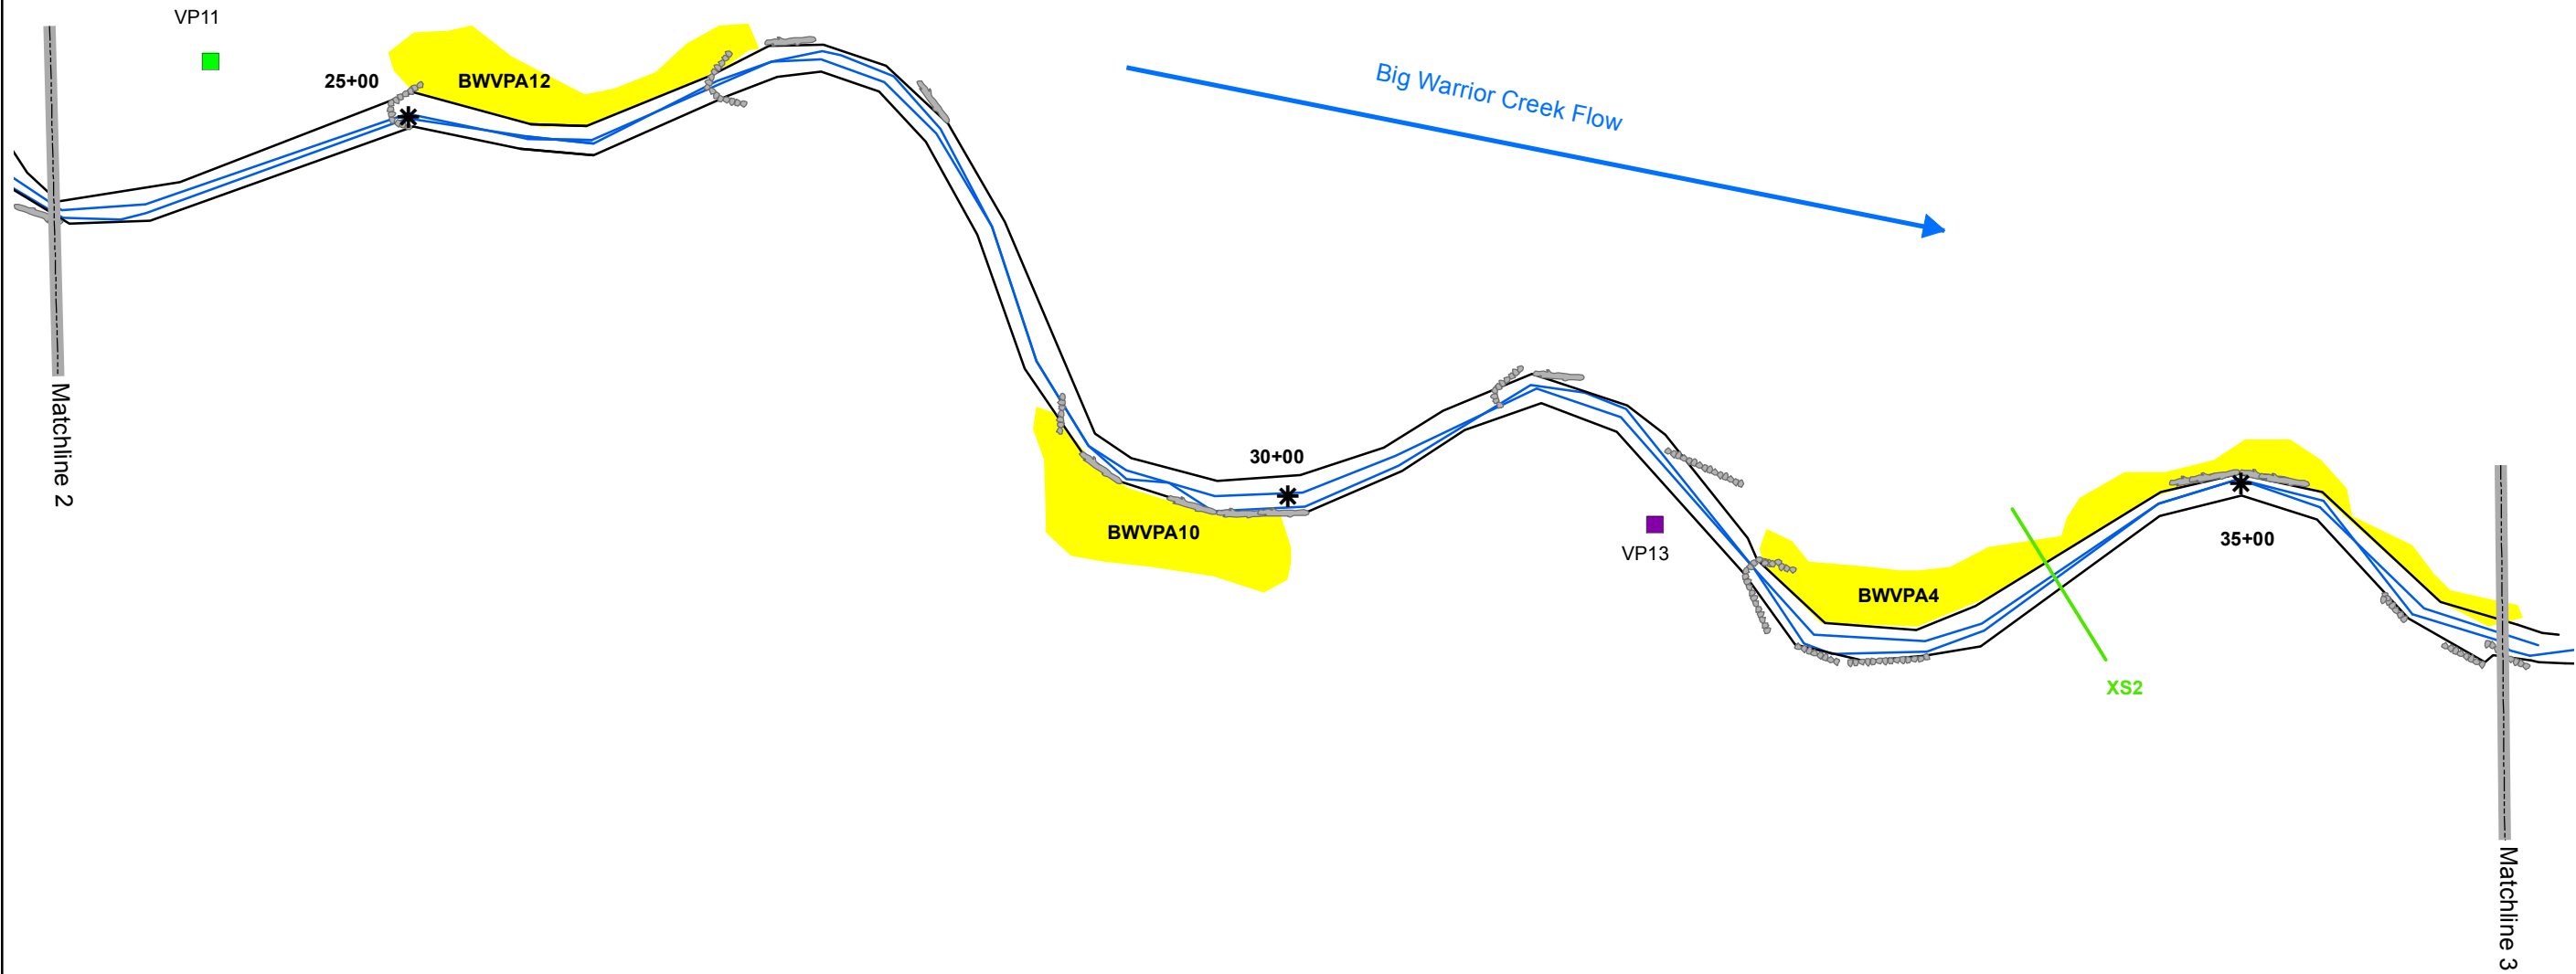
Vegetation
 Current Condition
 Plan View

EEP Project Number 00412			
Big Warrior Creek			
Feature #	Feature/Issue	Station #/Range	Suspected Cause
BWVPA4	Invasive/exotic plant	33+00 to 37+00	Kudzu and Chinese privet
BWVPA10	Bare ground	28+00 to 30+00	Poor survivability, soil and slope
BWVPA12	Invasive/exotic plant	25+00 to 26+80	Kudzu and Japanese honeysuckle

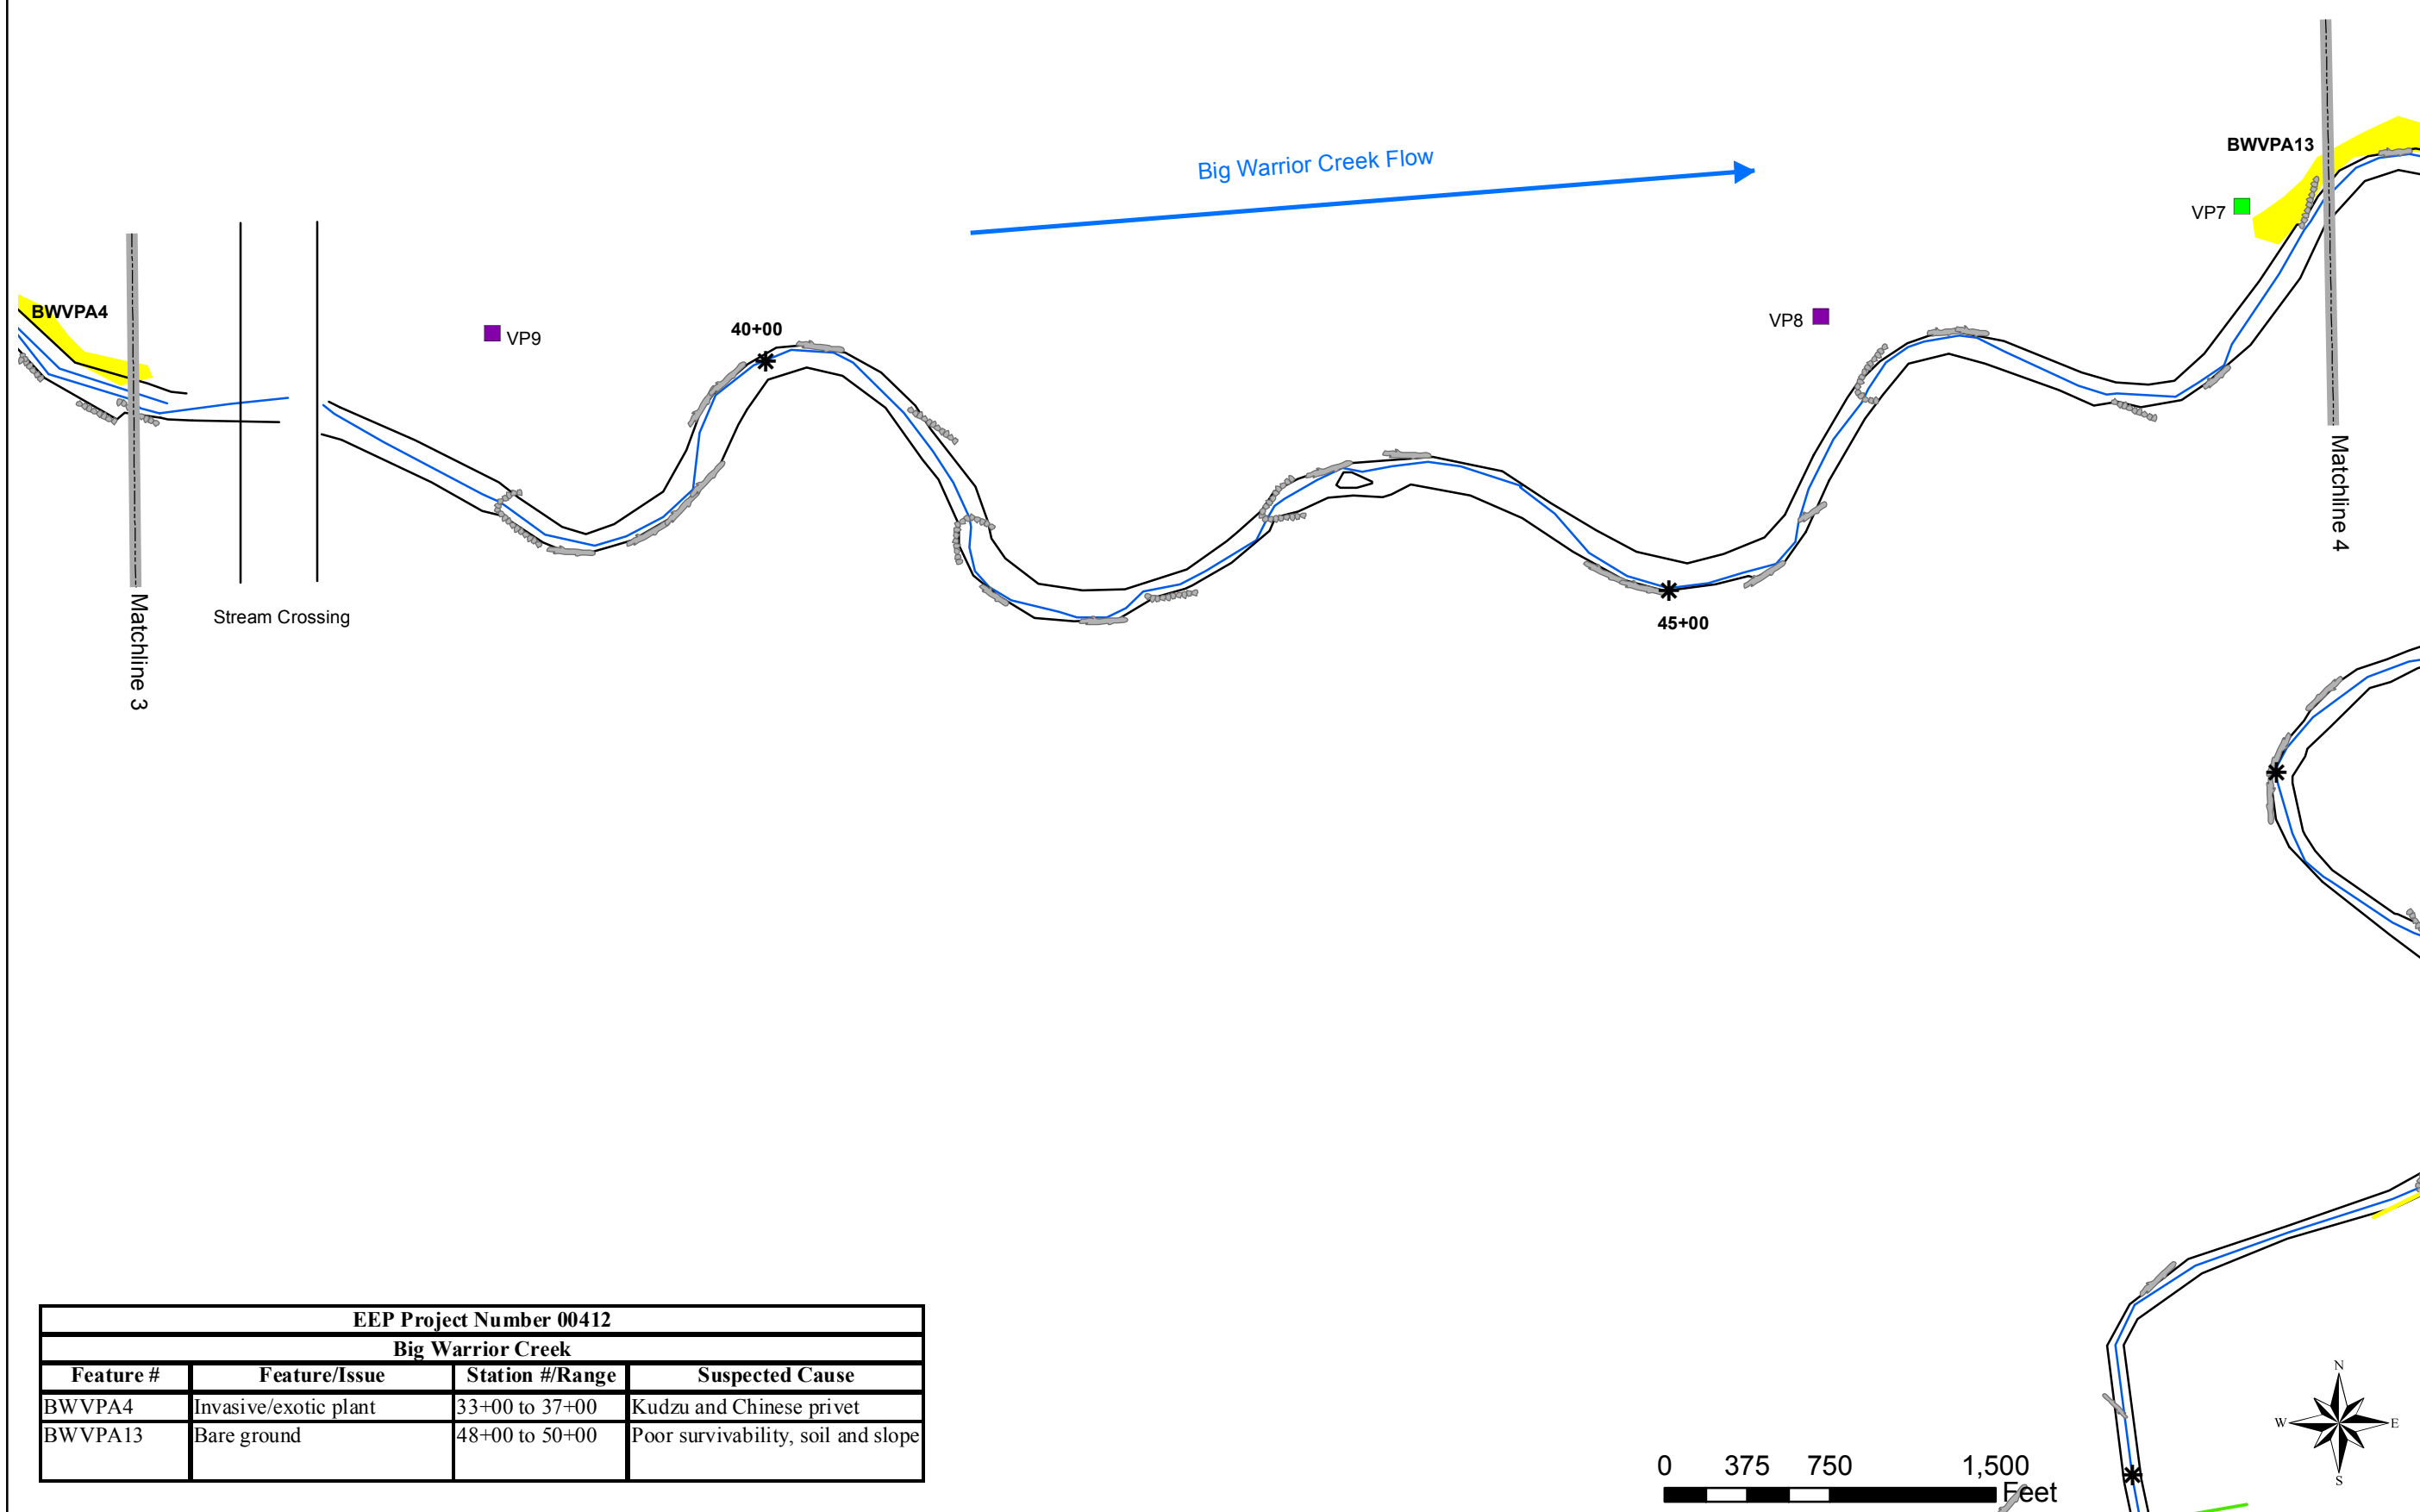
Vegetation
 Current Condition
 Plan View

EEP Project Number 00412			
Big Warrior Creek			
Feature #	Feature/Issue	Station #/Range	Suspected Cause
BWVPA4	Invasive/exotic plant	33+00 to 37+00	Kudzu and Chinese privet
BWVPA13	Bare ground	48+00 to 50+00	Poor survivability, soil and slope

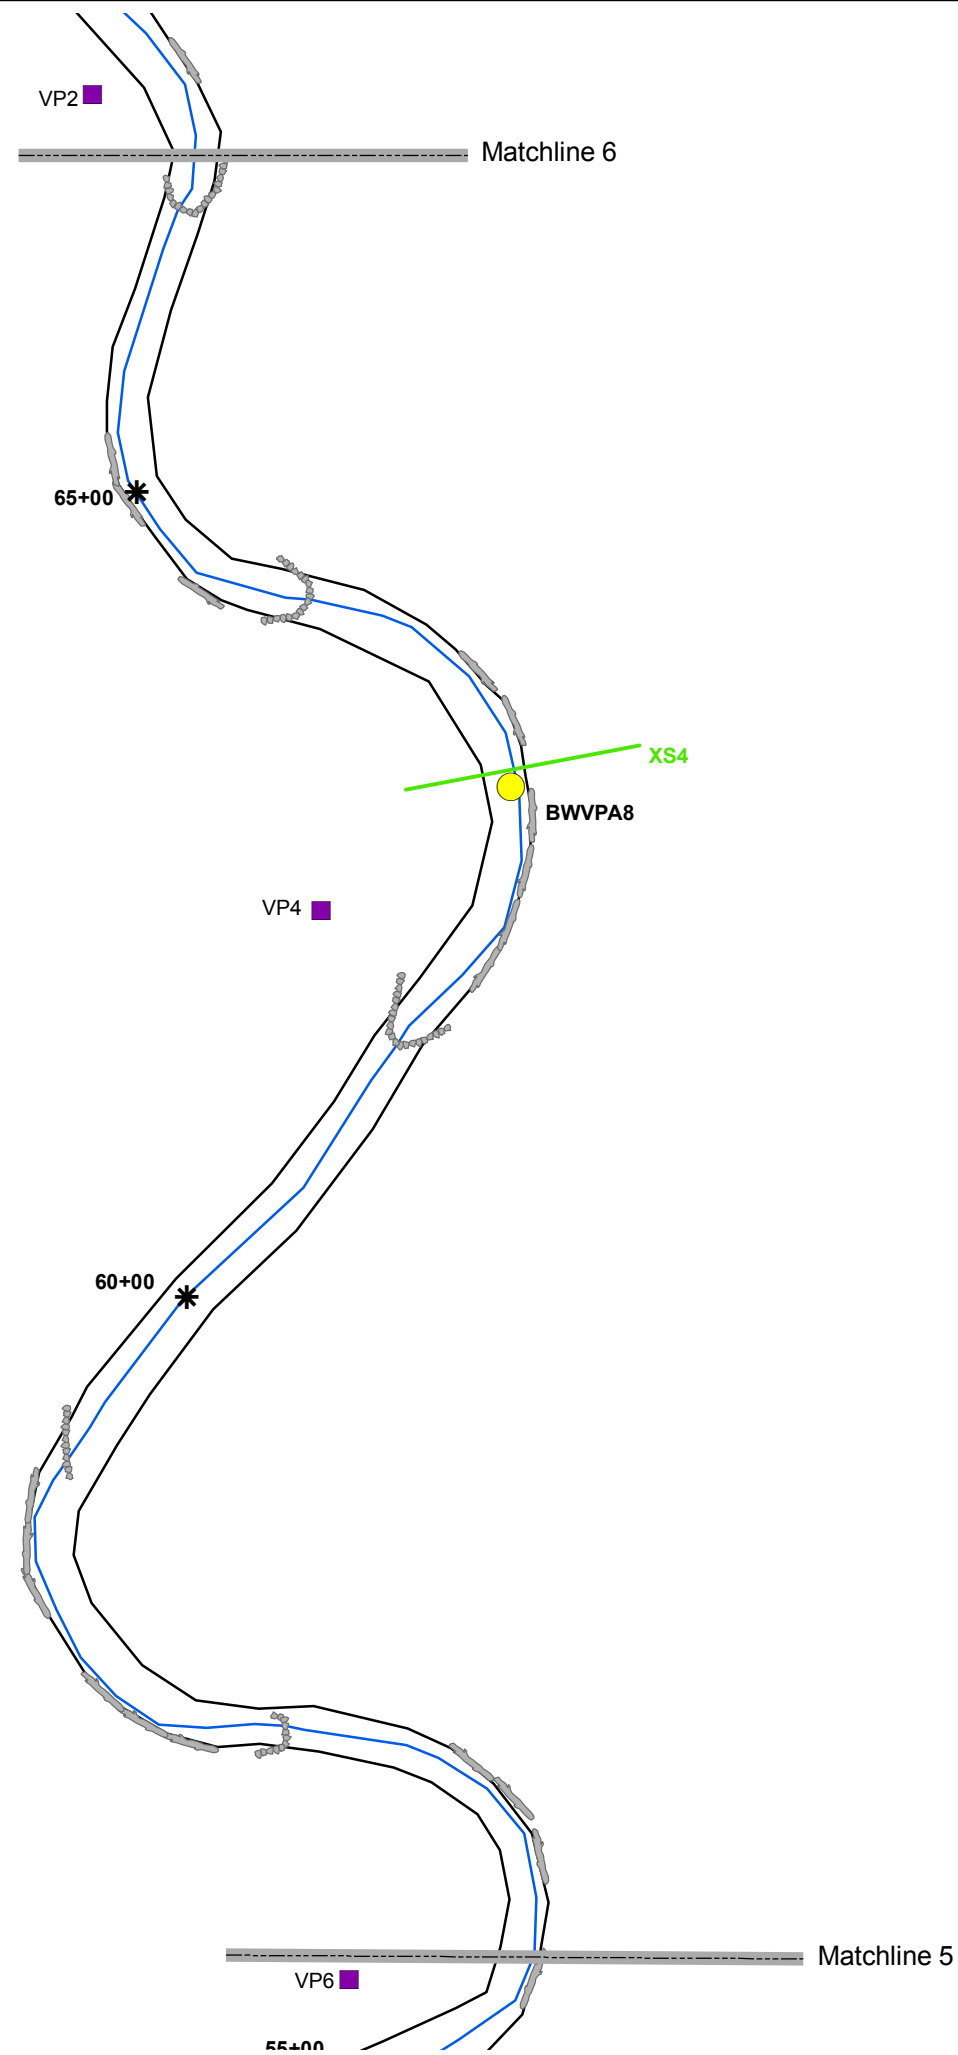
Big Warrior Creek Vegetative Problem Areas		
EEP Project Number 00412		
Big Warrior Creek		
Feature #	Feature/Issue	Station #/Range
BWVPA8	Invasive/exotic plant	63+50
