**Big Warrior Creek Stream Restoration
2009 Final Monitoring Report
Monitoring Year Five**

Ecosystem Enhancement Program Project Number 00412

Submitted: April 23, 2010

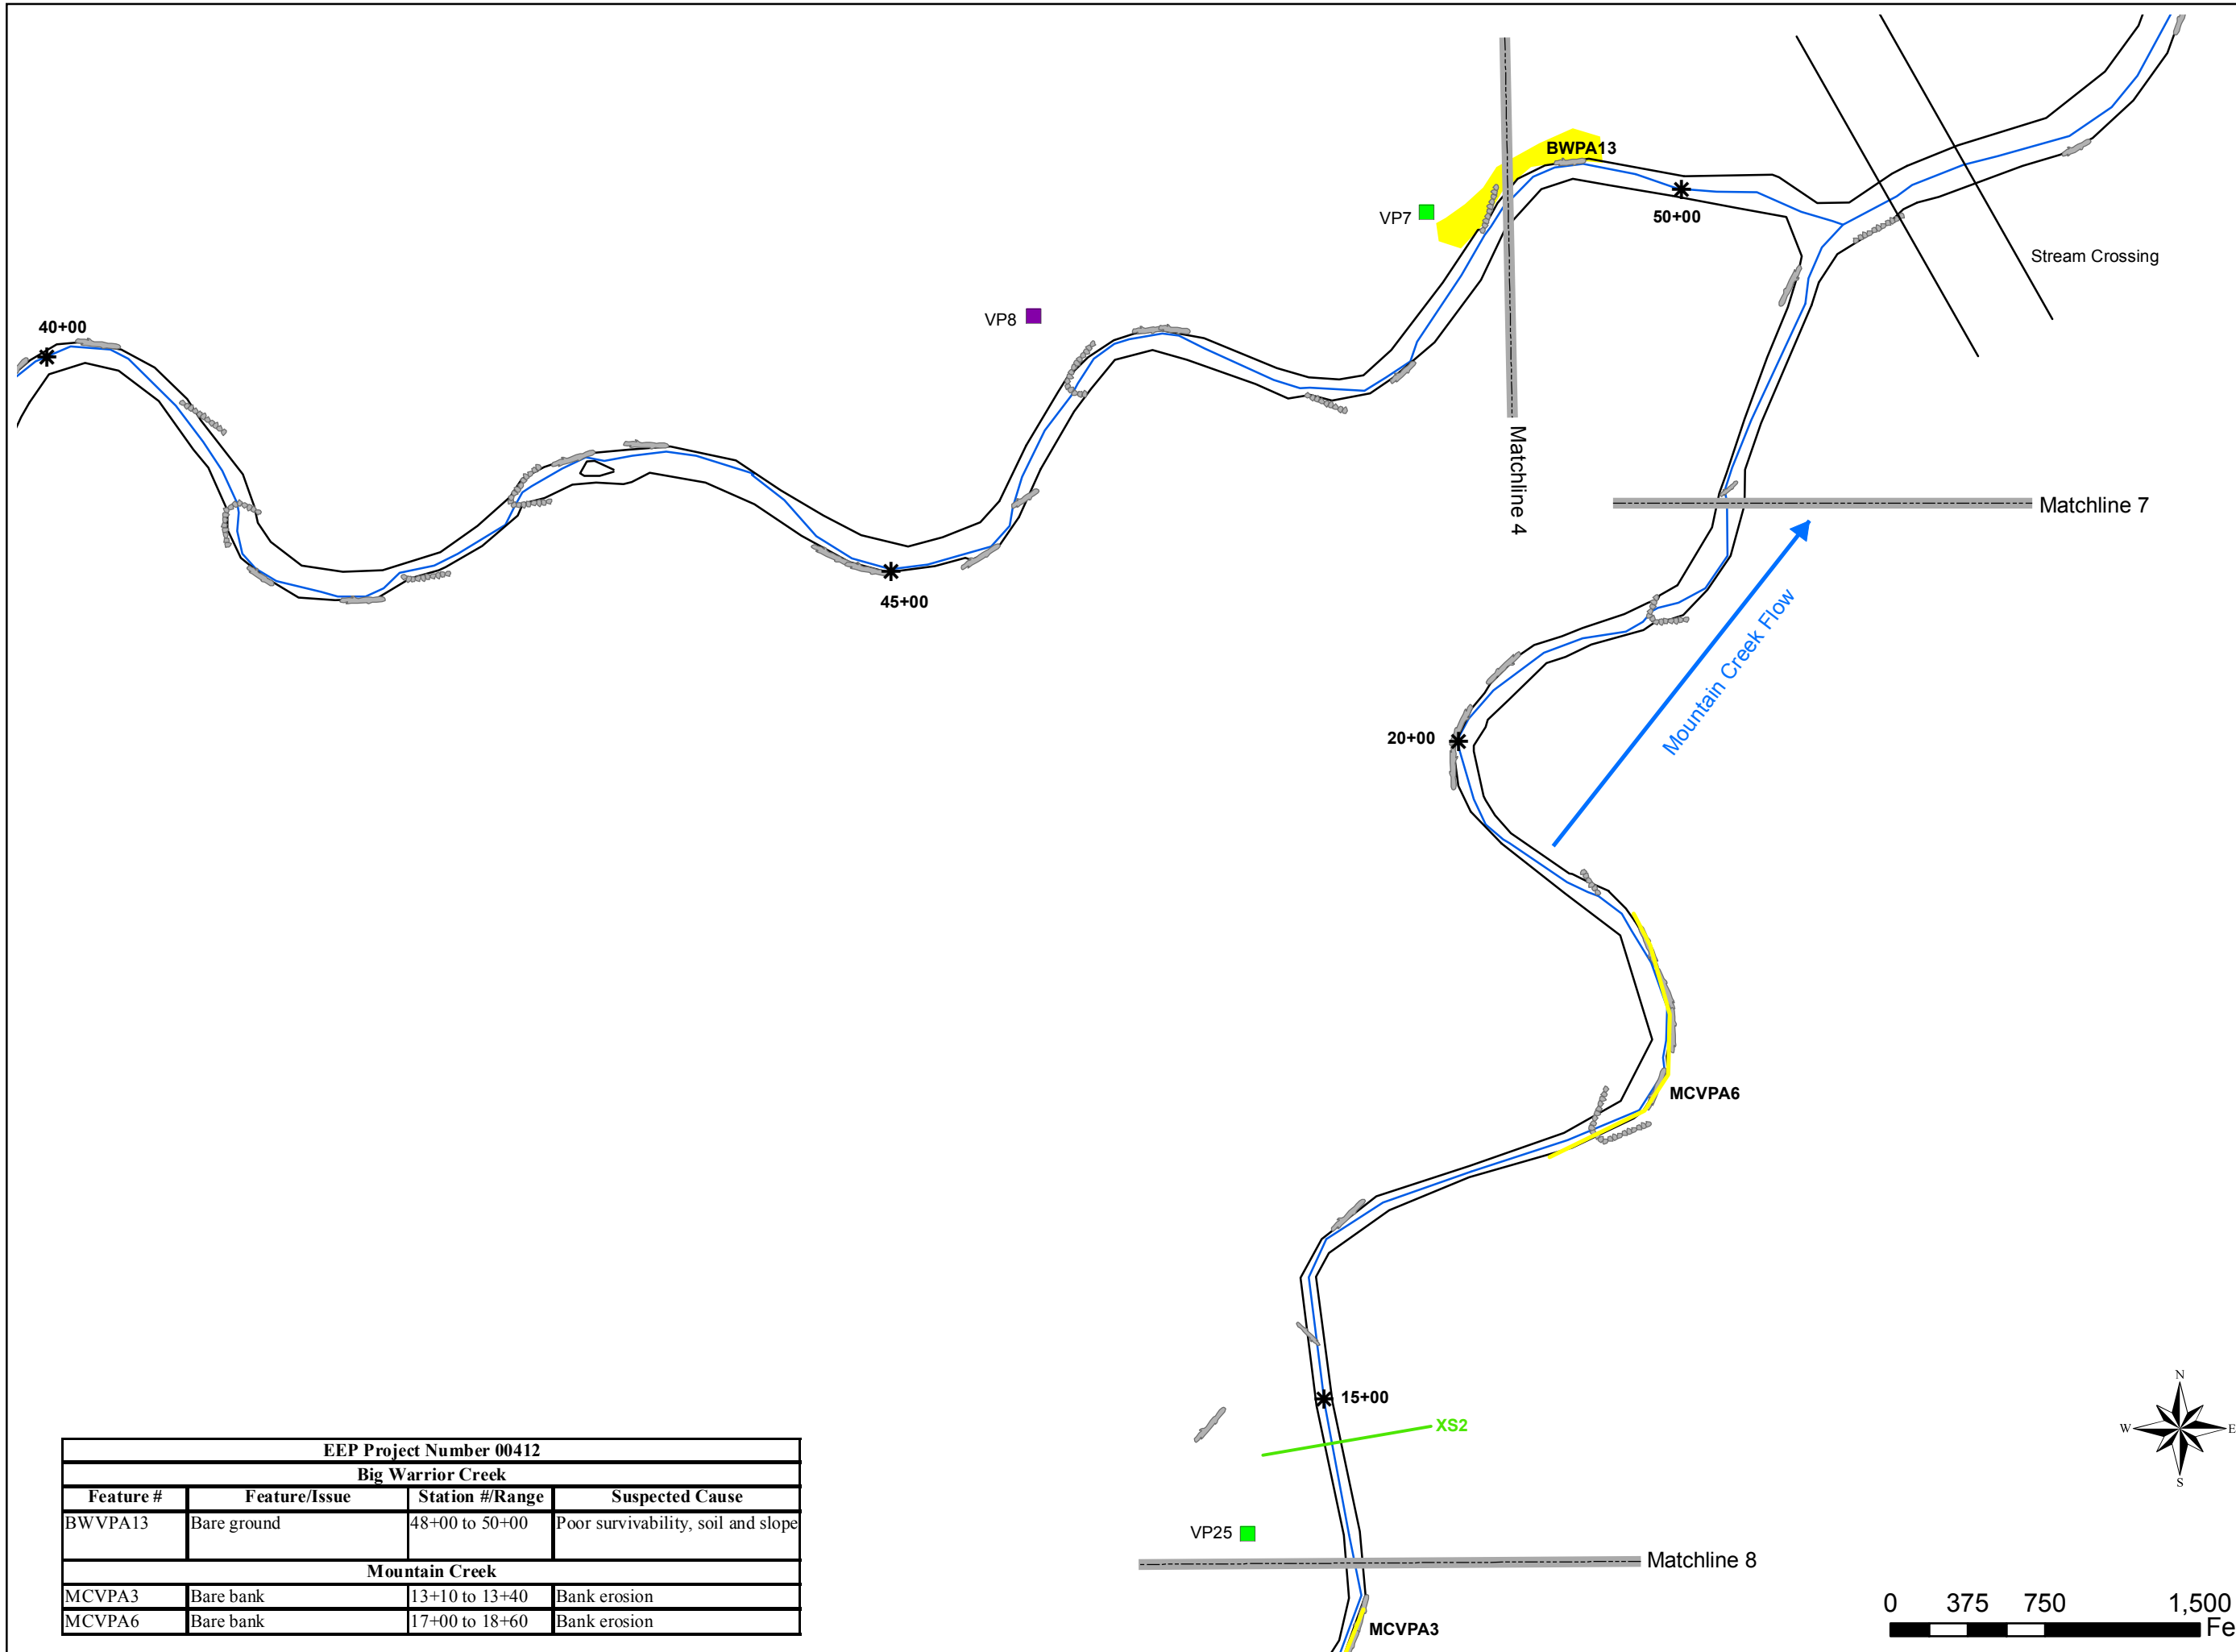
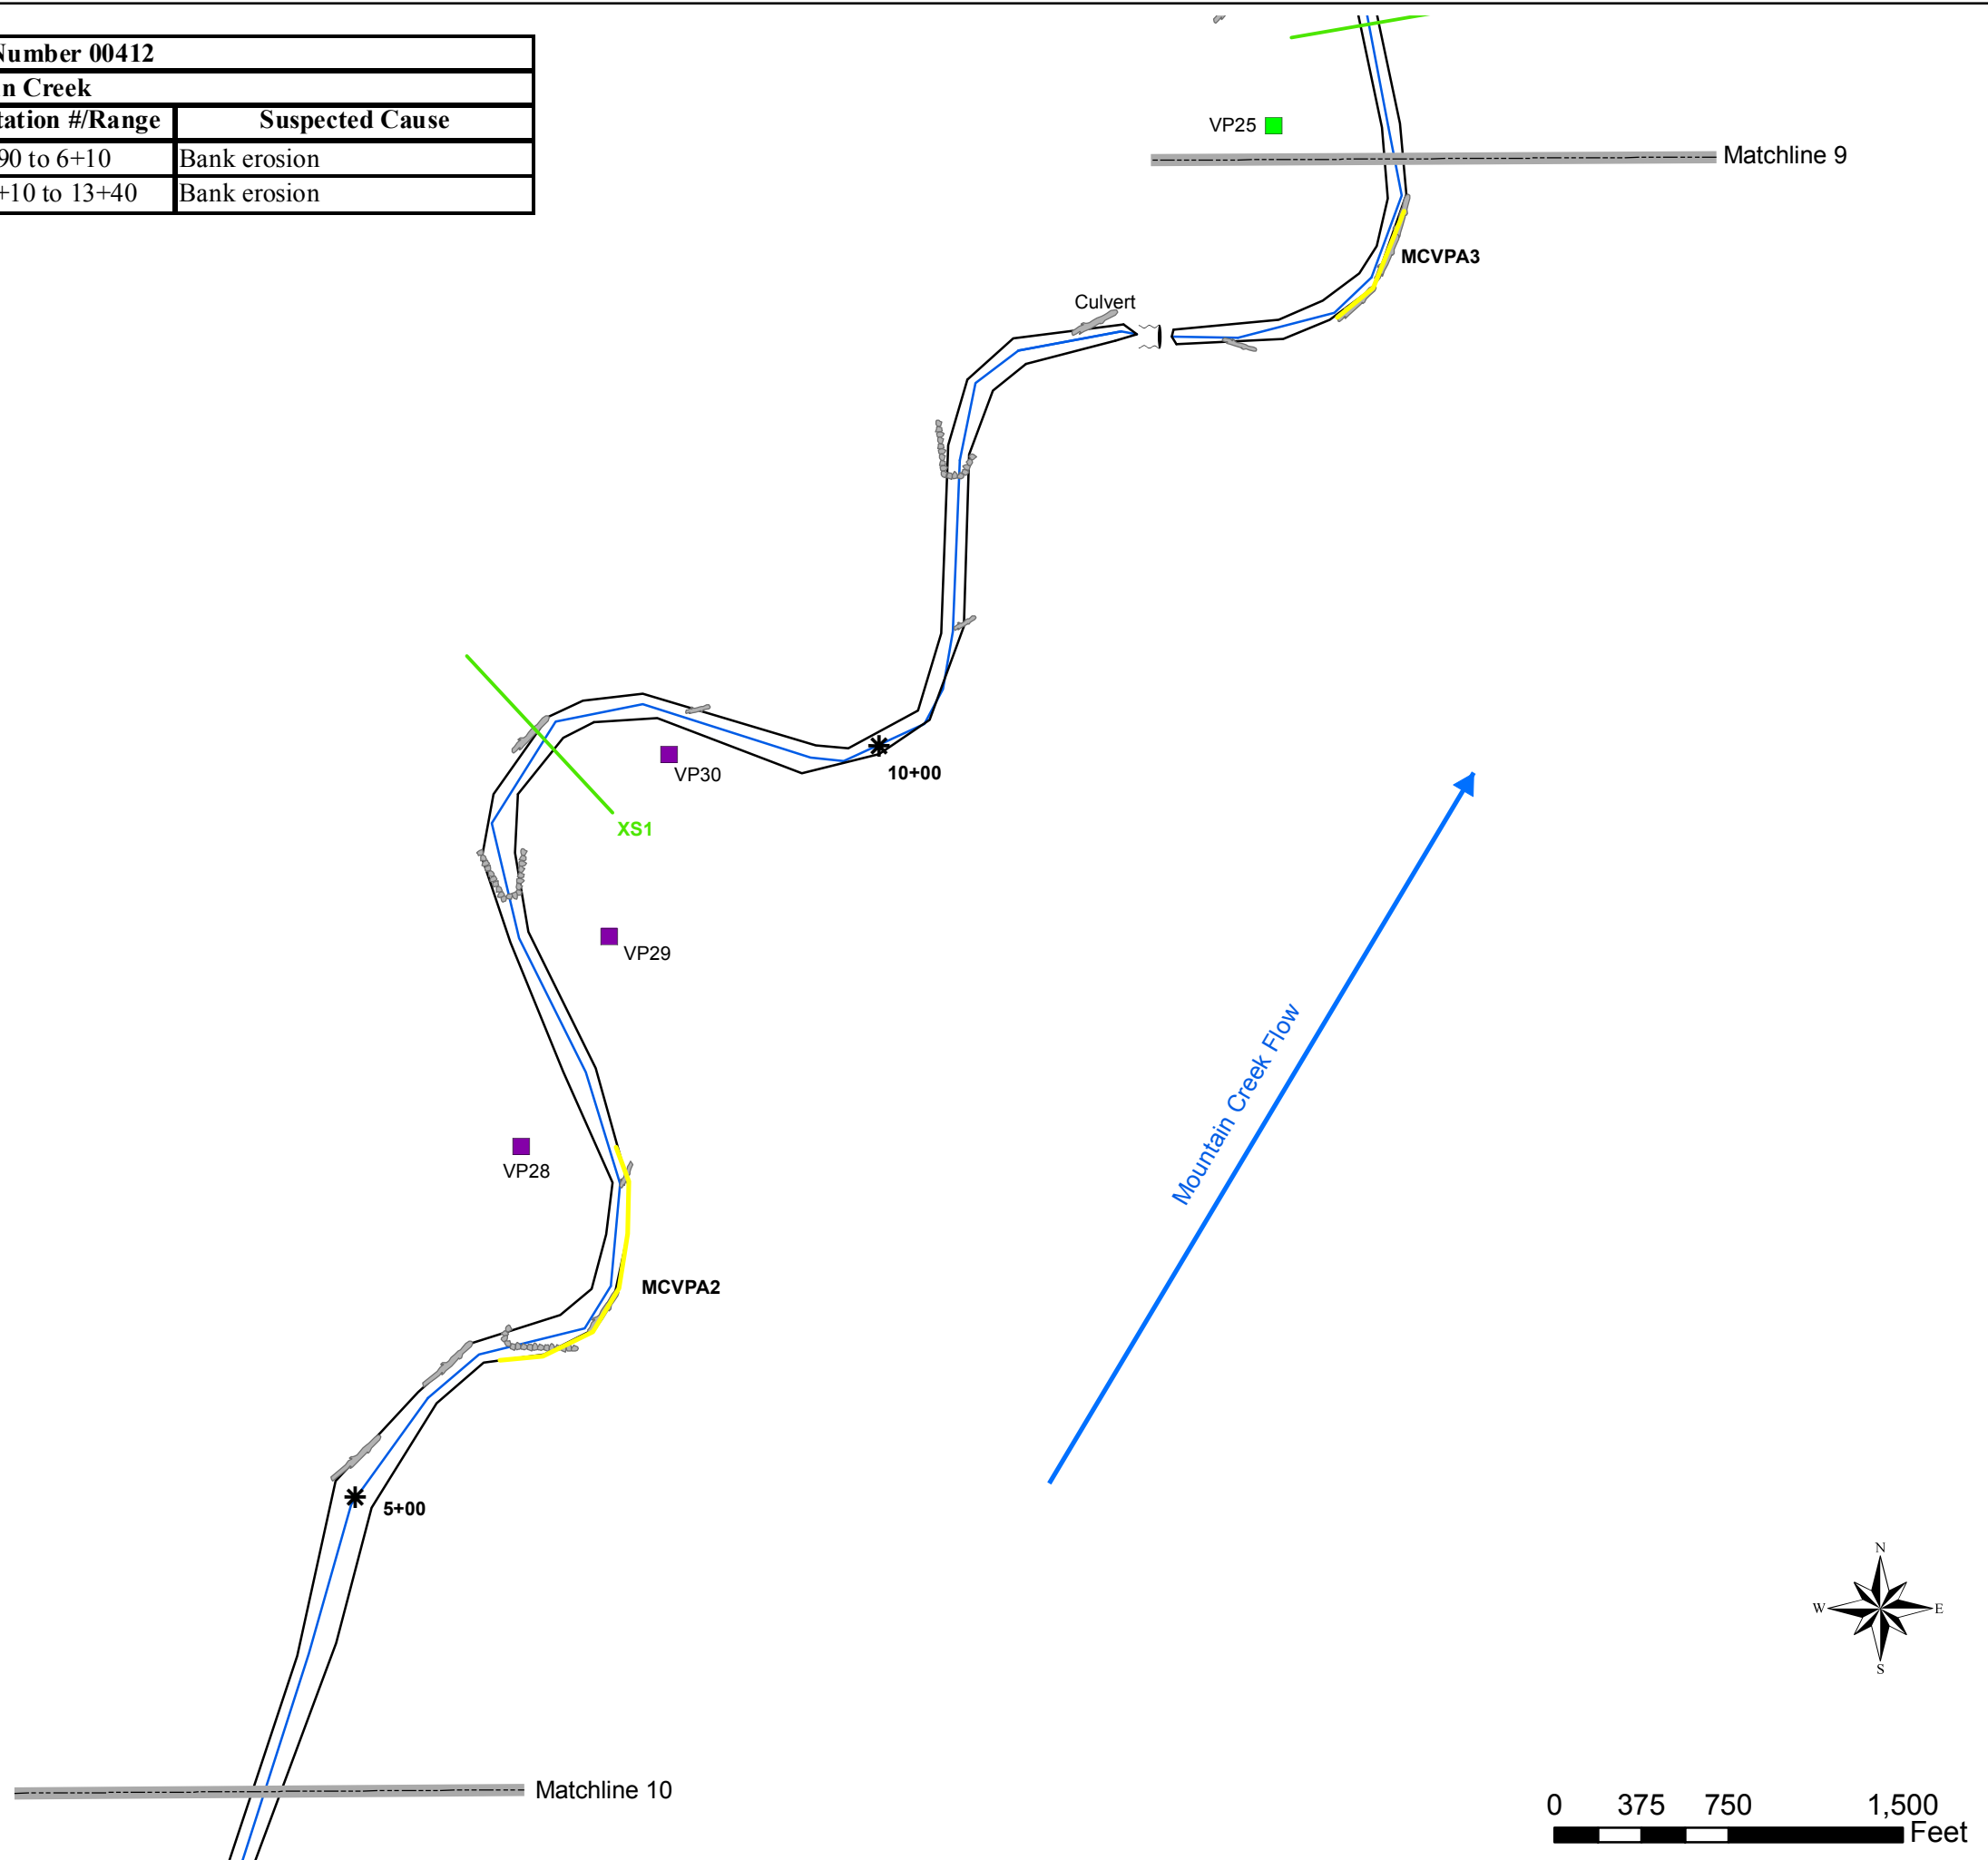
EEP Project Number 00412			
Big Warrior Creek			
Feature #	Feature/Issue	Station #/Range	Suspected Cause
BWVPA13	Bare ground	48+00 to 50+00	Poor survivability, soil and slope
Mountain Creek			
MCVPA3	Bare bank	13+10 to 13+40	Bank erosion
MCVPA6	Bare bank	17+00 to 18+60	Bank erosion

Feature #	Feature/Issue	Station #/Range	Suspected Cause
MCVPA2	Bare bank	5+90 to 6+10	Bank erosion
MCVPA3	Bare bank	13+10 to 13+40	Bank erosion

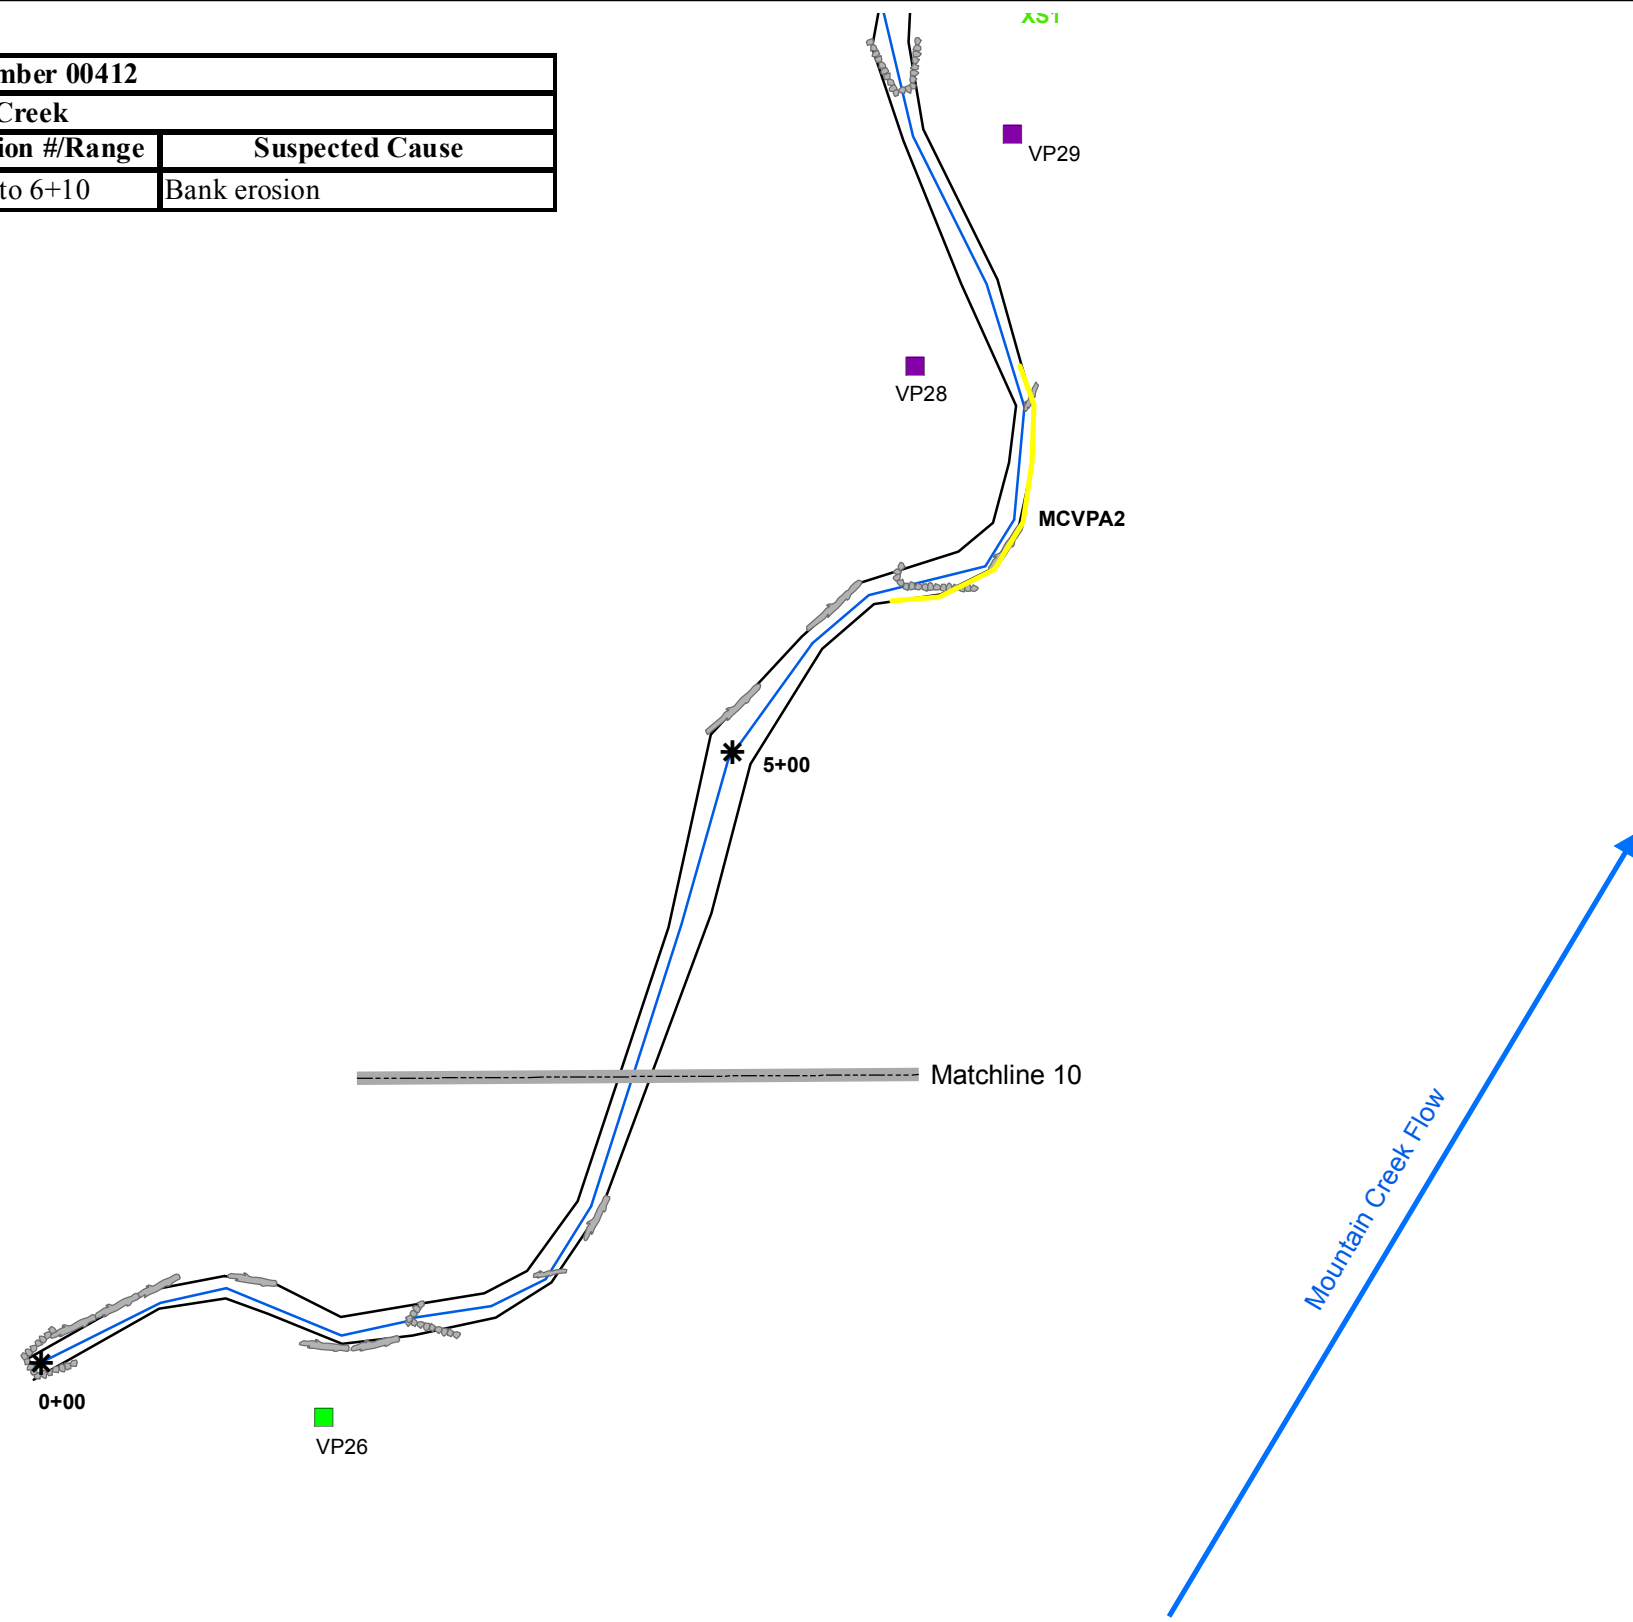
Feature #	Feature/Issue	Station #/Range	Suspected Cause
MCVPA2	Bare bank	5+90 to 6+10	Bank erosion

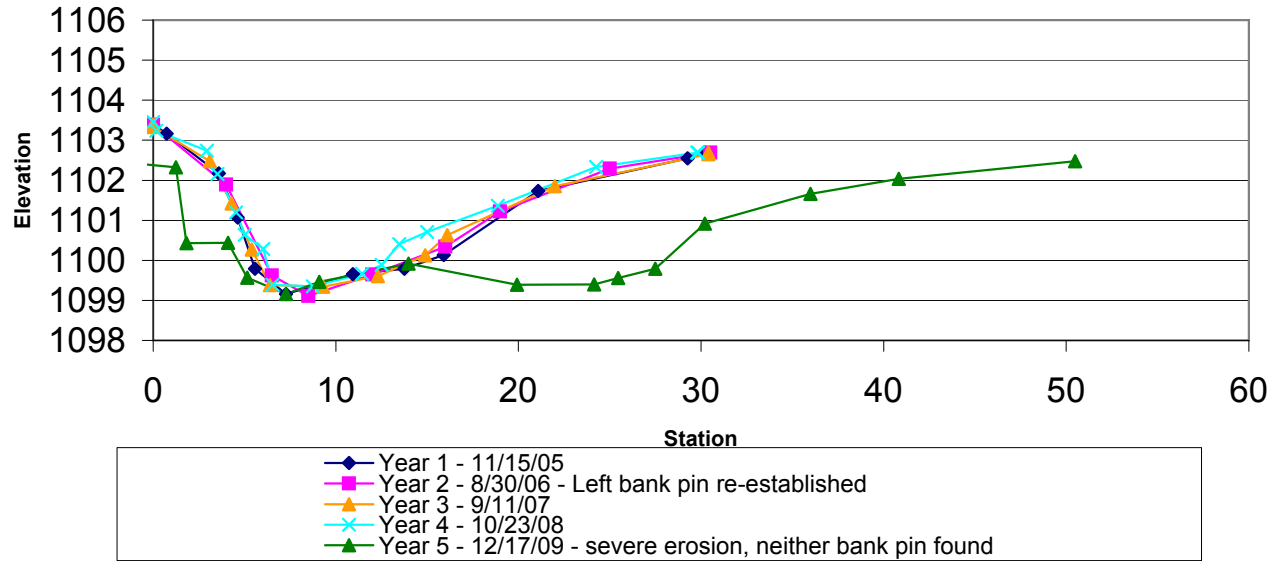
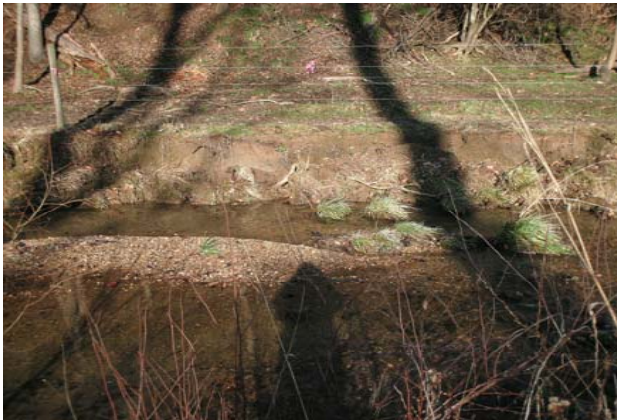
Big Warrior - Mountain Creek XS 1, Pool, Year 1, 2, 3, 4, & 5 Overlay

Utilized common right rebar from Year 1 to set Year 2, 3, 4, & 5 on same elevation. Severe bank erosion in 2009 - Right pin not located. Replaced on new top of bank.
