Year One Monitoring Report

WELLS CREEK AT SYDNOR
PROPERTY

December 2005

ARCADIS G&M of North Carolina, Inc.
801 Corporate Center Drive
Suite 300
Raleigh,
North Carolina 27607-5073
Tel 919 854 1282
Fax 919 854 5448

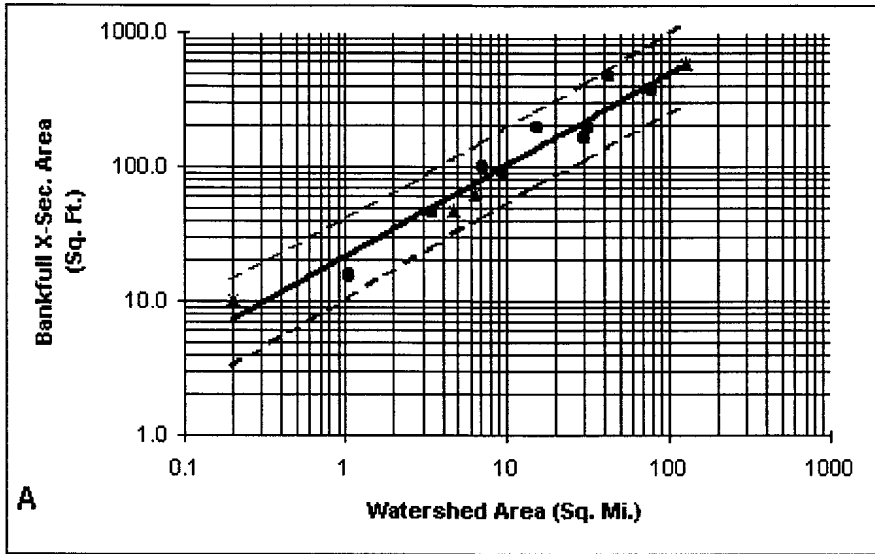
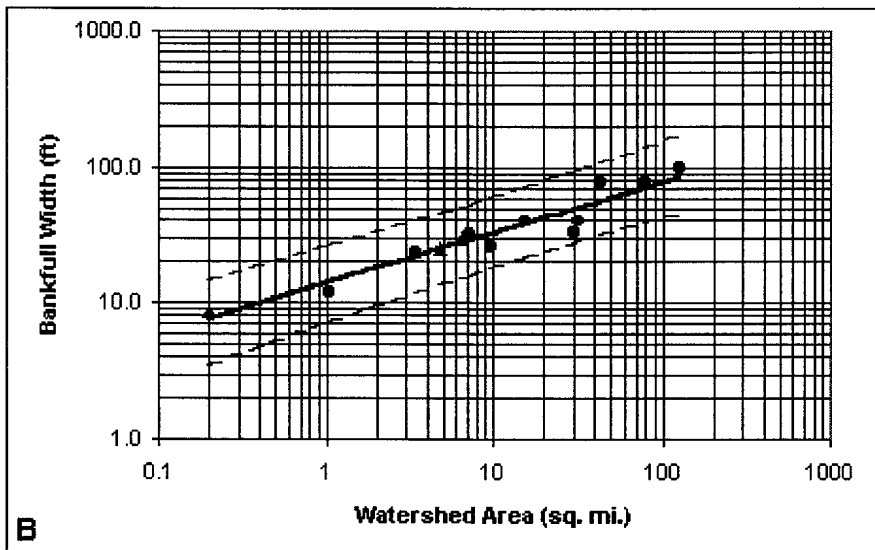
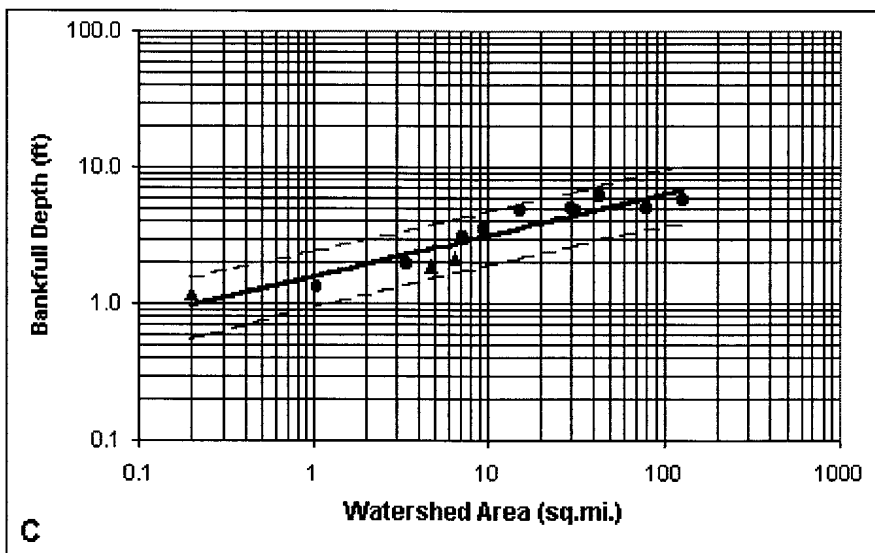
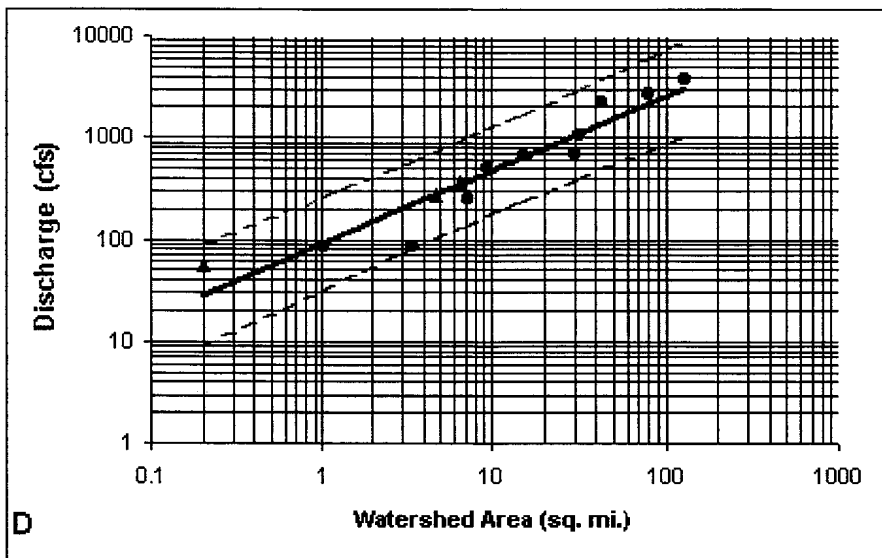
Bankfull hydraulic geometry relationships for rural Piedmont North Carolina Streams. The four graphs represent:

a) cross sectional area, b) width, c) depth, and d) discharge. The circles represent gage stations and the triangles represent ungaged streams. The outside dashed lines are the 95% confidence intervals for all the data points.

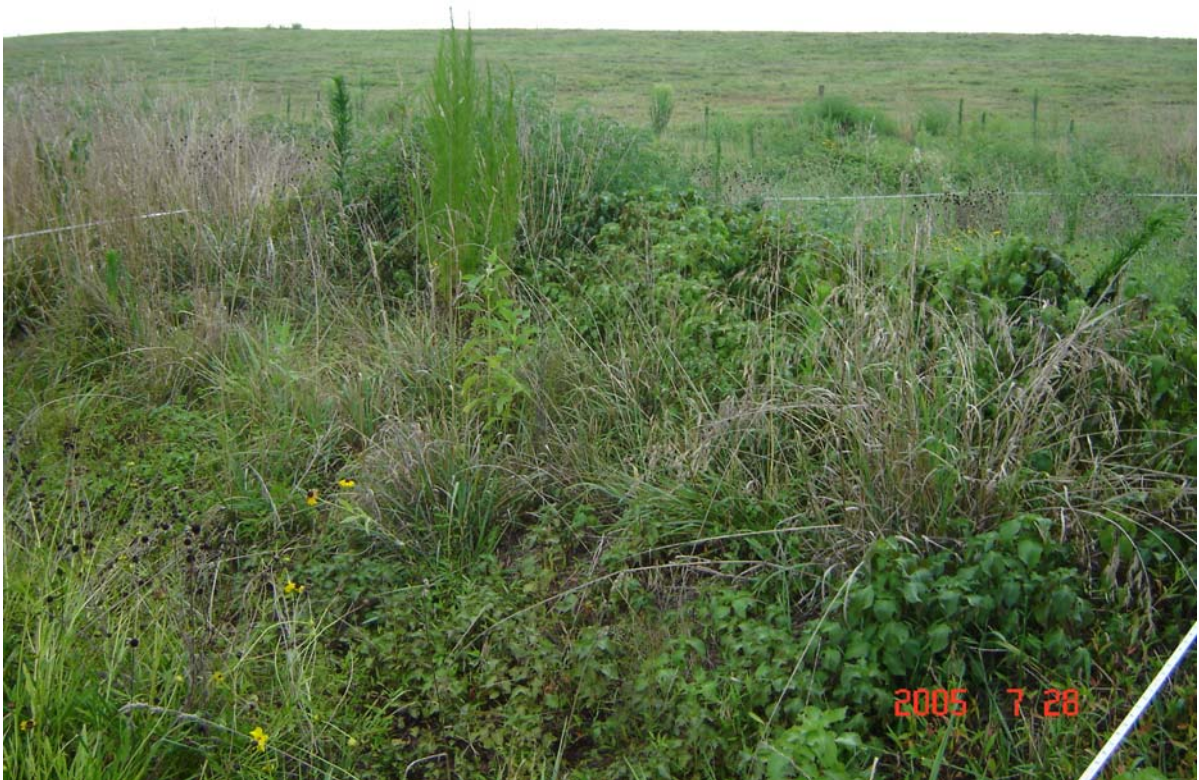
Reach #1. Vegetation Plot #2. View from northeast corner looking to southwest corner. Year one monitoring. 07/28/05

All vegetation monitoring plots are meeting the established success criteria of 320 stems per acre with the exception of Vegetation Plot #2 located on Reach 1. This plot has a robust layer of *Microstigium viminium* that survived herbicide treatment. The *Microstigium* is outcompeting the planted bare root seedlings and inhibiting the natural establishment of vegetation. Vegetation Plot #2 currently has 5 surviving bare root seedlings (3 species), that calculates to 250 stems per acre. Stem counts in the remaining vegetation plots result in 350 to 1,050 stems per acre. Total number of stems by species is presented in Table 6, and photographs of each plot are shown in Appendix C.

Monitoring both areas in future monitoring events will be crucial. It is possible that these invasive species may spread throughout the buffer area and could potentially prevent the site from meeting the vegetation success criteria. In which case, remedial actions may be required.

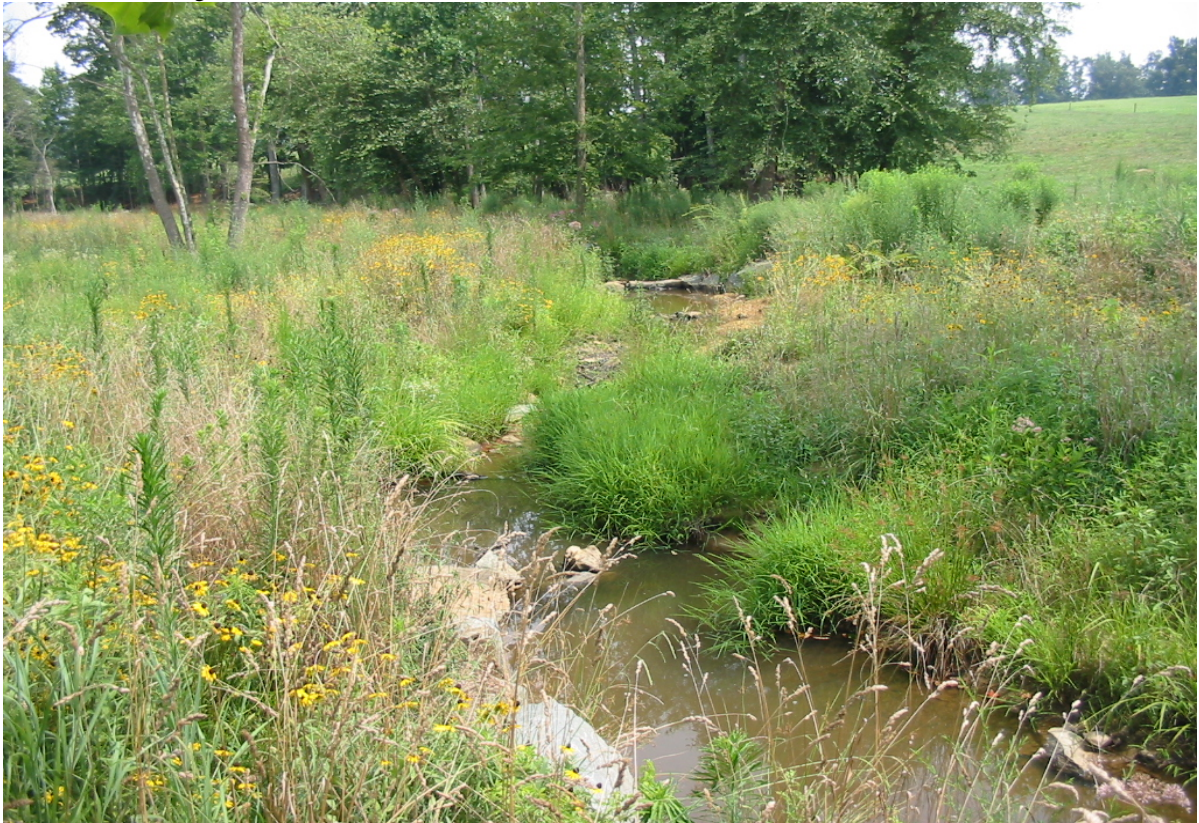
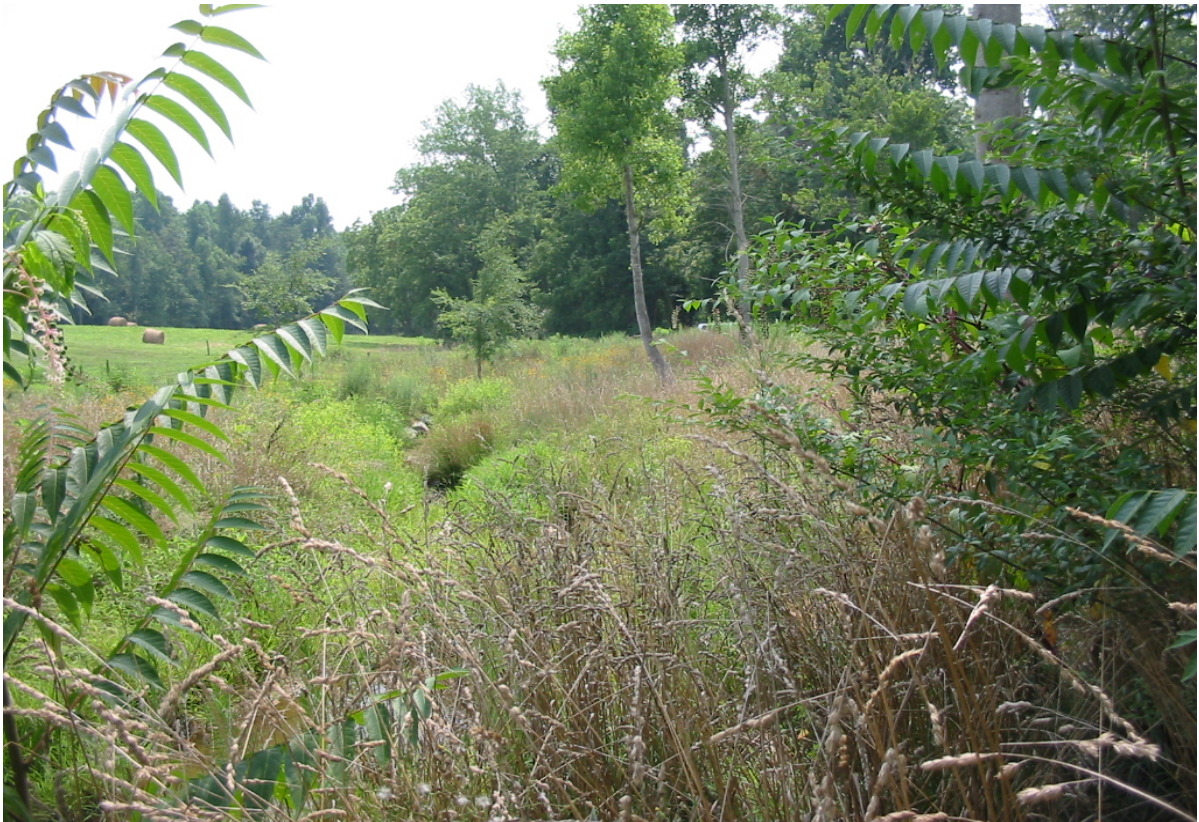
An area of *Ailanthus altissima* has persisted herbicide treatment on Reach 2 in the vicinity of photograph point 8. The area is approximately 400 square feet and is comprised of several small *Ailanthus* trees.

Reach #2. Photograph Point #8. Looking upstream. Year one monitoring. 07/19/05

Reach #2. Photograph Point #8. Looking downstream. Year one monitoring. 07/19/05
