**WELLS CREEK
FINAL MONITORING REPORT
YEAR 2 OF 5
2006**

EEP Project # 414
Alamance County, North Carolina

1025 Wade Avenue
Raleigh, NC 27605
Phone: (919)789-9977
Project Manager:
Phillip Todd
ptodd@sepiengineering.com

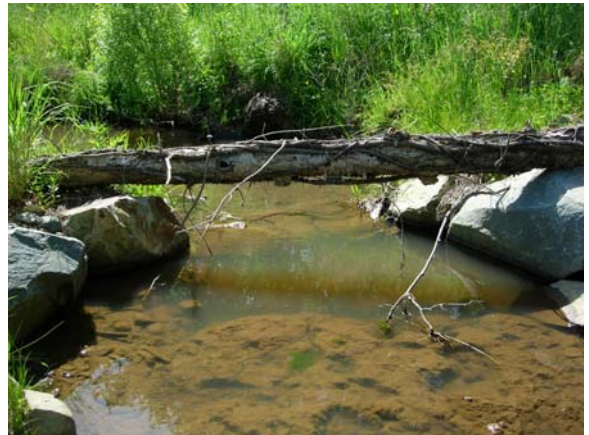
Photo 5:

Table VI. Vegetative Problem Areas			
Feature/Issue	Station # / Range	Probable Cause	Photo #
Bare Flood Plain	UT - Station 11+80	area washed from storm events	6
	UT - Station 12+50	area washed from storm events	5
	UT - Station 14+20	area washed from storm events	4
	UT - Station 18+50	area washed from storm events	2
Invasive/Exotic Populations	Reach 1 - Station # 20+50 Lt	Japanese grass overtaking area - from off site	8
	Reach 1 - down from Crest Gauge	Japanese grass overtaking area - from off site	1
	Reach 2 - Station #11-13	Japanese grass overtaking area - from off site	7

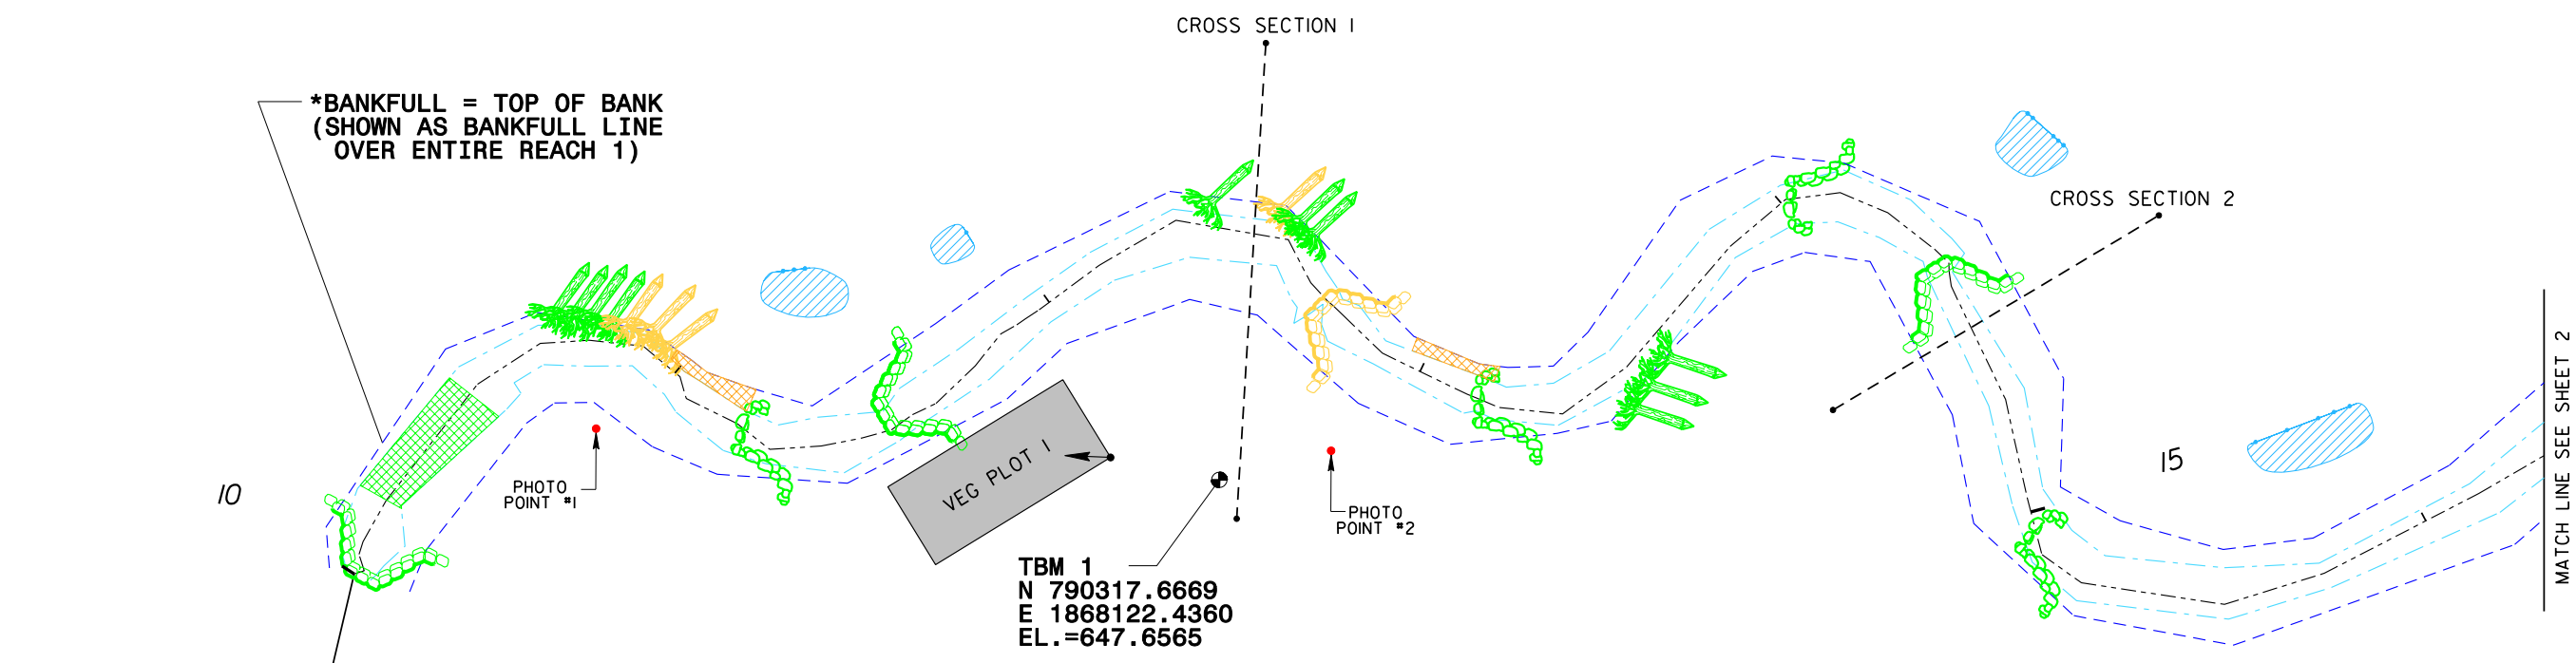
WELLS CREEK - REACH 1

Wells Creek Reach 1		
Feature Issue	Station numbers	Suspected Cause
Aggradation	10+19.45	Channel built too wide; narrowing to a more stable dimension
	10+49.06	
Rootwad	10+86.31	Location of rootwads upstream creating backeddys around downstream rootwads
Rootwad	10+90.81	
Rootwad	10+95.99	
Bank Erosion (left bank)	10+96.92	Location of rootwads upstream creating backeddys downstream
	11+18.70	
Rootwad	12+56.46	Location of upstream rootwad creating backeddys downstream; possibly angled
Cross-Vane	12+74.24	Piping around structure on right side
Bank Erosion (left bank)	12+96.27	Flow direction coming from upstream cross-vane and backwater affect of downstream J-Hook; also lack of vegetation
	13+15.91	
Aggradation (grass)	17+47.84	Downstream J-hook elevation higher which created deposition upstream; eventually built up so grasses growing in channel
	17+67.01	
Aggradation (grass)	17+86.54	
	17+95.15	
Central Bar (grass)	17+95.15	Downstream rootwads and cross-vane causing deposition upstream and creation of a central bar with grasses growing on it.

Feature Issue	Station numbers	Suspected Cause	Photo number
Bank Erosion (left bank)	10+23.43 10+51.20	Possibly due to upstream structure placement, soil type, lack of bank vegetation for a significant amount of time after construction, and/or radius of	1
Bank Erosion (left bank)	10+77.55 11+43.84	Toe Erosion along left bank and some slumping and erosion along right bank; possibly due to soil type, lack of vegetation immediately after construction, and/or channel built wider than designed.	2
Bank Erosion (right bank)	10+82.65 11+73.21		
Bank Erosion (left bank)	11+85.04 11+90.79	Bank Erosion upstream of rootwad; possibly caused by back eddy from rootwad	3
Rootwad	11+94.19	Angle of rootwad to flow and size	
Bank Erosion (left bank)	11+98.26 12+08.84		
Aggradation (grass-lateral bar)	12+17.11 12+55.50	Channel might have been built too wide in which the channel is narrowing up to a more stable dimension.	4

Bank Erosion (right bank)	12+55.57 12+58.04	Bank Erosion downstream of rootwad; possibly caused by back eddy from rootwad	
Rootwad	12+80.32	Angle of rootwad to flow and size	
Bank Erosion (right bank)	12+82.72 12+91.37	Possibly due to rootwad upstream creating back eddy.	
Aggradation (grass)	12+91.37 13+35.93	Channel might have been built too wide in which the channel is narrowing up to a more stable dimension.	
Bank Erosion (left bank)	13+60.32 13+67.30	Probably from radius of curvature	
Debris Jam	14+23.09	Natural	5
Bank Erosion (right bank)	14+60.81 14+95.15	Soil Type or lack of vegetation	
J-hook	15+02.51	Angle and placement of J-hook	
Bank Erosion (right bank)	15+15.42 15+94.29	Soil Type or lack of vegetation. Channel may have been built too wide and is narrowing up.	7 and 8
Bank Erosion (left bank)	15+17.73 15+80.06		
J-hook	15+99.16	Angle and placement of J-hook	12
Bank Erosion (right bank)	16+10.02 16+19.74	Probably due from flow directing into bank from upstream J-hook.

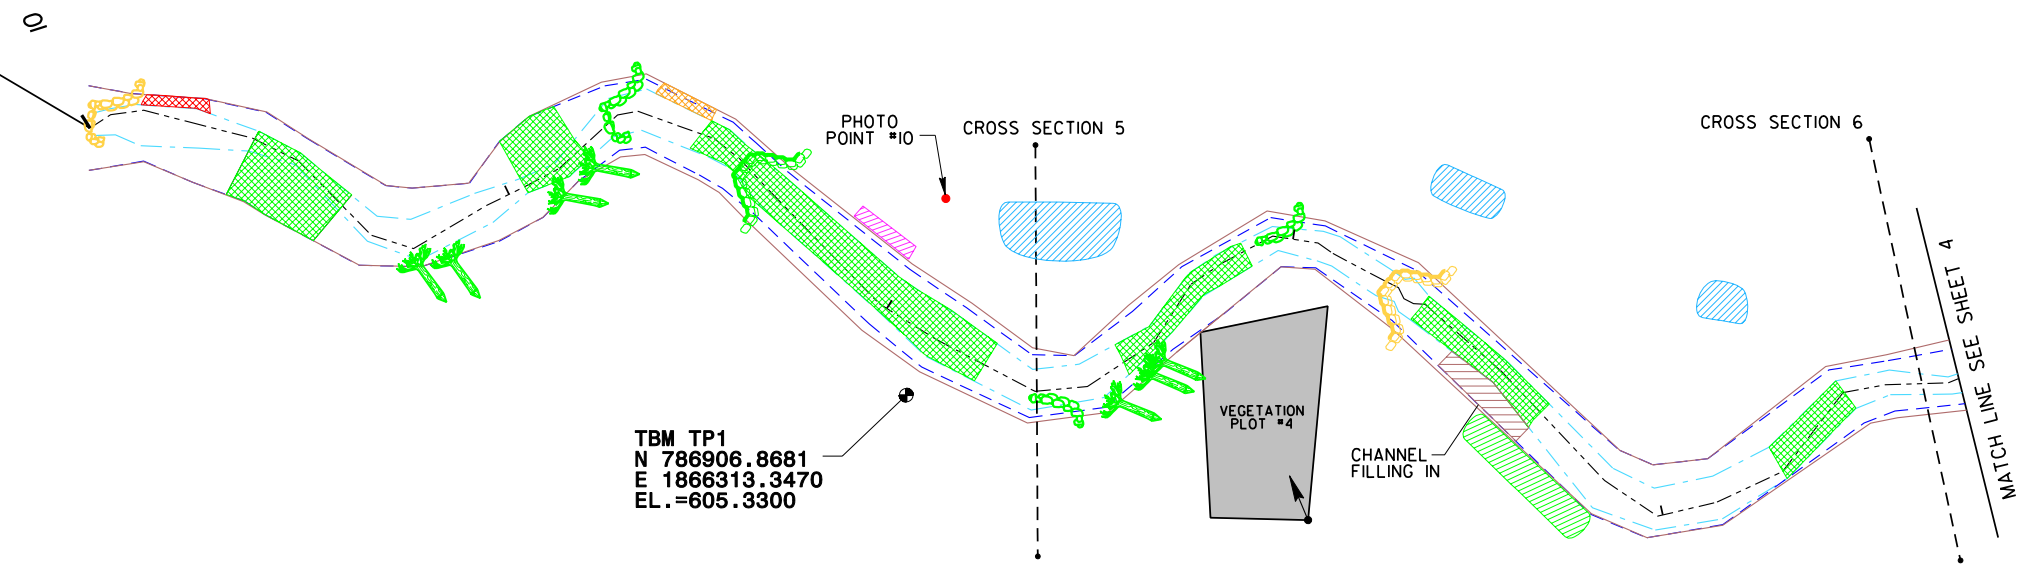
UT TO WELLS CREEK

Wells Creek Reach UT		
Feature Issue	Station numbers	Suspected Cause
J-Hook	10+01.12	Angle and placement of J-hook
Bank Erosion (left bank)	10+12.06 10+25.72	Possibly due to flow directed to bank from the J-hook upstream
Aggradation (grass)	10+35.95 10+59.41	Channel is narrowing
Aggradation (grass)	11+03.53 11+18.18	Channel is narrowing
Bank Erosion (left bank)	11+34.93 11+47.68	Possibly due to flow directed to bank from the J-hook upstream
Aggradation (grass)	11+45.40 12+23.77	Channel perhaps built too wide and is trying to narrow up
Aggradation (grass)	12+55.97 12+90.57	Channel perhaps built too wide and is trying to narrow up
Cross-Vane	13+24.20	
Aggradation (filling in lateral bar)	13+43.70 13+66.80	Channel is narrowing
Aggradation (grass)	13+36.94 13+66.19	Channel is narrowing itself. This is further evidenced by the formation of a lateral bar beside it on the right bank
Aggradation (grass)	14+28.98 14+47.38	Channel perhaps built too wide and is trying to narrow up

Aggradation (grass)	14+81.82 15+25.40	Channel perhaps built too wide and is trying to narrow up
J-Hook	16+31.95	Angle and placement of J-hook
Bank Erosion (left bank)	16+43.74 16+61.60	Possibly due to flow directed to bank from the J-hook upstream
Aggradation (grass)	16+60.00 16+96.87	Channel perhaps built too wide and is trying to narrow up
Bank Erosion (right bank)	17+11.03 17+21.01	Possibly caused lack of bank protection to redirect flow directed onto bank
Bank Erosion (right bank)	17+29.05 17+70.00	Angle and placement of Vane
Bank Erosion (left bank)	17+52.04 17+73.83	Possibly due to lack of vegetation
Bank Erosion (right bank)	17+74.82 17+94.03	Possibly cause by flow directed to the bank from the Vane upstream
Rootwad	18+04.93	Placement of rootwad too high. Dried out.
Rootwad	18+08.00	Placement of rootwad too high. Dried out.
Rootwad	18+14.62	Placement of rootwad too high. Dried out.
Bank Erosion (right bank)	18+44.89 18+52.10	Possibly due to lack of vegetation

Aggradation (grass)	18+75.29 19+02.00	Channel perhaps built too wide and is trying to narrow up
Rootwad	19+18.75	
Rootwad	19+28.39	
Bank Erosion (right bank)	19+19.71 19+23.76	Possibly caused by flow directed onto bank from Vane immediately upstream
Aggradation (grass)	19+34.67 19+51.23	Channel is narrowing
Bank Erosion (left bank)	19+60.23 19+86.81	Possibly due to lack of bank protection/vegetation
