**WELLS CREEK
FINAL MONITORING REPORT
YEAR 3 OF 5
2007**

EEP Project # 414
Alamance County, North Carolina

1025 Wade Avenue
Raleigh, NC 27605
Phone: (919)789-9977
Project Manager:
Phillip Todd
ptodd@sepiengineering.com

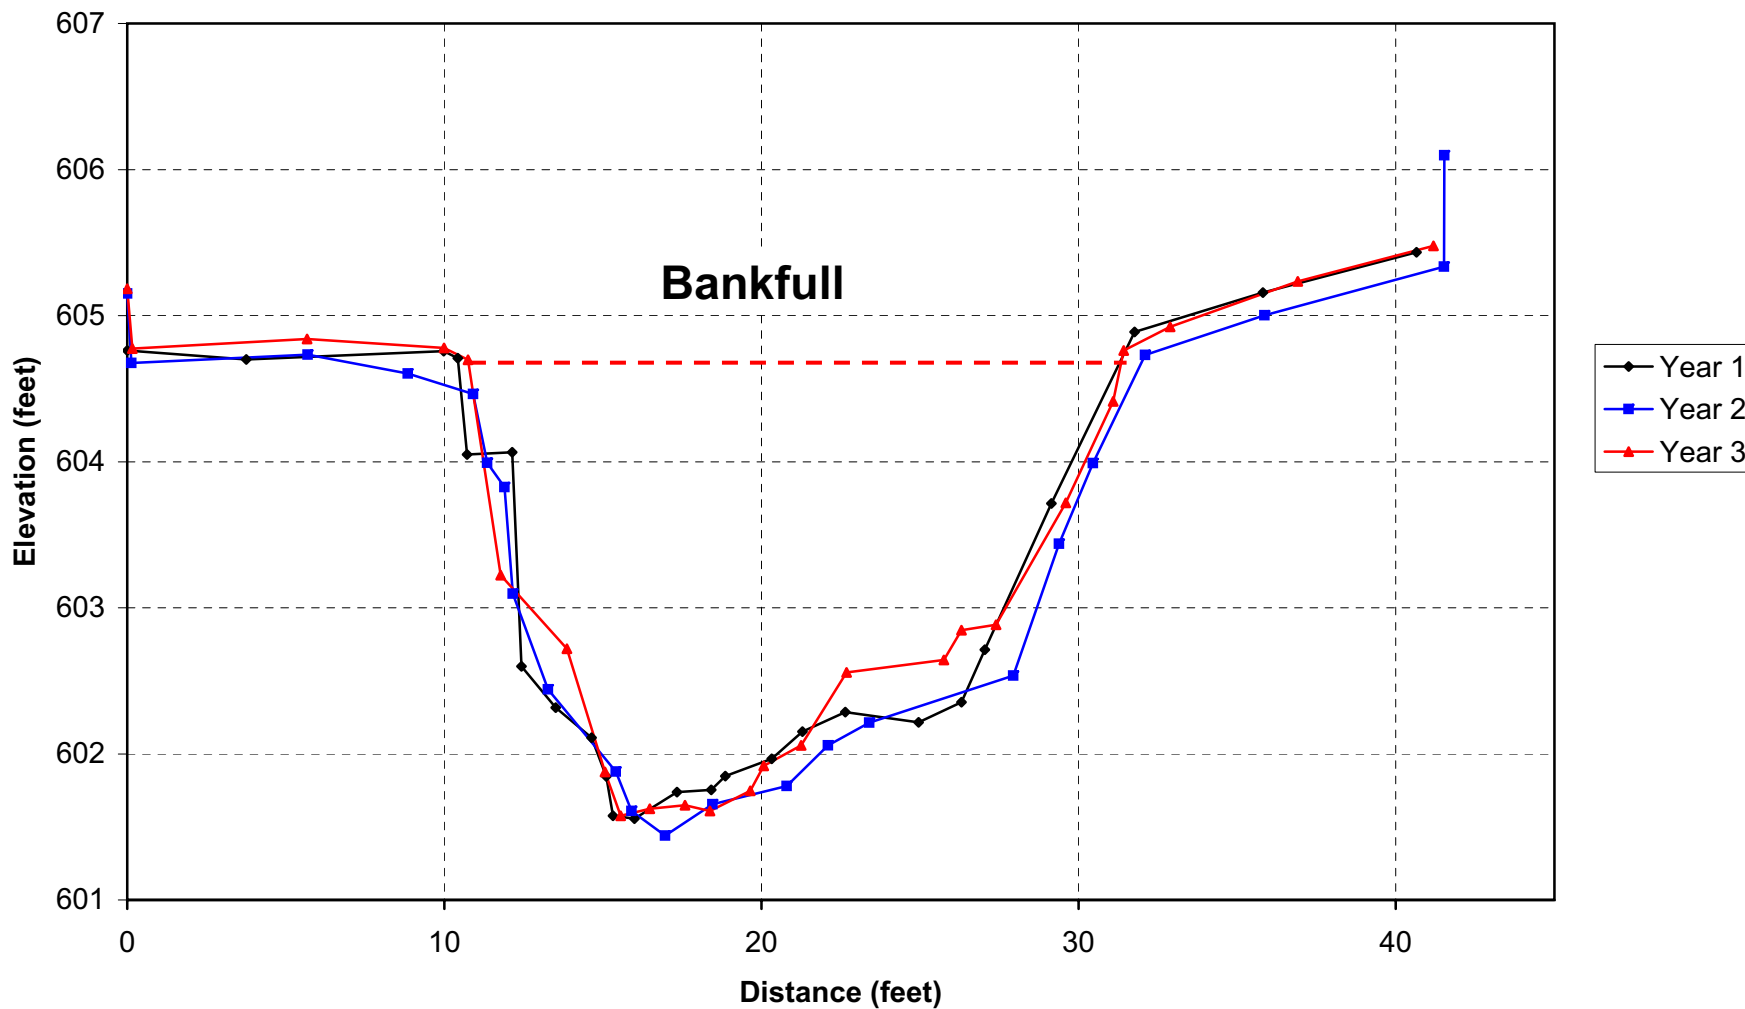
Cross Section Overlay (Years 1 - 3)
Well Creek - Reach 2
Cross Section #9 (Riffle)

In Reach 2, cross sections #10 and #11 remain stable between monitoring Years 2 and 3 and have no problem areas associated with their location. Cross section #9 crosses a section of aggradation, which is consistent with a slight filling in of the right side of the stream bed. The aggradation is noted on the cross sectional overlay, and there is a slight overall decrease in the cross-sectional area of cross section #9 since Monitoring Year 1. Also it is apparent, through observation of the cross sectional overlay, that cross section #12 experienced a significant down-cutting of the channel bed between Monitoring Years 1 and 2. The channel then stabilized after the scour event, and the overlay between Monitoring Years 2 and 3 remains stable. This observation is consistent with a notable increase in both cross sectional area and bankfull mean depth between Monitoring Years 1 and 2, and subsequent consistency in these variables between Monitoring Years 2 and 3.
