**WELLS CREEK
FINAL MONITORING REPORT
YEAR 4
2008**

EEP Project # 414
Alamance County, North Carolina

Original Design Firm:
ARCADIS G&M of North Carolina, Inc.
801 Corporate Center Drive, Suite 300
Raleigh, NC 27607

Monitoring Firm:

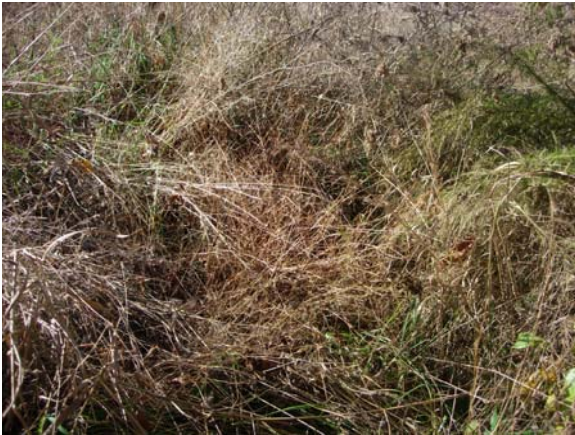
Photo 2: Japanese grass (*Microstegium vimineum*) growth (Station No. 20+; view upstream on right bank; 11-6-2008).

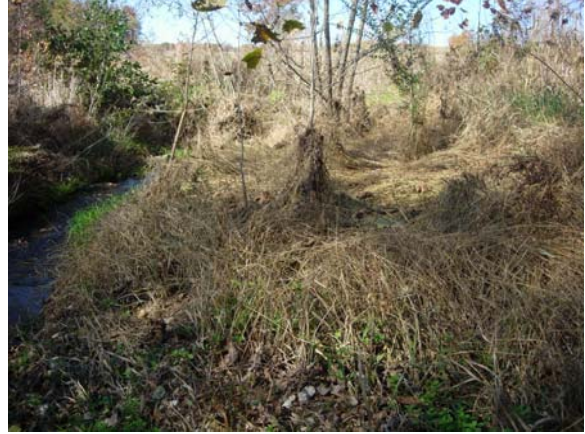
Photo 2: Japanese grass (*Microstegium vimineum*) growth (Station No. 14+78; view downstream on right bank; 11-6-2008).

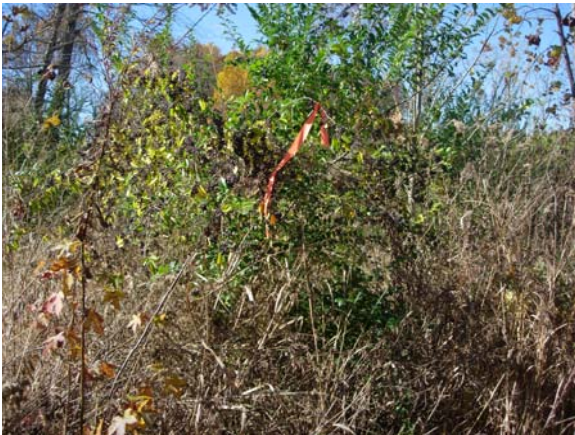
Photo 3: Chinese privet (*Ligustrum sinense*) growth (Station No. 15+76; view is within Vegetation Plot 8; 11-6-2008).

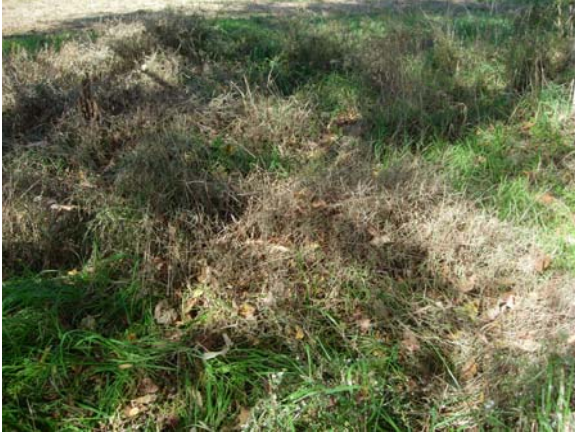
Photo 1: Japanese grass (*Microstegium virmineum*) growth (Station No. 15+20; view of right bank; 11-6-2008).

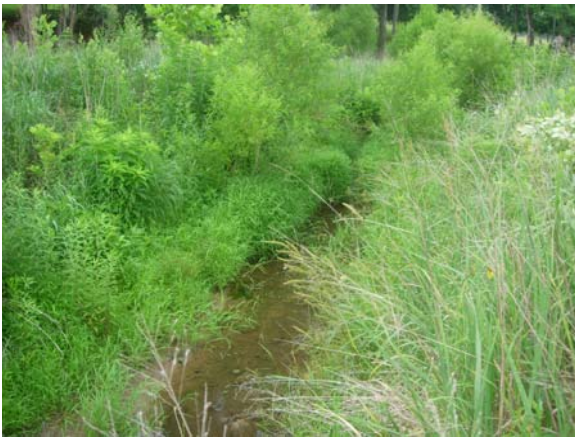
Photo 2: Japanese grass (*Microstegium virmineum*) growth along sidebar (Station No. 15+20; view downstream; 12-16-2008).
