**WELLS CREEK
FINAL MONITORING REPORT
YEAR 5 OF 5
2009**

EEP Project # 414
Alamance County, North Carolina

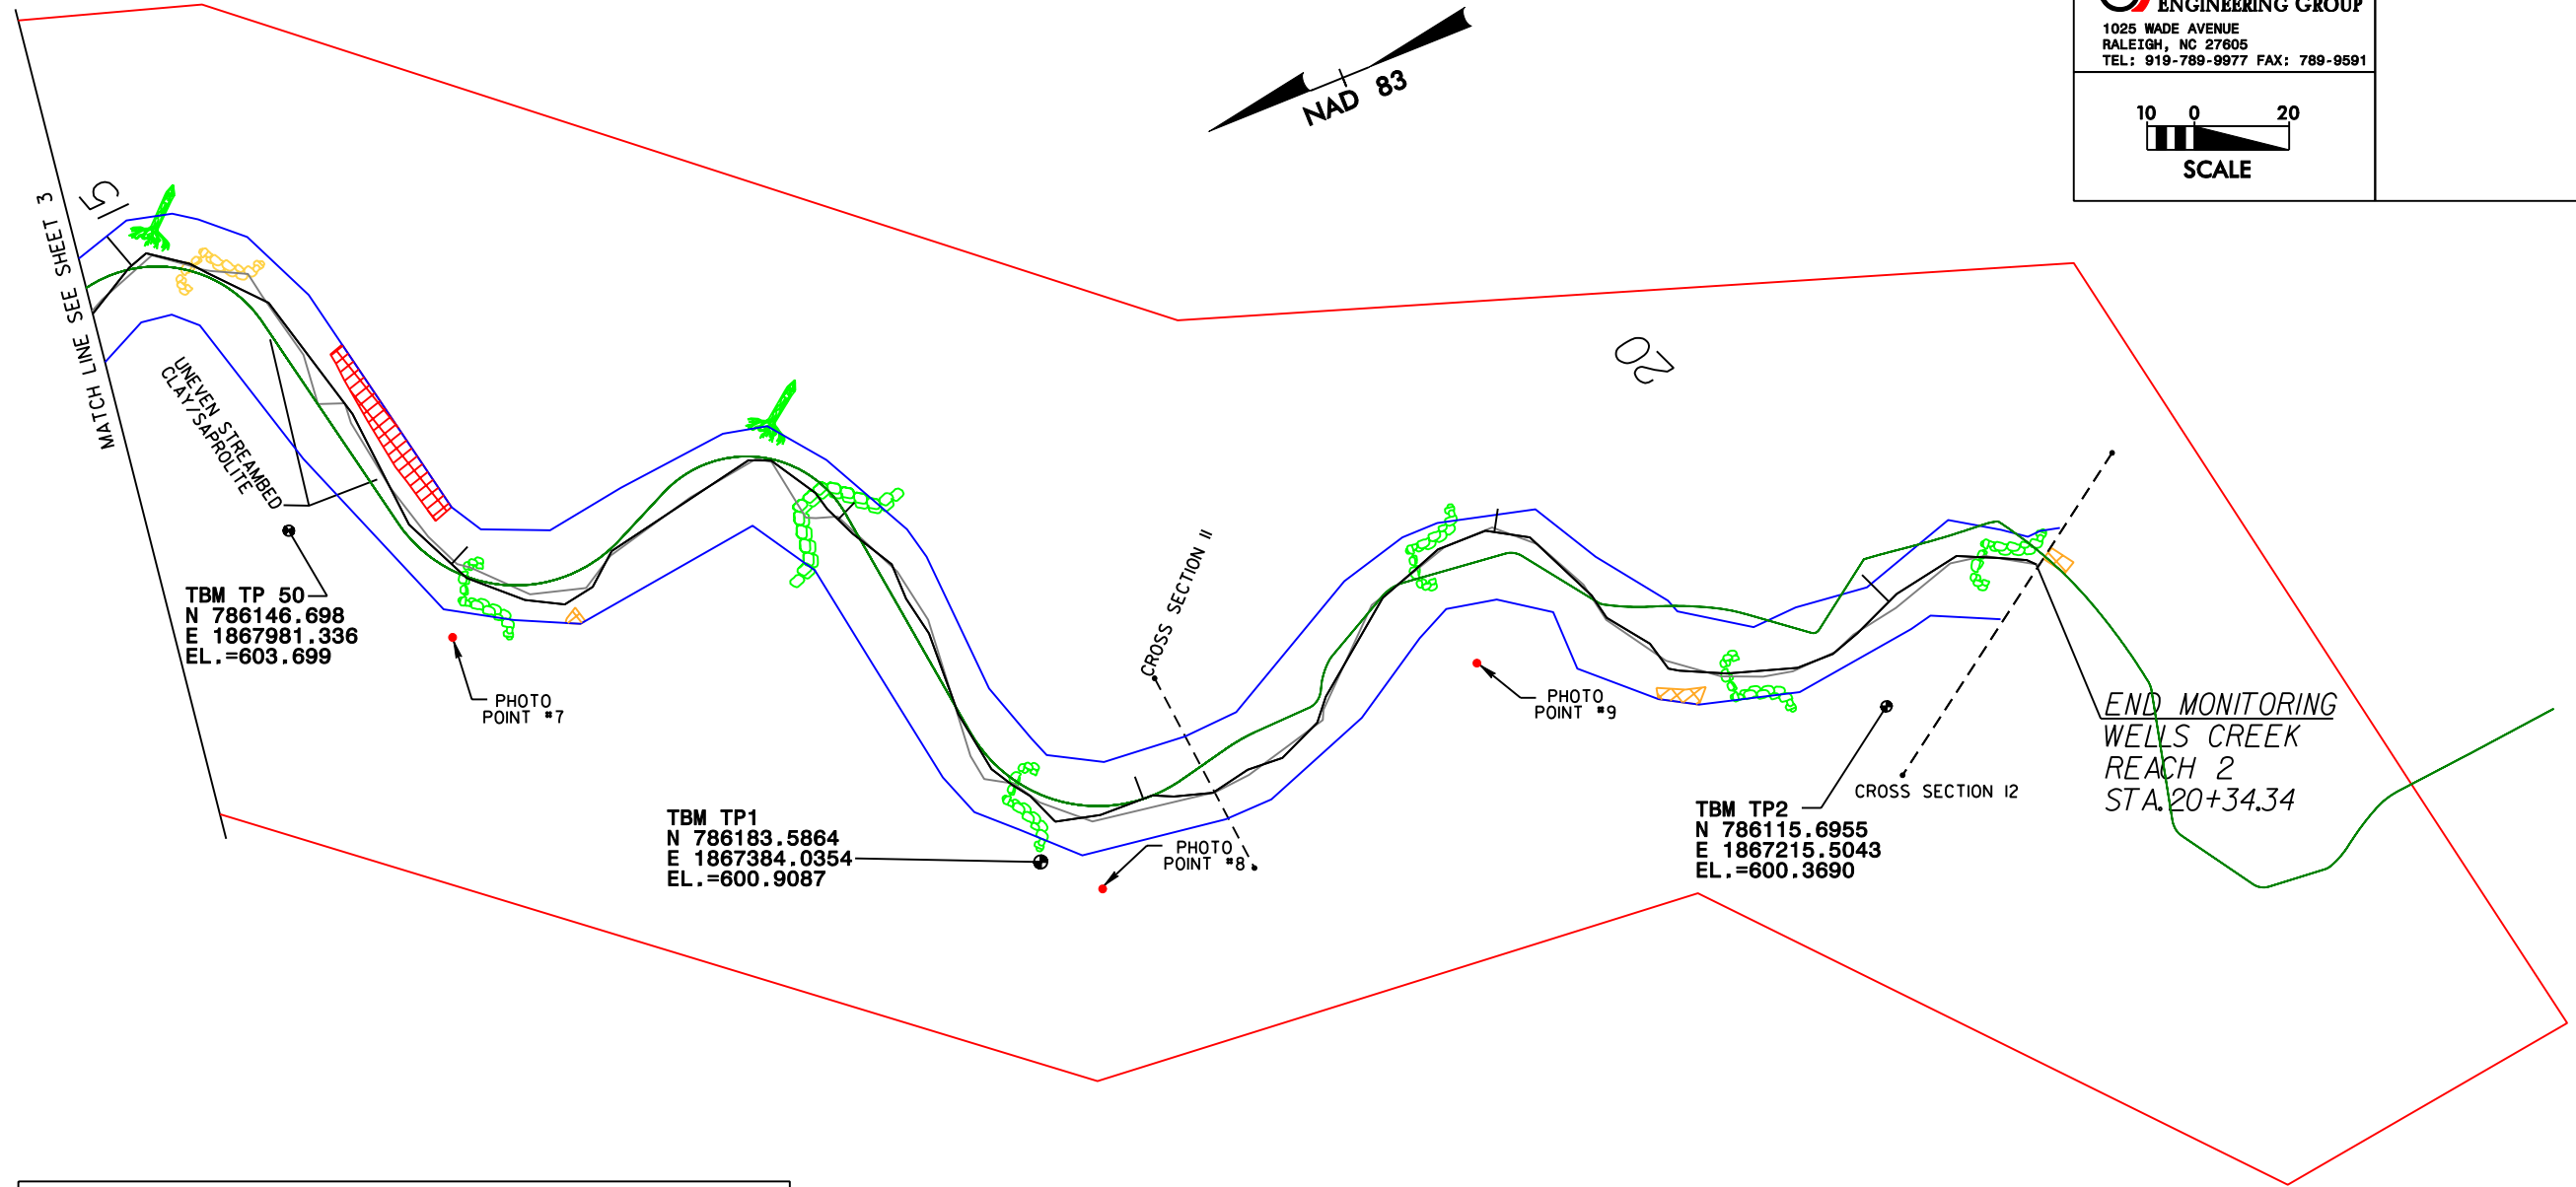
*The beaver dam listed last year at the very end of Reach 2 was either removed or washed downstream, as it was observed to be absent on May 12, 2009.

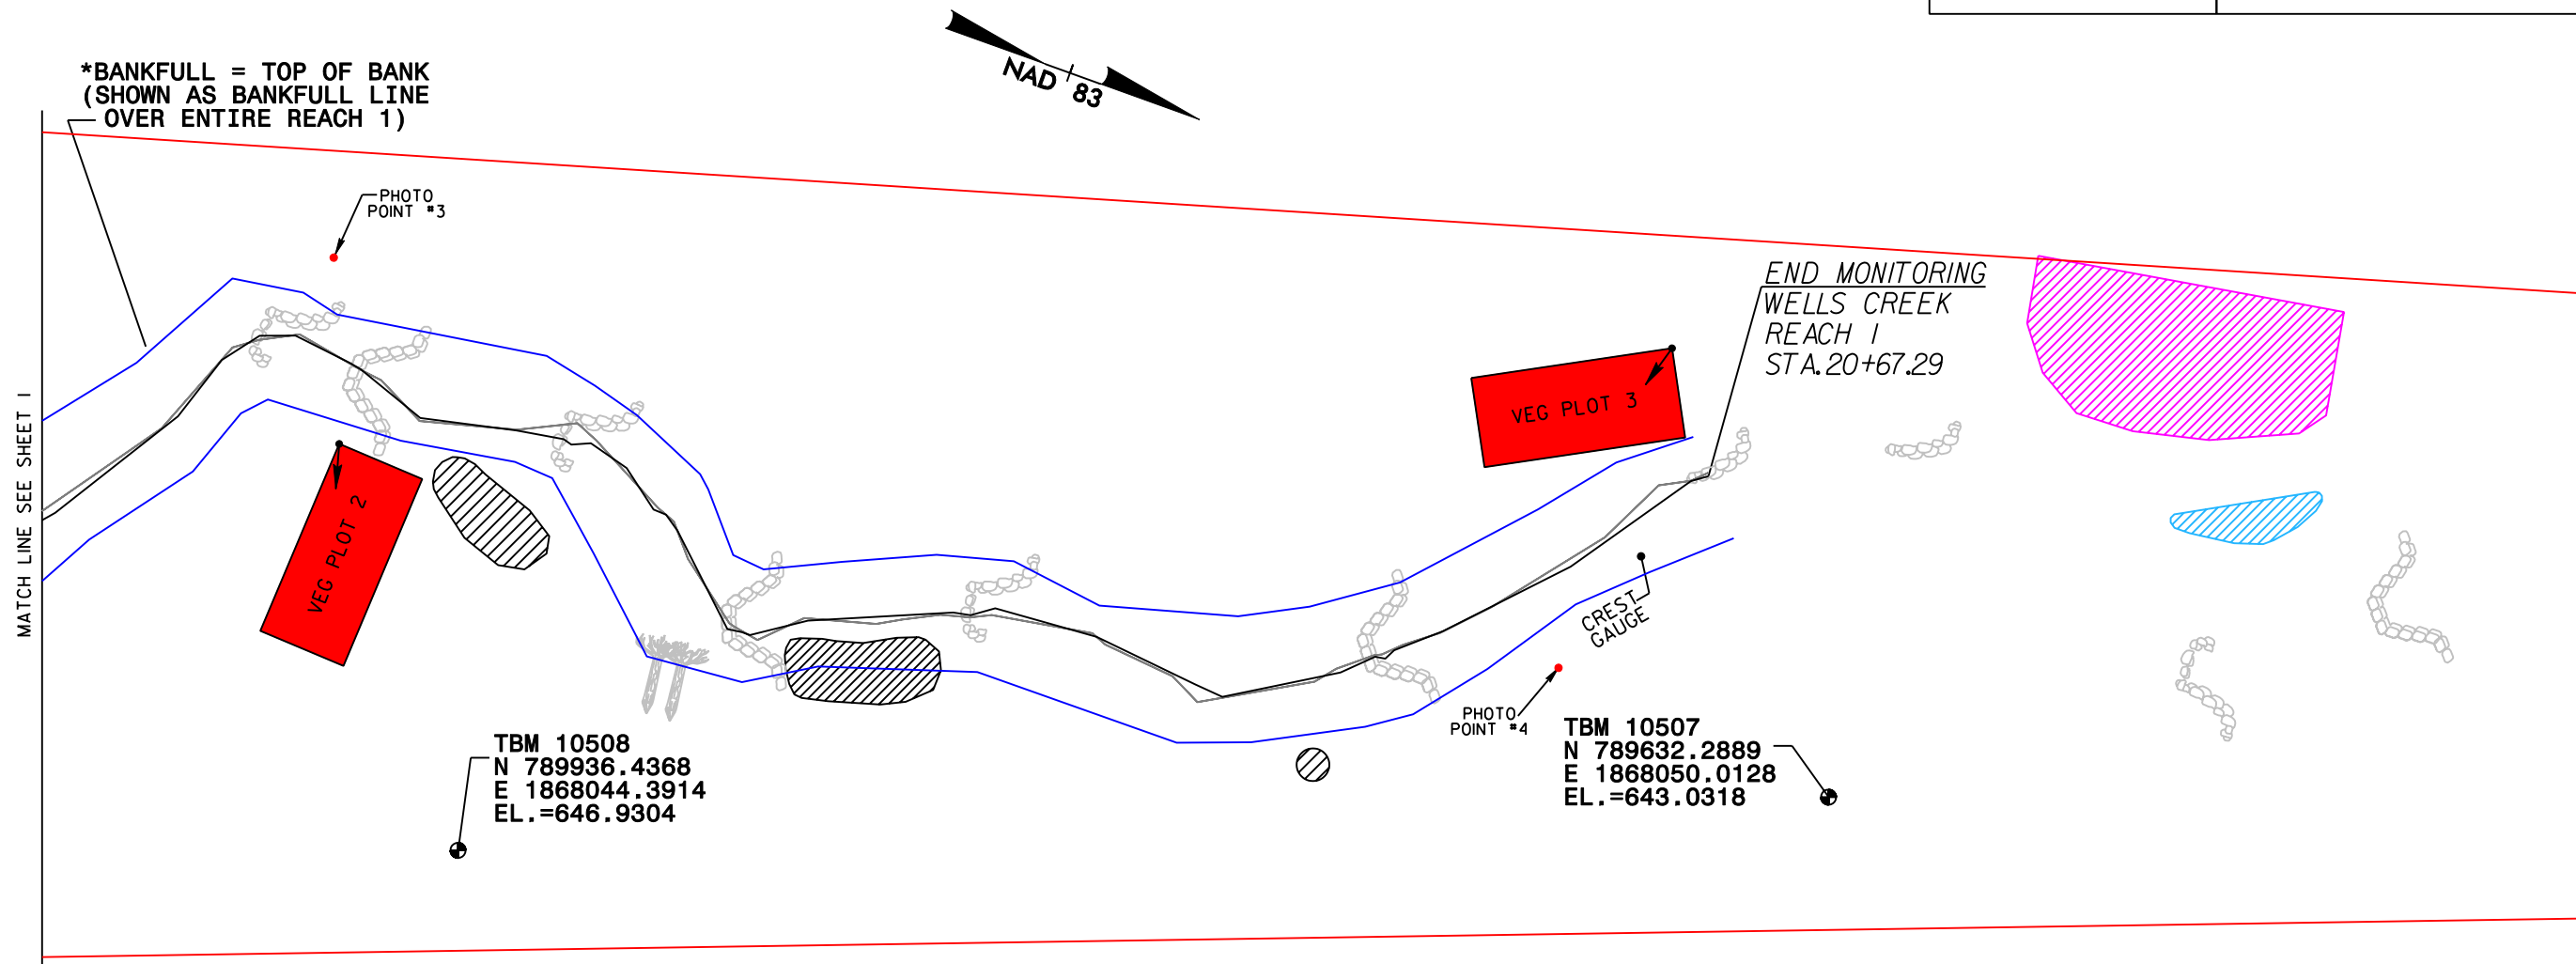
*It was observed on April 7, 2009 that multiple cattle had accessed the easement in the recent past, but had since been removed. This occurred after January 8 as no cattle damage was observed during that site visit. Fresh hoof prints were observed at all locations, forming trails along the top of bank and over other areas of the floodplain. Minimal hoof-shear was observed at a couple of locations along the top of bank. It was obvious that much of the herbaceous understory had been grazed, although the buffer health does not appear to have been negatively impacted from this grazing.

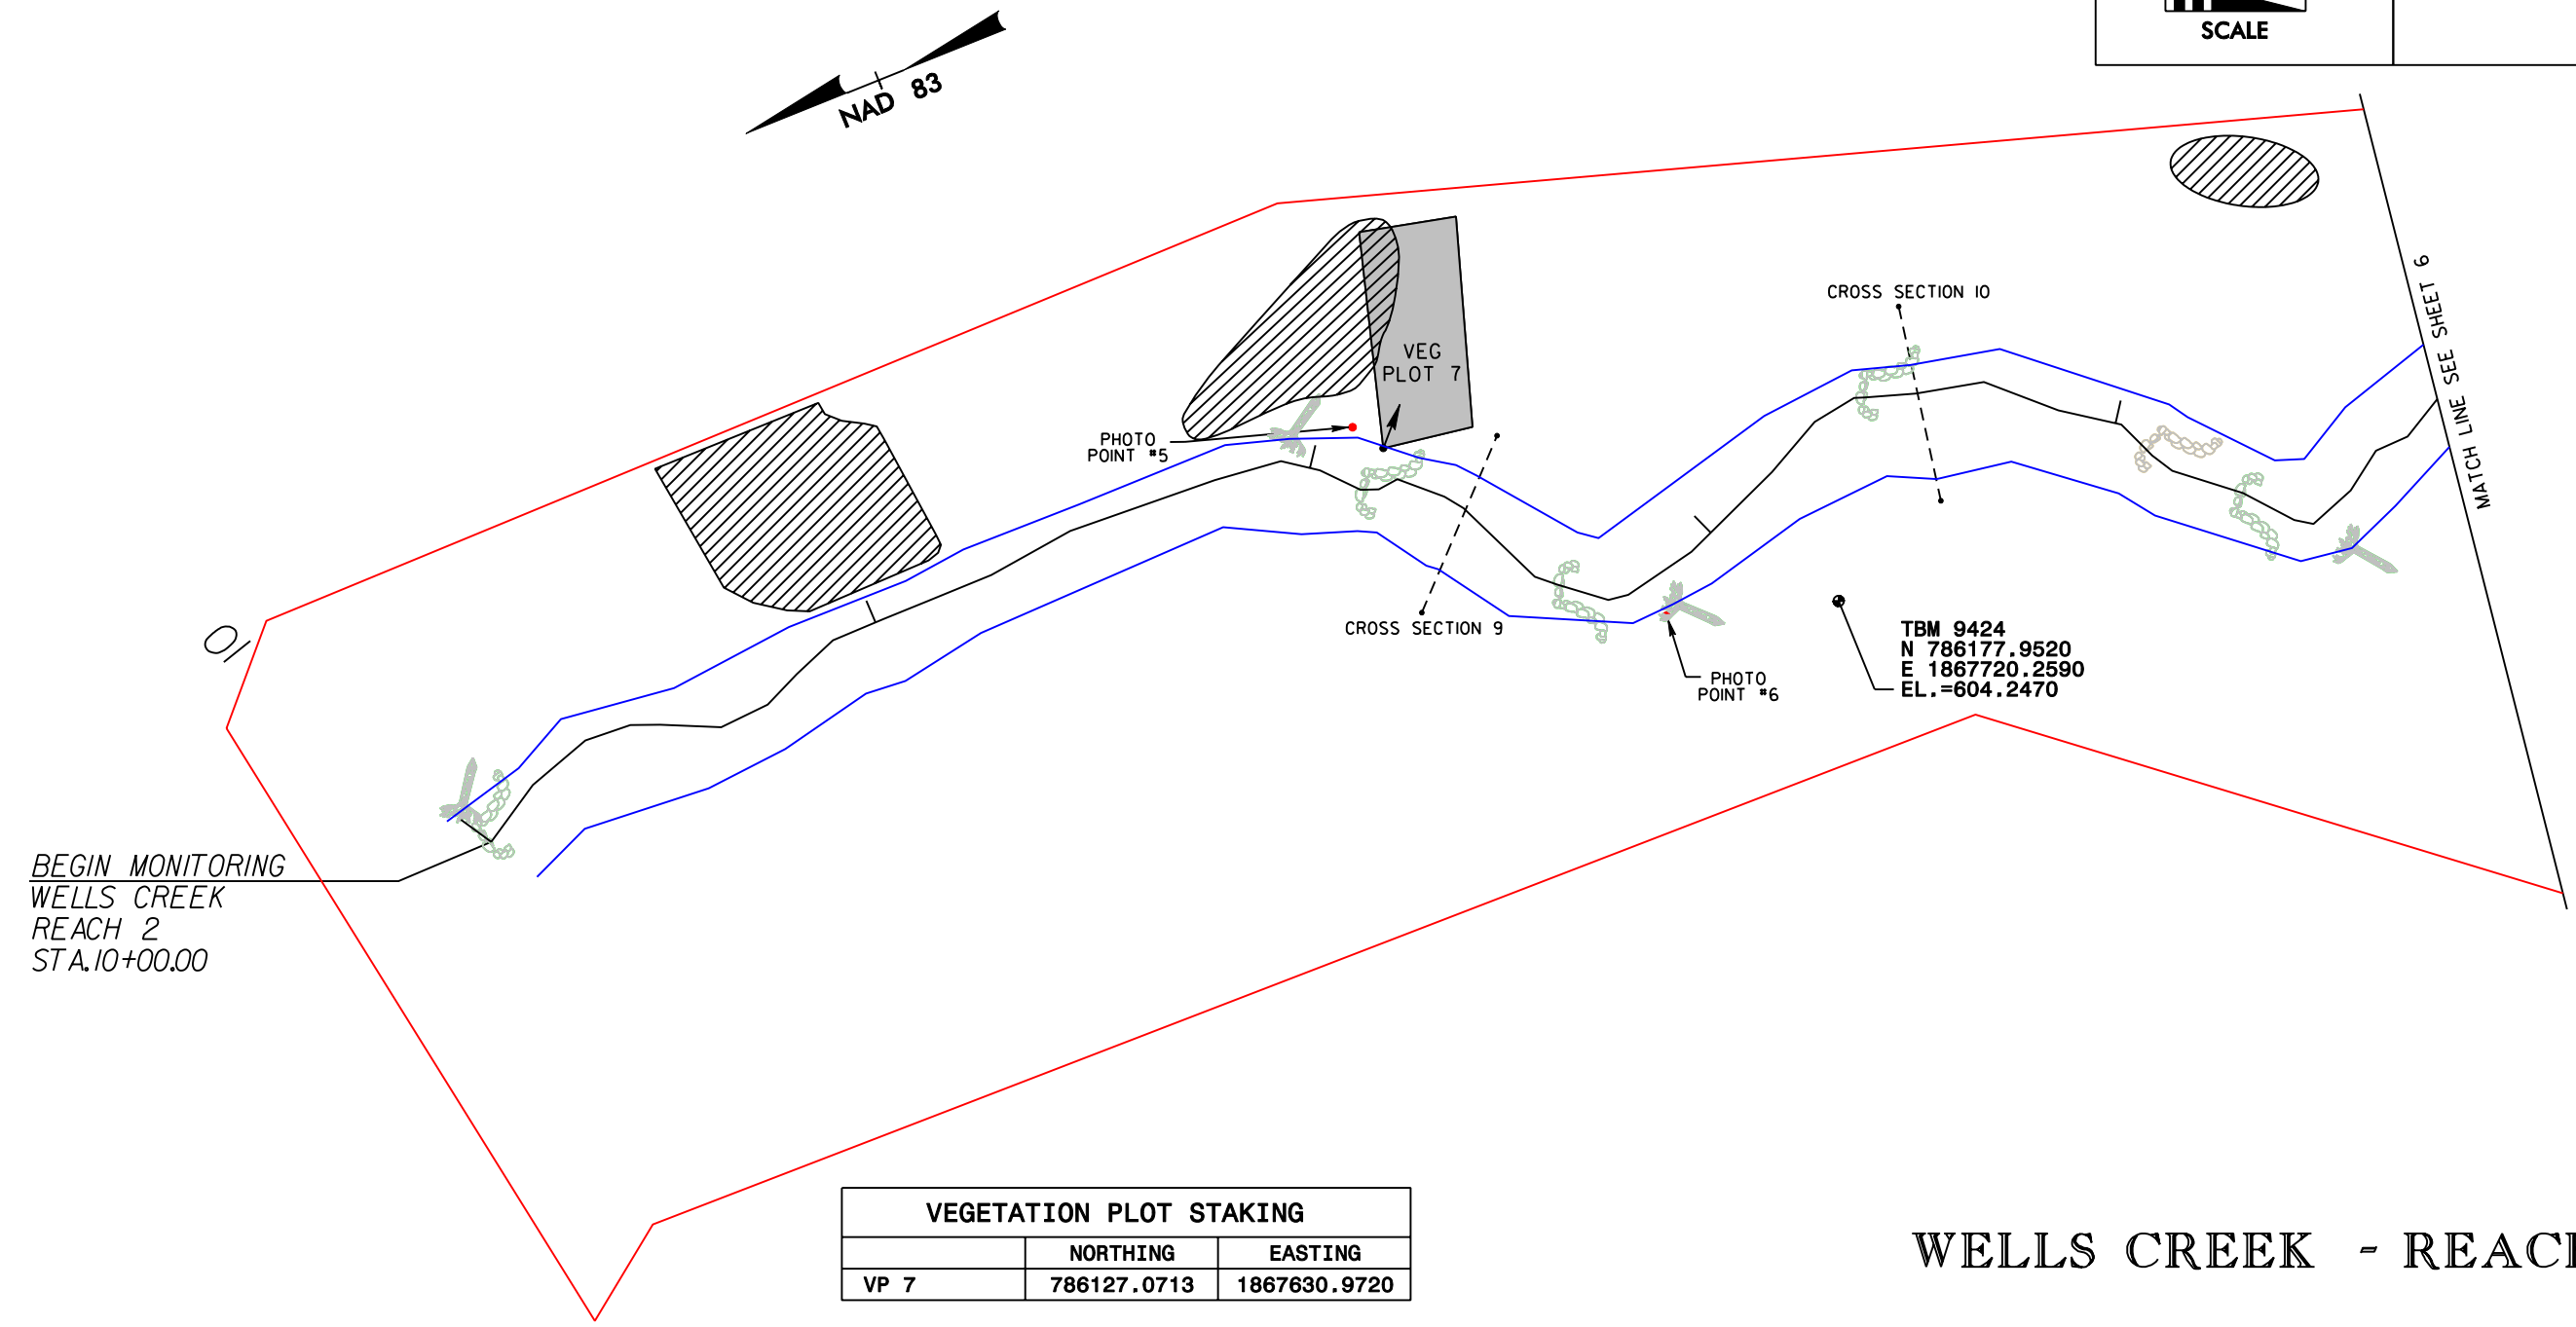
*It was observed on April 7, 2009 that multiple cattle had accessed the easement in the recent past, but had since been removed. This occurred after January 8 as no cattle damage was observed during that site visit. Fresh hoof prints were observed at all locations, forming trails along the top of bank and over other areas of the floodplain. Minimal hoof-shear was observed at a couple of locations along the top of bank. It was obvious that much of the herbaceous understory had been grazed, although the buffer health does not appear to have been negatively impacted from this grazing.
