WHITELACE CREEK STREAM ENHANCEMENT
AND WETLAND RESTORATION SITE
MONITORING REPORT (YEAR 2 OF 5)

Lenoir County, North Carolina
EEP Project No. 420

Status of Plan: Final
Submission Date: March 2008

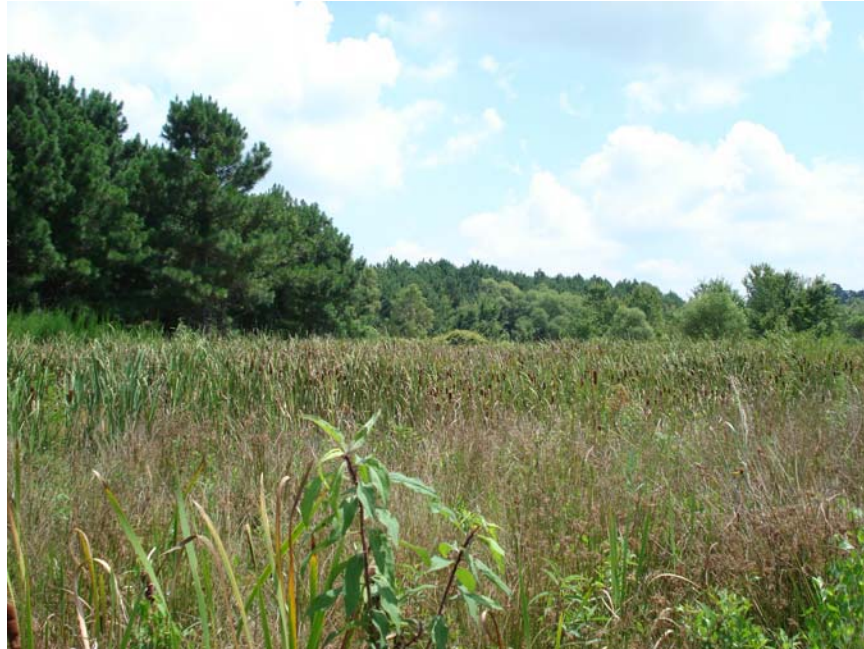
Photo 1. *Typha latifolia* has invaded the floodplain on the left bank upstream of Veg Plot 9, presumably in response to beaver induced flooding (7/31/07)

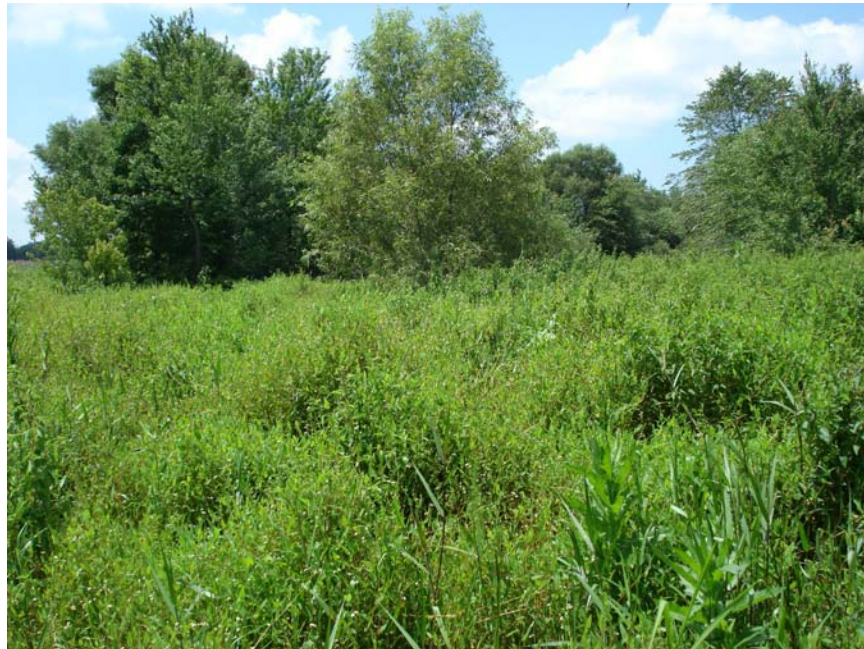
Photo 2. *Persicaria sagittata* is out competing planted woody species at Veg Plot 13 (7/31/07)

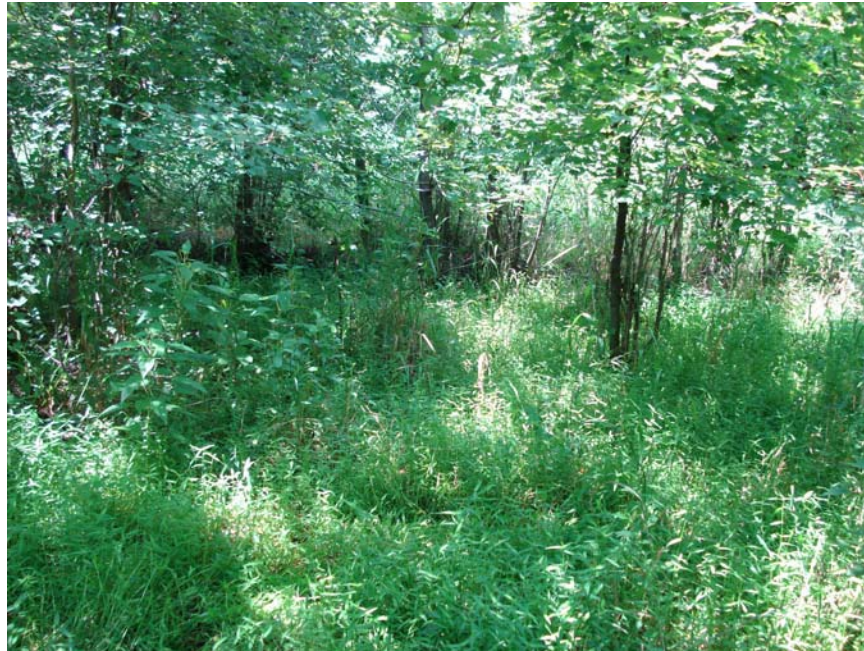
Photo 3. *Murdannia keisak* is competing with desired herbaceous species at Veg Plot 11 (7/31/07)

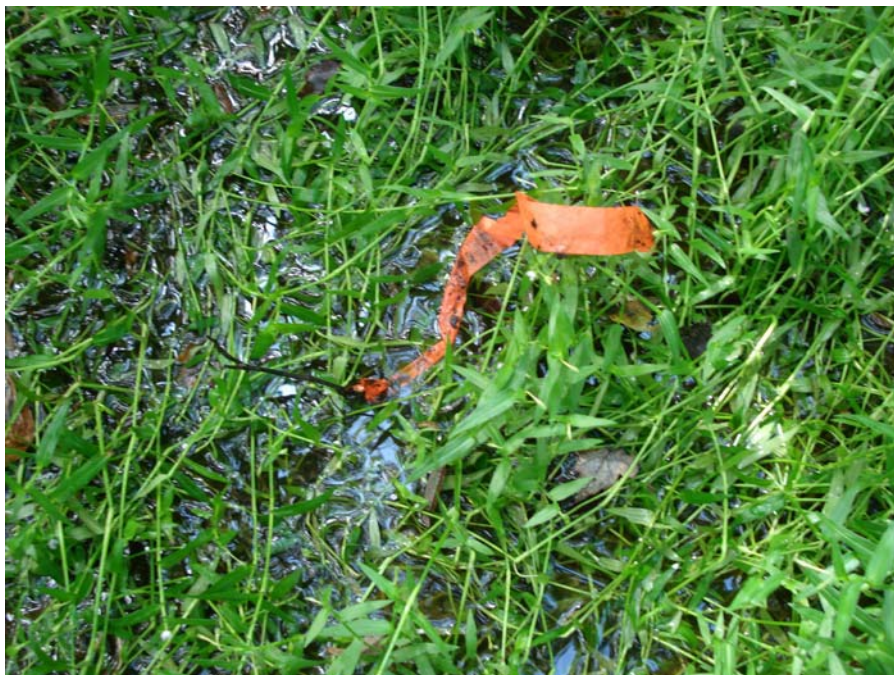
Photo 4. Flooding, dead planted tree and *Murdannia keisak* at Veg Plot 11 (9/23/07)

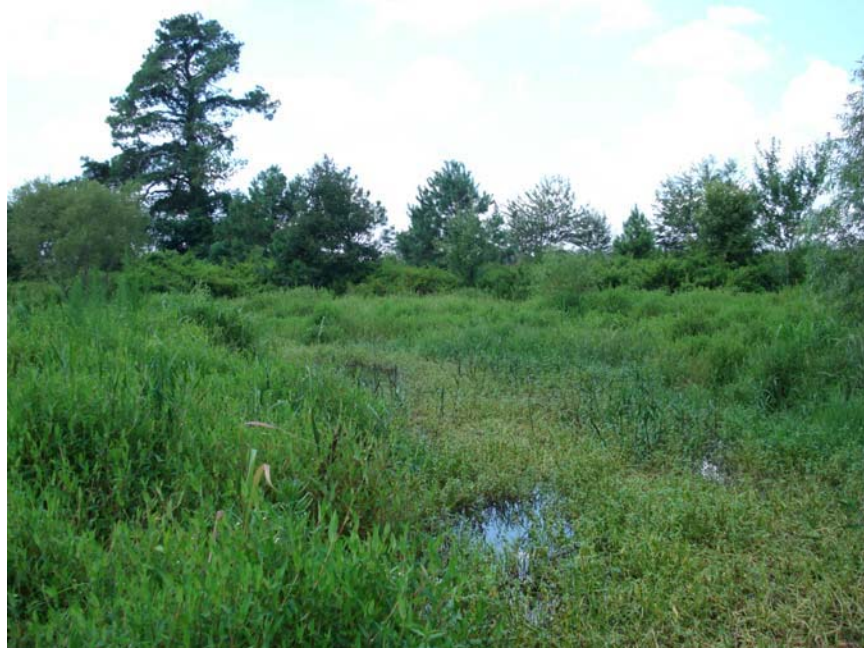
Photo 5. The stream channel is choked with *Persicaria* near Veg Plot 14 (looking downstream, 7/31/07).

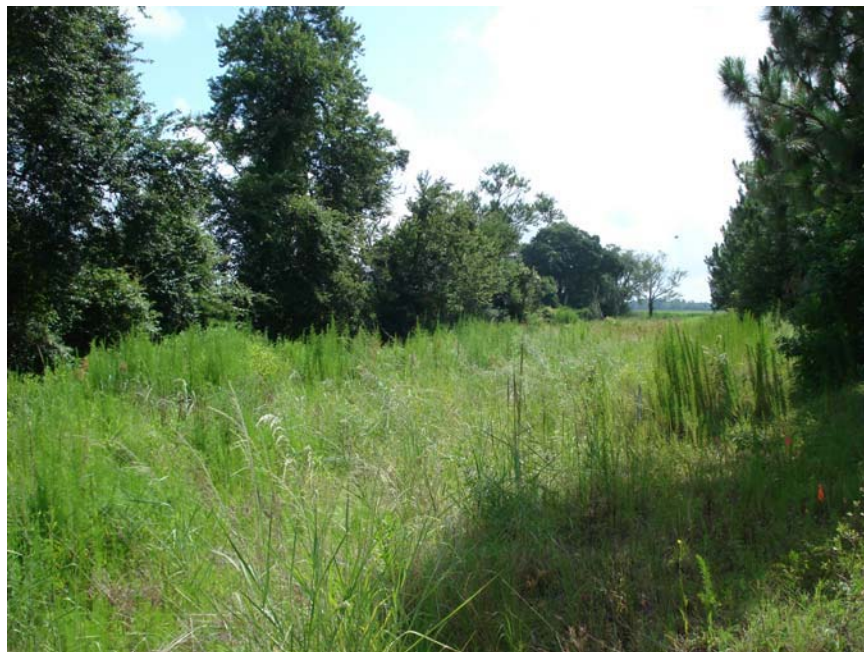
Photo 6. At Veg Plot 1 there was limited planted vegetation found on floodplain – probably due to previous flood events. On the face of the slope up to the original ground elevation, the planted vegetation was doing better. (Stream is on left side of photo, 7/31/07)

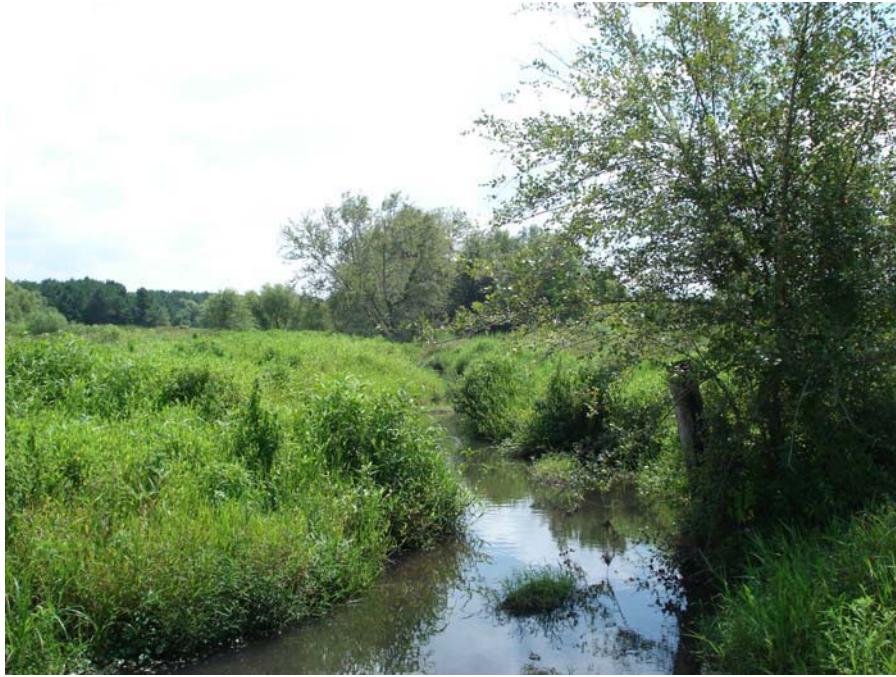
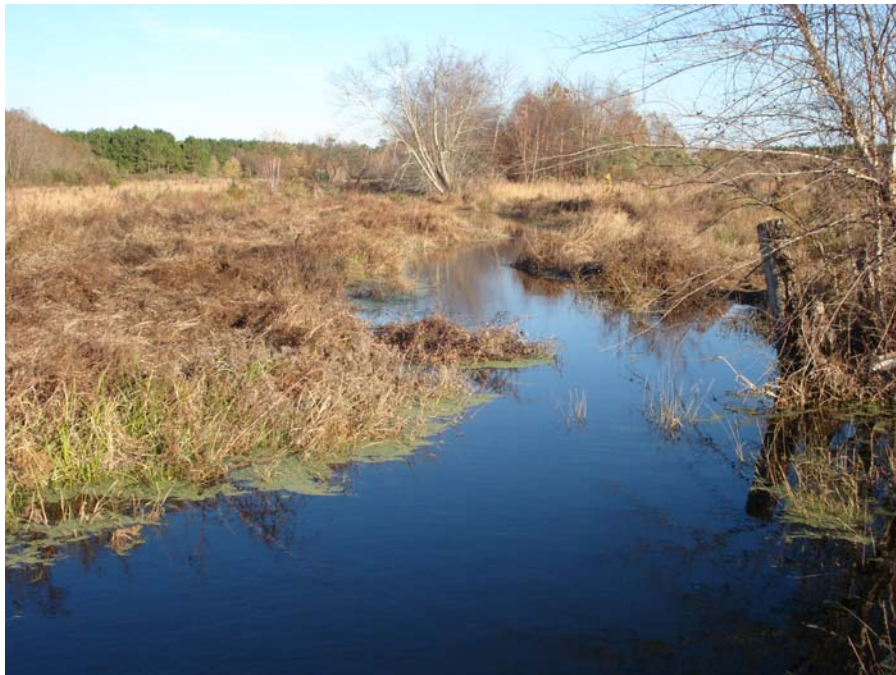
Photos 7/8. Looking downstream from the bridge (upper photo, 7/31/07) and (lower photo 11/16/07).
Flooding likely due to beaver activity downstream.

allowing the site hydrology to return to conditions outlined in the restoration plan. However, beaver activity is likely to continue. Therefore, the site should be replanted with trees of appropriate species and size to withstand periodic inundation.

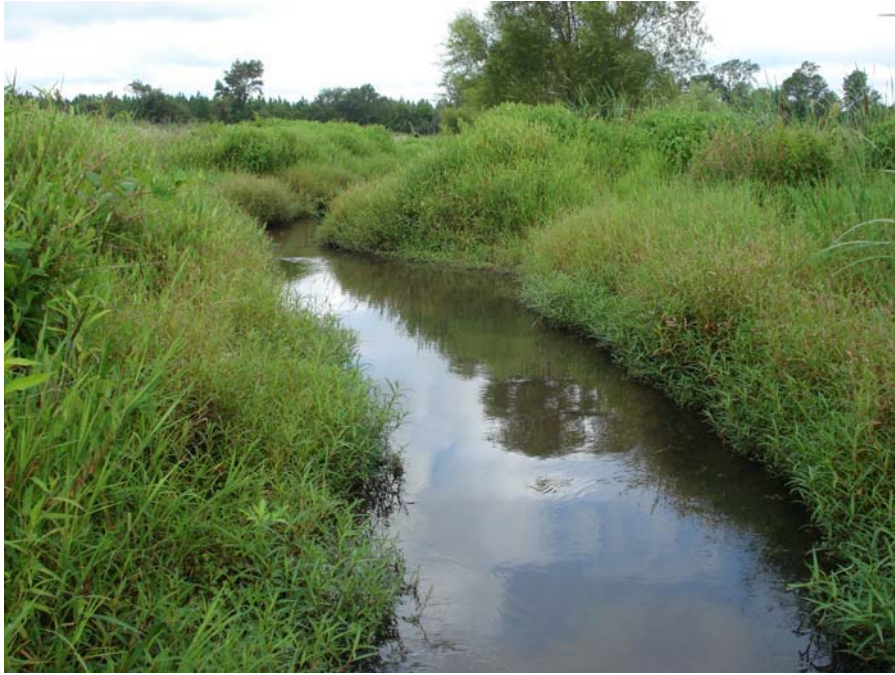
Photo 1. Looking upstream at crest gauge location (7/31/07).

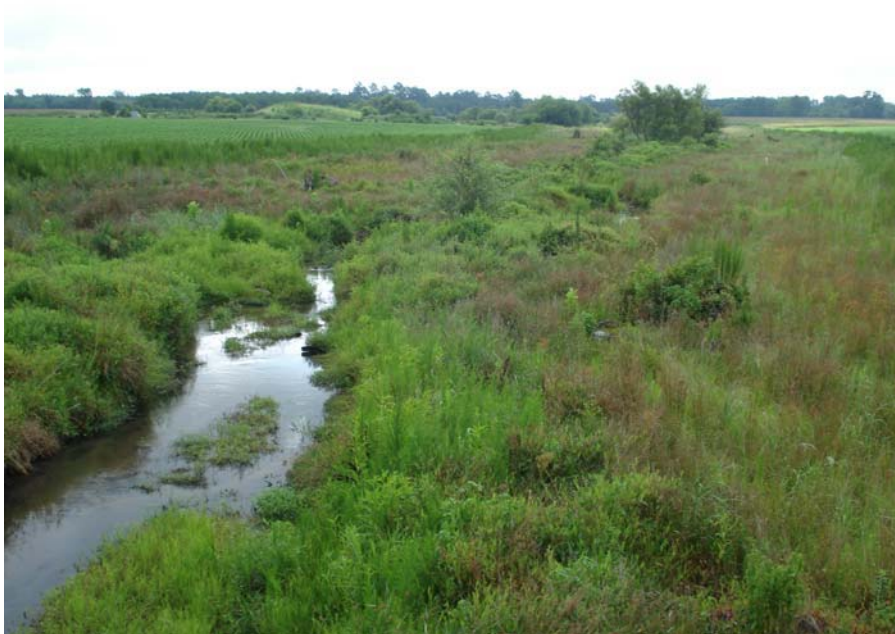
Field reconnaissance noted that the stream is an E type channel (Rosgen Classification) which is common in the coastal plain, with a low width-to-depth ratio and flat slopes (Appendix B4, Photo 1). The stream has excellent connection to the floodplain, with bank height ratio being approximately one. The channel shows signs of past straightening, but all banks are stable with little to no signs of bank erosion over the entire stream reach. In a few sections (mostly downstream) the stream has developed several mid-channel bars which are well vegetated (Appendix B4, Photo 2). This would indicate that the channel width is too wide in these areas. Mid-channel bars in some instances can lead to lateral migration and bank instability. However, with the abundance of bank vegetation and low flows there are currently no signs of instability. These areas should be monitored in the future.

Photo 2. Looking downstream near station 10+00 (7/31/07). Note formation of mid-channel bars. Stand of trees is near vegetation plot 4.

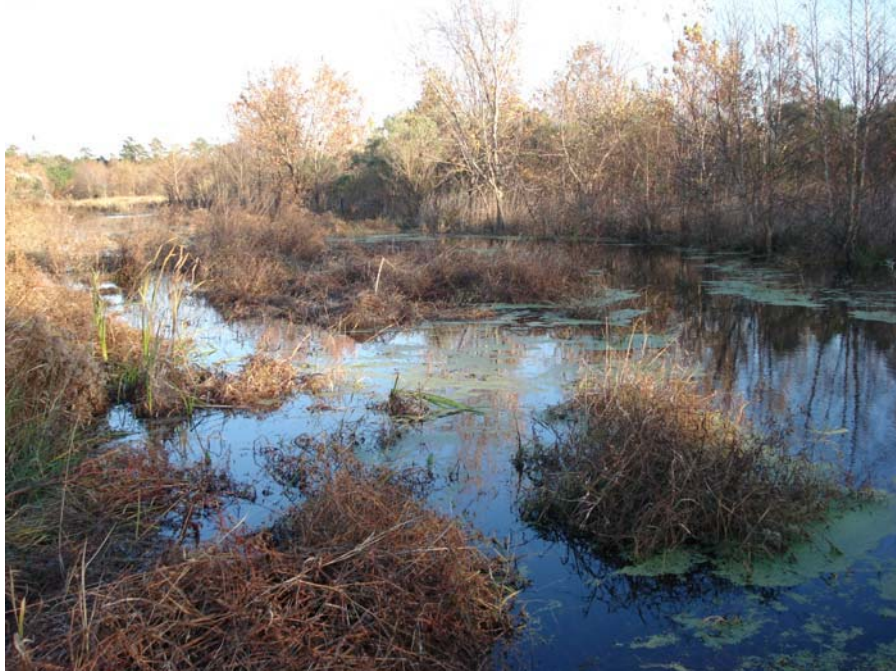
Photo 3. Flooding downstream of road near Veg Plot 7 - looking downstream (11/16/07)

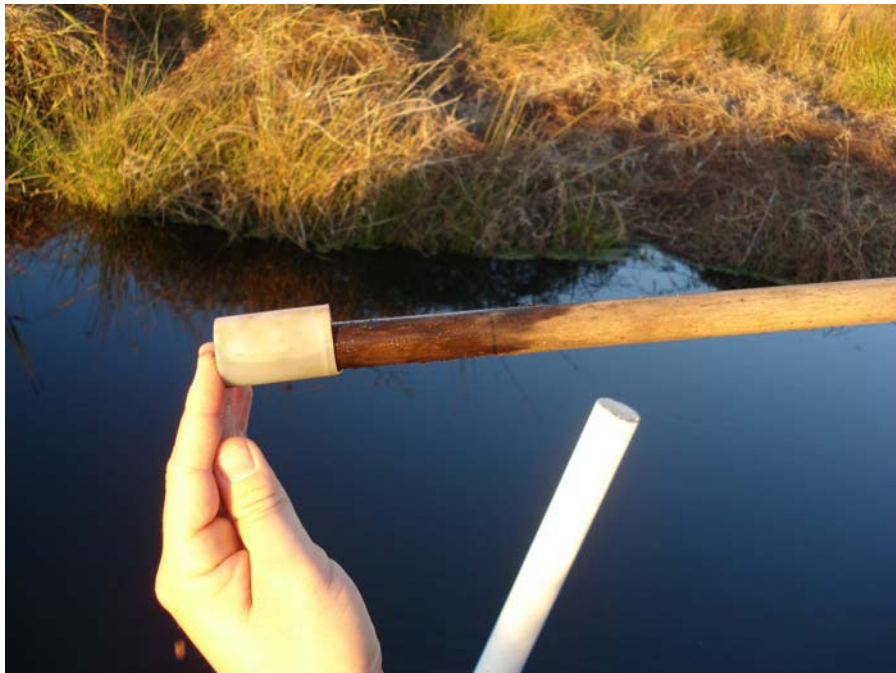
The crest gauge was checked during two site visits to Whitelace Creek in September and November of 2007 (Appendix B4, Photo 4). The September visit indicated that an overbank event had occurred since the last visit. In November, the water level was above bankfull, likely due to beaver activity near the crest gauge. In addition, the water level across the site rose throughout the Year 2 monitoring period. Since North Carolina has been in an extreme drought throughout this time it is likely that the overall rise in hydrology can be attributed to beaver activity downstream.

Photo 4. Crest gauge showing water above bankfull (11/16/07)

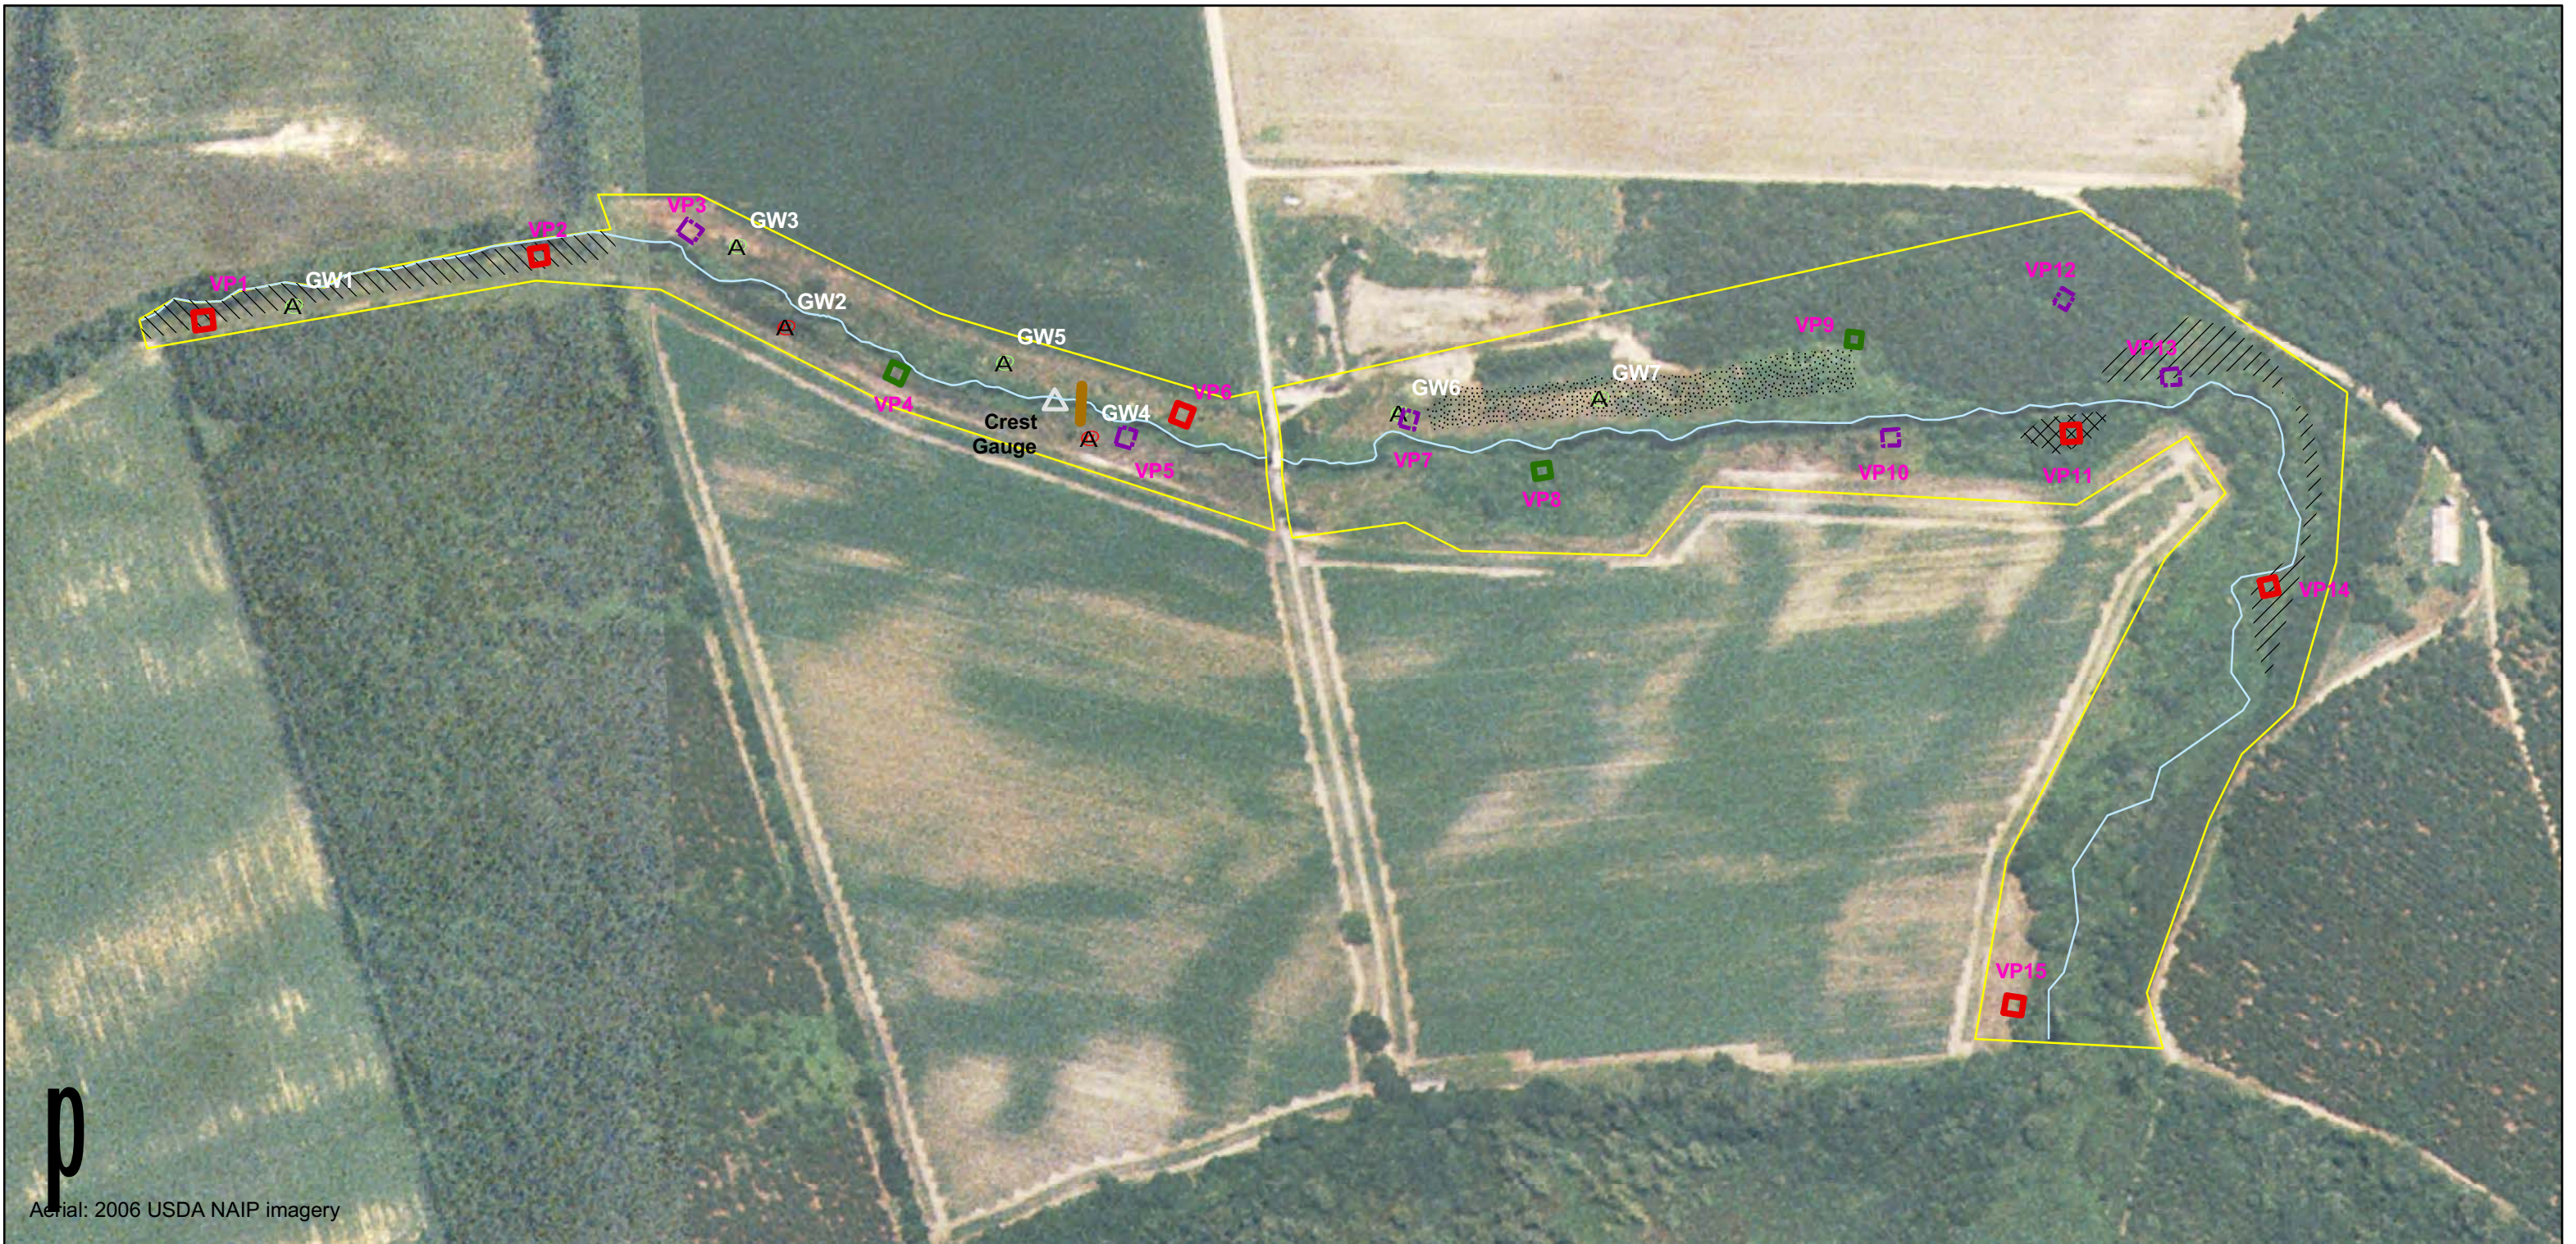
Appendix D Current Condition Plan View Map
 Whitelace Creek Stream Enhancement and Wetland Restoration, EEP #420
 Lenoir County, North Carolina
 March 2008

Monitoring revealed that 3 of the 9 plots (33%) met the 3-year vegetative success criteria of 320 planted stems or greater per acre. There are a number of issues causing the failure of the remaining 6 plots. There was a relatively low number of healthy plant species in vegetation plots 1 through 5, likely due to previous heavy flooding in 2006 as noted in the Year 1 monitoring report. In 2007, the higher areas onsite have been adversely affected by an extreme drought while the lower areas onsite have been flooded by beaver activity. Other problems included the presence of invasive or exotic species such as *Typha latifolia*, *Murdannia keisak*, and *Persicaria sagittata*. *Persicaria* is currently causing problems with vegetation vigor and survival and should be controlled. *Typha* and *Murdannia* will be watched throughout the monitoring period to ensure that they do not start causing harm to the planted species. See Exhibit Table A6 in Appendix A1, as well as accompanying photos provided in Appendix A2. It should be noted that there were a large number of river birch and silverling volunteers throughout the site. The major issue affecting the poor performance of the vegetation on the site is the localized flooding caused by beaver activity. The beavers should be removed, thereby allowing the site hydrology to return to a conditions outlined in the restoration plan. However, beaver activity is likely to continue. Therefore, the site should be replanted with trees of appropriate species and size to withstand periodic inundation.
