WHITELACE CREEK STREAM ENHANCEMENT  
AND WETLAND RESTORATION SITE  
MONITORING REPORT (YEAR 3 OF 5)

Lenoir County, North Carolina  
EEP Project No. 420

Status of Plan: Final  
Submission Date: April 2009

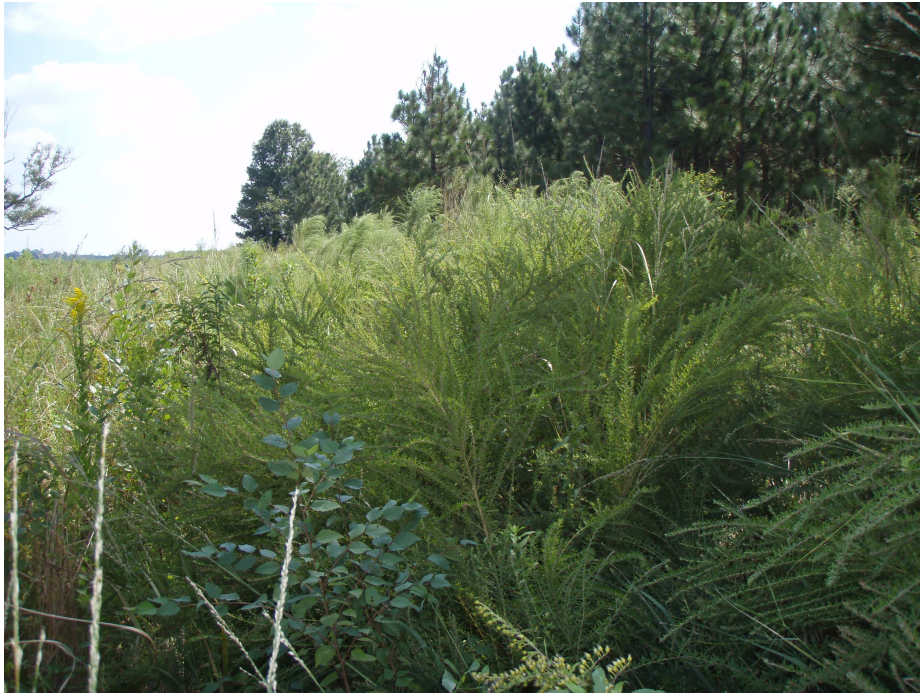
Other problems included the presence of invasive or exotic species such as *Typha latifolia*, *Murdannia keisak*, *Persicaria sagittata*, and *Lespedeza*. *Persicaria* is currently not as abundant on-site as it was in Year 2. *Typha*, *Murdannia*, and *Lespedeza* will be watched throughout the monitoring period to ensure that they do not start causing harm to the planted species. There is also weak woody vegetation in and around Vegetation Plots 1, 2, and 15. See Exhibit Table A6 in Appendix A1, as well as accompanying photos provided in Appendix A2. However, there continues to be a large number of river birch and silverling volunteers throughout the site.

Photo 1. Lespedeza near Vegetation Plot 2 (9/18/08)

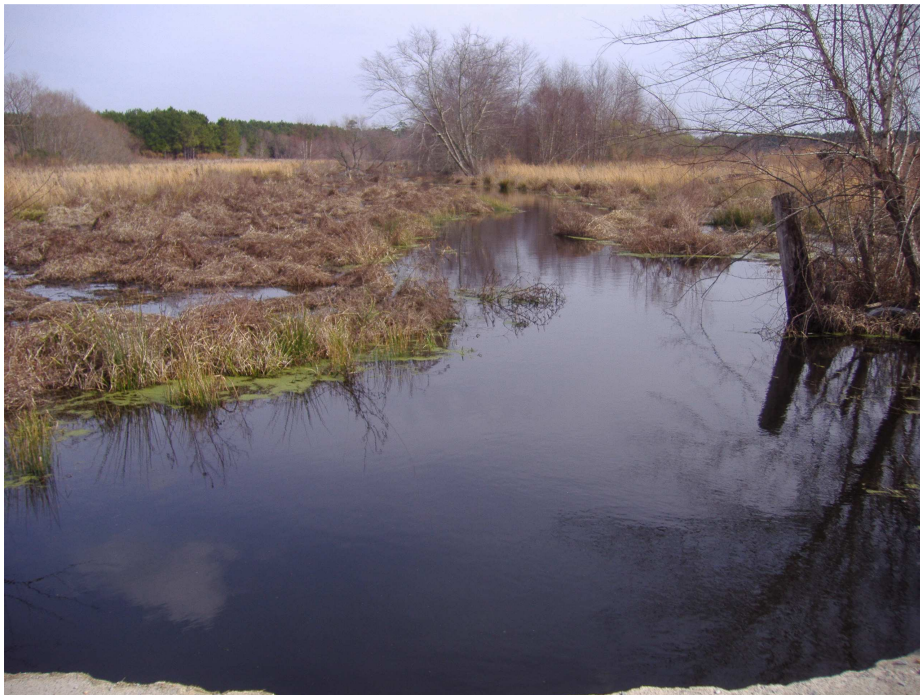
The major issue affecting the poor performance of the vegetation on the site is the previous localized flooding caused by beaver activity earlier in the year and recent drought. The beavers should be removed, thereby allowing the site hydrology to return to conditions outlined in the restoration plan. However, beaver activity is likely to continue. Therefore, the site should be replanted with trees of appropriate species and size to withstand periodic inundation.

Photo 2. Flooding (2/04/08)

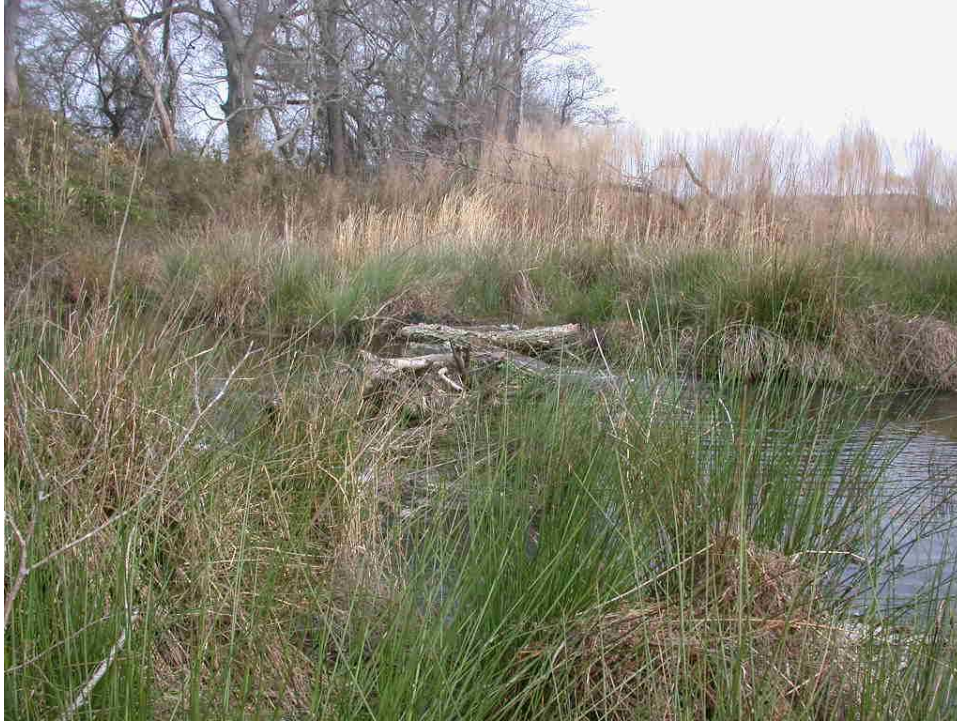
Photo 3. Beaver dam near Vegetation Plot 3 (3/19/08)

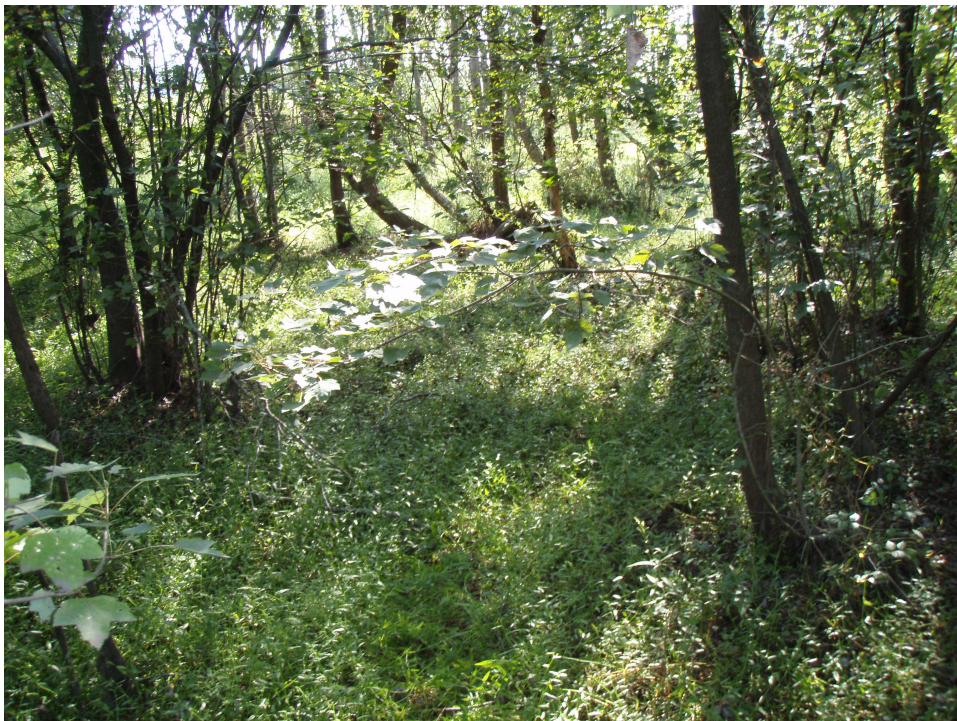
Photo 4. *Murdannia* in Vegetation Plot 11 (3/19/08)

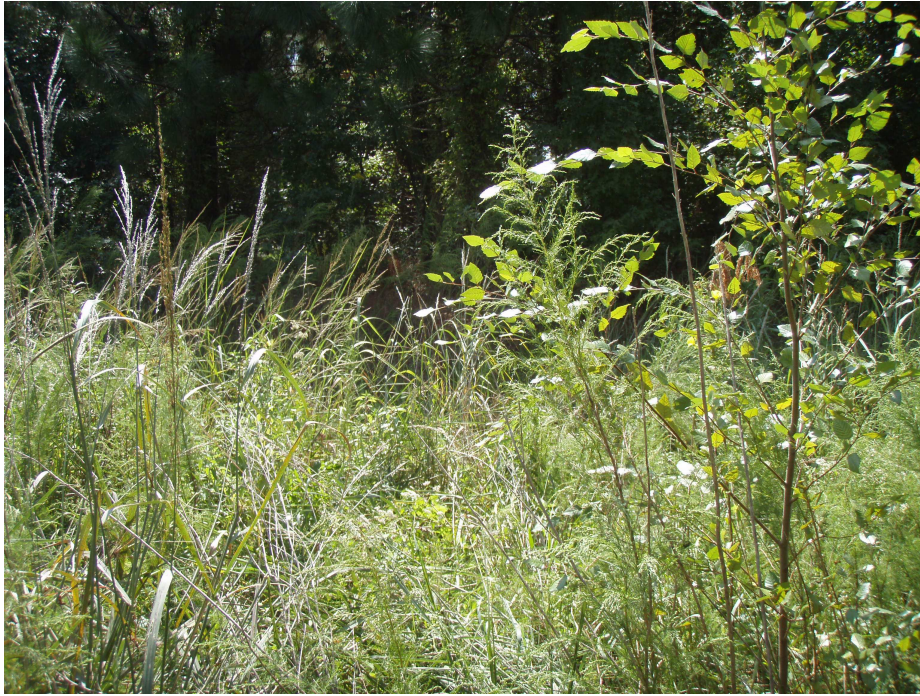
Photo Station 1: Vegetation Plot 1 (9/18/08)

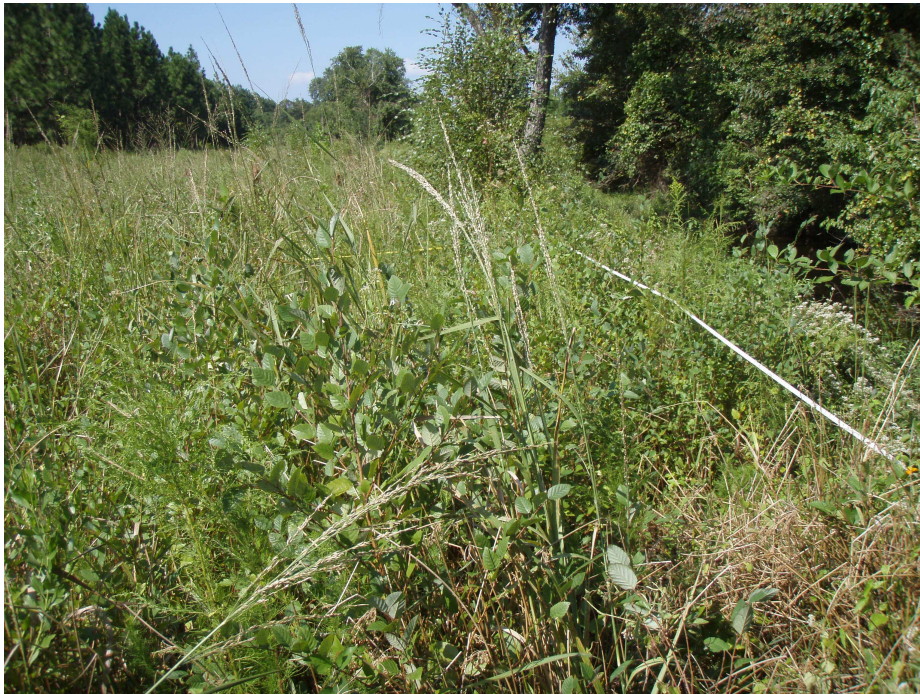
Photo Station 2: Vegetation Plot 2 (9/18/08)

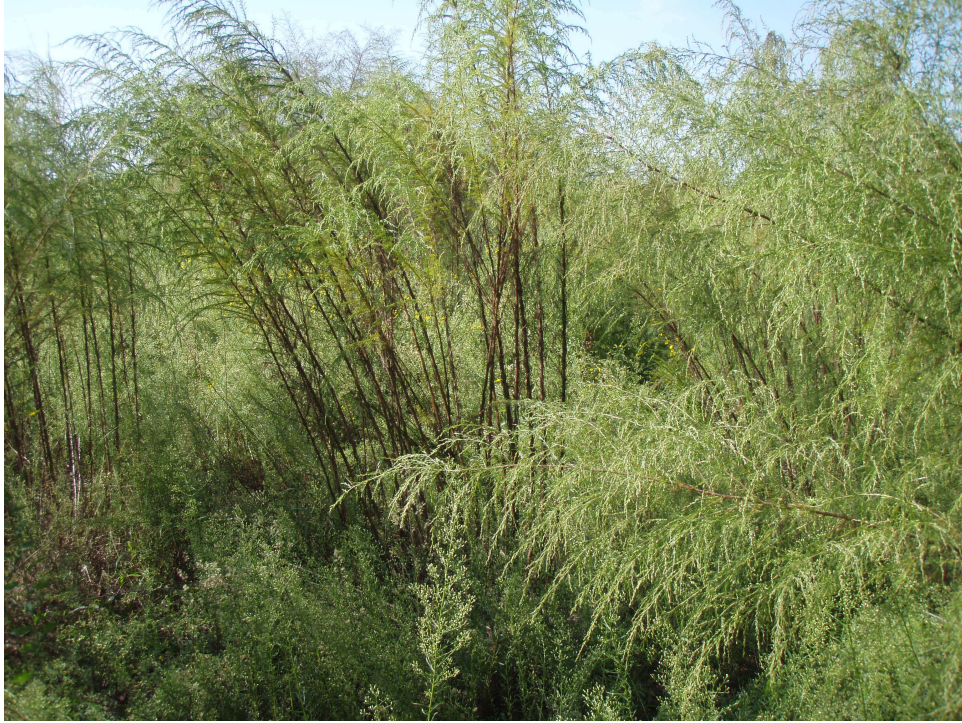
Photo Station 9: Vegetation Plot 15 (9/18/08)

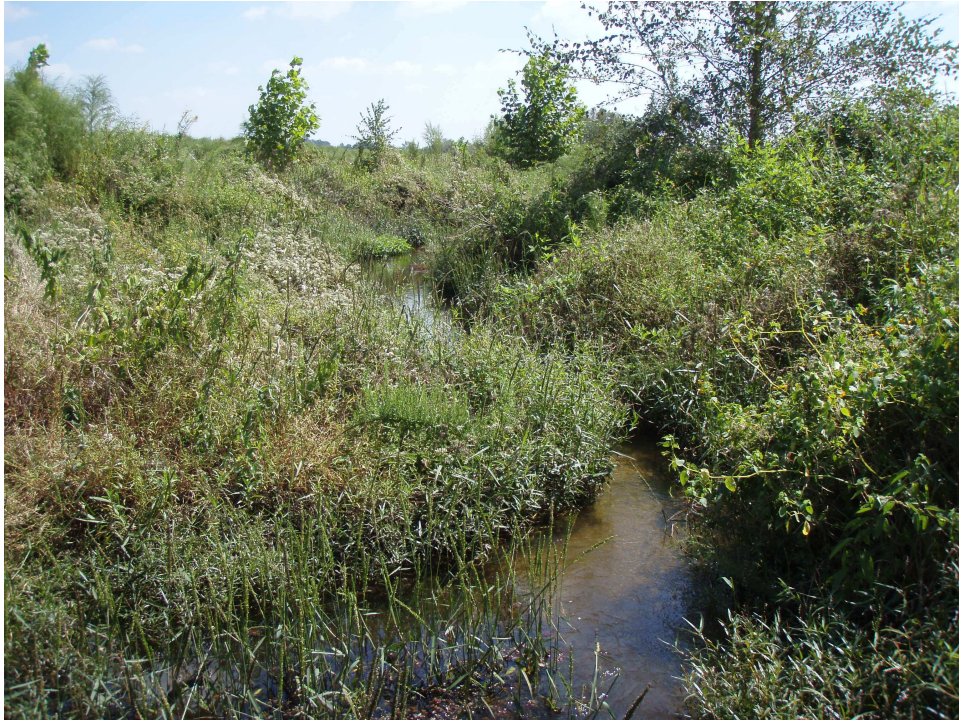
Field reconnaissance noted that the stream is an E type channel (Rosgen Classification) which is common in the coastal plain, with a low width-to-depth ratio and flat slopes (Appendix B4, Photo 1 & 3). The stream has excellent connection to the floodplain, with bank height ratio being approximately one. The channel shows signs of past straightening, but all banks are stable with little to no signs of bank erosion over the entire stream reach. In a few sections (mostly downstream) the stream has developed several mid-channel bars which are well vegetated (Appendix B4, Photo 2). This would indicate that the channel width is too wide in these areas. Mid-channel bars in some instances can lead to lateral migration and bank instability. However, with the abundance of bank vegetation and low flows there are currently no signs of instability. These areas will continue to be monitored in the future.

Photo 1. Looking downstream near deerstand (9/18/2008).

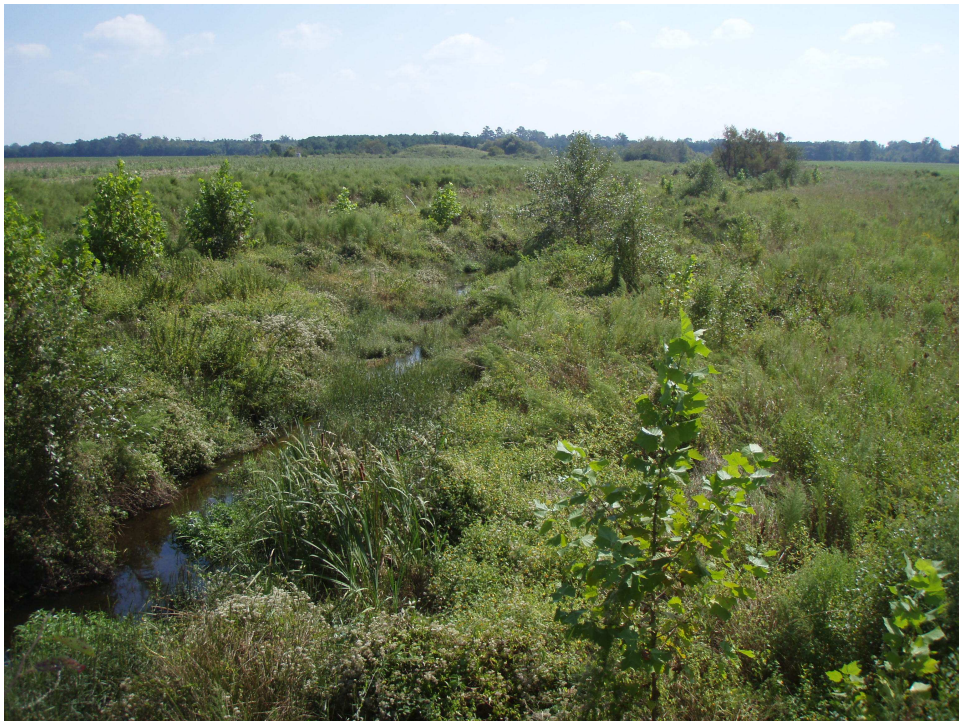
Photo 2. Looking downstream near station 10+00 (9/18/08). Note formation of mid-channel bars. Stand of trees is near Vegetation Plot 4.

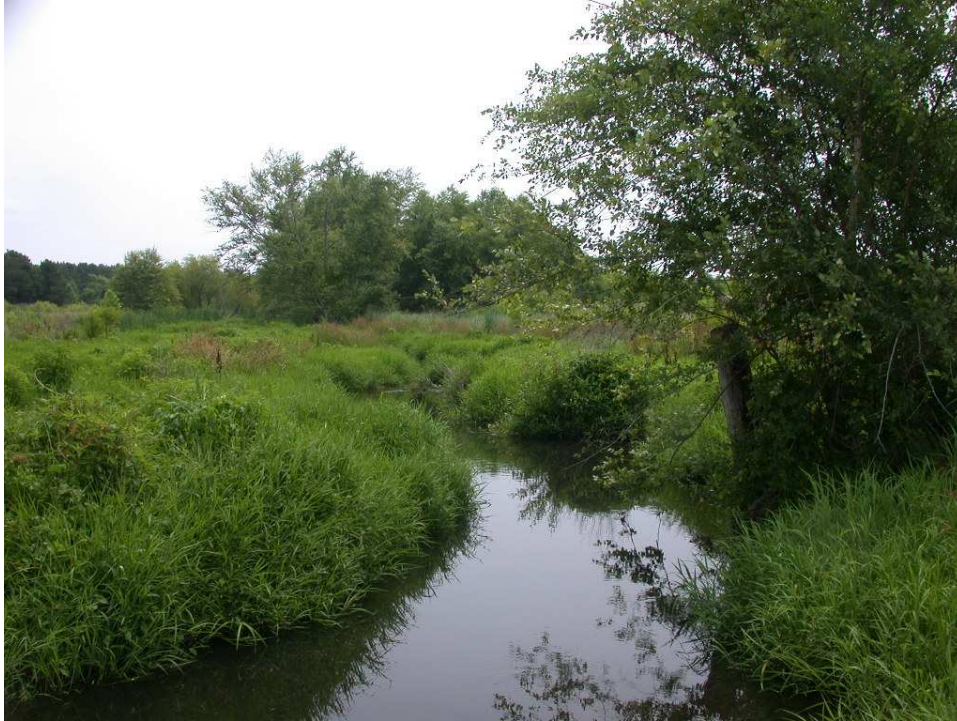
Photo 3. Looking downstream of road near Vegetation Plot 7 (9/18/08).

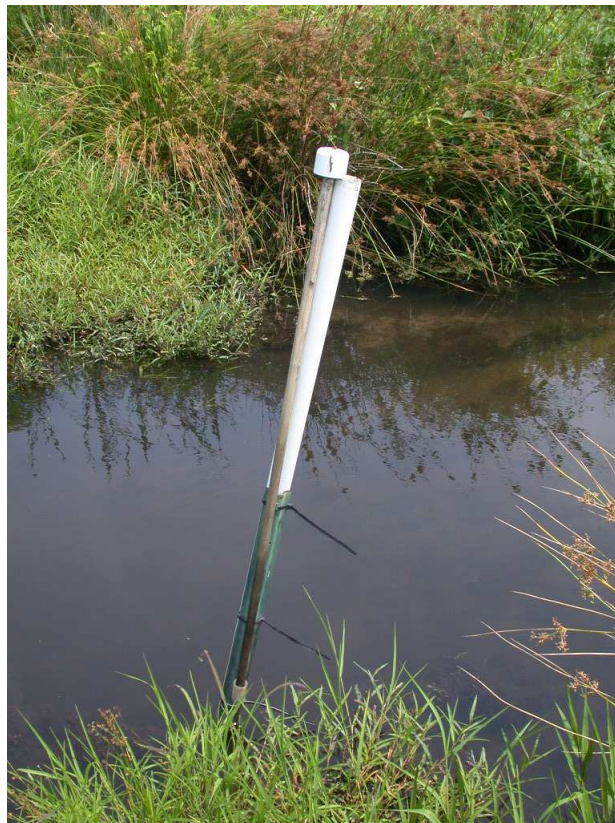
The crest gauge was checked during multiple site visits to Whitelace Creek in February, July, and September of 2008. The February and September visits indicated that an overbank event had occurred since the previous visit (Appendix B4, Photo 4). Additionally, there is currently a beaver dam onsite, located near Vegetation Plot 3 (Appendix B4, Photo 5).

Photo 4. Crest gauge showing water above bankfull (7/03/08)

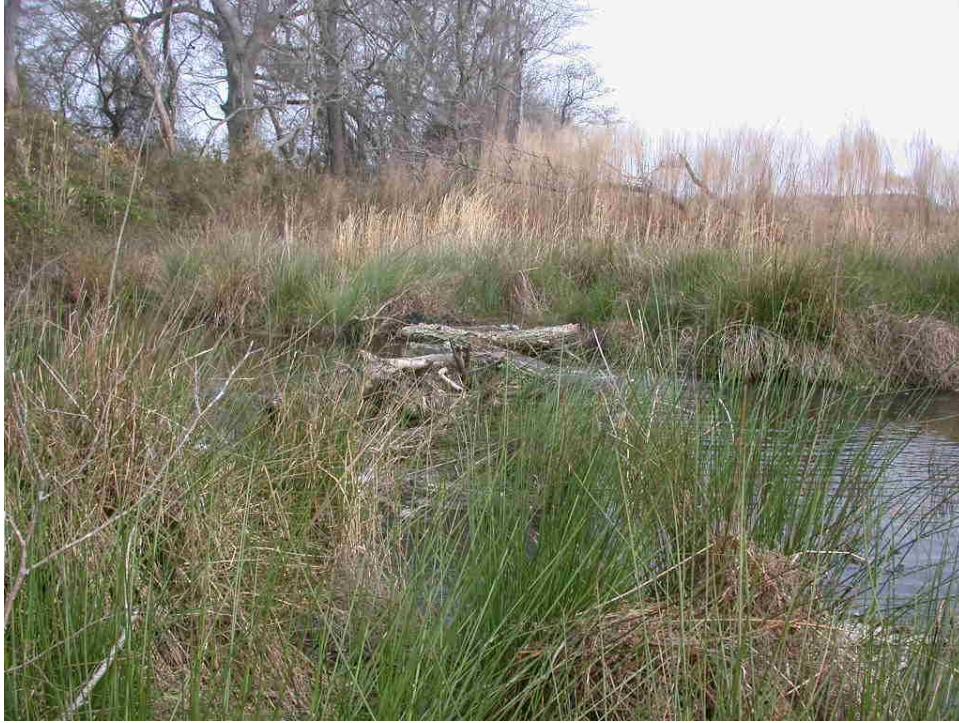
Photo 5. Beaver dam located near Vegetation Plot 3 (3/19/08)

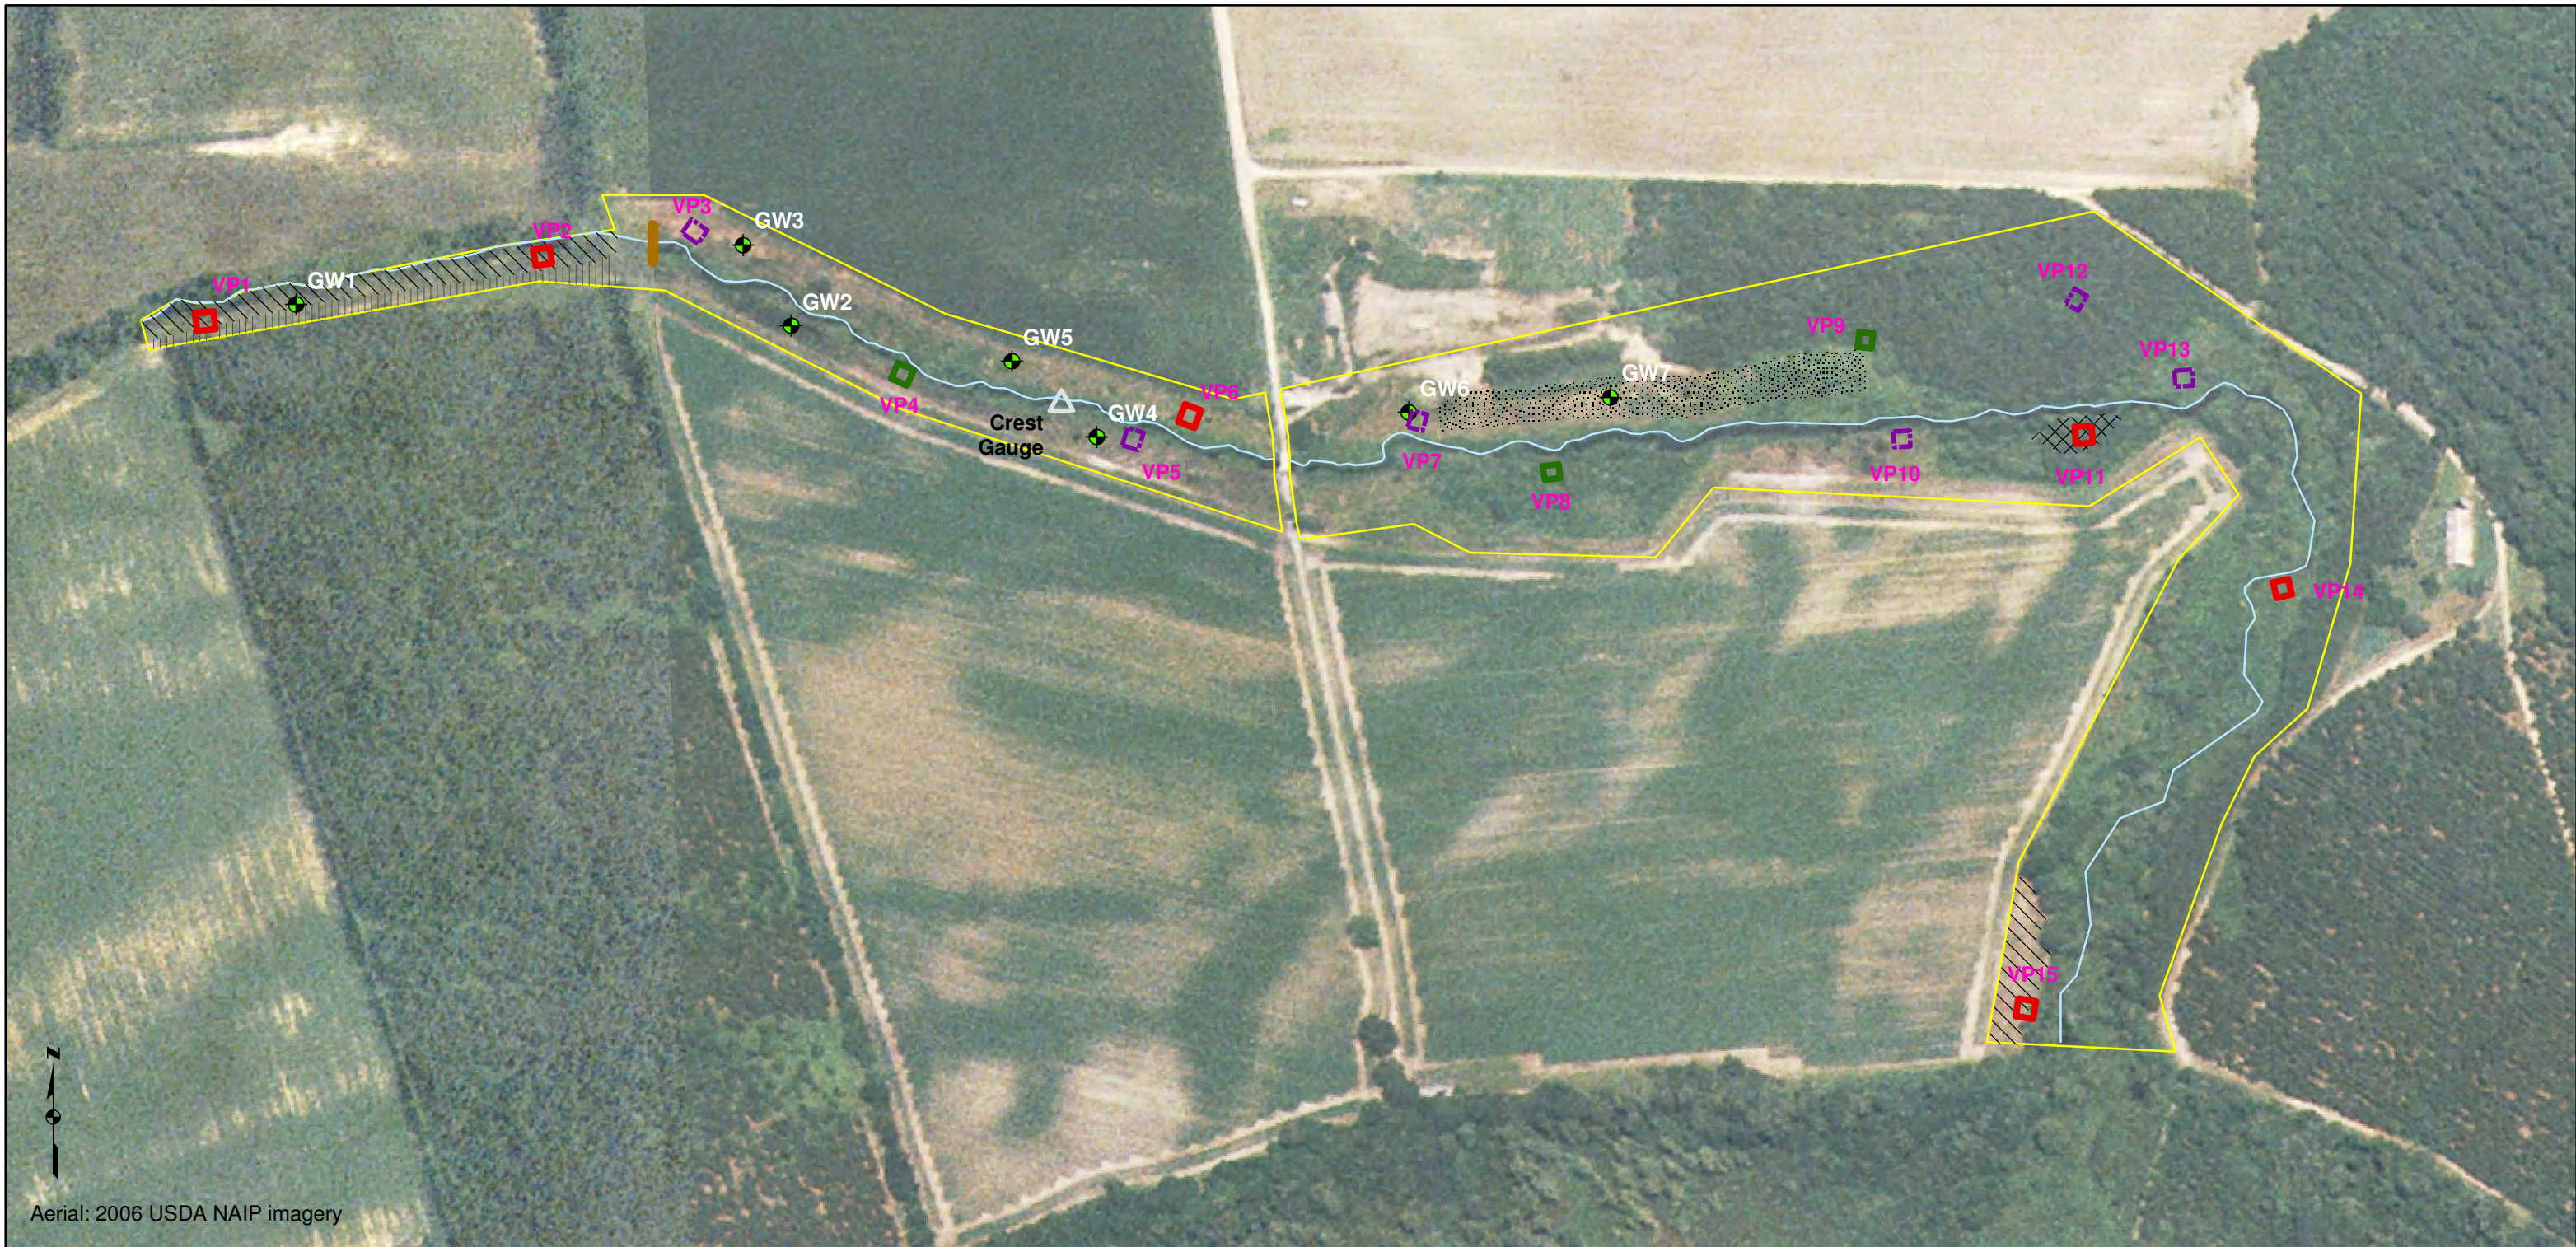
Appendix D. Current Condition Plan View Map MY3  
 Whitelace Creek Stream Enhancement and Wetland Restoration, EEP #420  
 Lenoir County, North Carolina  
 November 2008

Vegetative problem areas are shown on the Current Condition Plan View in Appendix D.

The plan view of the wetland problem areas is in Appendix D.
