WHITELACE CREEK STREAM ENHANCEMENT
AND WETLAND RESTORATION SITE
MONITORING REPORT (YEAR 4 OF 5)

Lenoir County, North Carolina
EEP Project No. 420

Status of Plan: Final
Submission Date: November 2009

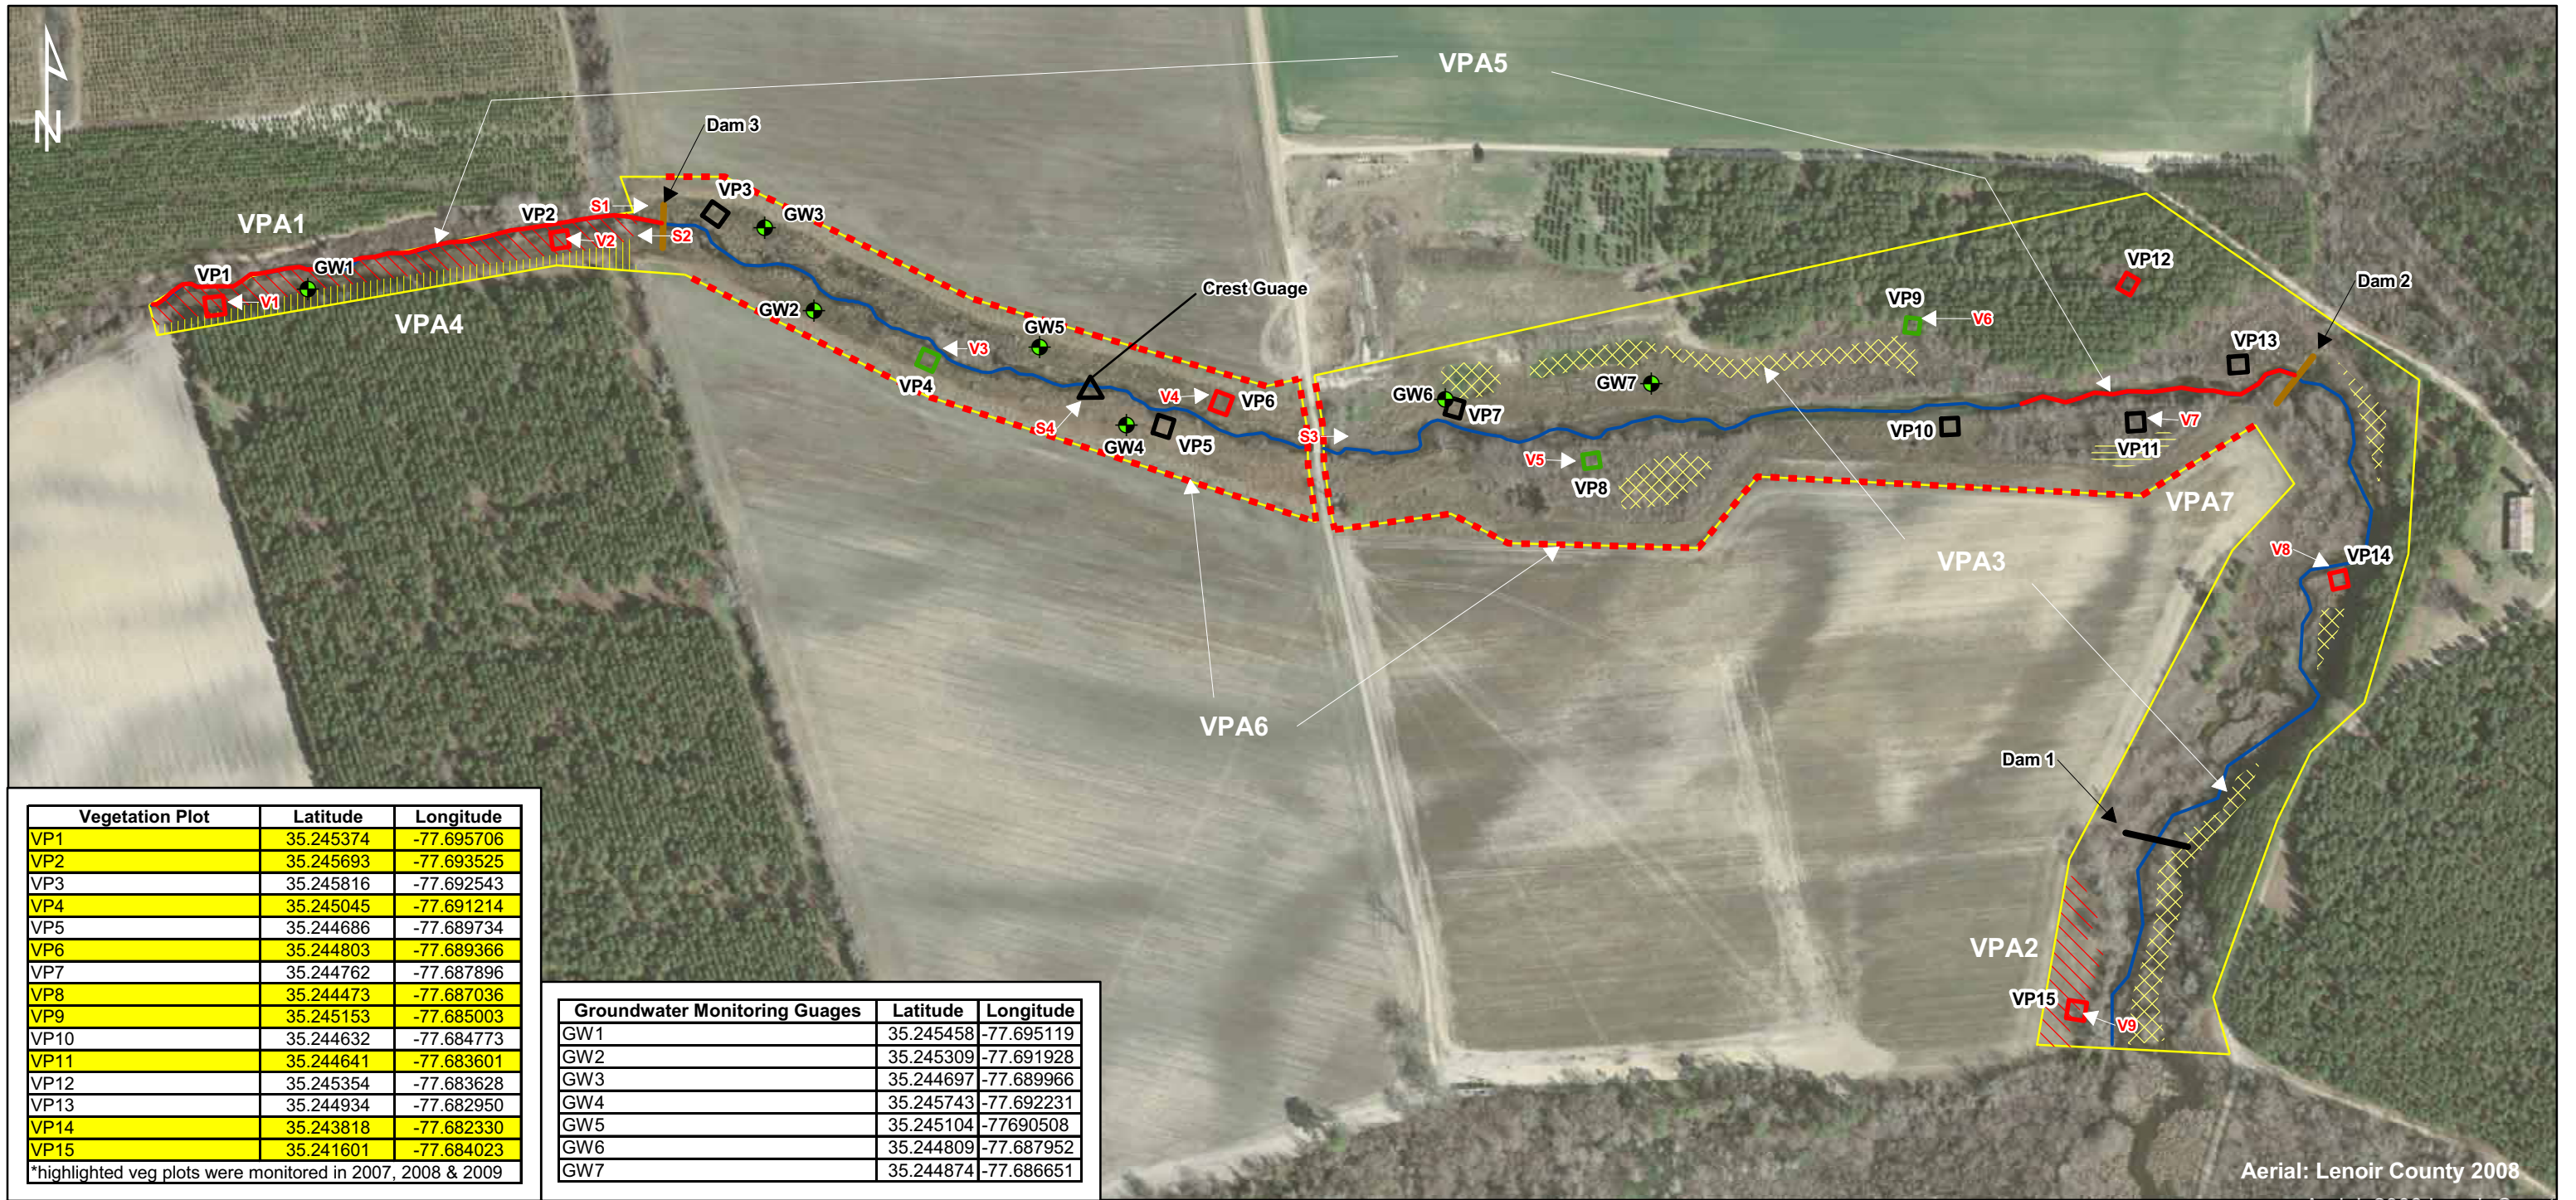
Figure 2 - Current Condition Plan View Map MY4
 Whitelace Creek Stream Enhancement and Wetland Restoration, EEP #420
 Lenoir County, North Carolina
 November, 2009

Overall, the major issues on the site include localized flooding and foraging caused by beaver activity. The beavers should be removed to allow the hydrology of the site to return to conditions outlined in the restoration plan. Beaver activity is likely to continue; therefore, areas of the site currently exhibiting weak planted species survival should be replanted with trees of appropriate species and size to withstand periodic inundation. During the initial assessment site visit on March 20, 2009, a large beaver dam (Dam 1) was observed along the downstream portion of the reach just downstream from Vegetation Plot 14. Additional beaver activity was observed near Groundwater Well 3, but no beaver dam was found during site visits early in the year. This summer, remedial measures were taken to remove the large beaver dam (Dam 1). During the vegetation monitoring site visit on September 16, 2009, two additional beaver dams were observed. A large dam (Dam 2) exists upstream of Vegetation Plot 14 and just downstream of the 90° right turn in the channel. The beavers most likely moved upstream from their original location (Dam 1). A beaver lodge is located approximately 20 feet from Vegetation Plot 11. A second smaller dam (Dam 3) was also observed just downstream from the deer stand located near Station 10+00. Resprouts were observed only in specimens thought to have been damaged by beaver or deer browse. It should be noted

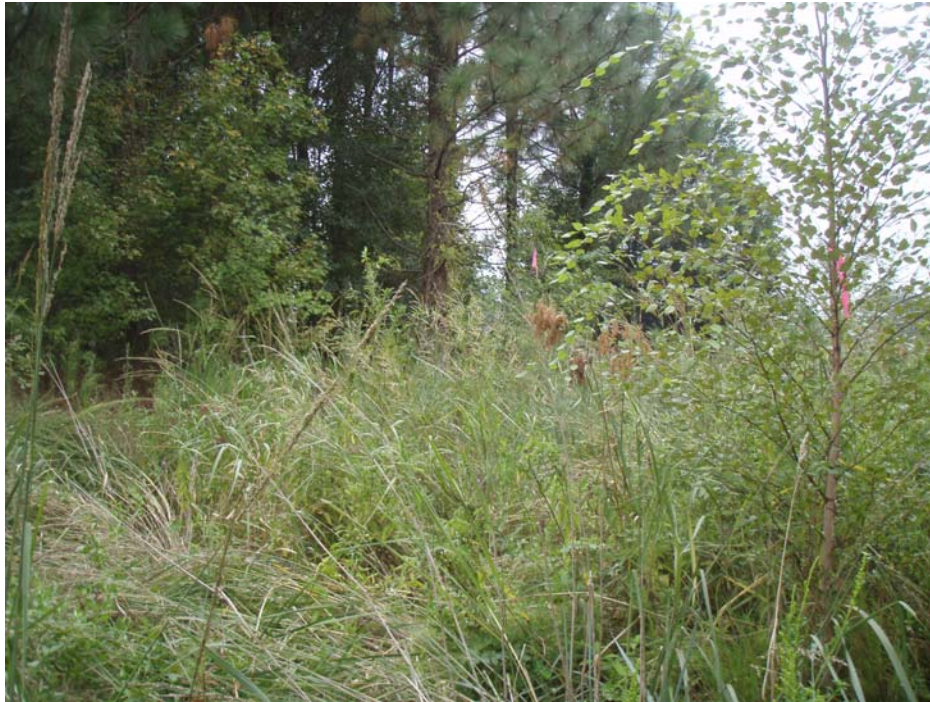
Photo Station 1: Vegetation Plot 1 (9/16/09).

Table 5 - Vegetation Plot Mitigation Success Summary		
Whitelace Creek Wetland Restoration Site / EEP Project No. 420		
Vegetation	Vegetation Density Met	Tract Mean
Plot ID	(288 stems/acre)	
VP1	N (243)	30% (256 stems/acre)
VP2	N (202)	
VP4	Y (445)	
VP6	N (202)	
VP8	Y (404)	
VP9	Y (404)	
VP11	N (81)	
VP14	N (202)	
VP15	N (121)

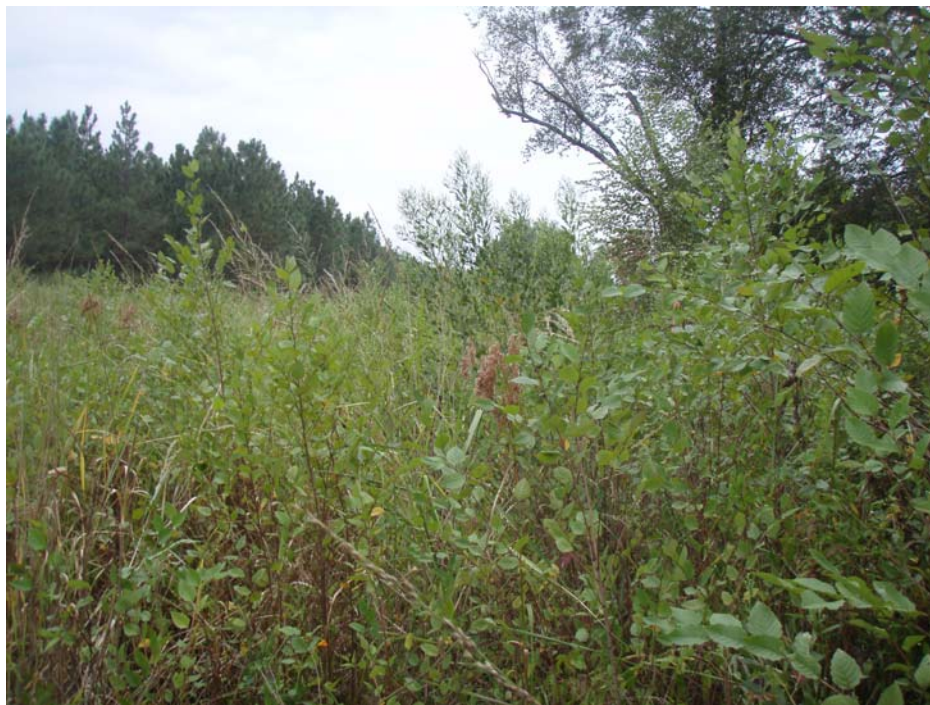
that vigorous woody volunteer recruitment (especially *Betula nigra*) was observed in the upper section of the reach near Vegetation Plots 1 and 2. This will contribute to meeting success criteria for riverine wetlands but will not count toward riparian buffer success. Supplemental planting should be undertaken onsite to ensure vegetative success.

Photo Station 2: Vegetation Plot 2
Note recruitment of *Betula nigra* volunteers (9/16/09).

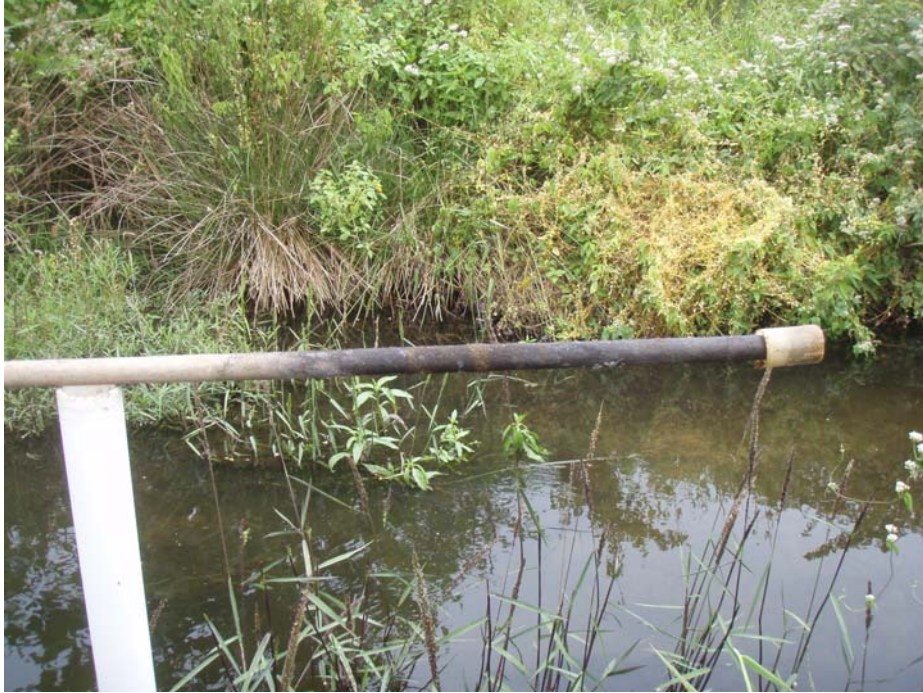
Photo Station 3 (S3) – Crest gauge showing bankfull event (09/16/09)
