WHITELACE CREEK STREAM ENHANCEMENT
AND WETLAND RESTORATION SITE
MONITORING REPORT (YEAR 5 OF 5)

Lenoir County, North Carolina
EEP Project No. 420

Status of Plan: Final
Submission Date: November 2010

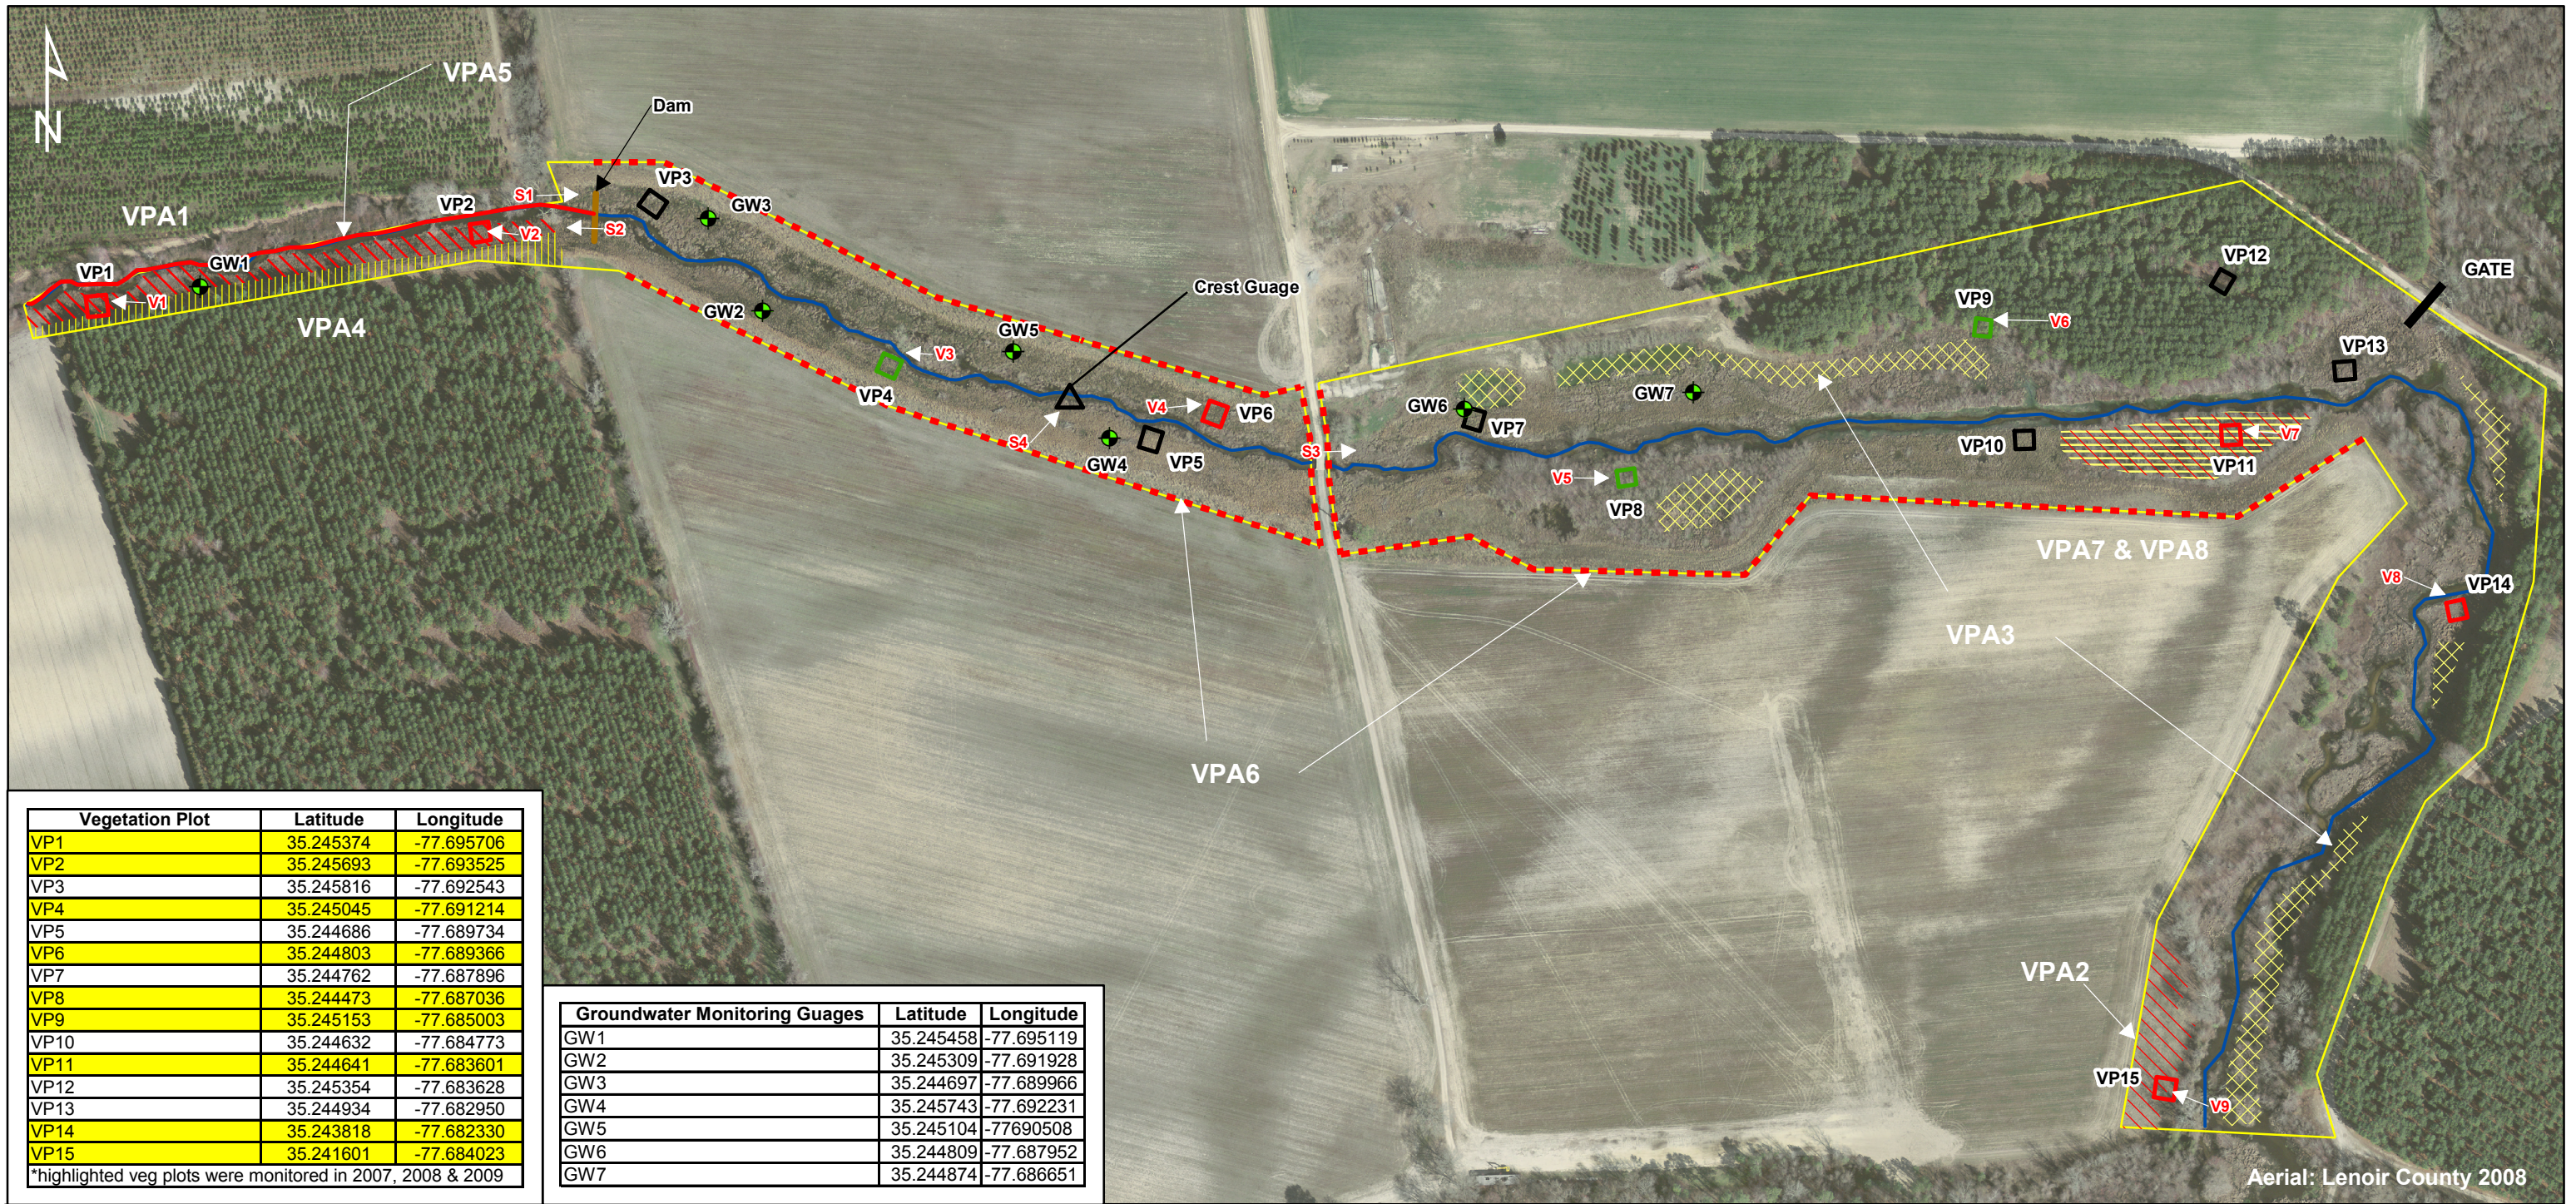
Figure 2 - Current Condition Plan View Map MY5
 Whitelace Creek Stream Enhancement and Wetland Restoration
 EEP Project Number 420
 Lenoir County, North Carolina
 November 2010

- Vegetation Plots**
- Not Monitored
 - <288 stems/acre
 - >288 stems/acre
- Major Vegetation Problem Areas**
- Poor Planted Species Survival (VPA1, VPA2, VPA8)
 - Possible Encroachment (VPA6)
 - Flooding from Beaver Dam (VPA5)
- Minor Vegetation Problem Areas**
- Lespedeza (VPA4)
 - Murdannia (VPA7)
 - Typha (VPA3)
- Stream**
- Stream
 - Conservation Easement
- Photo Points (V=Veg, S=Stream)**
- V1
- Crest Gauge**
- Crest Gauge
- Monitoring Gauges**
- Successful for MY4 (7)
- Beaver Dams**
- Current

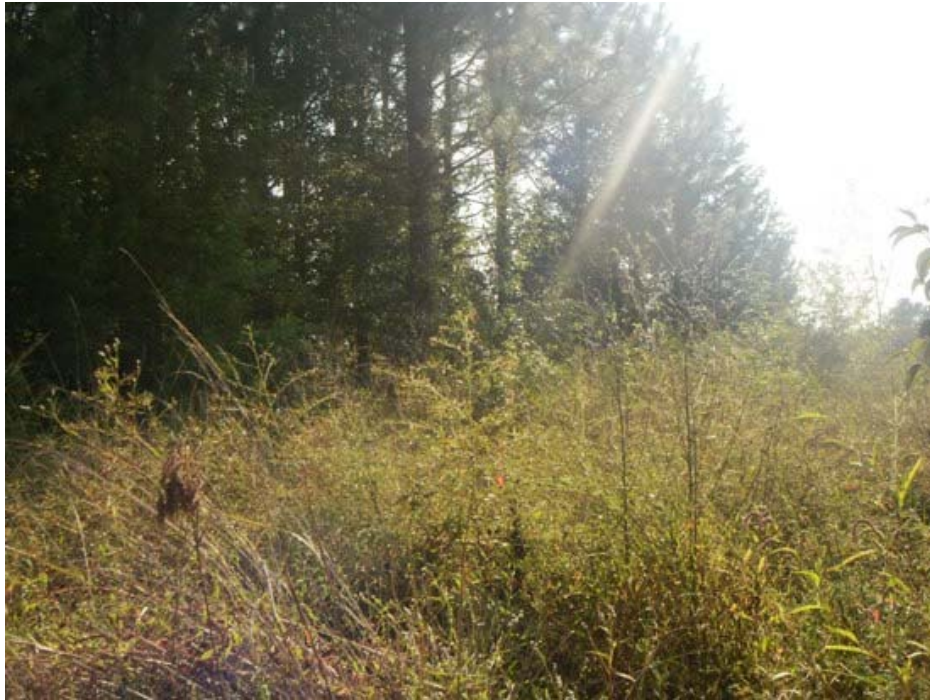
Photo Station 1: Vegetation Plot 1 (9/22/10).

Table 5 - Vegetation Plot Mitigation Success Summary		
Whitelace Creek Wetland Restoration Site / EEP Project No. 420		
Vegetation	Vegetation Density Met	Tract Mean
Plot ID	(260 stems/acre)	
VP1	N (202)	33% (216 stems/acre)
VP2	N (81)	
VP4	Y (405)	
VP6	N (162)	
VP8	Y (364)	
VP9	Y (324)	
VP11	N (0)	
VP14	N (243)	
VP15	N (162)
