Whittier Creek Mitigation Project

Year 2 (2023) Monitoring Report

Surry County, North Carolina

DMS Project ID No. 100020

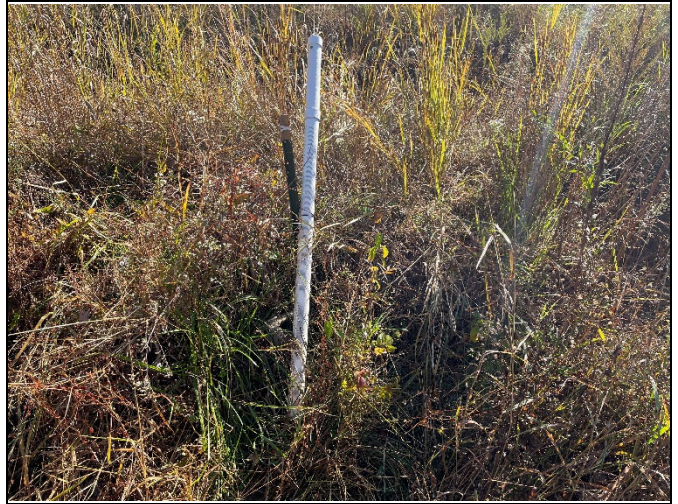
Continuous Stage Recorder #2 on UT4b (10/25/2023)

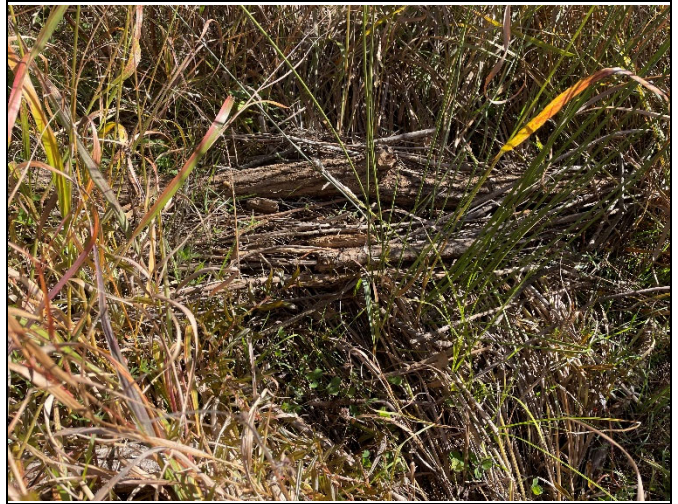
R7 Overbank Event Evidence (10/25/2023)

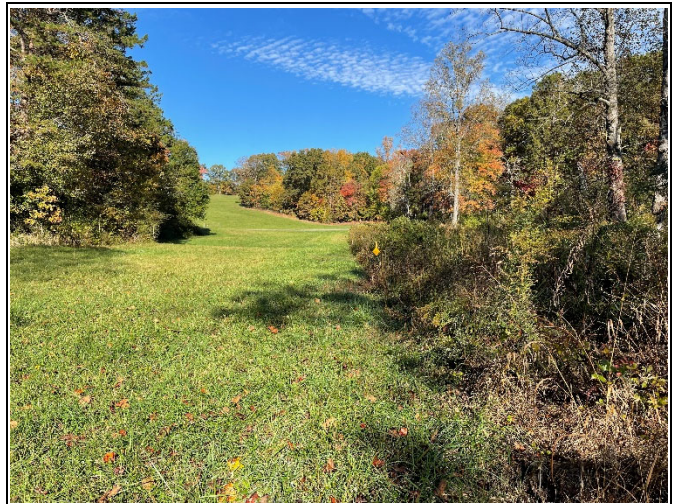
Encroachment to the CE on UT4a resolved (10/24/2023)

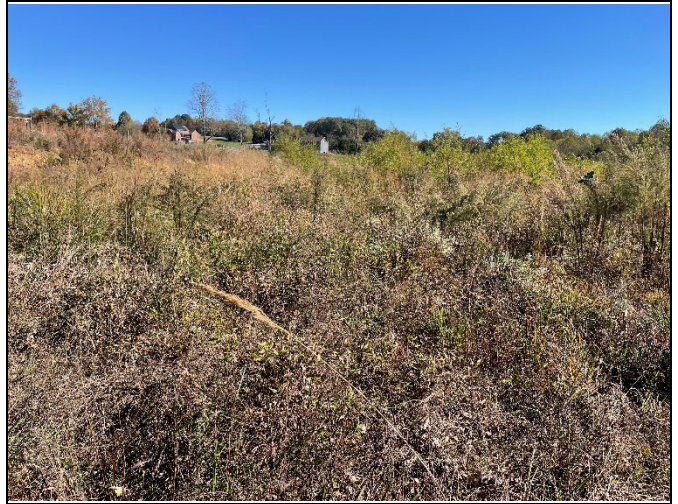
Kudzu treatment along R7 (10/25/2023)

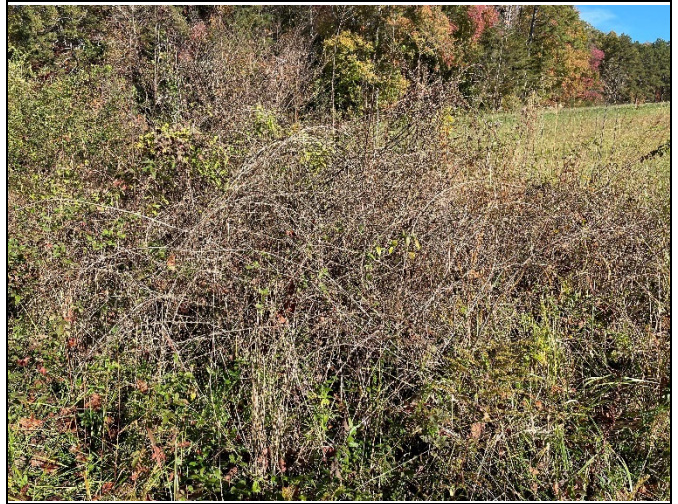
Multiflora rose and Privet treatment along UT4a (10/24/2023)

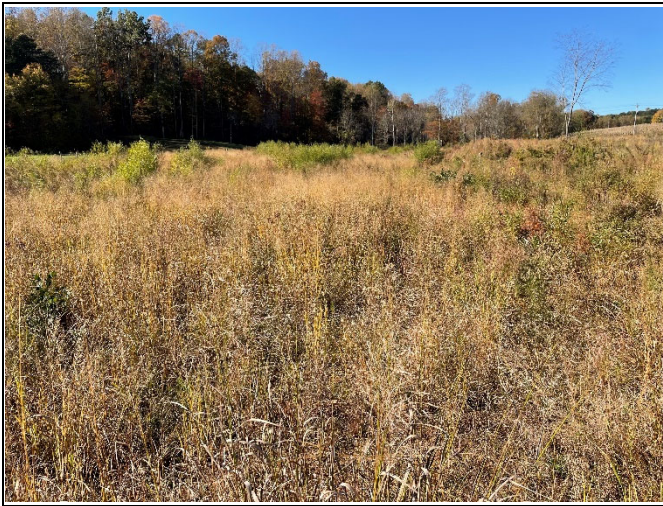
Veg transect taken along R7 right floodplain (10/24/2023)

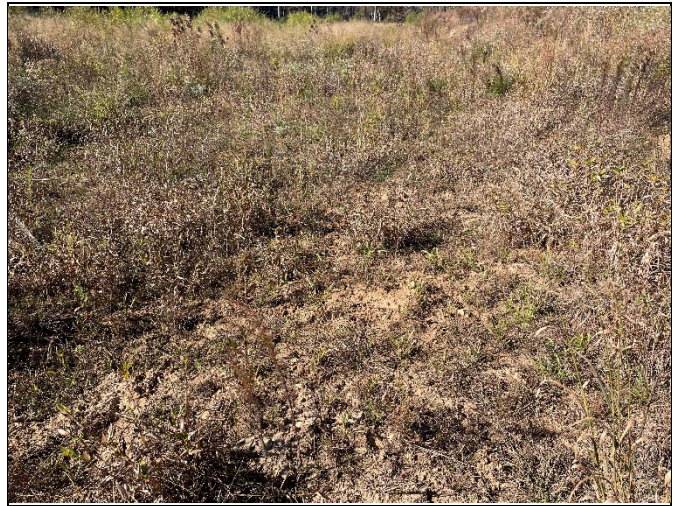
There is however, A Vegetation Problem Area (VPA) identified during the Year 2 monitoring (Table 6 in Appendix B). The VPA consists of low herbaceous and low vigor totaling 0.1 acres observed along the right bank of R7 close to station 20+75. These are areas that are impacted by compacted soils and overbank events after the confluence of UT5 and R7. This area was previously called out during Year 1 monitoring and has shown improvements throughout this year. Michael Baker supplementally planted these areas (0.69 acres) with appropriate species including Sycamore (*Platanus occidentalis*), Box elder (*Acer negundo*), and Sugarberry (*Celtis laevigata*) along with soil amendments during February 2023 (see Table 7). Michael Baker plans to do additional soil amendments and supplemental planting in areas of low vigor and high mortality. Lastly, invasive species were treated throughout the project consisting of privet (*Ligustrum sinense*), multiflora rose (*Rosa multiflora*), and Kudzu (*Pueraria montana*). Repeat treatments will take place during monitoring year 3 where needed. The exact locations of the VPA, supplemental planting, and invasive treatments are shown in the Current Condition Plan View (CCPV) found in Appendix B. During Year 1, an encroachment area was identified and reported along the right floodplain of UT4a. Michael Baker has since communicated with the landowner and installed posts with horse tape along the CE boundary. This was installed during February 2023 and no further encroachments were identified during Year 2 monitoring. Photographs can be found in Appendix B's MY2 Additional Project Photos.

VPA 1 low herbaceous growth and vigor (10/25/2023)
