**2004 - 2005 Monitoring Report for the Wild  
Mitigation Site on Obids Creek, Ashe County**

North Carolina Department of Transportation Stream Mitigation  
Program

Transportation Improvement Project R-529

Period Covered, April 28, 2004 – June 30, 2005

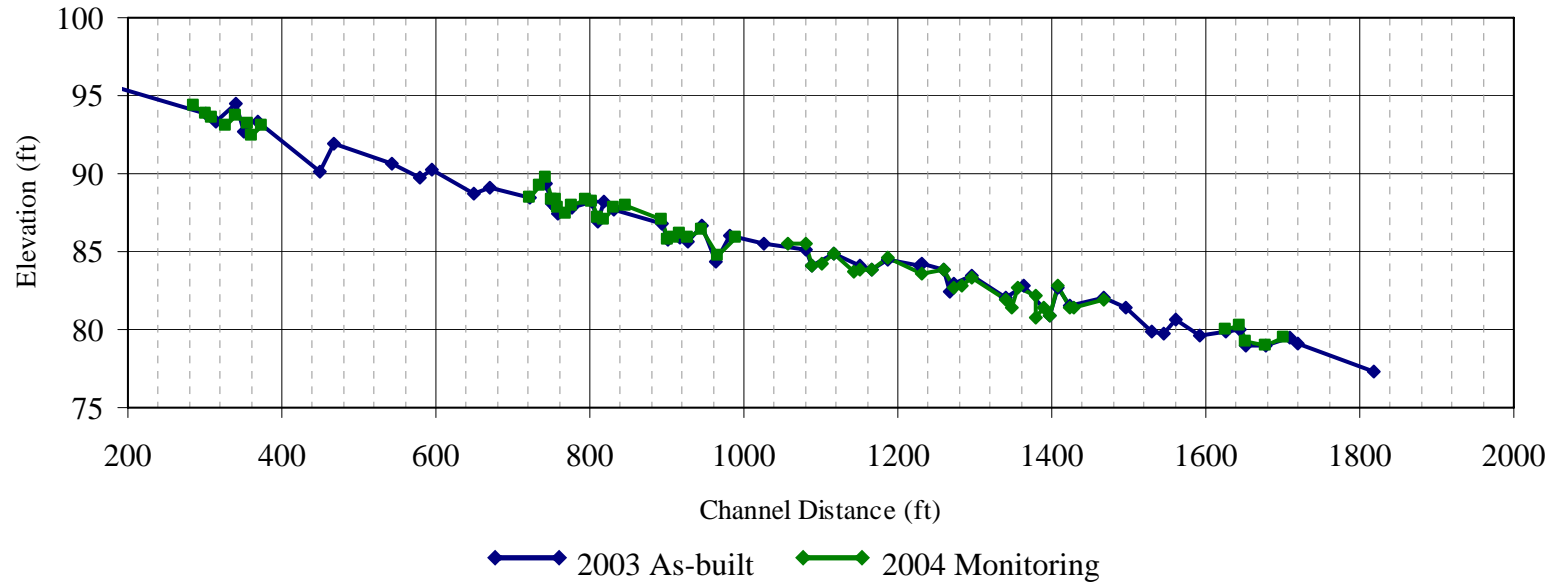
FIGURE 2. Longitudinal profile comparisons, Wild site, Obids Creek, Ashe County, 2003-2004.

Longitudinal profile data was collected during 2004 from four reaches; stations 2+86 – 3+73, 7+21 – 9+90, 10+56 – 12+60, and 12+82 – 14+67 (Figure 2). These sections were compared with the as-built longitudinal profile. No appreciable change in the longitudinal profile was present between 2003 and 2004. The longitudinal profile has remained stable with no identified aggradation or degradation areas. Minor changes in the longitudinal profile are the result of normal storm events and not the result of stream enhancement activities. Therefore, a longitudinal profile survey was not collected in 2005.

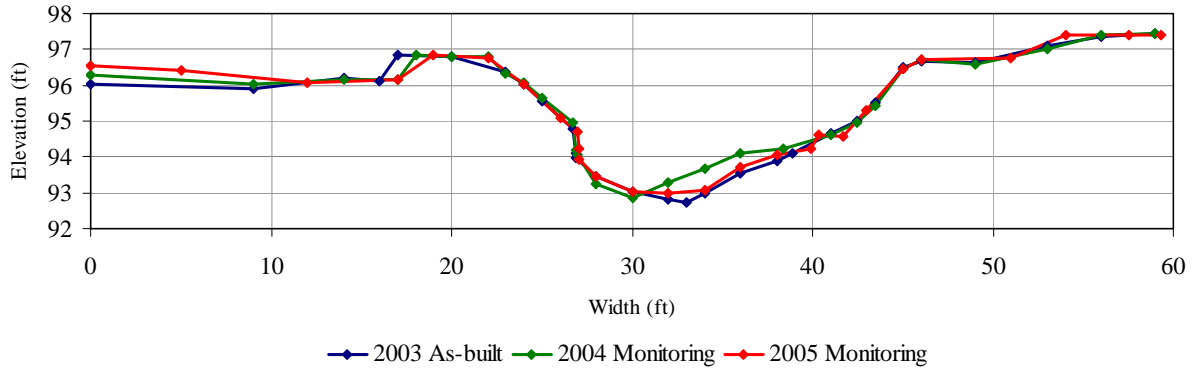
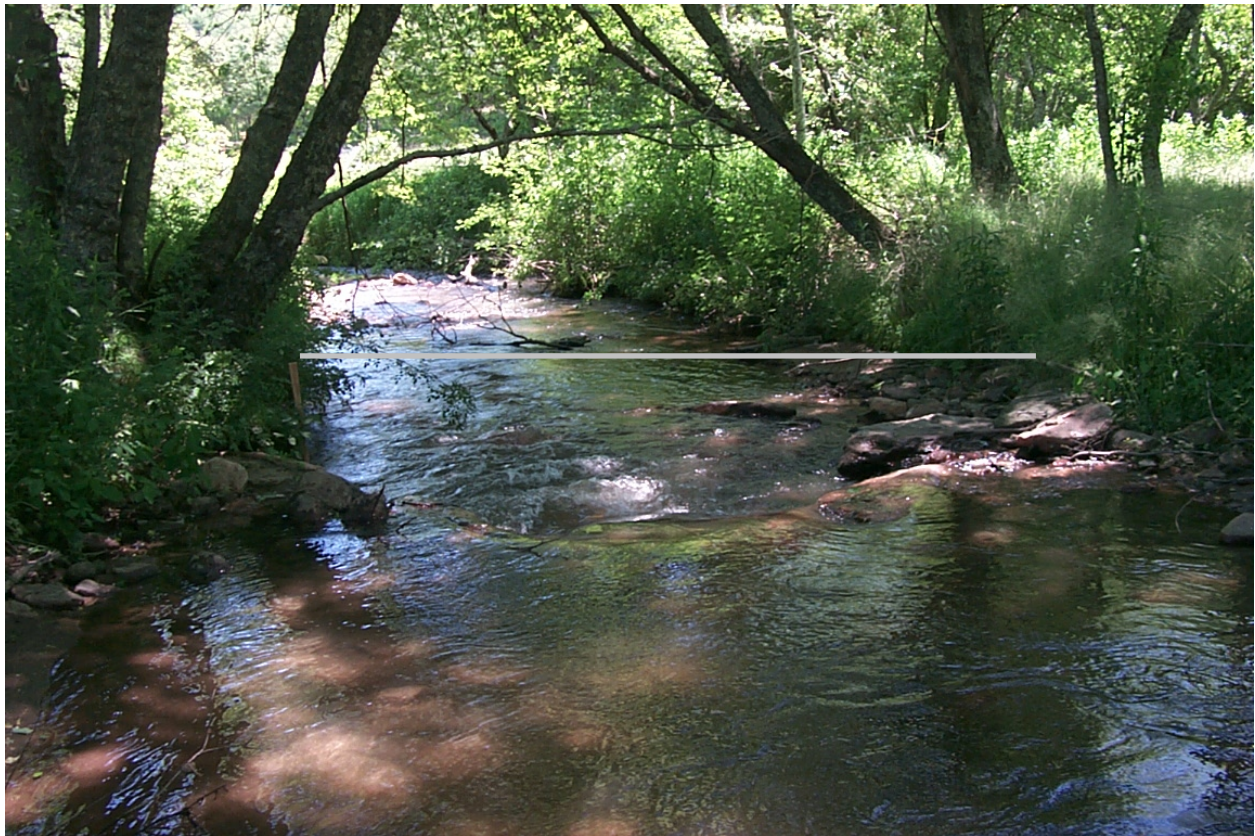
FIGURE 3.1. Cross-section station 3+55, riffle.

CROSS-SECTION 3+55 – riffle (Figure 3.1): This cross-section is located over a deep riffle just below a cross vane. There has been little change in the cross-section from 2003 thru 2005. The thalweg deepened to as-built elevations following the three September 2004 hurricanes. This cross-section has remained stable with no lateral movement (bank erosion) observed along the left and right banks.

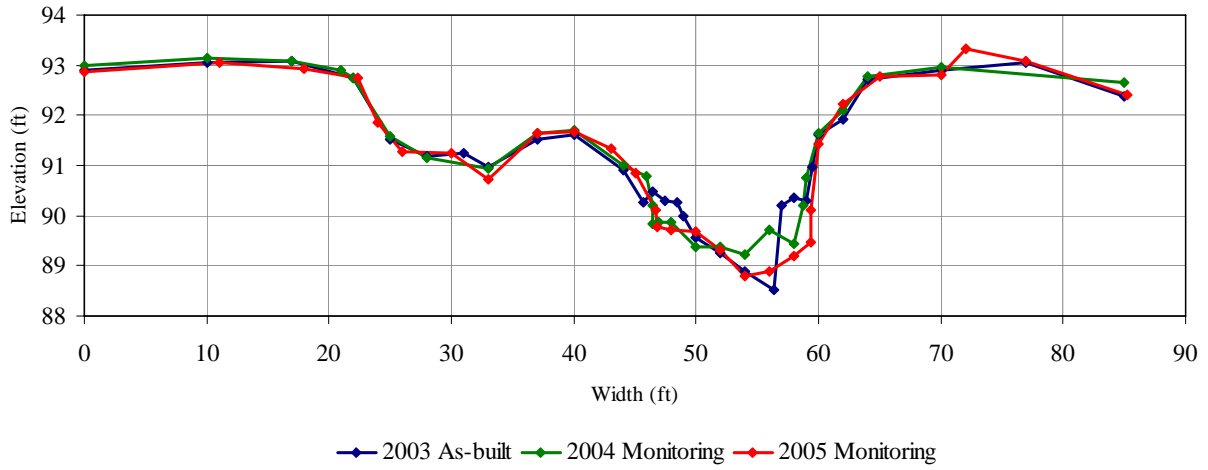
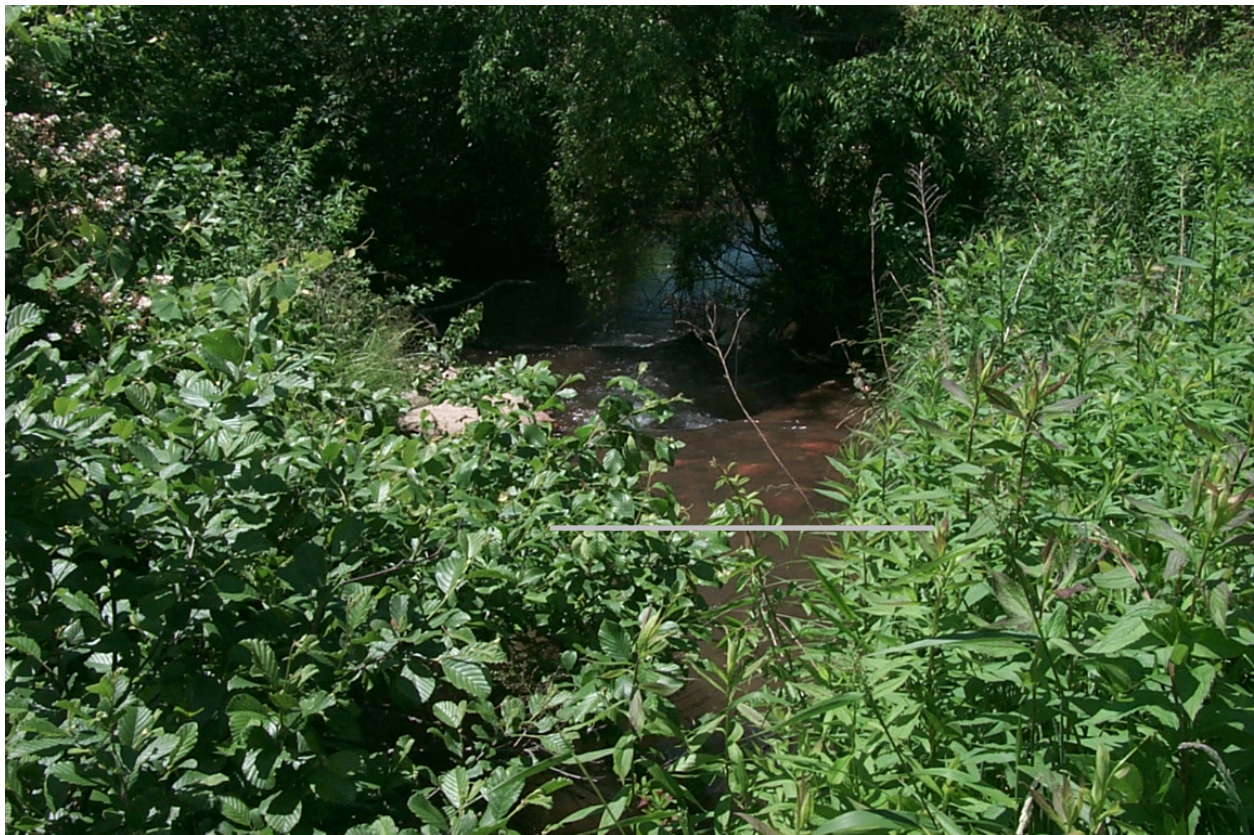
FIGURE 3.2. Cross-section station 7+36, pool.

CROSS-SECTION 7+36 – pool (Figure 3.2): This cross-section is located over the tail end of a long pool just above a cross vane. There has been some channel migration along the right bank at cross-section station 0+59.4 since completion of the project. However, the bank is stable and well vegetated.

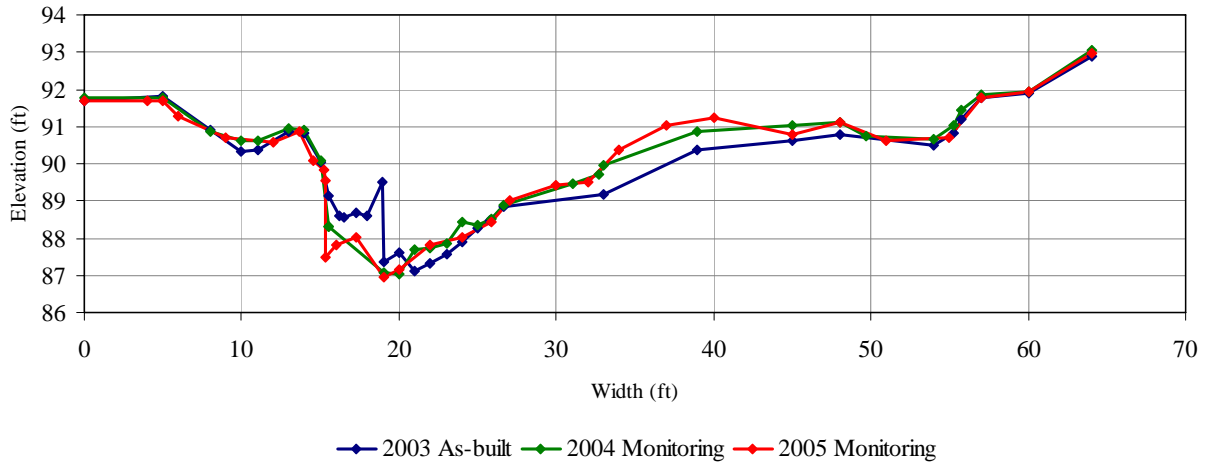
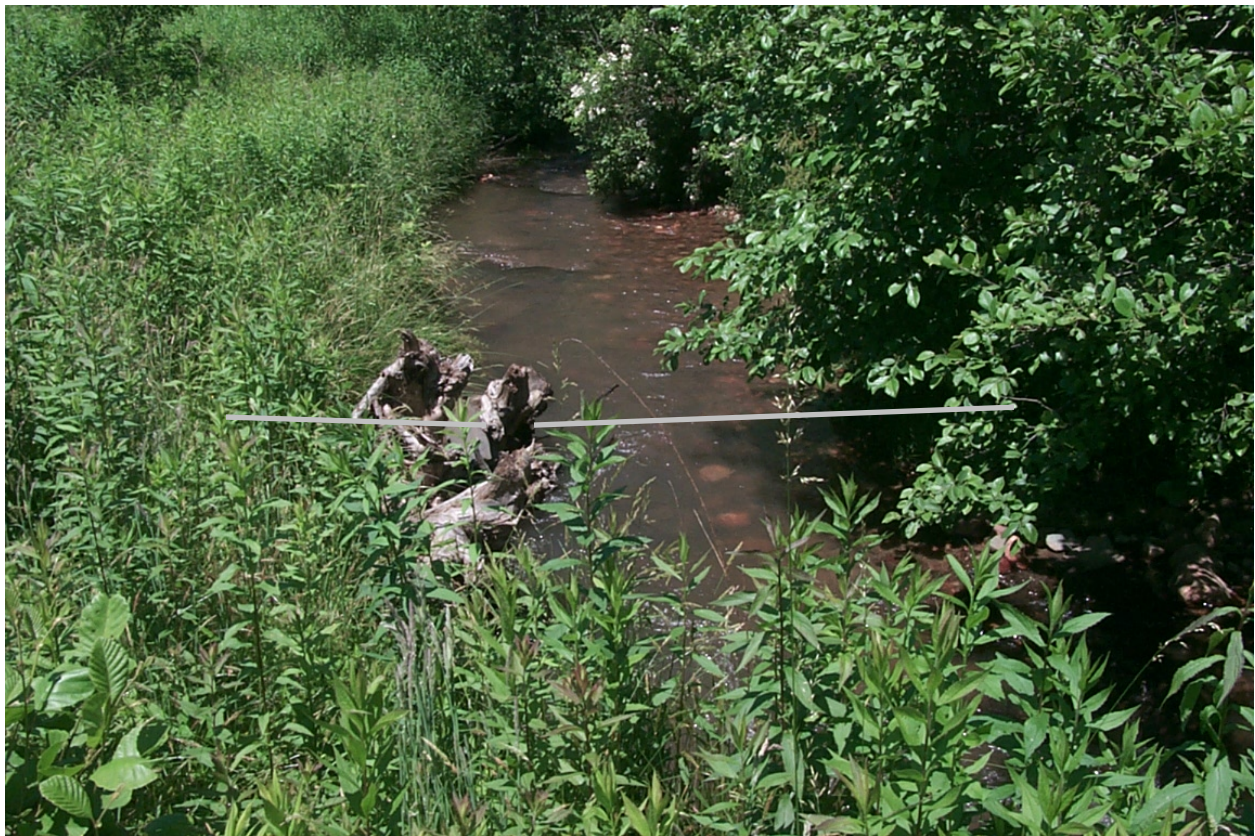
FIGURE 3.3. Cross-section station 8+19, riffle.

CROSS-SECTION 8+19 – riffle (Figure 3.3): This cross section is located over a riffle. The thalweg profile has remained stable exhibiting only minor adjustments due to storm events. The unusual high point for the as-built survey at station 0+18.9 was shot on top of a root wad, instead of behind or to the side of the structure. The build up of the bank from stations 0+30 – 0+50 is due to cattle no longer having access to this crossing area and the result of streambed materials (silt, sand, gravel) being captured by riparian vegetation during flood events. This cross-section has remained stable with no lateral movement (bank erosion) observed along the left and right banks. However, a few holes have developed behind the root wads. These sites will need to be monitored for possible bank erosion problems in the future.

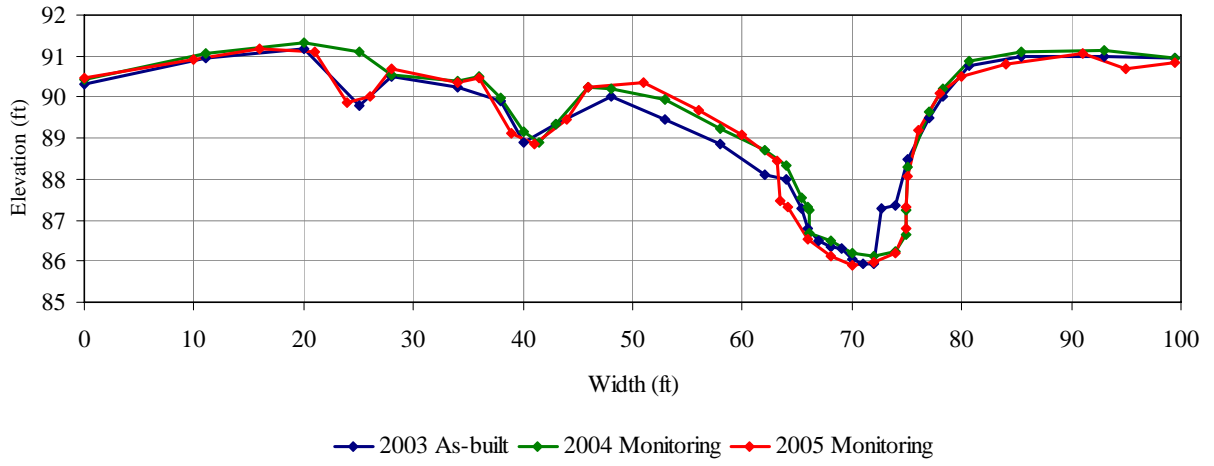
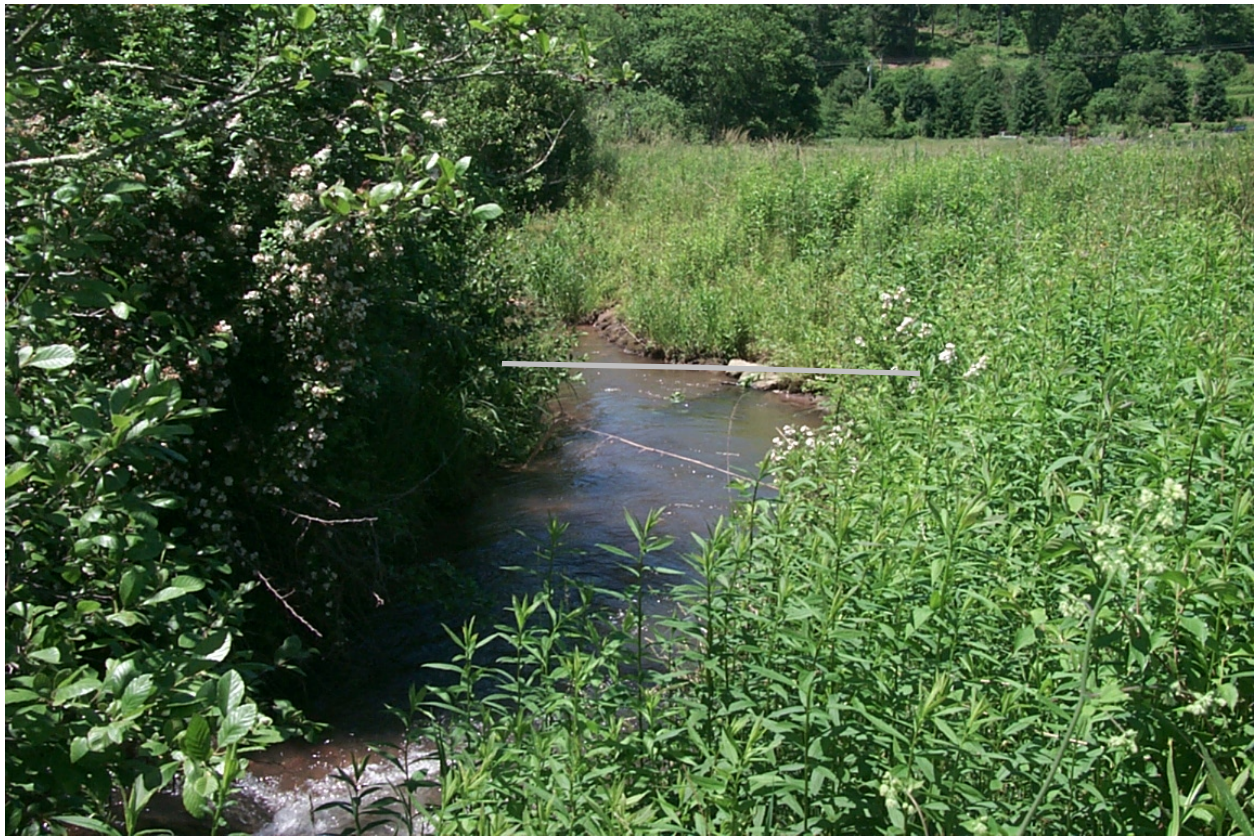
FIGURE 3.4. Cross-section station 9+16, run.

CROSS-SECTION 9+16 – run (Figure 3.4): This cross-section is located over a run below a cross vane with root wads along the right bank. However, it could also be considered a fast pool. The 2004 and 2005 monitoring surveys indicate no major changes in the thalweg of the cross-section when compared with the as-built survey. However, as bank vegetation continues to increase in density, bank height has increased as streambed materials (silt, sand, gravel) are captured by riparian vegetation during flood events. This cross-section has remained stable with no lateral movement (bank erosion) observed along the left and right banks.

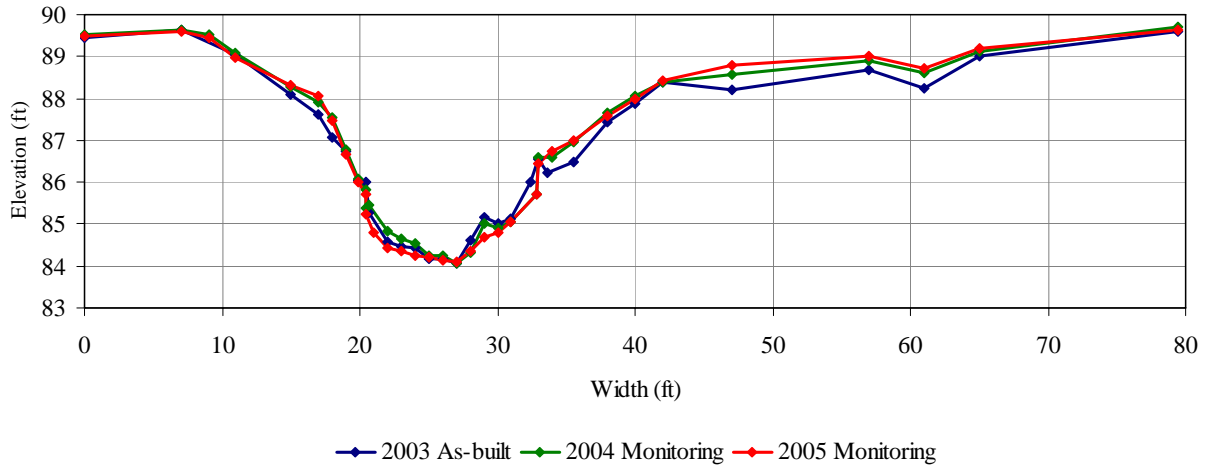
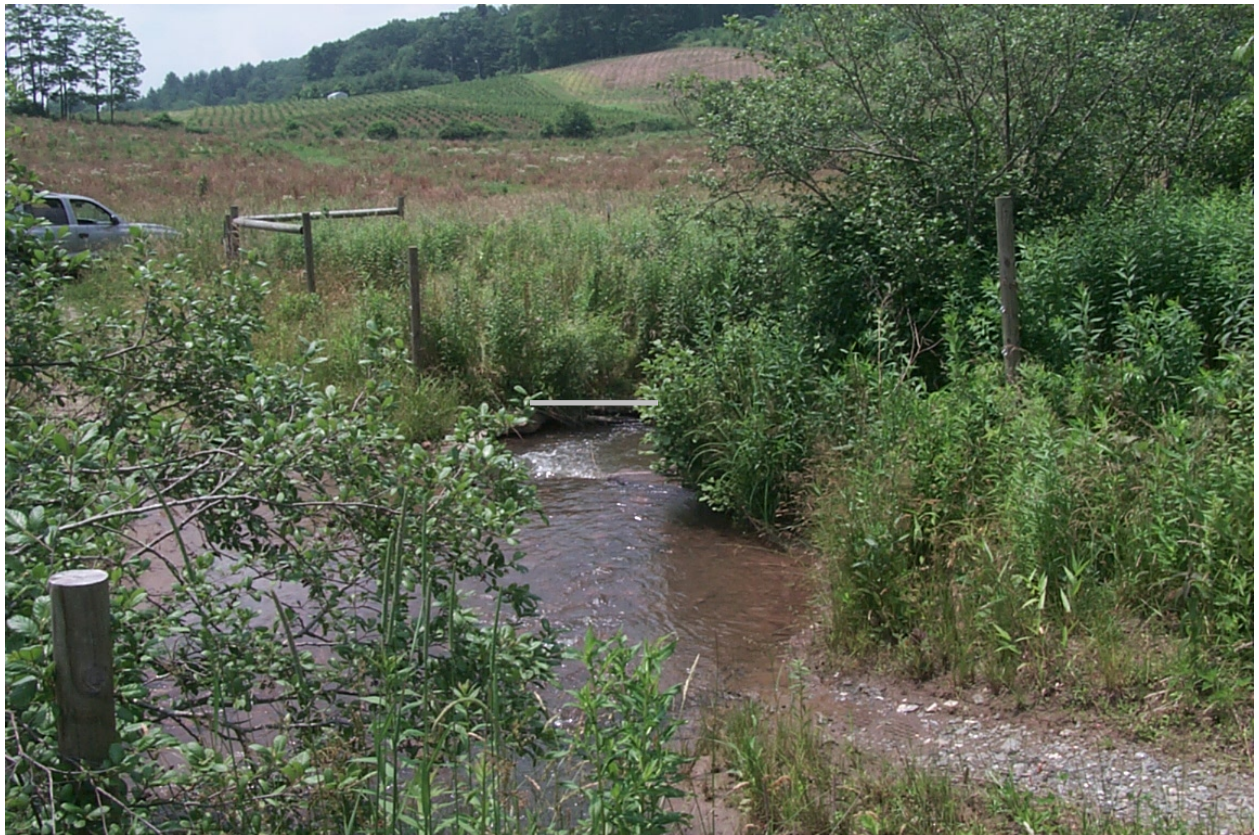
FIGURE 3.5. Cross-section station 10+88, pool.

CROSS-SECTION 10+88 – pool (Figure 3.5): This cross-section is located over a stable pool immediately downstream of the upper ford and below a cross vane with root wads along the left bank. There has been very little change in this cross-section.

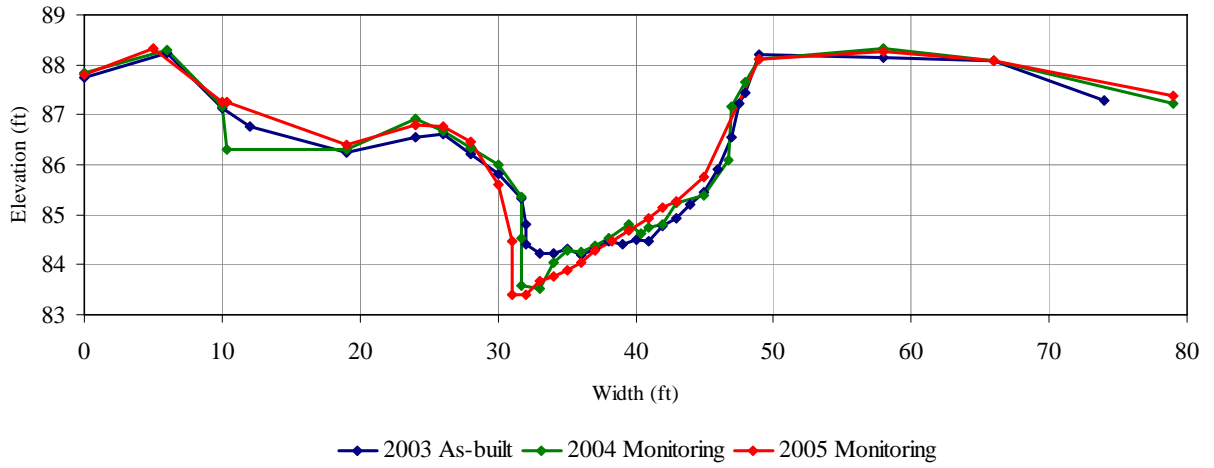
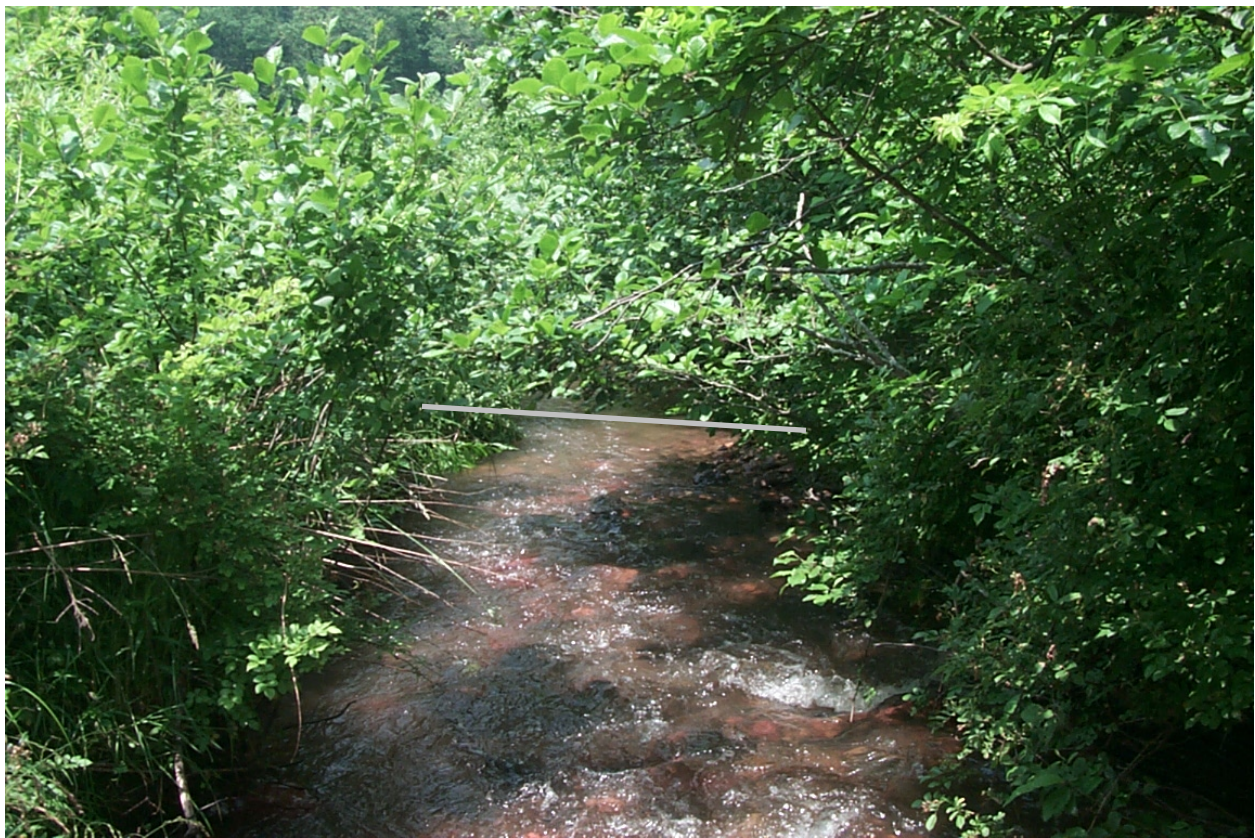
FIGURE 3.6. Cross-section station 12+31, riffle.

CROSS-SECTION 12+32 – riffle (Figure 3.6): This cross-section is located over a riffle. The only change at this site is 1 foot deepening of the thalweg along the left bank. Both banks are stable and well vegetated.

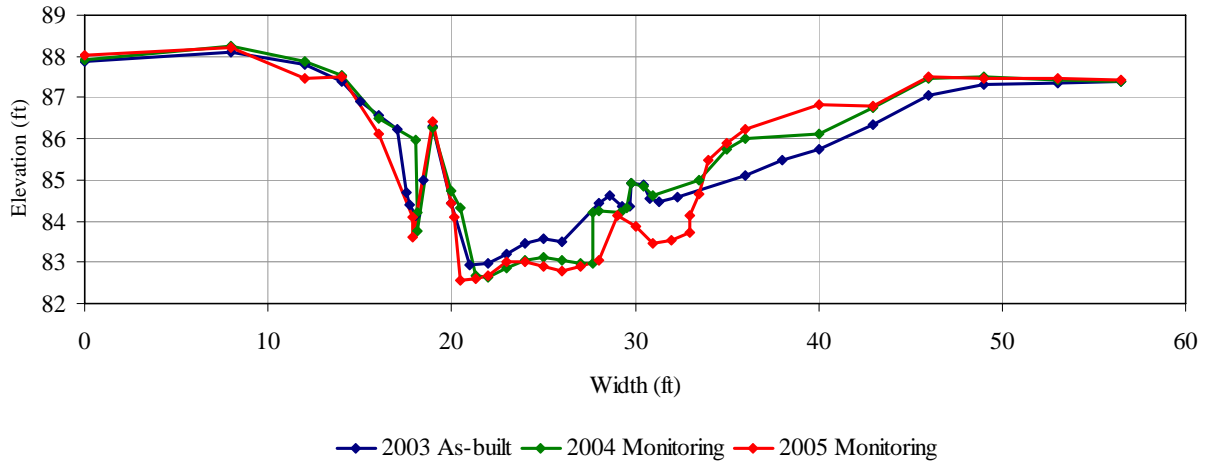
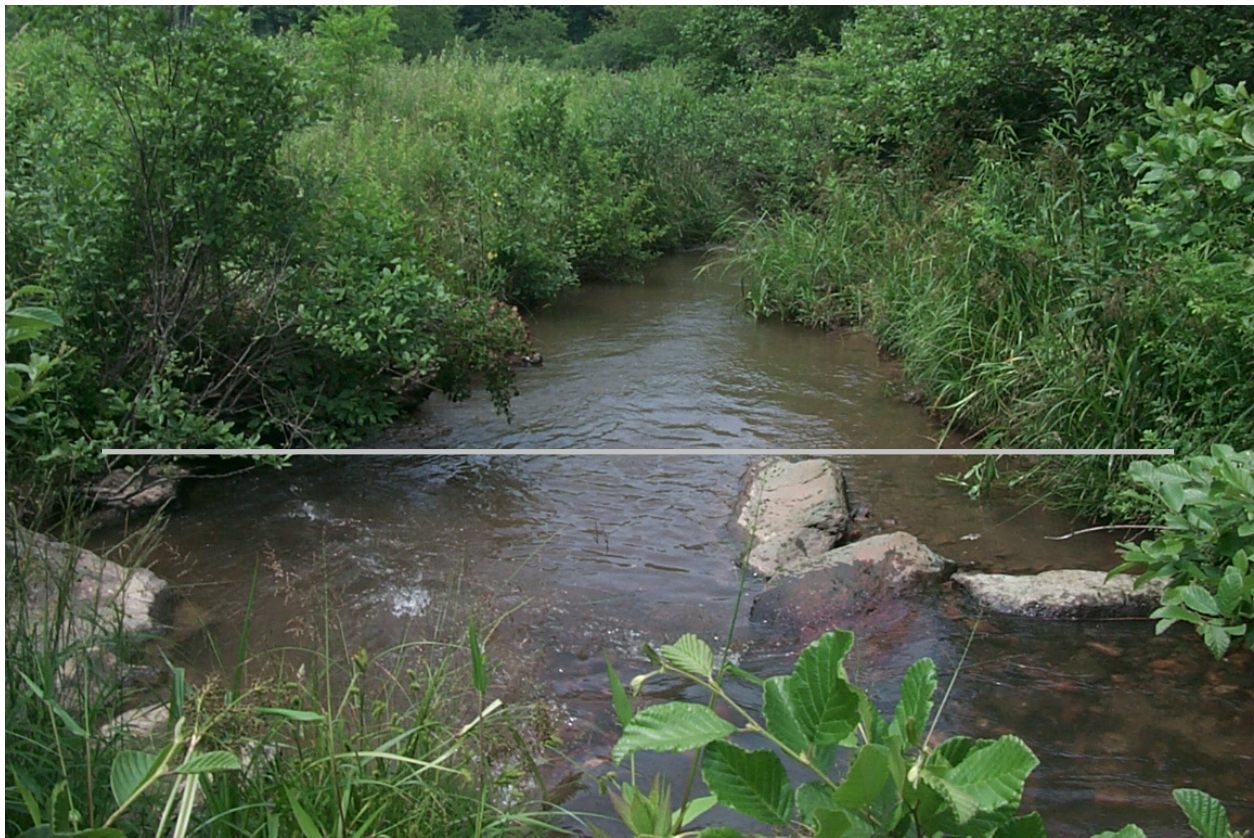
FIGURE 3.7. Cross-section station 12+74, pool.

CROSS-SECTION 12+74 – pool (Figure 3.7): This cross-section is located over a pool below a cross vane with root wads along the left bank. The thalweg has deepened next to the root wads. Station 0+17.9 identifies a hole behind the root wads whereas the high point at station 0+19 is on top of the root wads. The three September 2004 hurricanes moved a large boulder at stations 0+29 – 0+33. As a result channel depth increased between the boulder and the right bank with the bank remaining stable. The right bank continues to increase in height as a

direct result of streambed materials (silt, sand, small gravel) being captured by riparian vegetation during flood events. This cross-section is considered stable with no lateral movement (bank erosion) observed along the left and right banks.

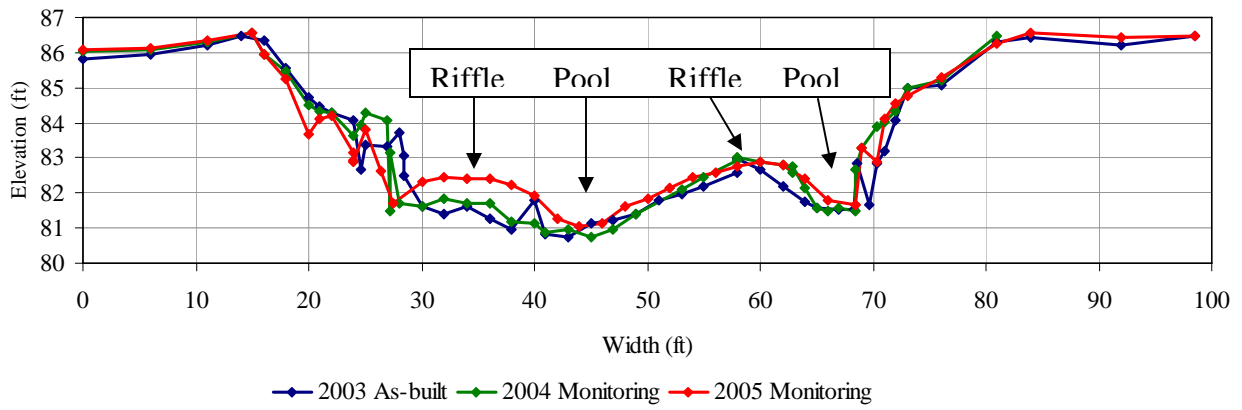
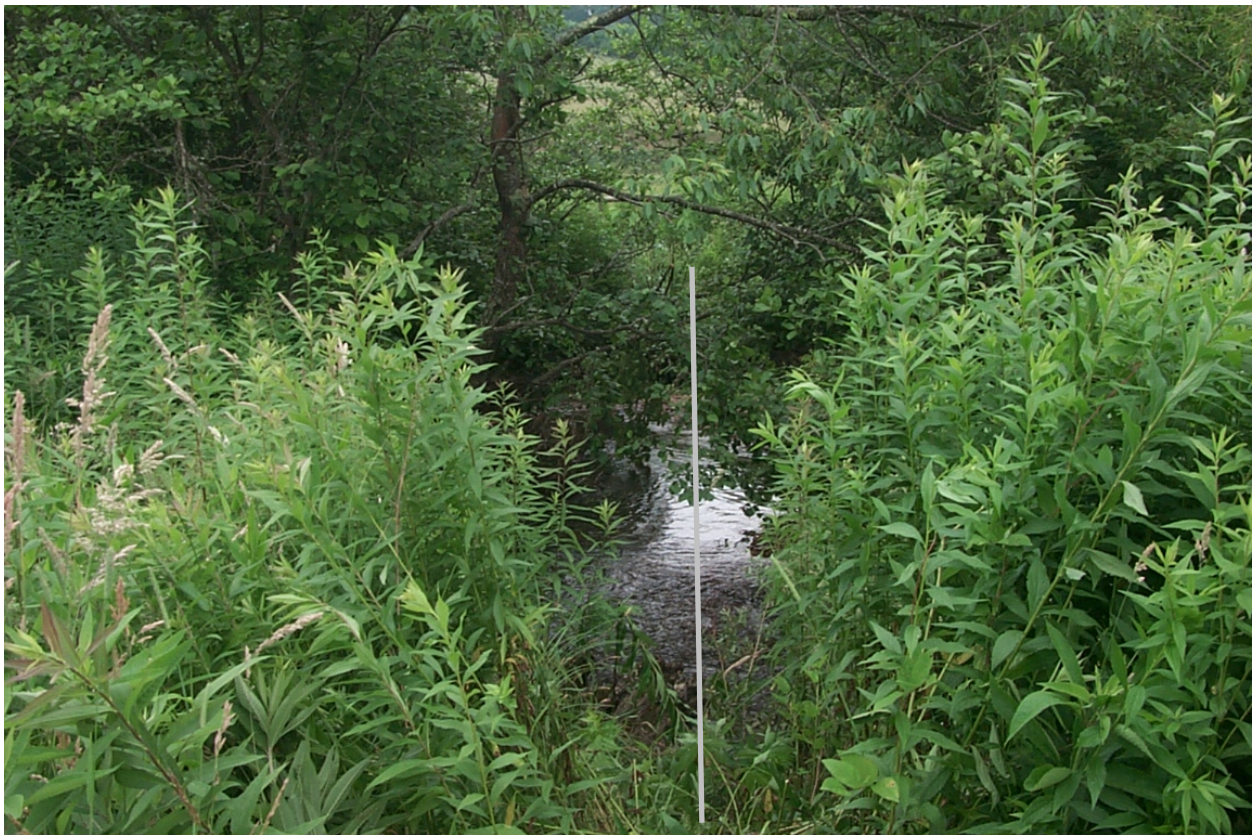
CROSS-SECTION 13+80 – 14+29 pool/riffle complex (Figure 3.8): This cross-section goes through an S curve meander pattern, making it part cross-section, part longitudinal profile. This allowed for the monitoring of two distinct pools that were created with root wads and bank re-shaping. The only noticeable change from 2003 to 2005 is the creation of a run feature from stations 0+30 – 0+40. This site is very stable and well vegetated. During the 2002 construction, transplants of tag alder *Alnus serrulata* and ninebark *Physocarpus opulifolius* were used on top of and behind the root wads on the right bank. These transplants have experienced rapid growth, providing bank stability and stream shading.

FIGURE 3.8. Cross-section station 13+80-14+29. This cross-section incorporates two different restoration sites into one. The cross-section was taken at an S-curve; it encompasses a riffle, pool, riffle and another small pool.

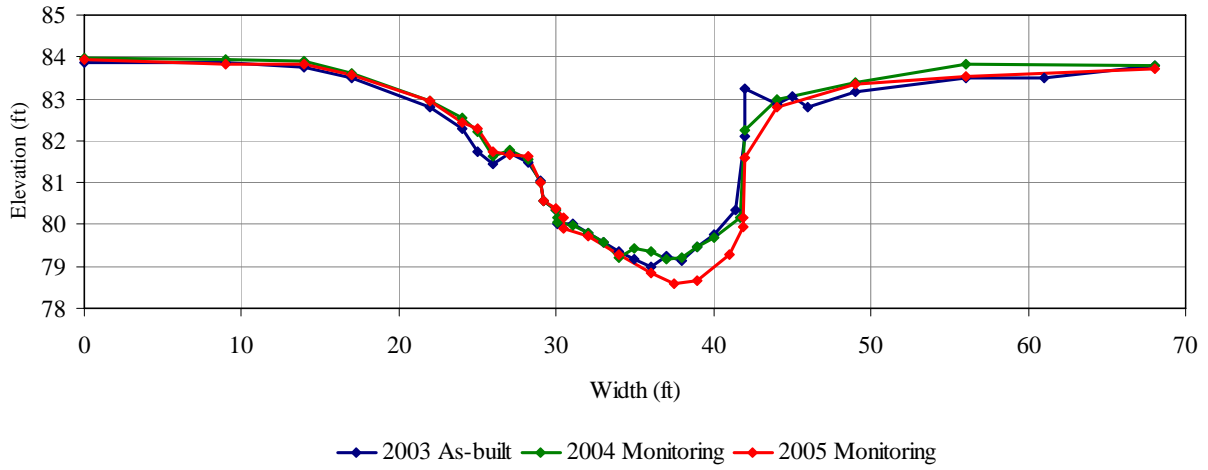
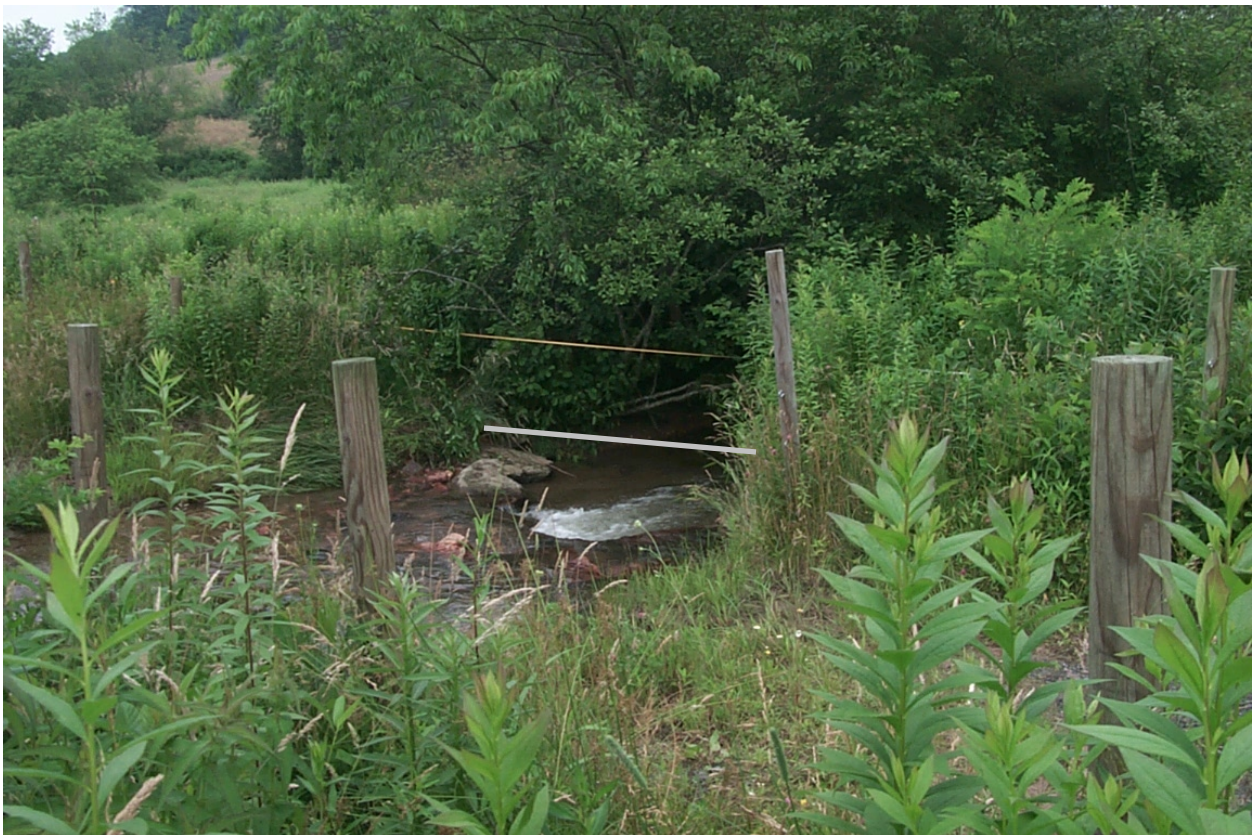
FIGURE 3.9. Cross-section station 16+52, pool.

CROSS-SECTION 16+52 – pool (Figure 3.9): This cross-section is located just below the lower ford and immediately below a cross vane. The cross-section has remained stable and the thalweg has deepened approximately 0.8 ft along the right bank. There have been some minor adjustments to the bankfull and floodplain areas that have captured streambed materials (silt, sand, small gravel) during flood events.

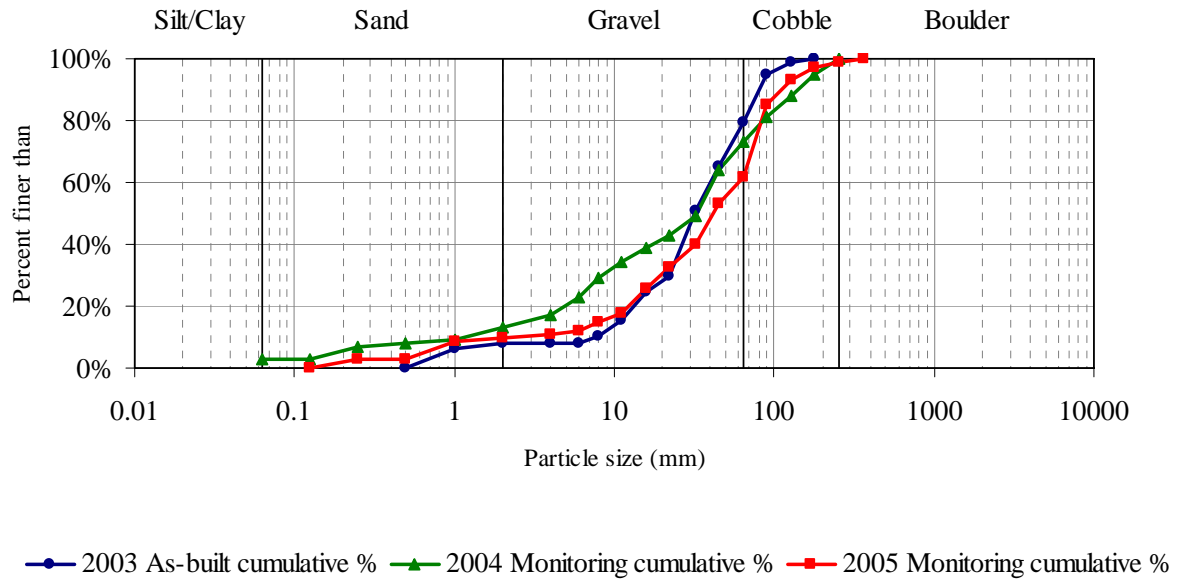
FIGURE 4. Pebble count comparisons, Wild site, Obids Creek, Ashe County, 2003-2005.

Bed material analysis was conducted in a riffle at cross-section 18+42 (Figure 4). Substrate analysis indicates a slight increase in all particle sizes, except for the D<sub>95</sub> category, from 2003 to 2005. Since 2003 the D<sub>50</sub> has coarsened from medium, to coarse, to very coarse gravel. The increase in particle size, especially the D<sub>50</sub> and D<sub>84</sub>, is probably a result of the elimination of cattle having access to streambanks and a shifting of the substrate following the three September 2004 hurricanes. Based on visual observations following these hurricane events, the stream substrate appeared cleaner with less silt and sand.
