**WILD MITIGATION SITE, OBIDS CREEK,
ASHE COUNTY**

Year 3 Monitoring Report

Period covered: June 30, 2005 - June 27, 2006

North Carolina Ecosystem Enhancement Program

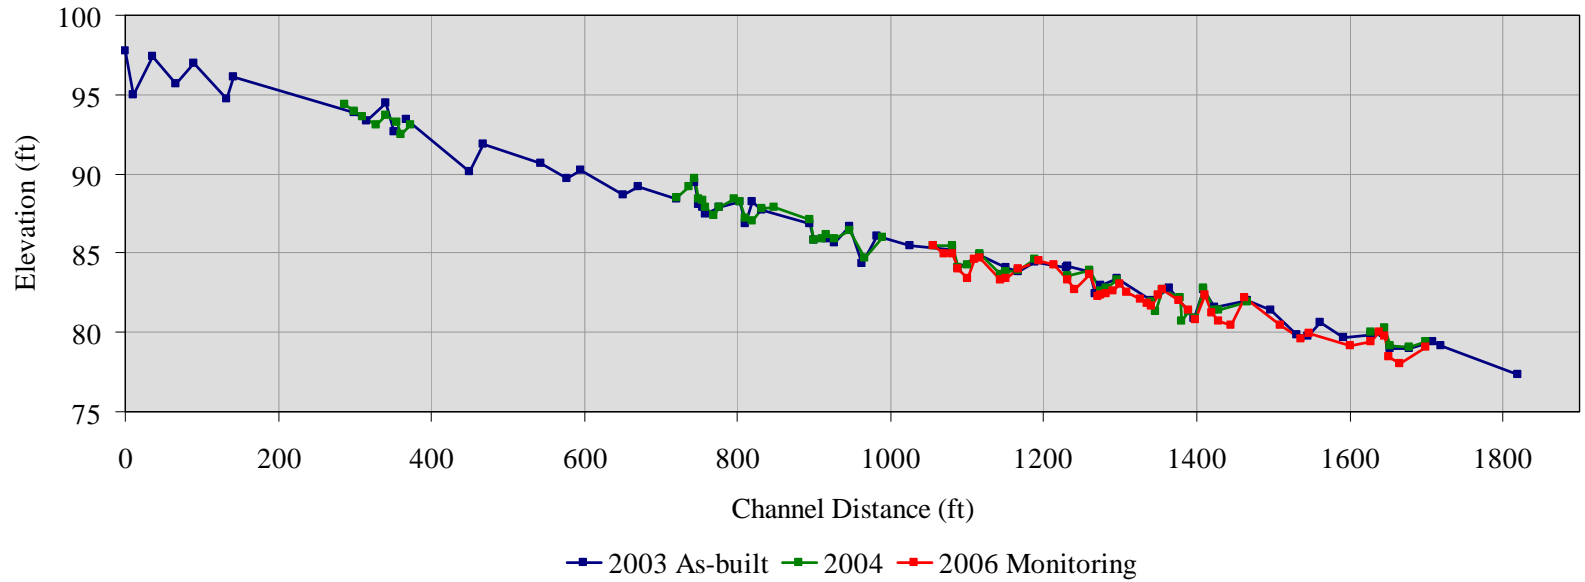
FIGURE 2.—Longitudinal profile comparisons, Wild site, Obids Creek, Ashe County, 2003-2006.

Visual observations prior to the longitudinal survey indicated that the channel thalweg had changed little from previous surveys, therefore a decision was made to collect longitudinal profile data only from stations 10+56 to 17+00 (Figure 2). Had the initial 2006 data revealed a significant change in the channel profile, then the entire project reach would have been surveyed. No appreciable change in the longitudinal profile occurred between 2003 and 2006. A longitudinal profile survey was not conducted in 2005. The longitudinal profile indicates the thalweg has remained stable with minimal degradation occurring where pools are present. These

minor changes in the longitudinal profile are expected natural occurrences and not the result of disturbances associated with the stream enhancement activities.

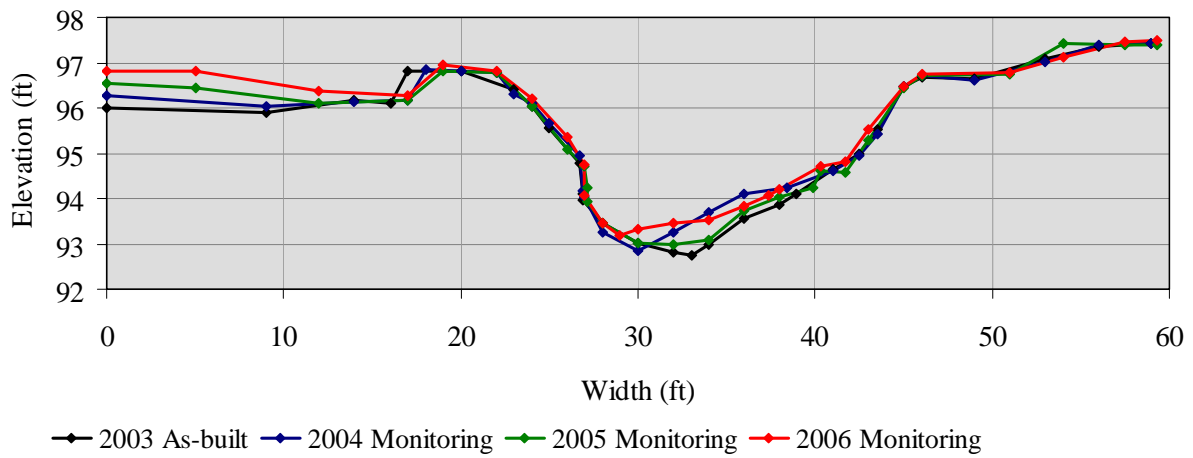
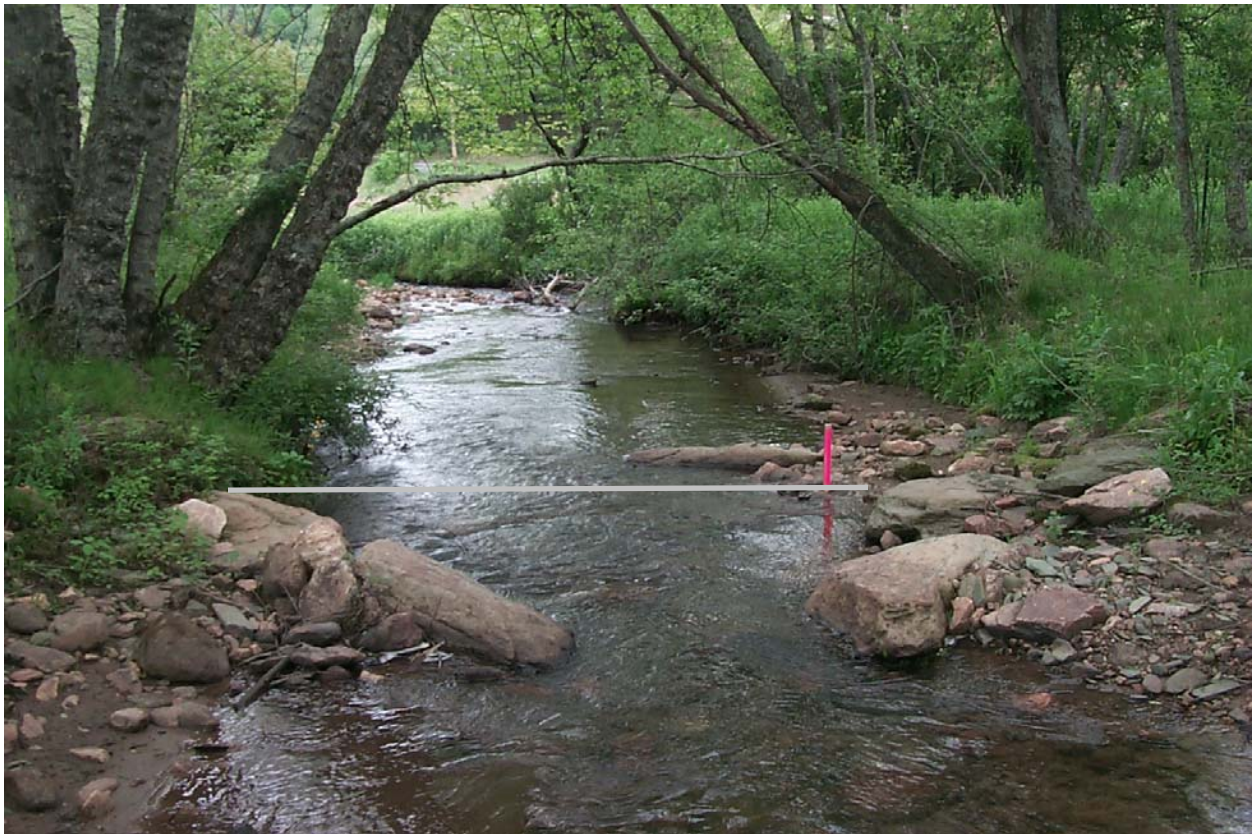
FIGURE 3.1.—Cross-section station 3+55, riffle.

CROSS-SECTION 3+55 – riffle (Figure 3.1): This cross-section is located over a deep riffle just below a crossvane. There has been little change in the cross-section from 2003 thru 2006. The thalweg aggraded slightly. This cross-section has remained stable with no lateral movement (bank erosion) observed along either streambank. The left bank has increased in height due to the riparian vegetation capturing streambed materials (silt, sand, and gravel) during flood events. Minor repairs were made to the crossvane in June of 2006. Two boulders were repositioned in the middle of the crossvane to increase the upstream pool's depth.

During the 2006 monitoring survey, four sites needing minor repairs were identified. A small excavator with a hydraulic thumb was used to make the repairs on June 16, 2006. Two large boulders were repositioned in the middle of the cross-vane at station 3+55. The shifting of the boulders could be attributed to the upstream landowner removing all of the vegetation off the banks of the unnamed tributary to Obids Creek in 2005, which increased the stream's velocity coming into this cross-section and redistributed the aforementioned boulders. At station 8+50 two boulders on the left bank were repositioned to make a mini-rock vane. As stated previously the damage at cross-section 12+74 was caused by flooding associated with 2004 hurricanes. That repair involved repositioning a large boulder on the right bank, backfilling the void with cobble and filling a scour hole behind the root wads. The fourth site was located at station 13+80 and required filling voids behind the root wads.

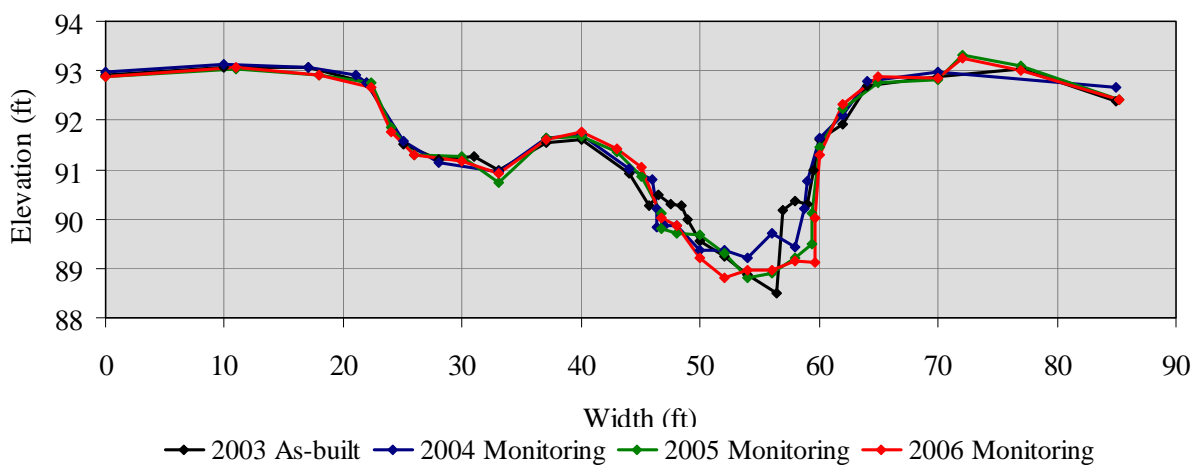
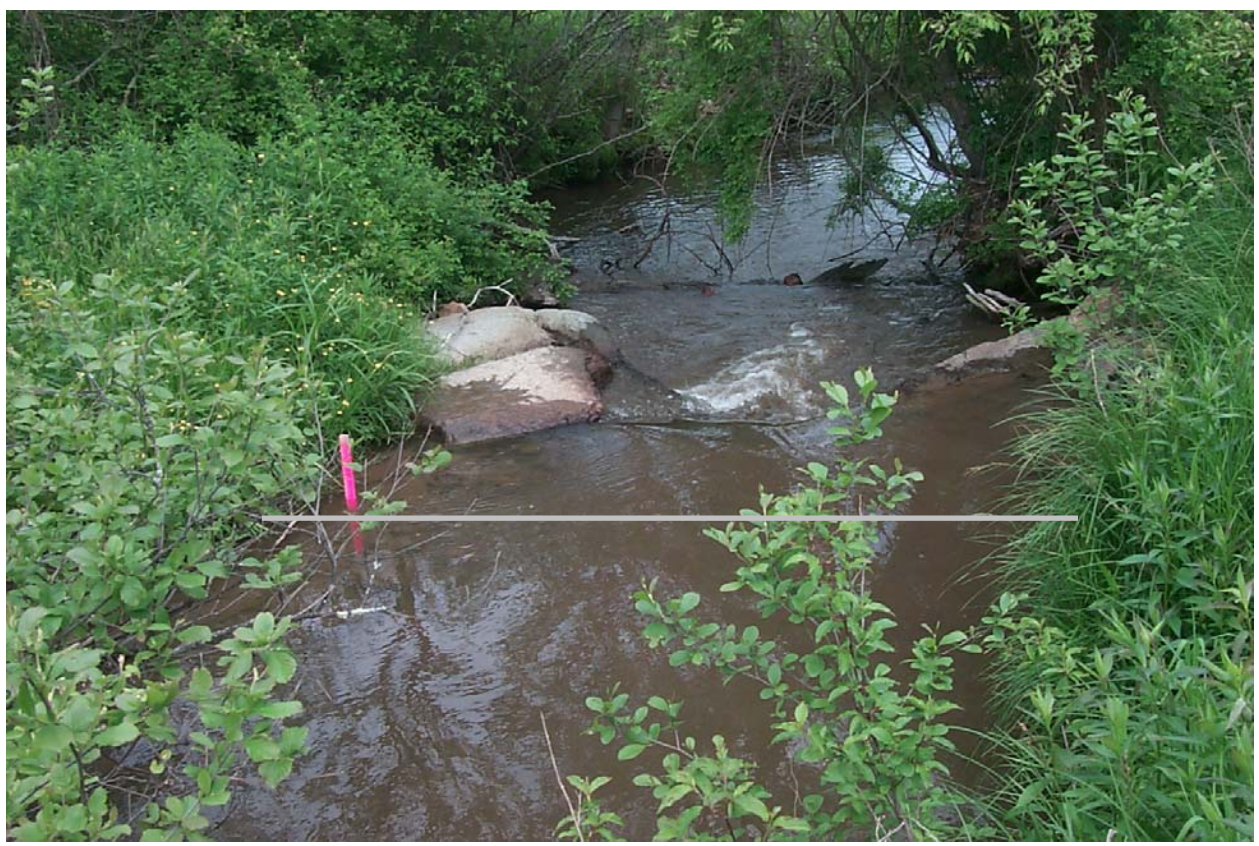
FIGURE 3.2.—Cross-section station 7+36, pool.

CROSS-SECTION 7+36 – pool (Figure 3.2): This cross-section is located over the tail end of a long pool just above a crossvane. There has been some channel migration along the right bank at cross-section position 0+59.4 since completion of the project. However, the bank is stable and well vegetated.

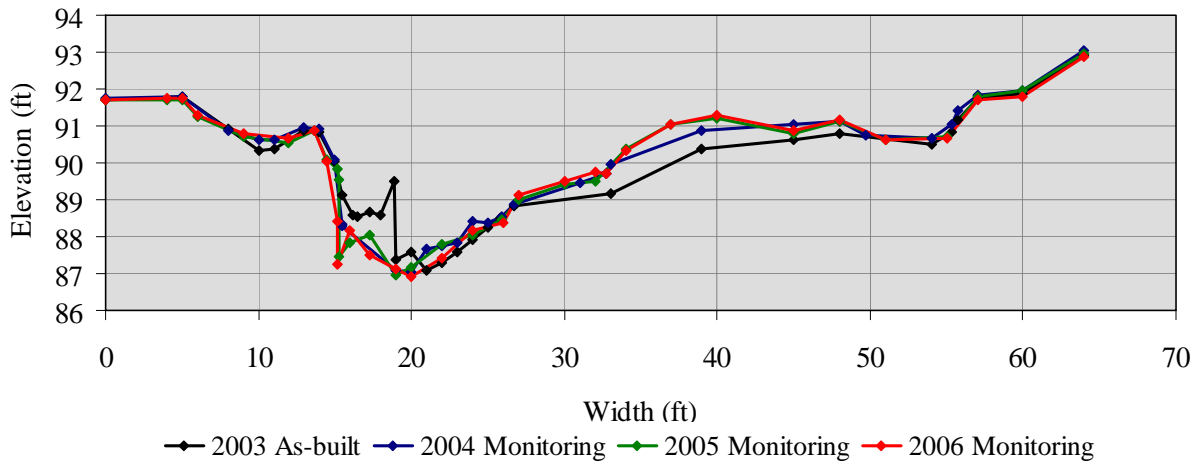
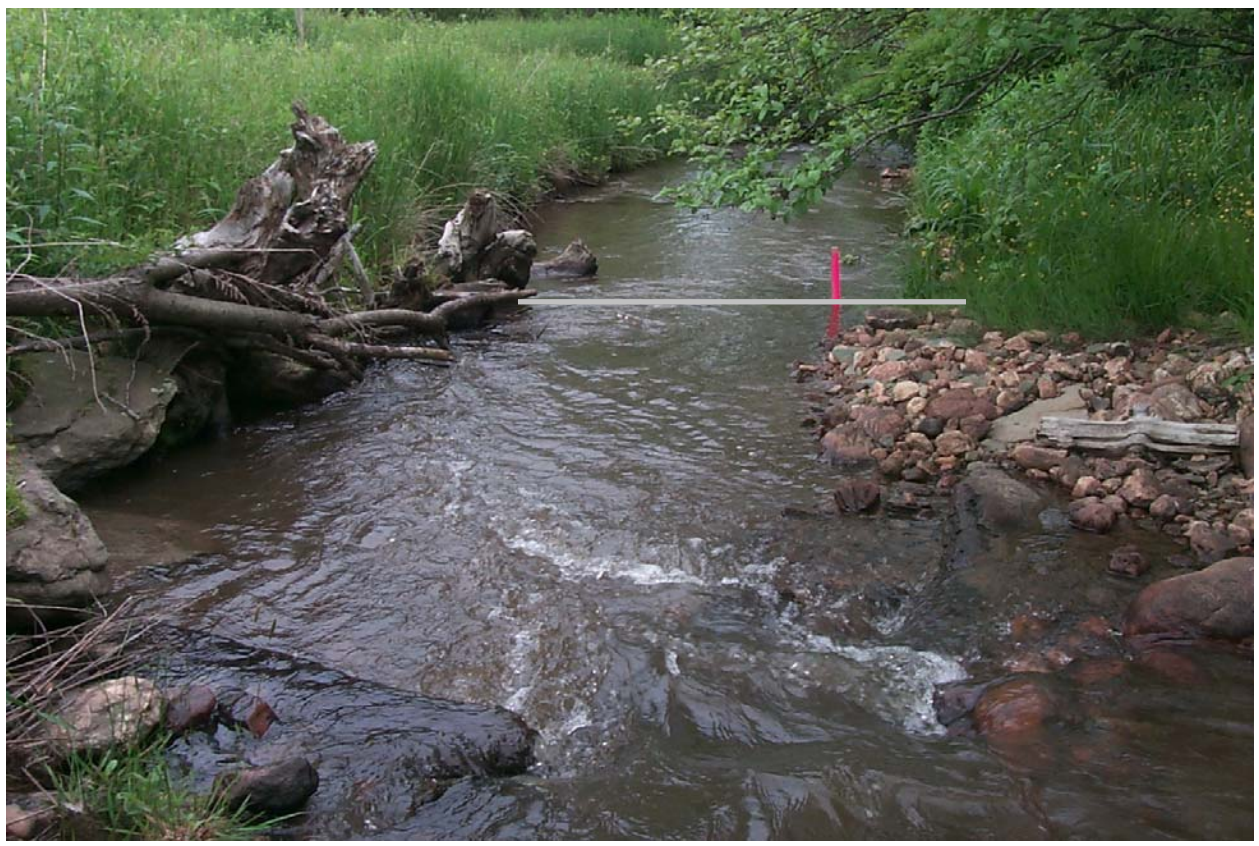
FIGURE 3.3.—Cross-section station 8+19, riffle.

CROSS-SECTION 8+19 – riffle (Figure 3.3): This cross-section traverses a riffle. The thalweg has remained stable, exhibiting only minor adjustments due to storm events. The unusual high point seen in the as-built data represents a measurement taken on top of a root wad. The build up of the bank from cross-section position 0+30 to 0+50 is due to cattle no longer having access to this area and streambed materials (silt, sand, and gravel) being captured by riparian vegetation during flood events. This cross-section has remained stable with no lateral movement (bank erosion) observed along the streambanks. However, a few minor holes have developed behind the root wads. These were repaired on June 16, 2006 by filling the holes with cobble.

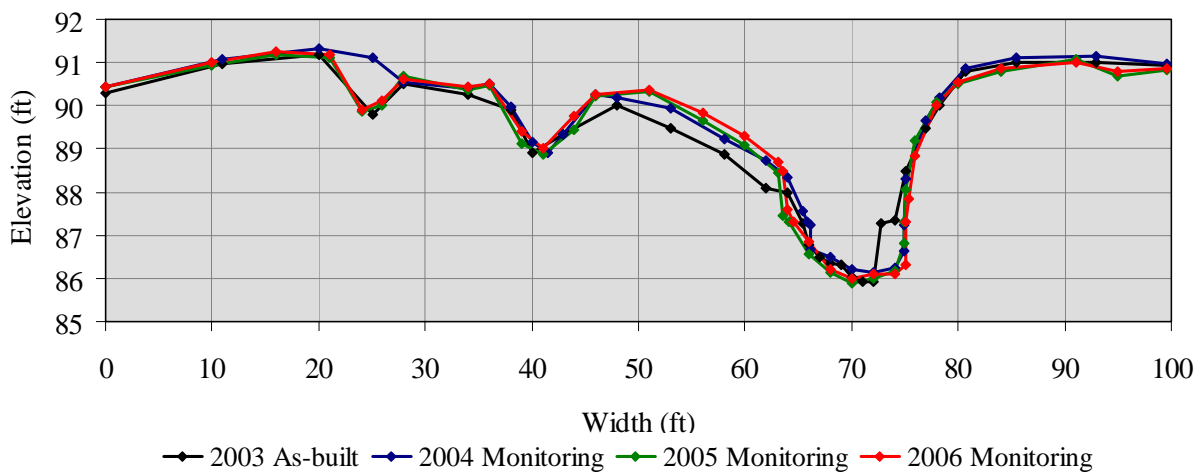
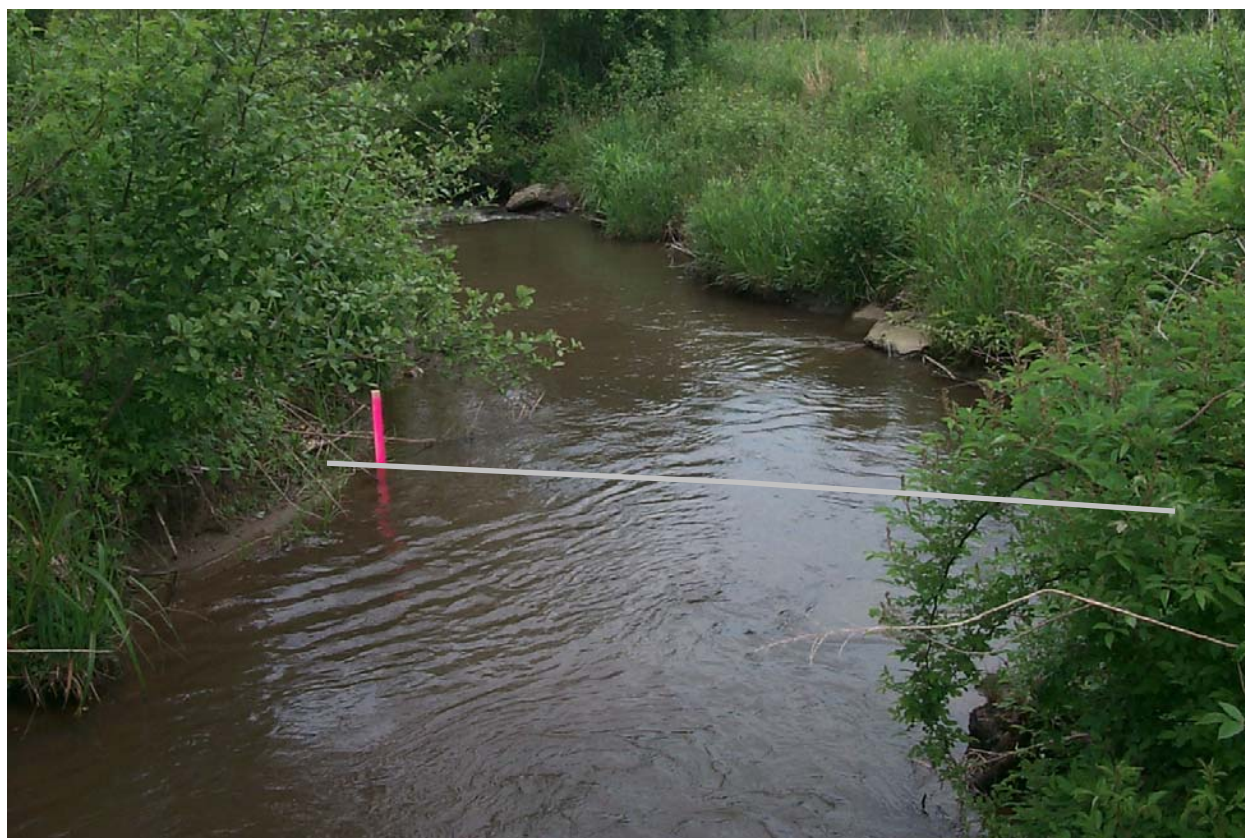
FIGURE 3.4.—Cross-section station 9+16, run.

CROSS-SECTION 9+16 – run (Figure 3.4): This cross-section is located over a run below a crossvane with root wads located along the right bank. However, it could also be considered a fast pool. The 2006 monitoring survey indicates no major changes in the thalweg of the cross-section when compared with the as-built survey. However, as bank vegetation continued to increase in density, bank height has increased as streambed materials (silt, sand, and gravel) were captured by the riparian vegetation during flood events. This cross-section has remained stable with no lateral movement (bank erosion) of the stream channel.

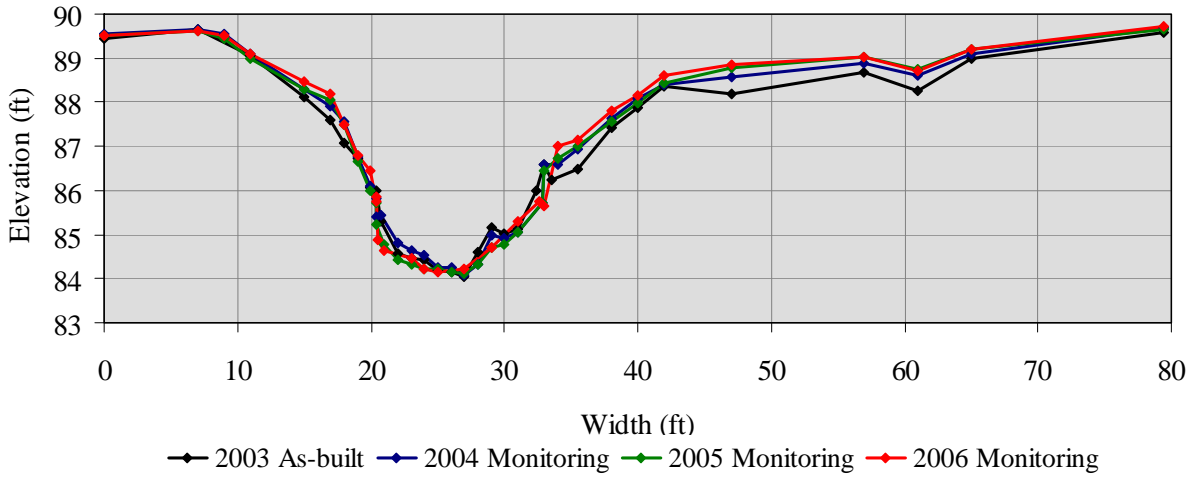
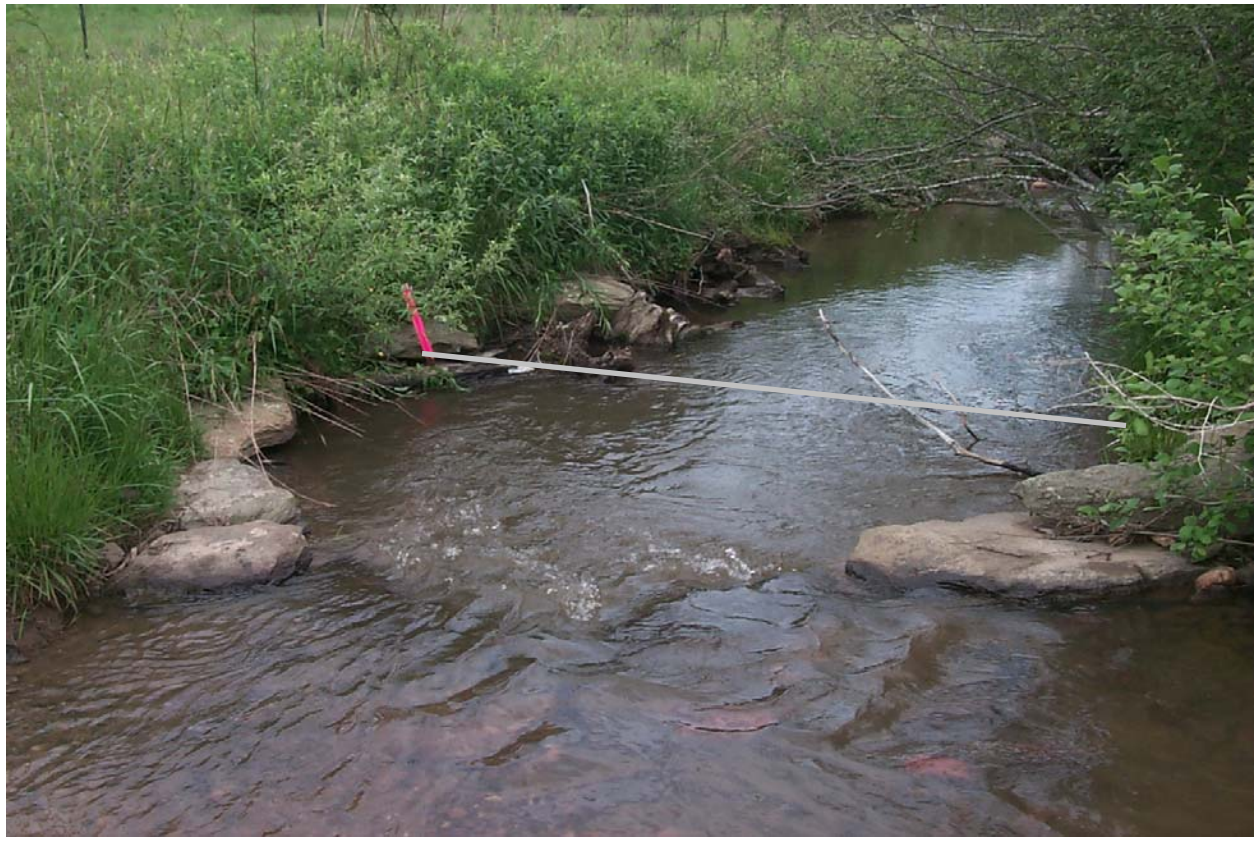
FIGURE 3.5.—Cross-section station 10+88, pool.

CROSS-SECTION 10+88 – pool (Figure 3.5): This cross-section is located over a stable pool immediately downstream of the upper ford and below a crossvane with root wads installed along the left bank. There has been little change in this cross-section since construction.

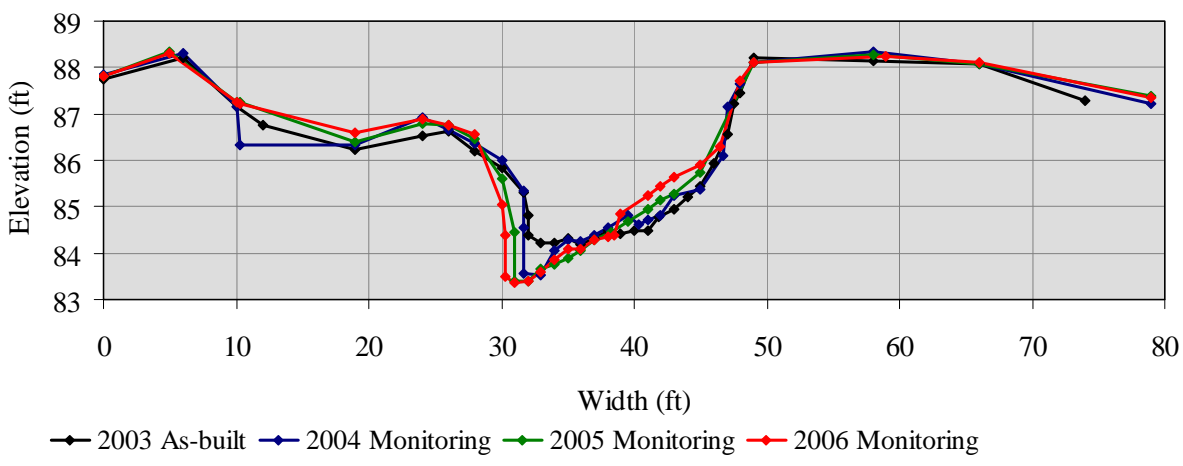
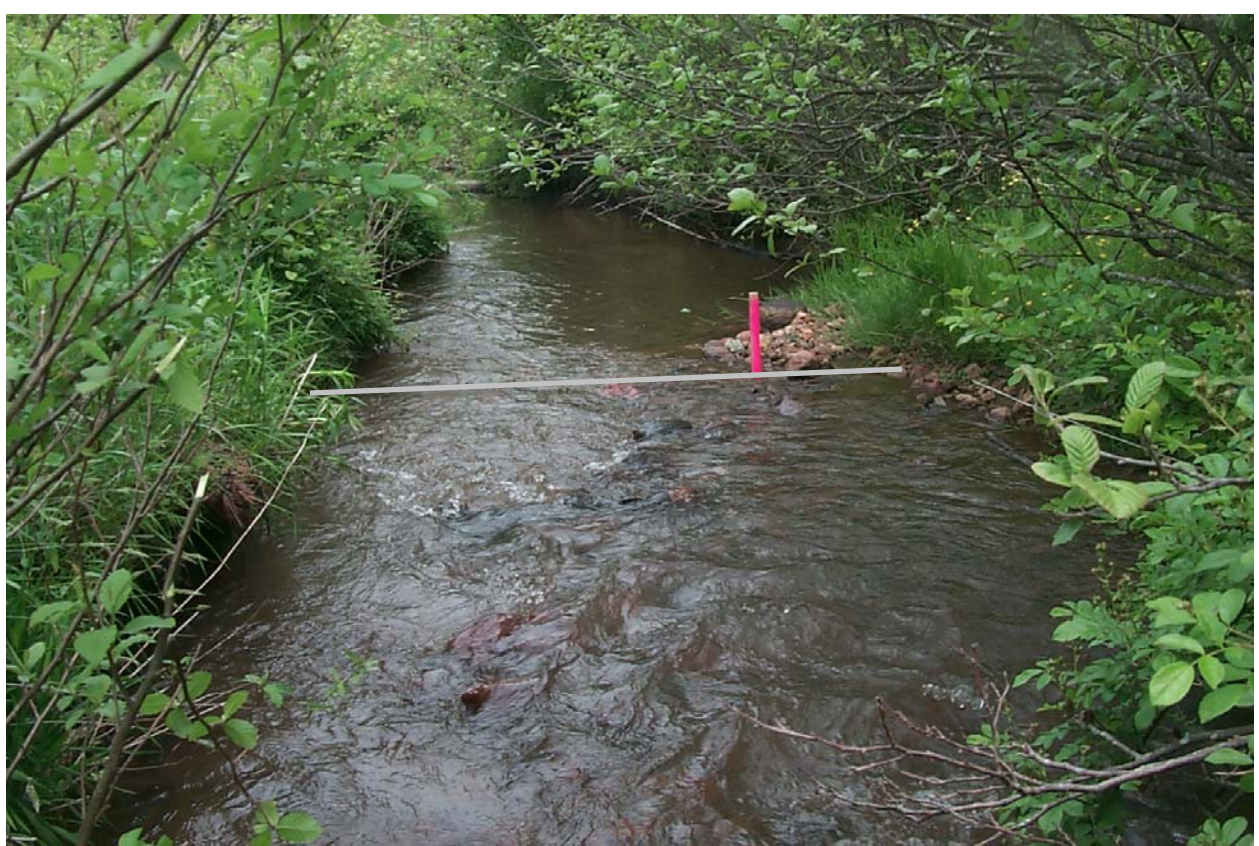
FIGURE 3.6.—Cross-section station 12+31, riffle.

CROSS-SECTION 12+31 – riffle (Figure 3.6): This cross-section is located over a riffle. The only change at this site has been a 1 foot deepening of the thalweg along the left bank. Both banks are stable and well vegetated.

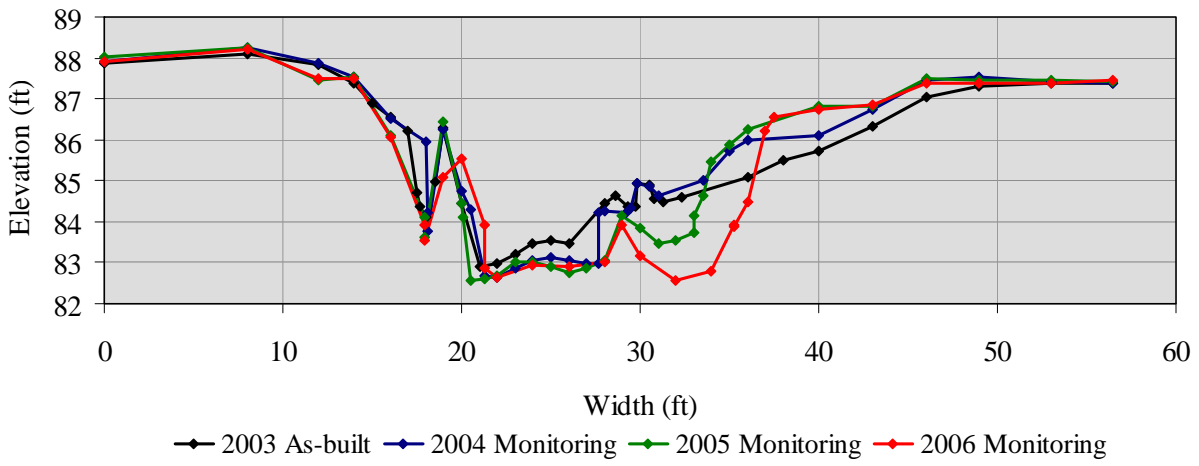
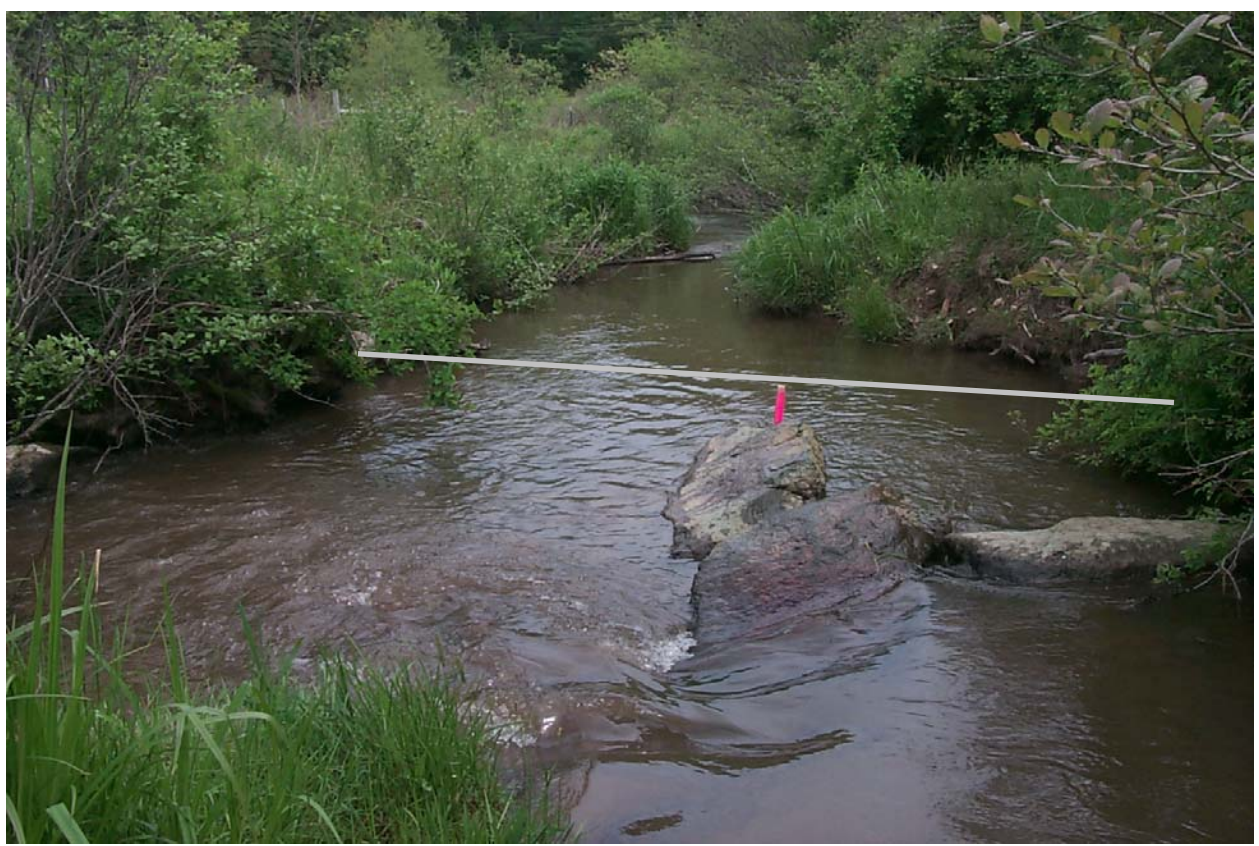
FIGURE 3.7.—Cross-section station 12+74, pool.

CROSS-SECTION 12+74– pool (Figure 3.7): This cross-section is located through a pool below a crossvane with root wads installed along the left bank. The thalweg has deepened next to the root wads. Cross-section position 0+17.9 identifies a hole behind the root wads, whereas the high point at position 0+19.0 is on top of the root wads. A series of three hurricanes in September 2004 moved a large boulder at this location causing the right bank to be cut away and resulting in an increase in channel depth between the boulder and the right bank. The large boulder was subsequently repositioned along the right bank and cobble placed in front of the boulder to alleviate pressure on the bank. Future monitoring should capture the effectiveness of the repairs.

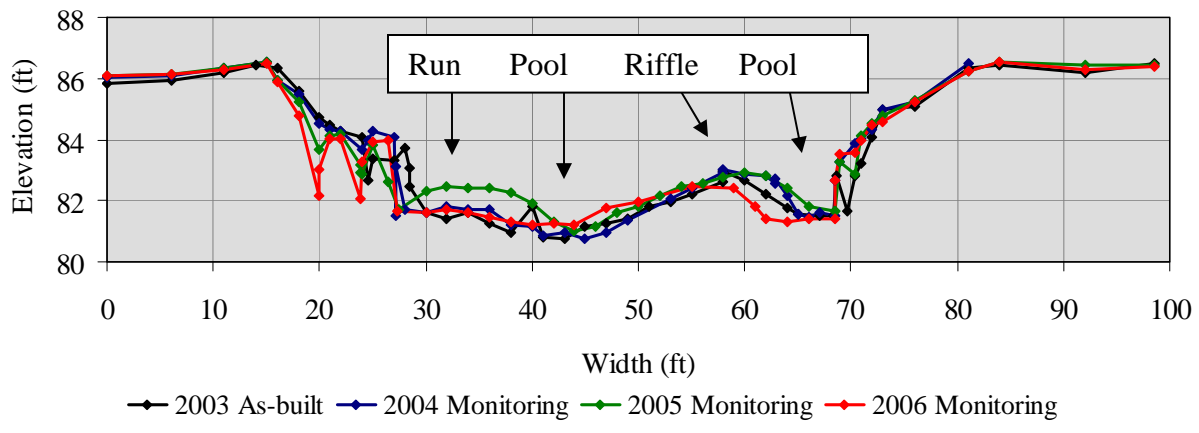
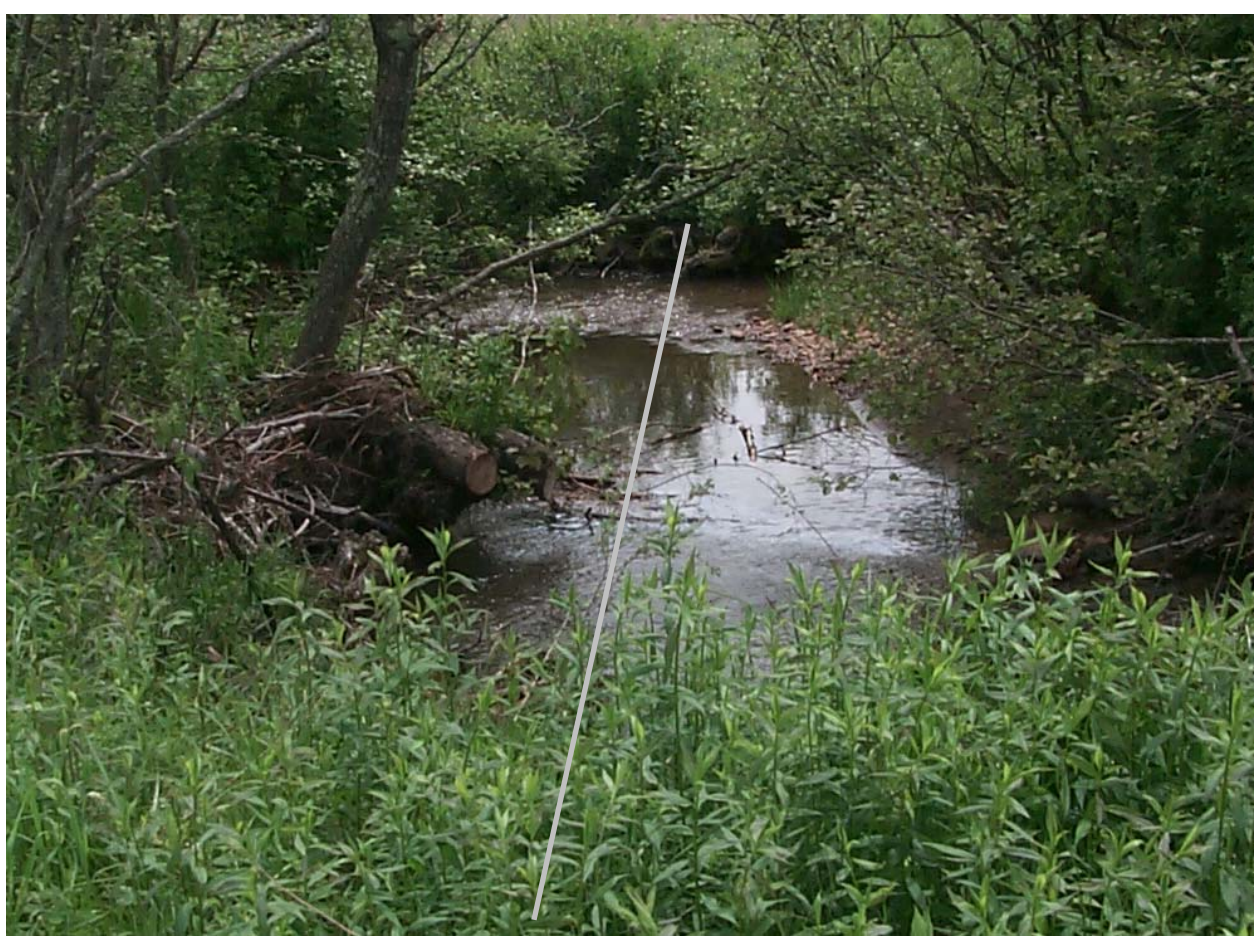
CROSS-SECTION 13+80 – 14+29 pool/riffle complex (Figure 3.8): This cross-section goes through an S-curve meander pattern, making it part cross-section, part longitudinal profile. This allowed for the monitoring of two distinct pools that were created with root wads and bank re-shaping. The only noticeable change from 2003 to 2006 is the creation of a run feature from cross-section position 0+30 to 0+40. This site is stable and well vegetated. During the 2002 construction, transplants of tag alder *Alnus serrulata* and ninebark *Physocarpus opulifolius* were used on top of and behind the root wads on the right bank. These transplants have experienced rapid growth, providing bank stability and stream shading. A hole that developed behind the root wads was repaired on June 16, 2006.

FIGURE 3.8.—Cross-section station 13+80-14+29. This cross-section incorporates two different restoration sites into one. The cross-section was taken at an S-curve that encompasses a run, pool, riffle, and a second small pool sequence.

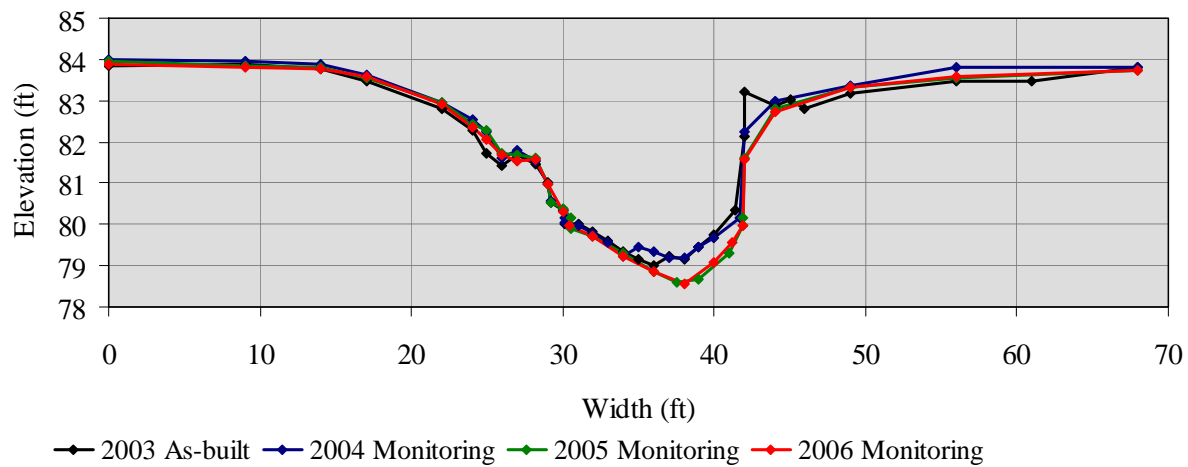
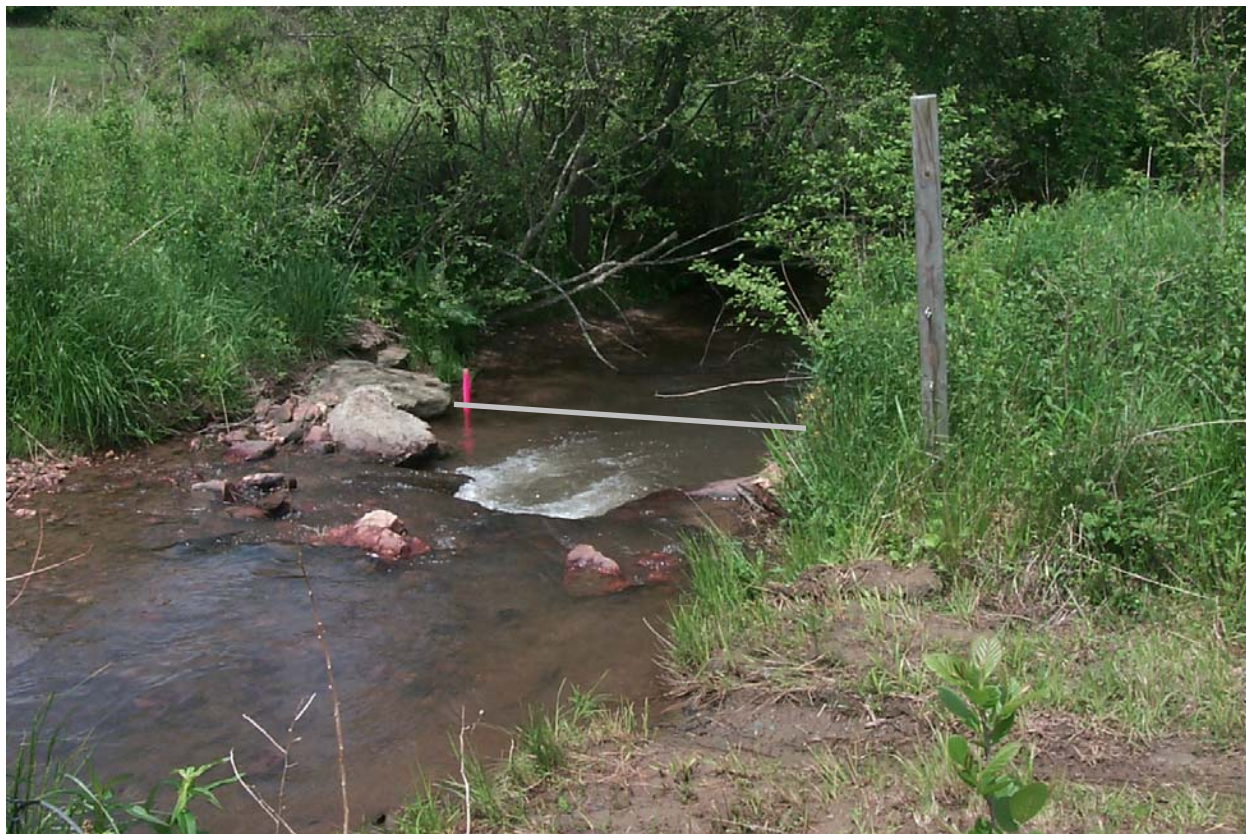
FIGURE 3.9.—Cross-section station 16+52, pool.

CROSS-SECTION 16+52 – pool (Figure 3.9): This cross-section is located below the lower ford and immediately below a crossvane. The cross-section has remained stable and the thalweg has deepened approximately 0.8 ft along the right bank. There have been some minor adjustments to the bankfull and floodplain areas due to the capture of streambed materials (silt, sand, small gravel) during flood events.

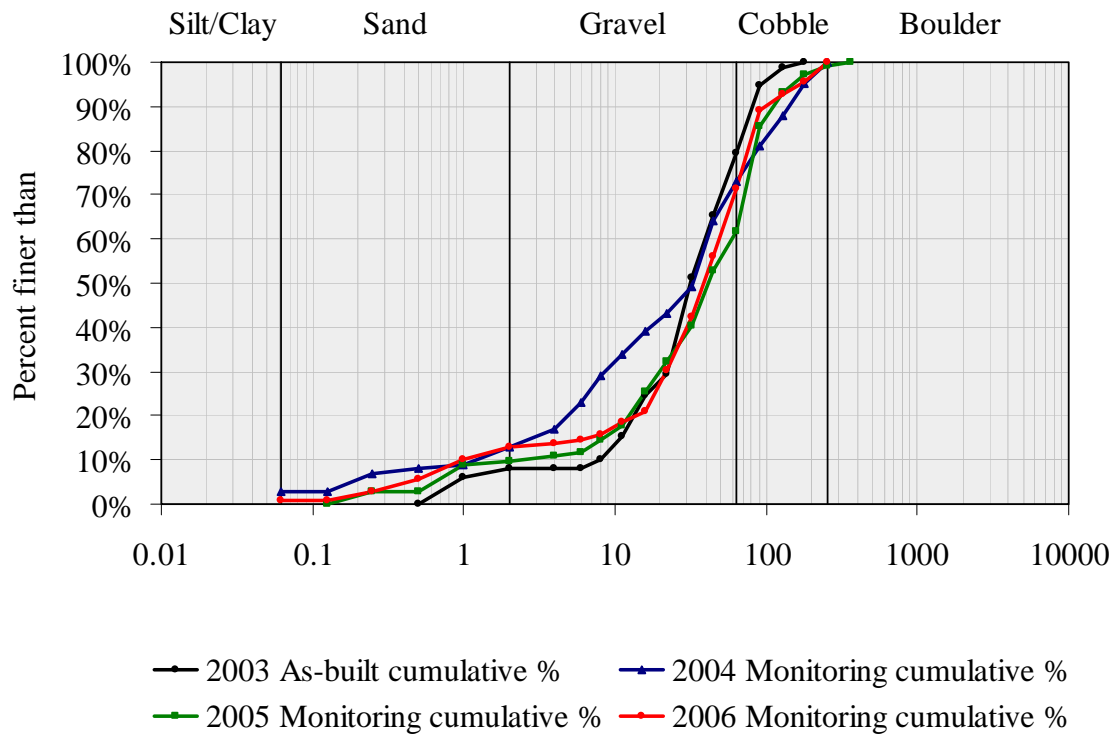
FIGURE 4.—Pebble count comparisons, Wild site, Obids Creek, Ashe County, 2003-2006.

Bed material was collected from a riffle at cross-section 8+19. Substrate analyses indicate most particle size classes have shown slight increases when compared to the as-built data. The exception to this is the D_{16} where a slight decrease has occurred. Since 2003 the D_{50} fraction has changed from a coarse to a very coarse gravel classification. The increase in particle size, especially the D_{50} and D_{84} , is probably a result of the elimination of cattle having access to streambanks and a scouring of the finer bed material following the three September 2004 floods. Visual observations conducted following these events confirmed the data in Figure 4 that the stream substrate contained less silt and sand.
