**WILD MITIGATION SITE, OBIDS CREEK,  
ASHE COUNTY**

Year 5 Monitoring and Closeout Report

Period covered: June 27, 2006 – December 31, 2007

North Carolina Ecosystem Enhancement Program

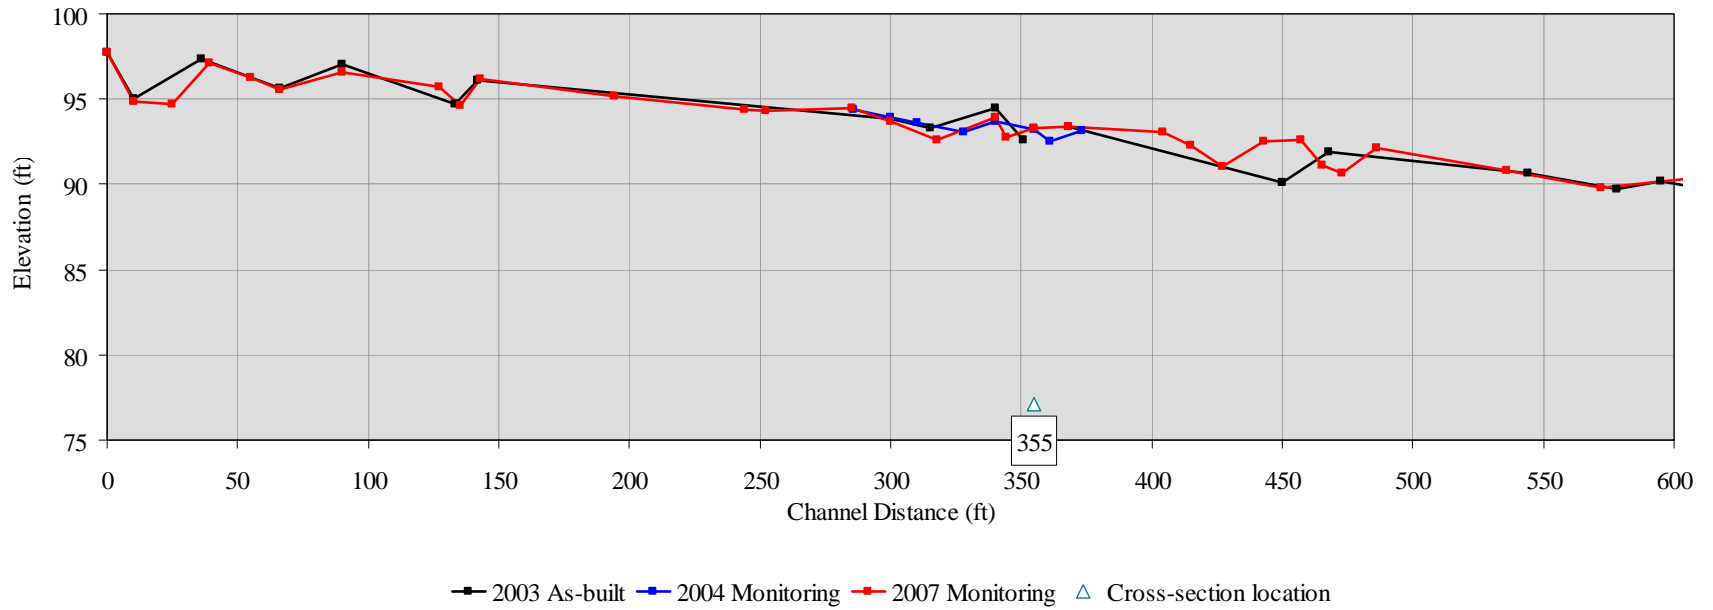
FIGURE 2.1.—Longitudinal profile between station 0+00 and station 6+00.

The 2007 longitudinal profile survey included the entire project reach and is compared to the as-built survey and the partial surveys of 2004 and 2006 (Figure 2). The 2007 survey revealed that the channel thalweg had changed little from previous surveys, the most notable exception to this occurs within the first 490 ft of stream. However, some of these changes are due to the greater number of survey points obtained in 2007 as compared with the as-built survey and not

actual changes in the channel thalweg. The lengthening of the plunge pool at station 0+25 and the decreasing pool length at station 1+30 are a reflection of the increased number of survey data points taken in 2007 (Figure 2.1).

The pool at station 3+18 deepened since the as-built and 2004 surveys were completed. The channel thalweg elevation at station 3+40, located on a rock weir decreased by a half of a foot since the as-built survey; this is the result of repairs made at this location in 2006. A plunge pool is now present below a rock weir at station 3+44; it was not present in 2004. The cross-section transect at station 3+55 showed no changes since the two previous monitoring events. However the small pool downstream of 3+55 has filled in, which is most likely a result of downstream changes in the stream channel.

From station 4+04 to 4+86 the channel thalweg differs greatly from the 2003 as-built survey (Figure 2.1). The stream channel at this location turns to the left and originally contained a single pool. As the point bar on the left bank built up over time, the stream channel migrated to the left, cutting around a maple tree and forming an island. The island split the single pool into two pools; one upstream of the island between stations 4+04 and 4+27 and one downstream of the island between stations 4+57 and 4+73. The right bank from station 4+20 to station 4+65 appeared stable. From station 4+86 to 6+00 the channel thalweg aligns closely with the 2003 as-built survey.

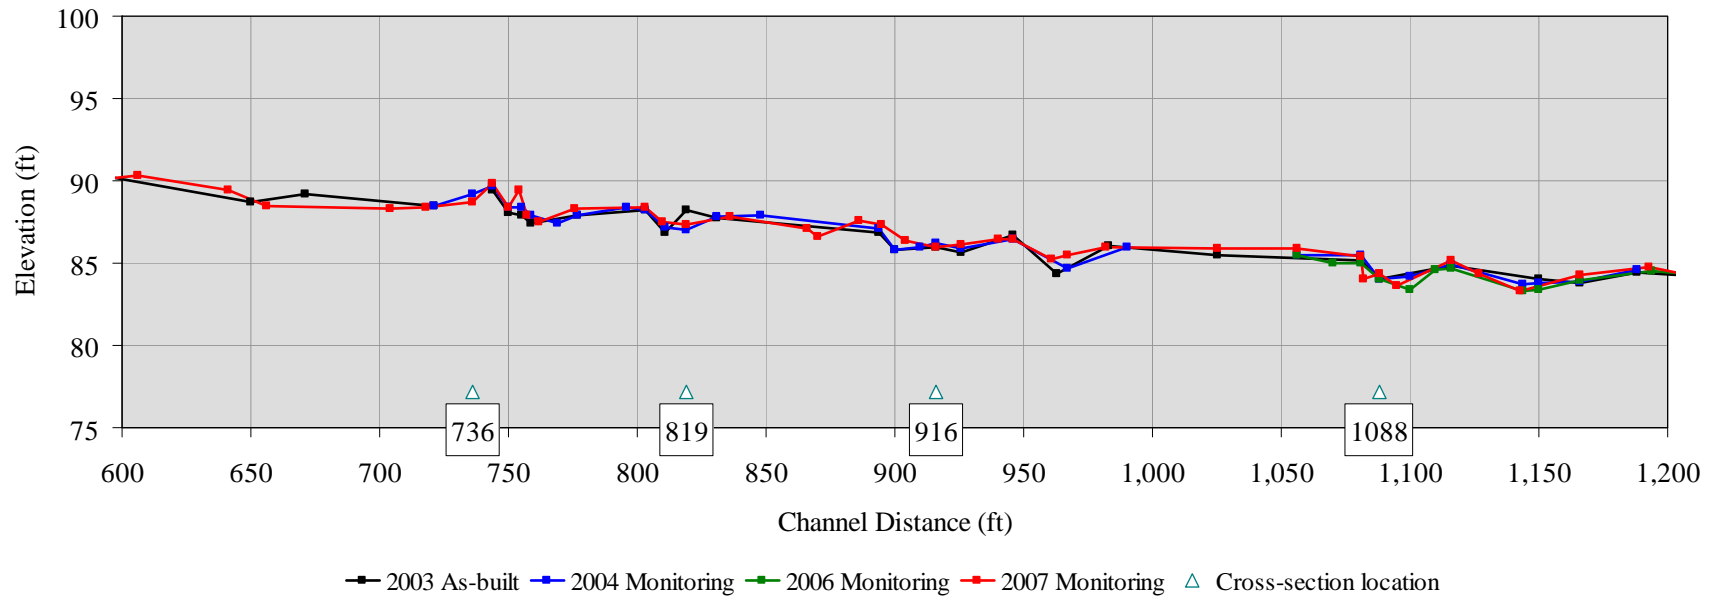
FIGURE 2.2.—Longitudinal profile between station 6+00 and station 12+00.

There have been minor channel changes between stations 7+44 and 7+62 (Figure 2.2). In previous years, a deep pool was located below a rock weir at station 7+44. Between 2004 and 2007, a tree fell across the stream at station 7+54 creating a step pool. There was no channel or bank instability associated with the addition of this tree, nor were there any significant changes in the channel between that point and station 14+00 (Figures 2.2 and 2.3).

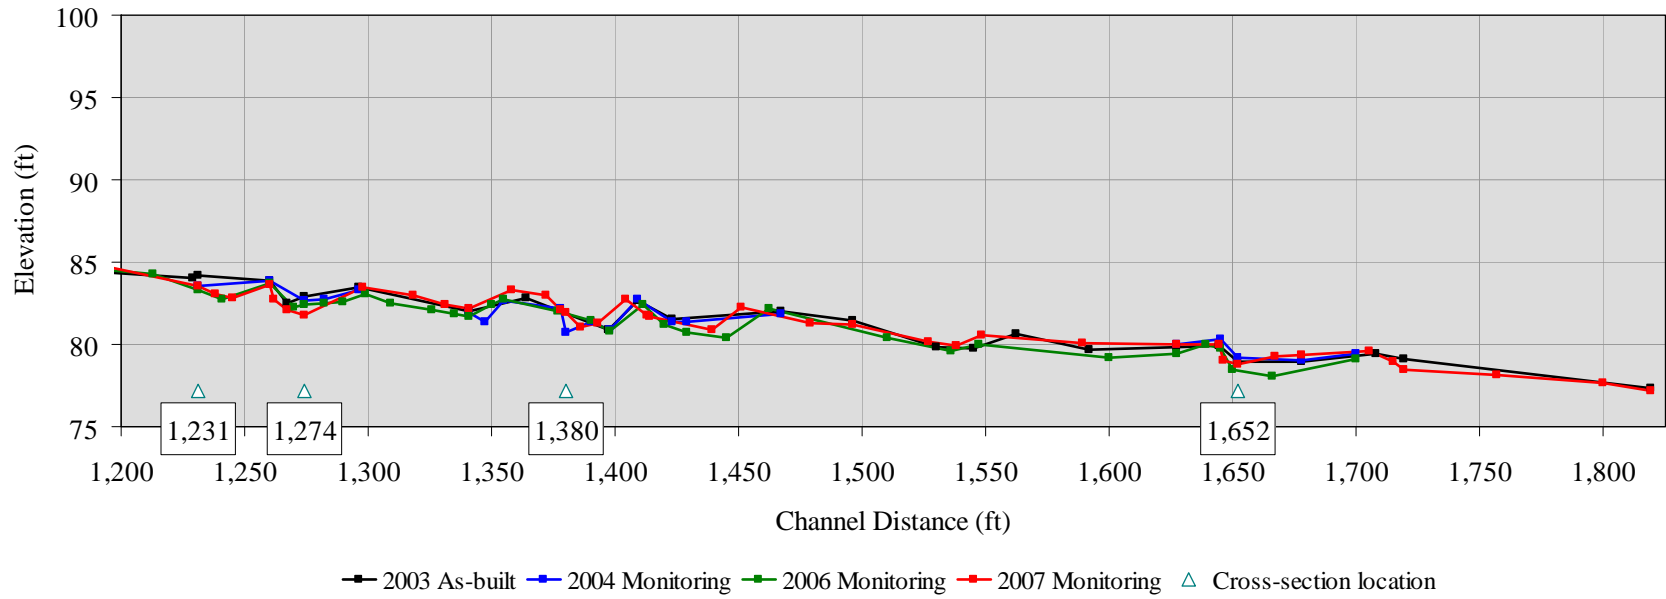
FIGURE 2.3.—Longitudinal profile between station 12+00 and station 18+20.

Two riffles located between stations 14+04 and 14+79 migrated upstream 5 and 11 feet (Figure 2.3). Instability of the right bank between stations 14+30 and 14+50 could have led to the migration of the riffles. The rock vane on the right bank at station 14+39 should help minimize further bank erosion. From station 14+79 to the end of the project the channel thalweg aligns closely with the previous years' monitoring data.

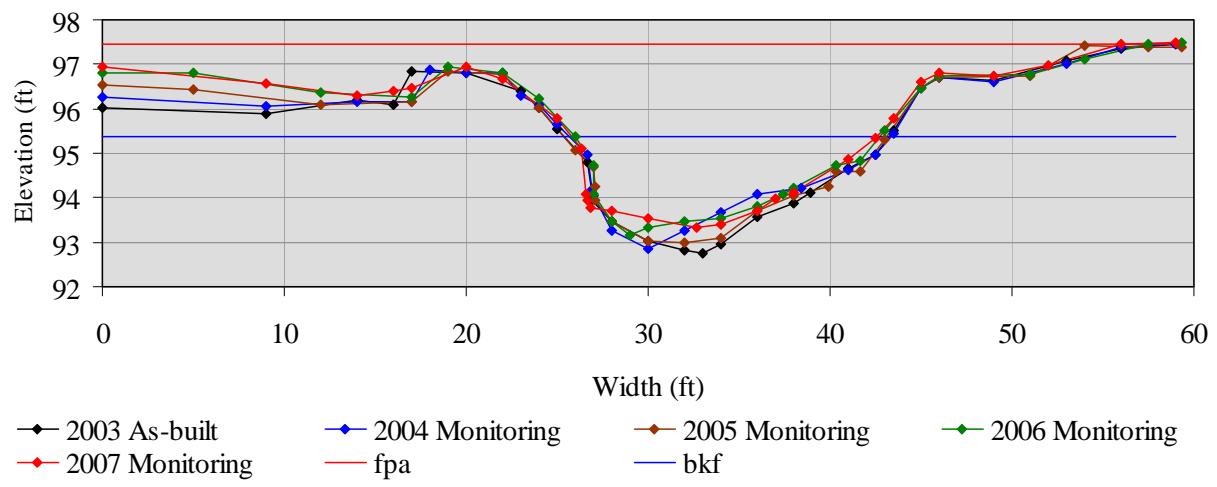
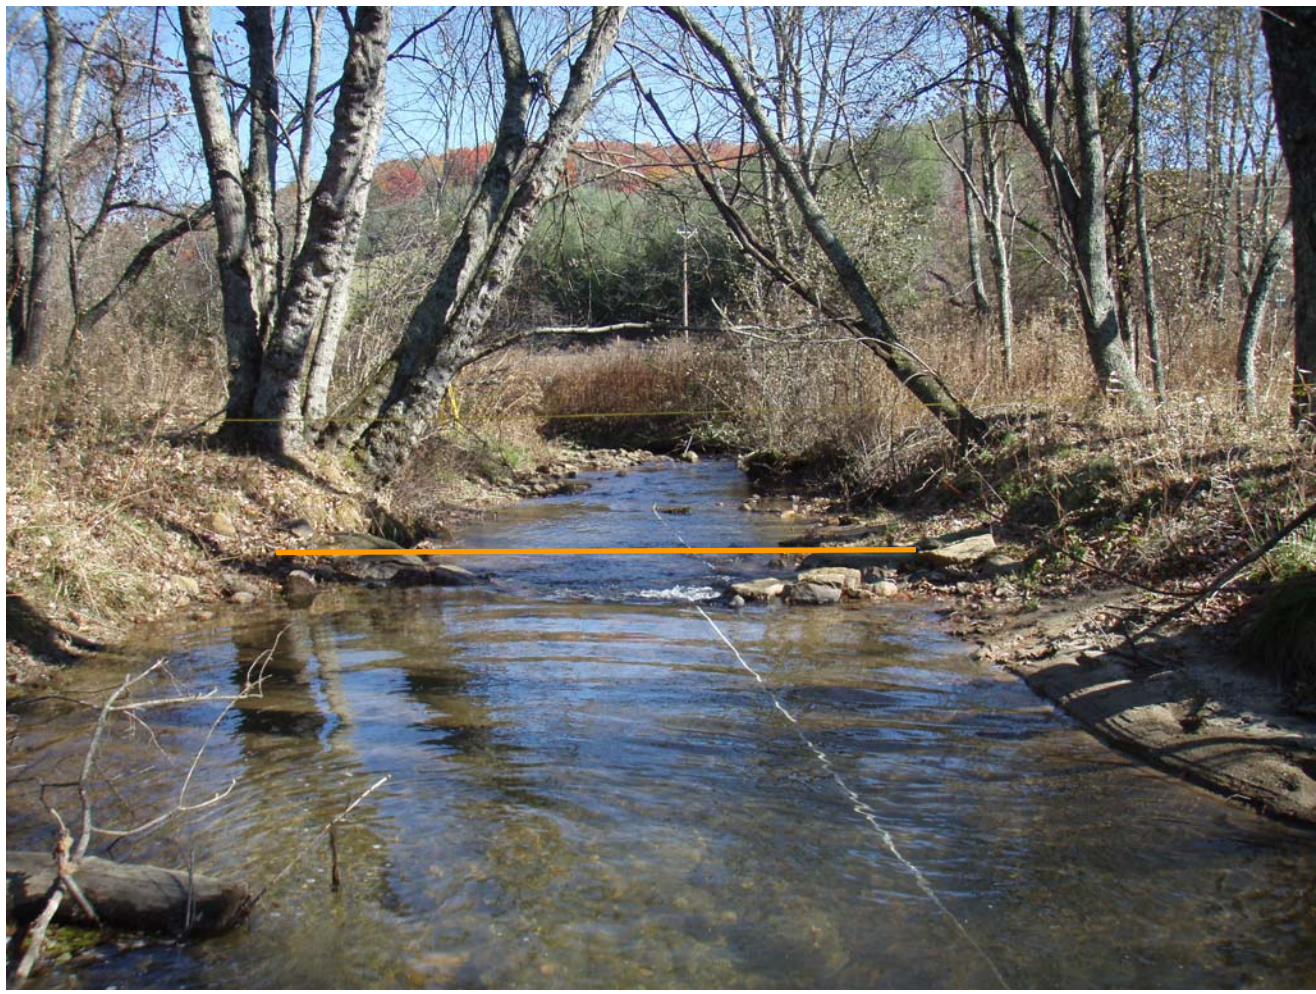
FIGURE 3.1.—Cross-section station 3+55, riffle.

CROSS-SECTION 3+55 – riffle (Figure 3.1): This cross-section is located over a deep riffle just below a crossvane. There has been little change in the cross-section from 2003 through 2007. The thalweg has decreased in depth about 0.6 ft. This cross-section has remained stable with no lateral movement (bank erosion) observed along either streambank. The left bank has increased in height due to the riparian vegetation capturing streambed materials during flood events. The 2006 repairs that were made to two boulders in the middle of the crossvane are functioning properly.

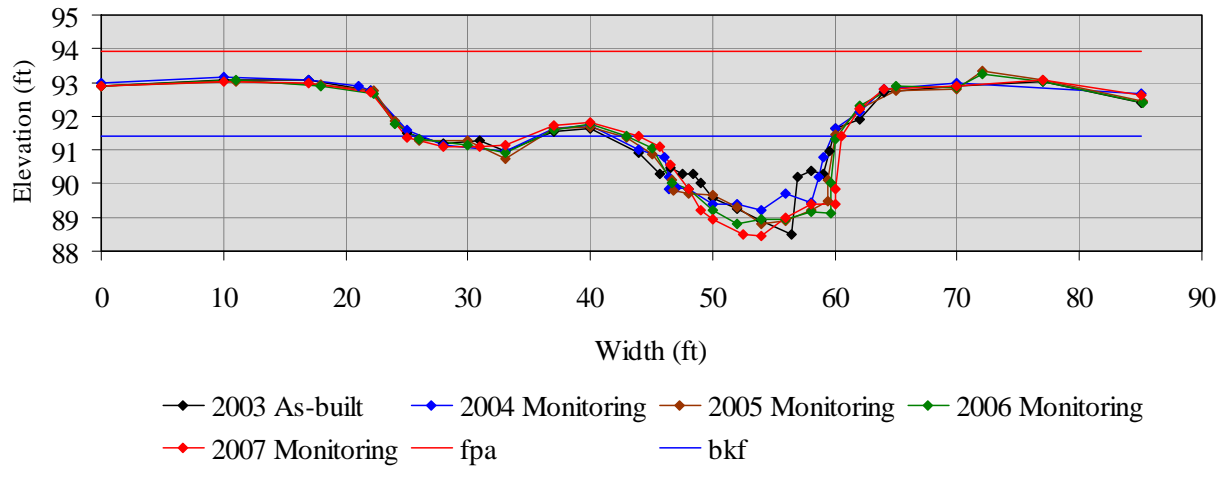
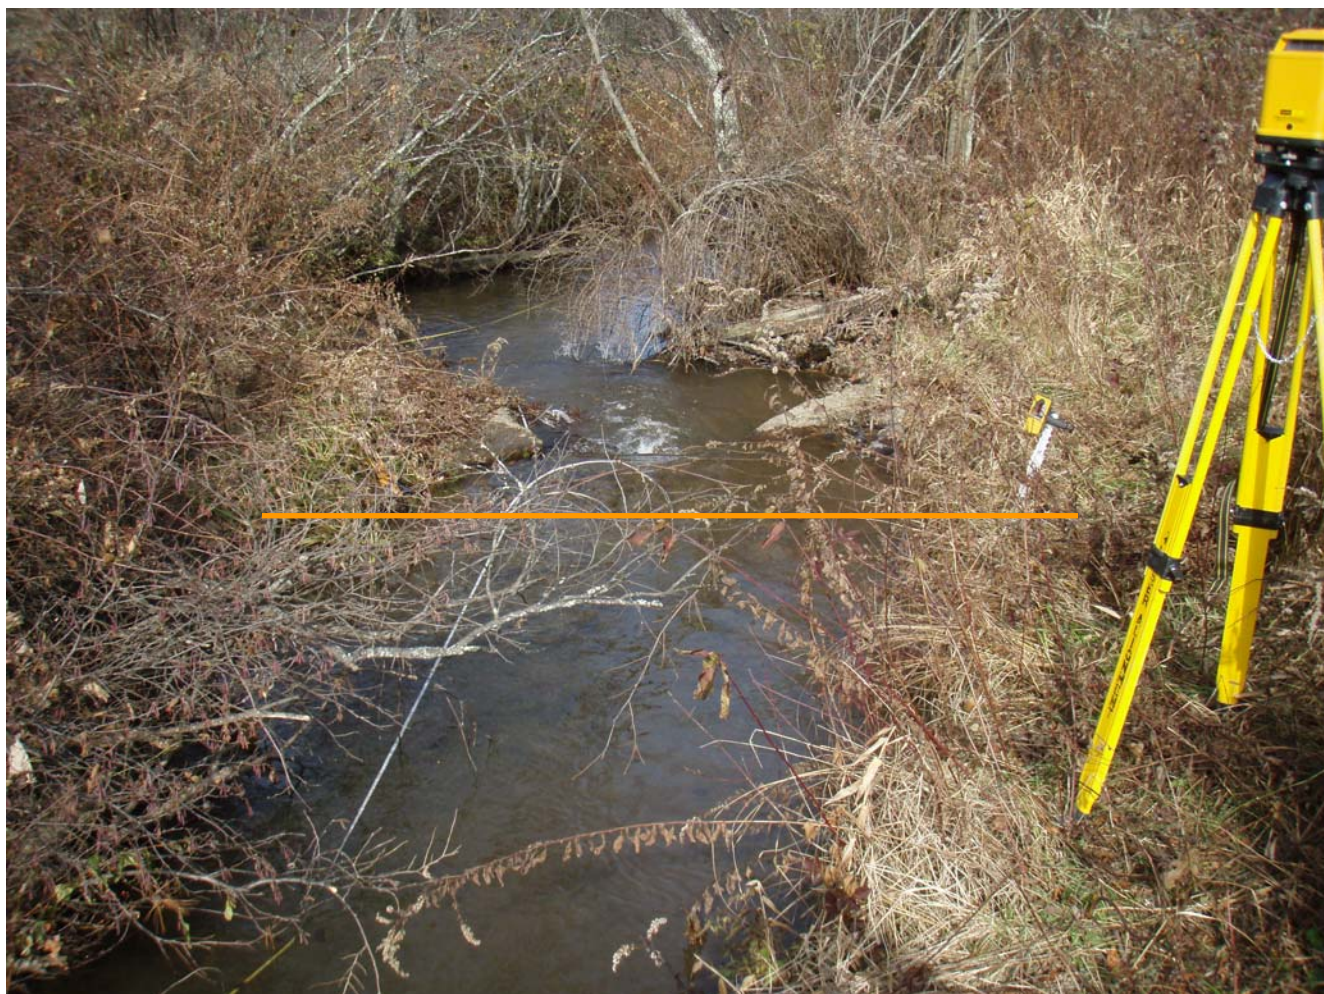
FIGURE 3.2.—Cross-section station 7+36, pool.

CROSS-SECTION 7+36 – pool (Figure 3.2): This cross-section transects the tail end of a long pool just upstream a crossvane. The thalweg at this location has continued to deepen since 2004. There has been some channel migration along the right bank at cross-section position 0+60 since completion of the project. However, the bank is stable and well vegetated.

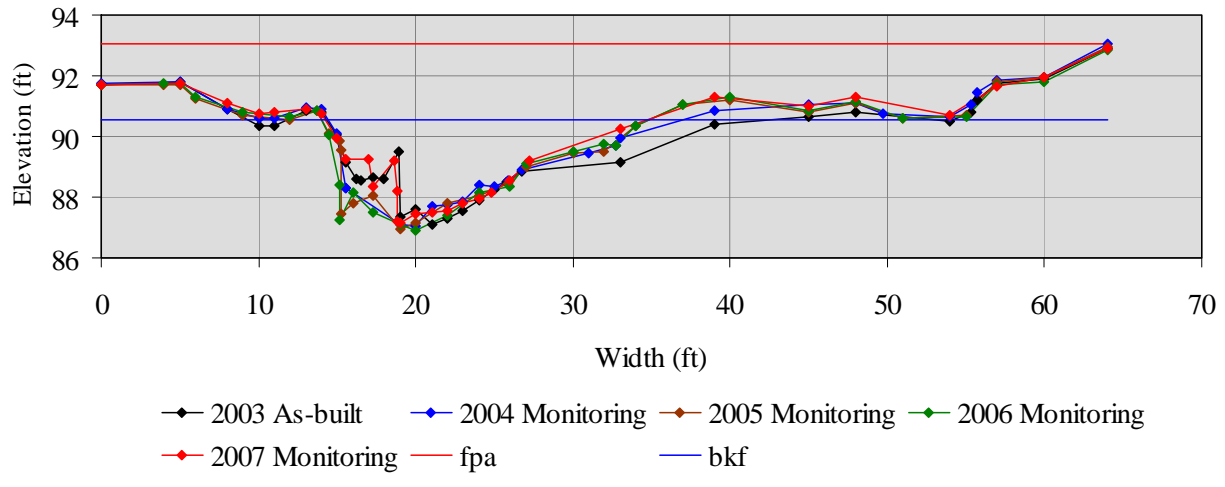
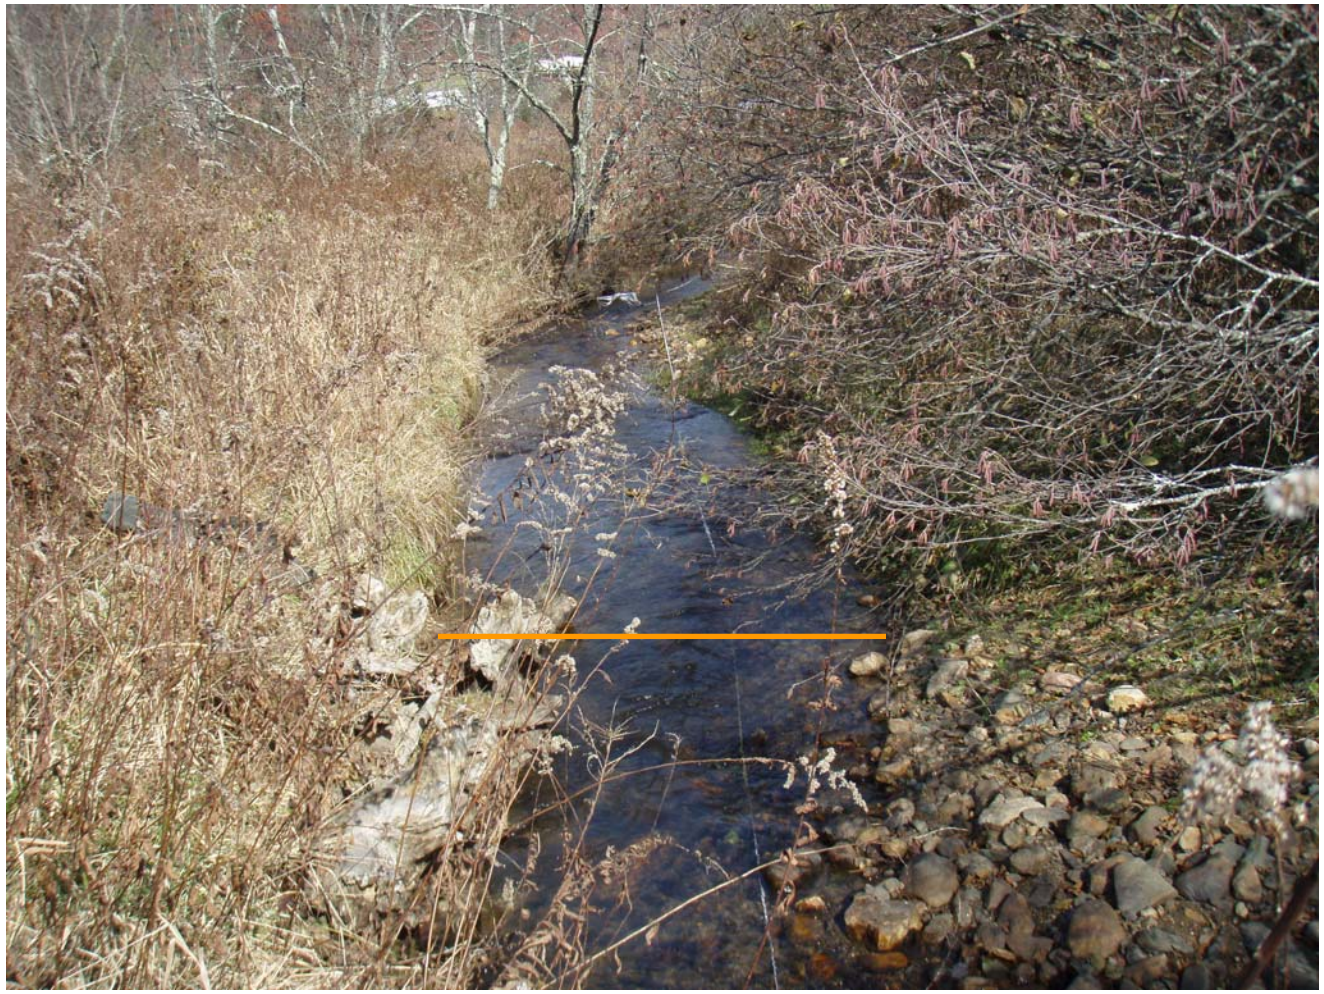
FIGURE 3.3.—Cross-section station 8+19, riffle.

CROSS-SECTION 8+19 – riffle (Figure 3.3): This cross-section traverses a riffle. The thalweg has remained stable, exhibiting only minor adjustments due to storm events. In 2007 between transect locations 0+15 and 0+17 there has been a build up of the right bank; this is a result of the repairs that were made in 2006 where holes behind the root wads were filled in. The unusual high points seen in the as-built and 2007 monitoring data, at transect location 0+19, represents a measurement taken on top of a root wad. The build up of the bank from cross-section transect location 0+30 to 0+55 is due to streambed materials being captured by riparian vegetation during flood events. This cross-section has remained stable with no lateral movement (bank erosion) observed along the streambanks.

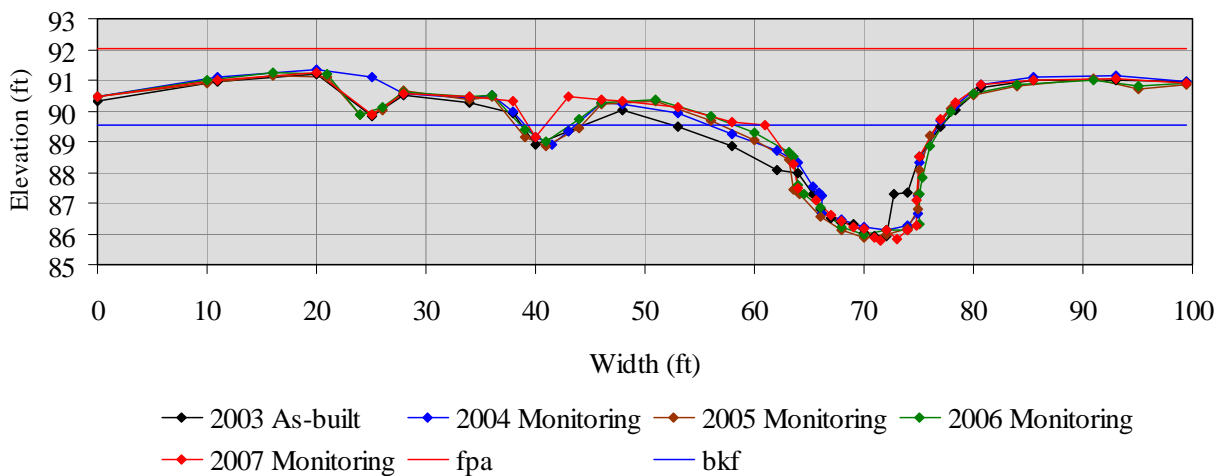
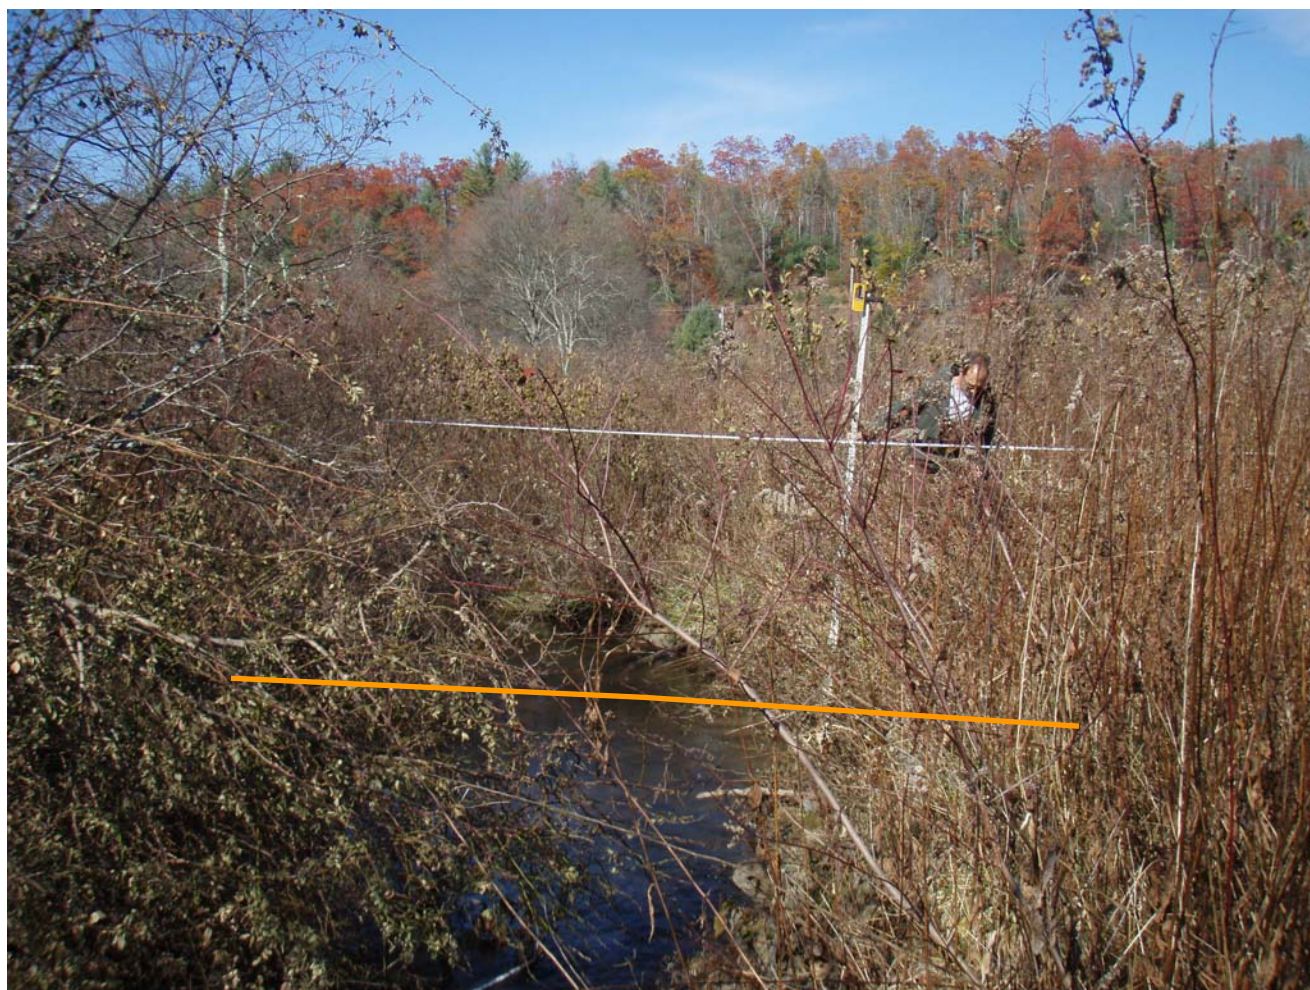
FIGURE 3.4.—Cross-section station 9+16, run.

CROSS-SECTION 9+16 – run (Figure 3.4): This cross-section transects a run downstream of a crossvane containing root wads along the right bank. However, it could also be considered a fast pool. The 2007 monitoring survey indicates no major changes in the thalweg of the cross-section when compared with the previous years' surveys. However, as bank vegetation continued to increase in density, bank height has increased as streambed materials were captured by the riparian vegetation during flood events. This cross-section has remained stable with no lateral movement (bank erosion) of the stream channel.

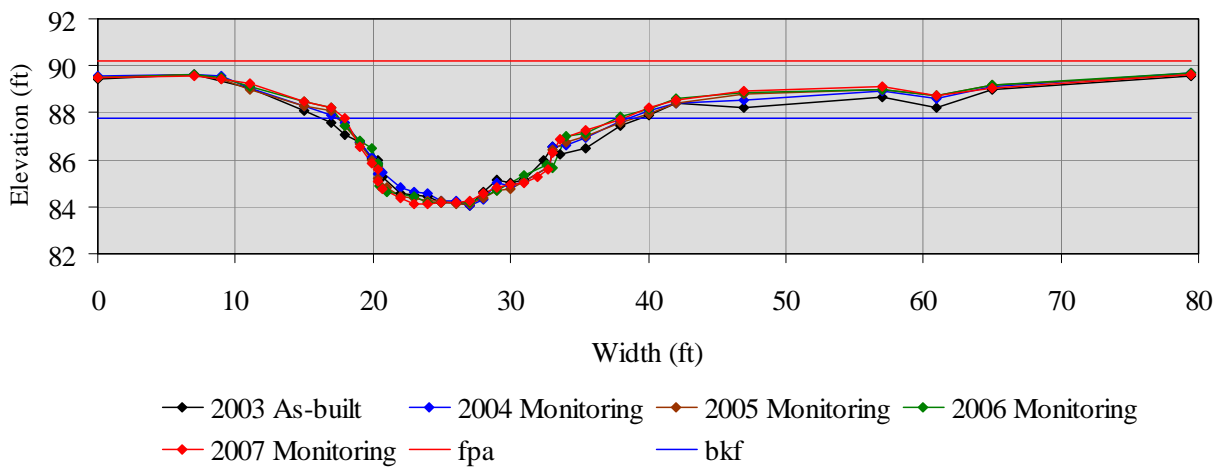
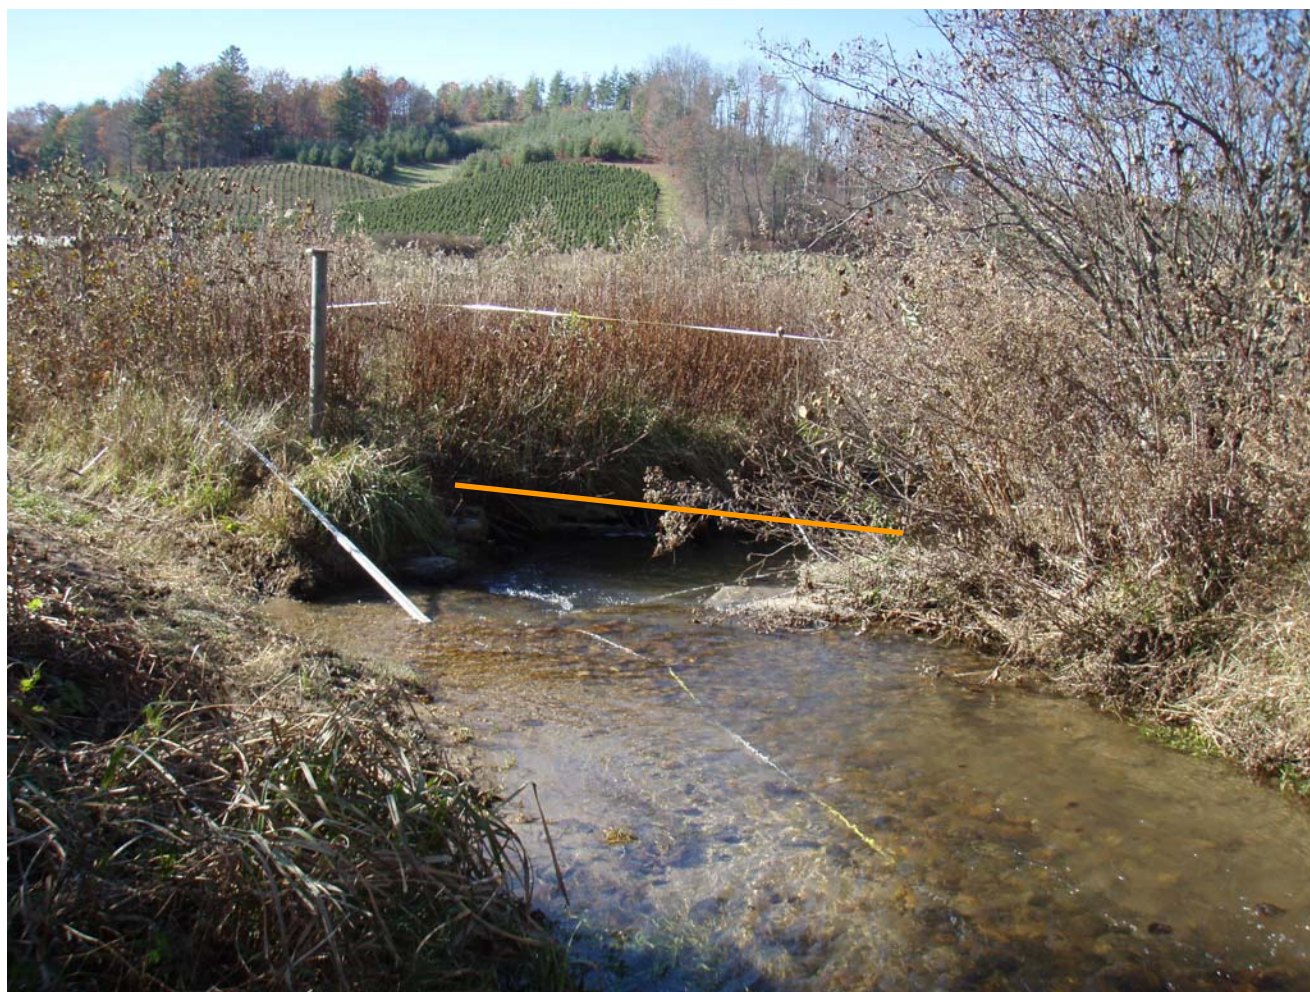
FIGURE 3.5.—Cross-section station 10+88, pool.

CROSS-SECTION 10+88 – pool (Figure 3.5): This cross-section transects a stable pool immediately downstream of the upper ford and a crossvane with root wads installed along the left bank. There has been little change in this cross-section since construction.

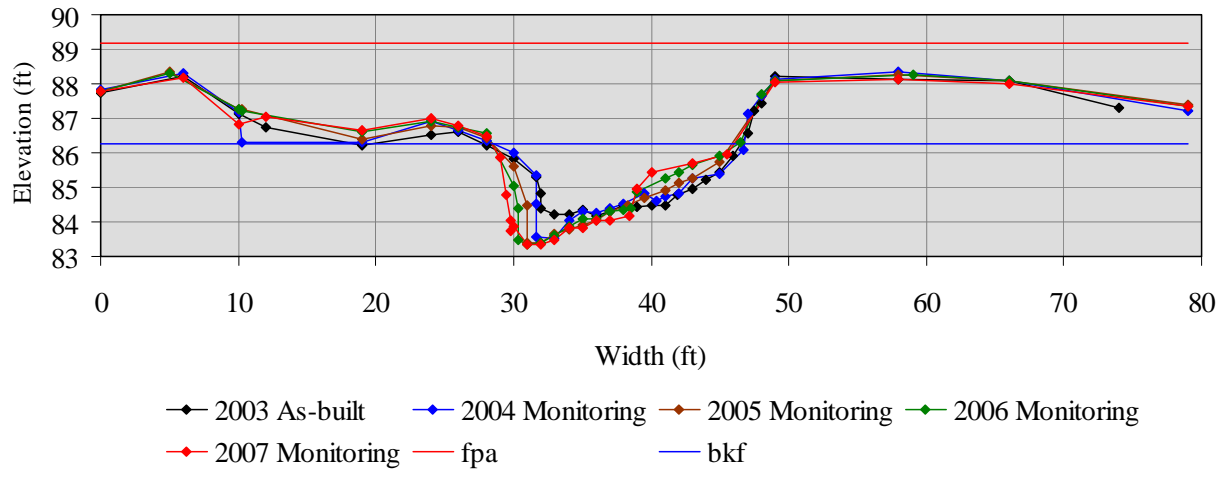
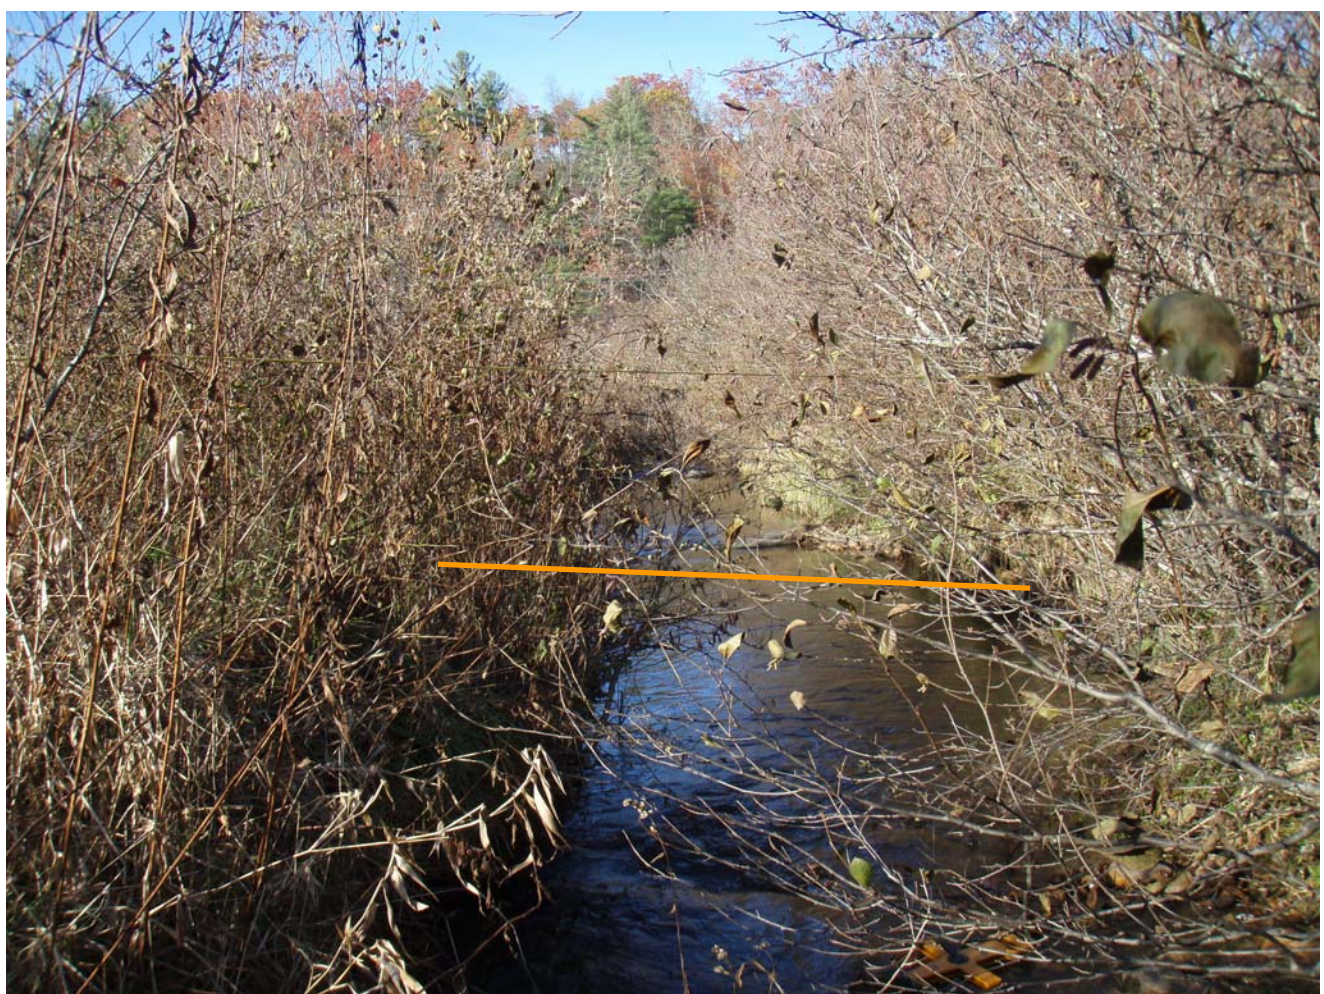
FIGURE 3.6.—Cross-section station 12+31, riffle.

CROSS-SECTION 12+31 – riffle (Figure 3.6): This cross-section transects a riffle. The only changes at this site have been a 1 ft deepening of the thalweg along the left bank, and formation of an inner berm along the right bank. Both banks are stable and well vegetated.

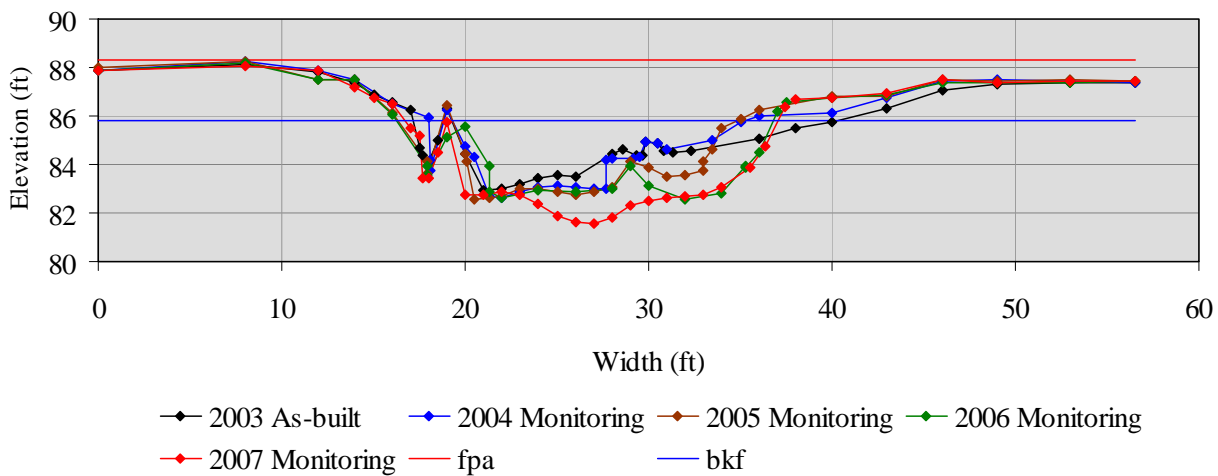
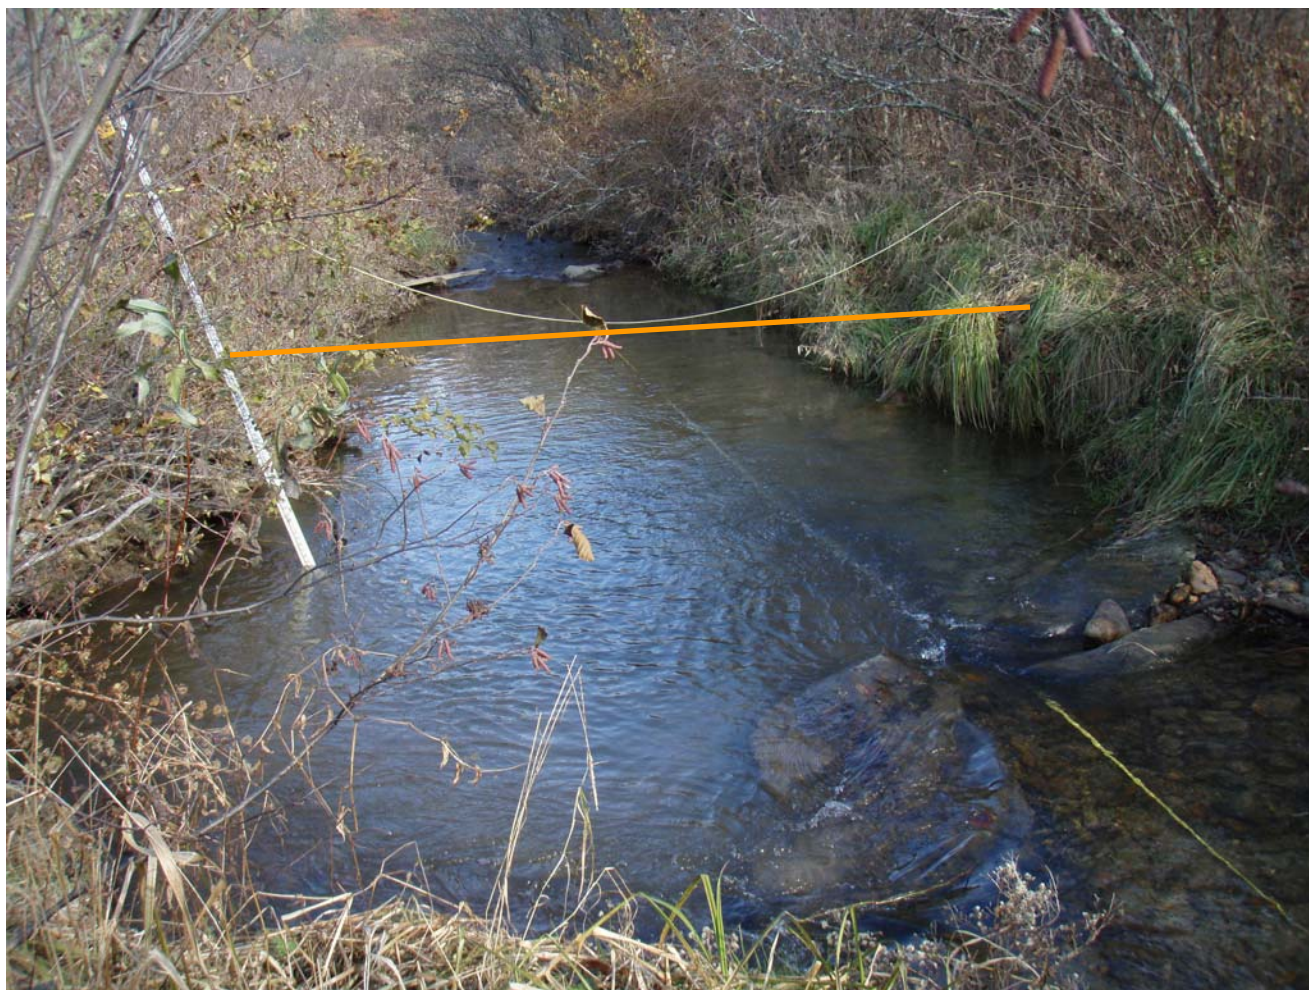
FIGURE 3.7.—Cross-section station 12+74, pool.

CROSS-SECTION 12+74 – pool (Figure 3.7): This cross-section transects a pool below a crossvane with root wads installed along the left bank. In 2006 a boulder was repositioned along the right bank and cobble placed in front of the boulder to alleviate pressure on the bank.

Previously this boulder caused the right bank to be cut away and resulted in an increase in channel depth between the boulder and the right bank. The thalweg has moved to the center of the channel as a result of repairs made in 2006. Cross-section transect location 0+18 identifies a hole behind the root wads, whereas the high point at position 0+19 is on top of the root wads. Both banks are stable and well vegetated.

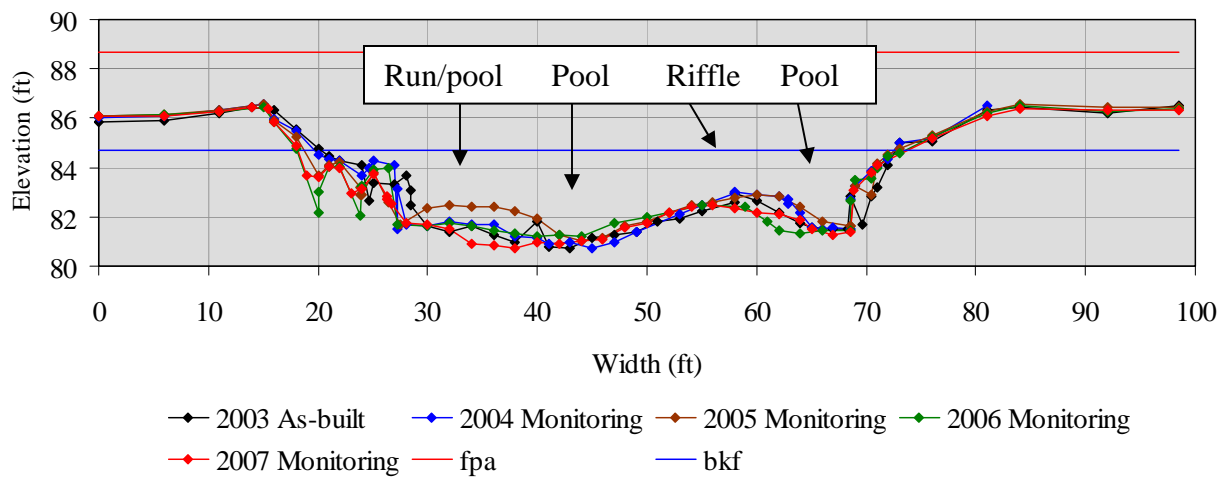
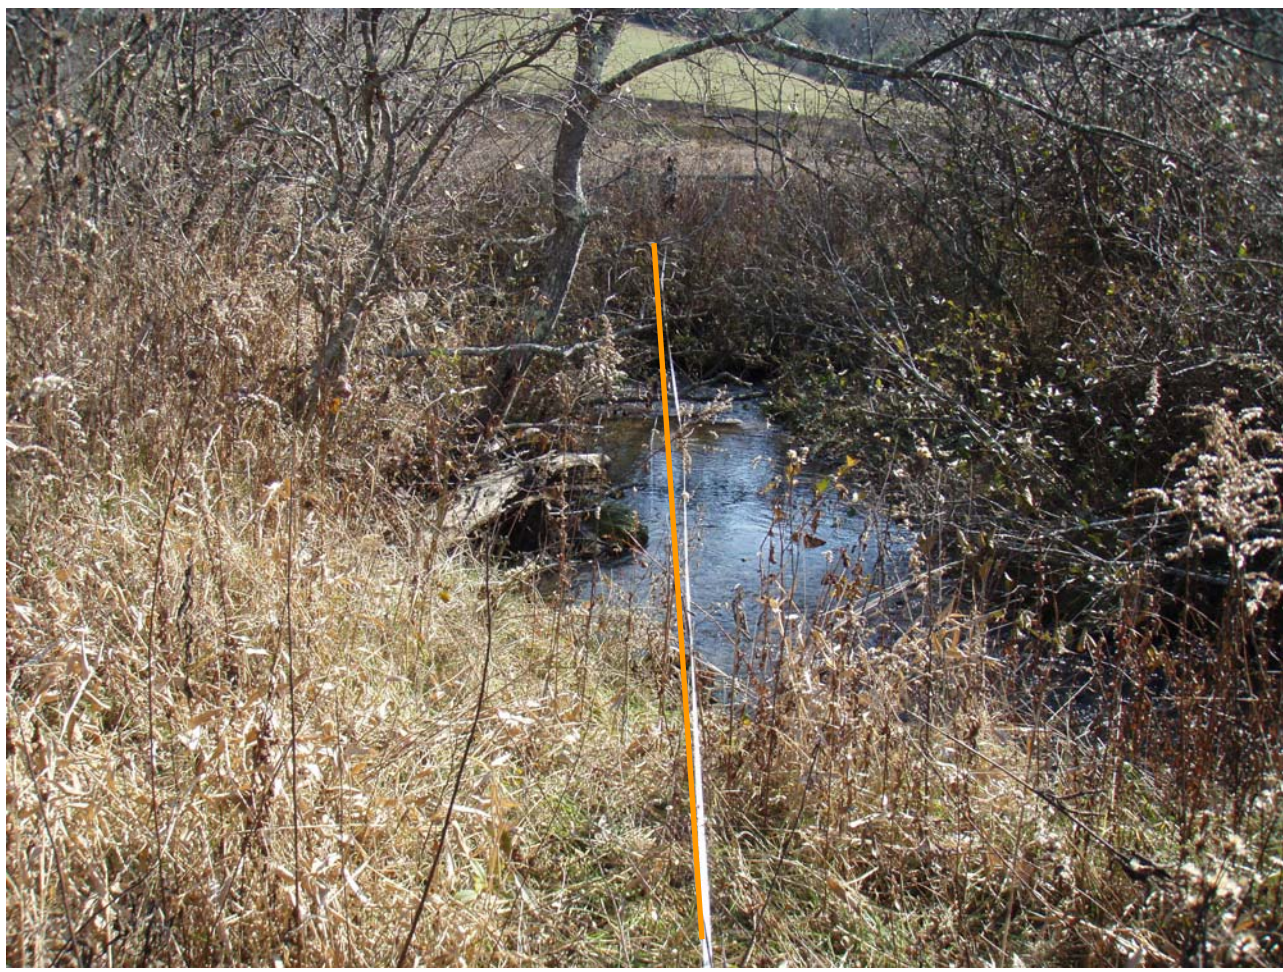
CROSS-SECTION 13+80 – 14+29 pool/riffle complex (Figure 3.8): This cross-section goes through an S-curve meander pattern, making it part cross-section, part longitudinal profile. This allowed for the monitoring of two distinct pools that were created with root wads and bank re-shaping. The holes behind the root wads at cross-section transect location 0+19 and 0+23 were filled in 2006. The thalweg at transect location 0+34 to 0+40 has evolved from a run to a pool feature. The stream bed is below that found in 2003. The riffle between transect location 0+54 and 0+60 has lengthened compared to the 2006 survey, although the riffle crest height is still below that found in 2003, 2004, and 2005. This site is stable and well vegetated.

FIGURE 3.8.—Cross-section station 13+80-14+29. This cross-section incorporates two different restoration sites into one. The cross-section was taken at an S-curve that encompasses a run/pool, pool, riffle, and a second small pool sequence.

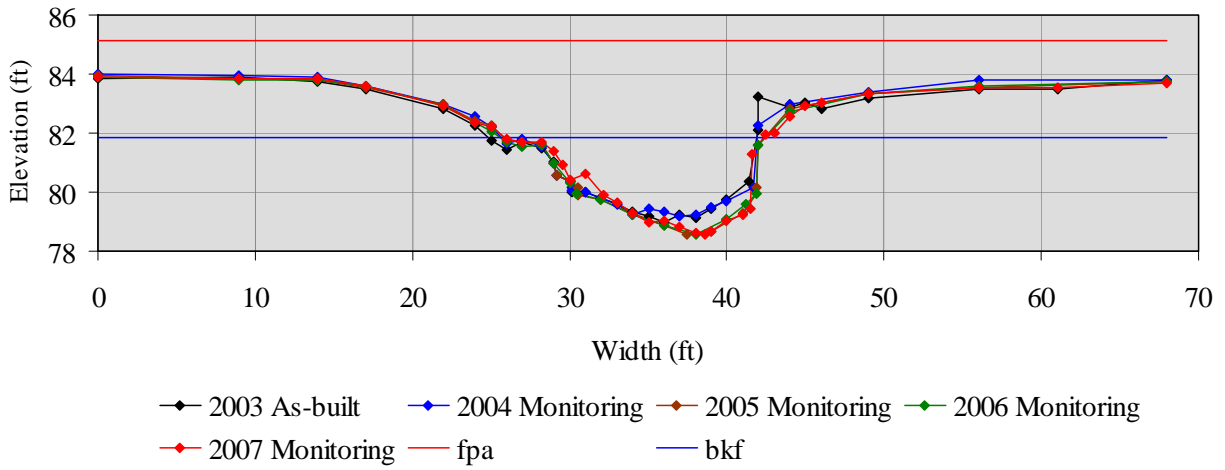
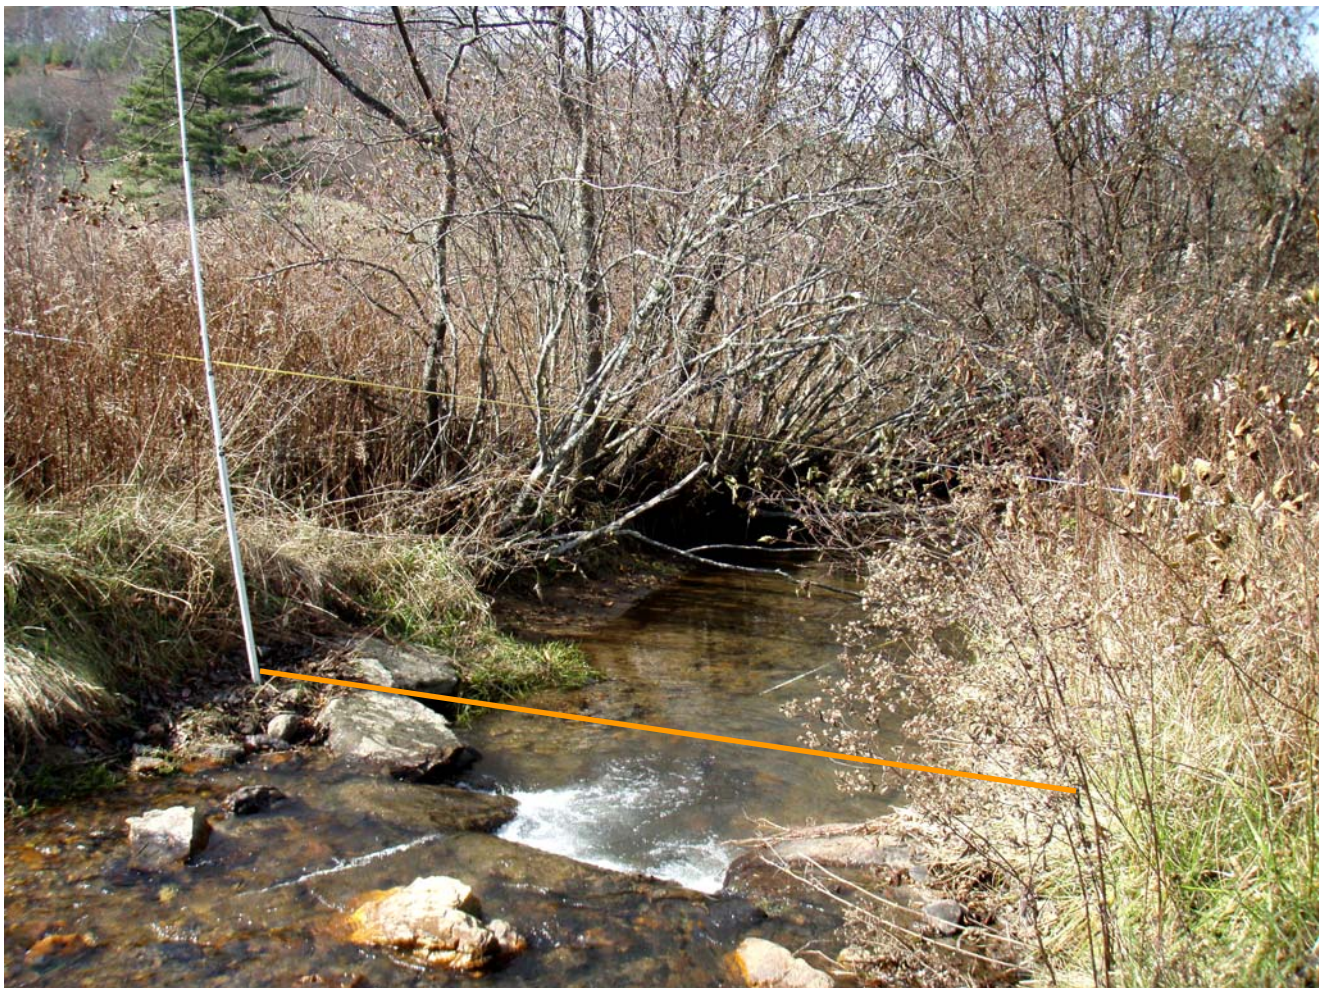
FIGURE 3.9.—Cross-section station 16+52, pool.

CROSS-SECTION 16+52 – pool (Figure 3.9): This cross-section is located downstream of the lower ford and a crossvane. The cross-section has remained stable and the thalweg has deepened approximately 0.8 ft since construction. The point at transect location 0+31 can only be explained as a rock or some other material present at the water's edge. There have been some minor adjustments to the bankfull and floodplain areas due to the capture of streambed materials during flood events.
