**WILD MITIGATION SITE, OBIDS CREEK,  
ASHE COUNTY**

Year 5 Monitoring and Closeout Report

Period covered: June 27, 2006 – December 31, 2007

North Carolina Ecosystem Enhancement Program

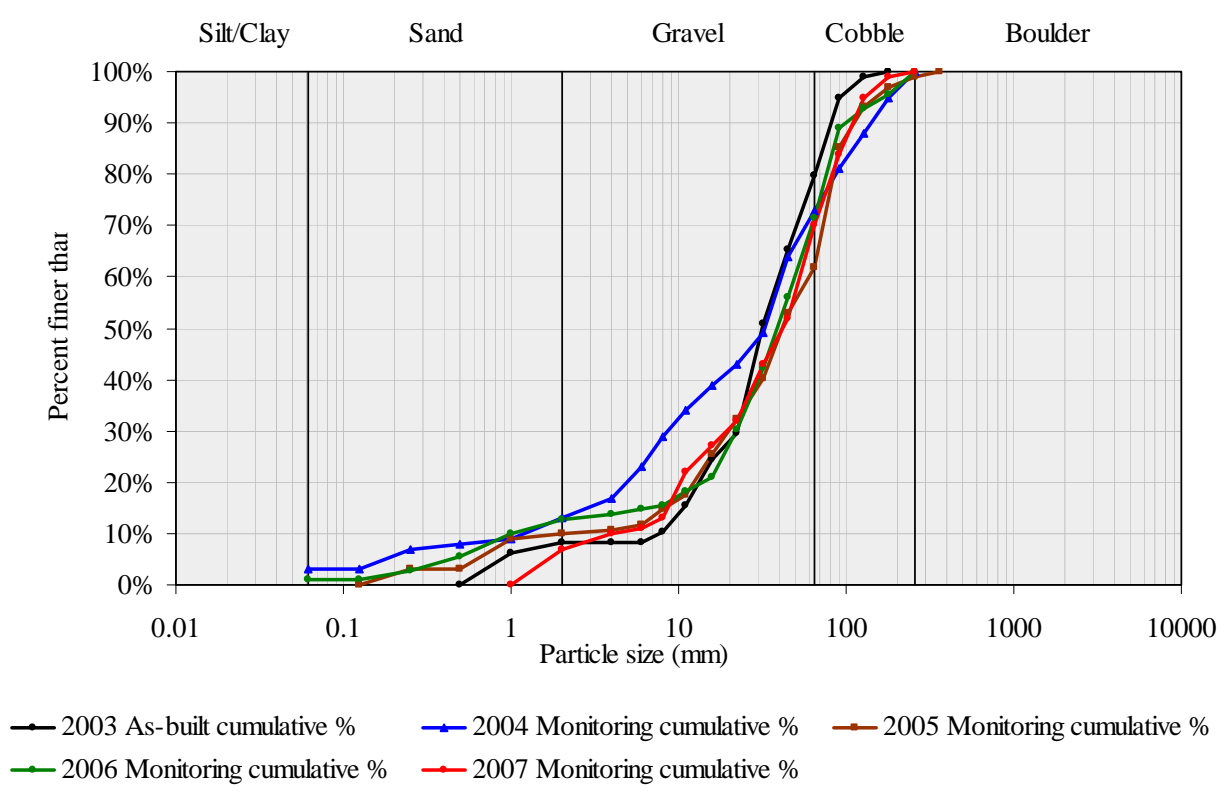
FIGURE 4.—Pebble count data comparisons, Wild site, Obids Creek, Ashe County, 2003-2007.

Bed material was collected from a riffle at cross-section 8+19 (Figure 4). Substrate analyses indicate all particle size classes have shown minor fluctuations throughout the five years of monitoring. The biggest fluctuation occurred in the  $D_{16}$  and  $D_{35}$  particle sizes of 2004. Currently, all particle sizes are greater than or equal to that found in 2003, except for the  $D_{16}$  size class. The increase in particle size, especially the  $D_{50}$  and  $D_{84}$ , is probably a result of the elimination of cattle having access to streambanks. Visual observations confirmed that the stream substrate contained less silt and sand.
