Wolf Pond Stream Restoration Project Annual Monitoring Report

Monitoring Year: 2009

Monitoring Year: 2

NCEEP Project Number: D 06054-B

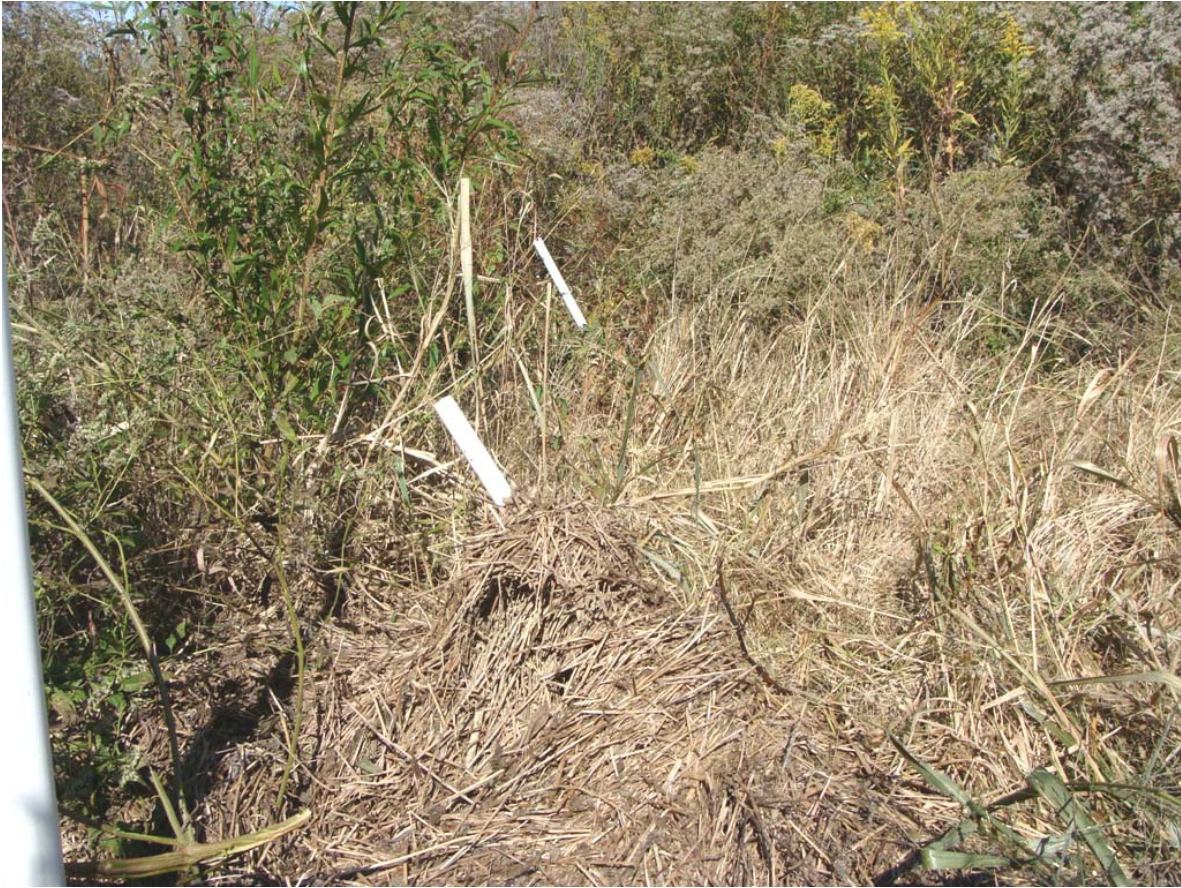
Wolf Pond is almost totally dominated by Goldenrod. Plots 1, 4, and 5 were very dense with growth 6 to 7 feet in height. All but one plot had browsed trees and 3 plots had trees that had been gnawed at the base. The stream had a slight flow at the time of the visit with tadpoles, fish, and algae in the pools except the reach adjacent to WP-4 and WP-5. WP-4 again showed impacts from water off of the field creating drifts. No impacts by animals or any vandalism was observed during this visit.

Feature/Issue	Plot/Station Range	Probable Cause	Photo Number
Drift Wood	WP-4	Upstream debris	Photo D 6

Photo D 6 – WP4 Problem Area (Drifts of Grasses)
