Table of Contents

1.0 Executive Summary

This Annual Monitoring Report documents the results of monitoring activities during the 2011 growing season on the Wolf Pond Stream Restoration Project. Construction of the site, including planting of trees, was completed in March 2008. The 2011 data documents results from the fourth year of geomorphic and vegetation monitoring at the site.

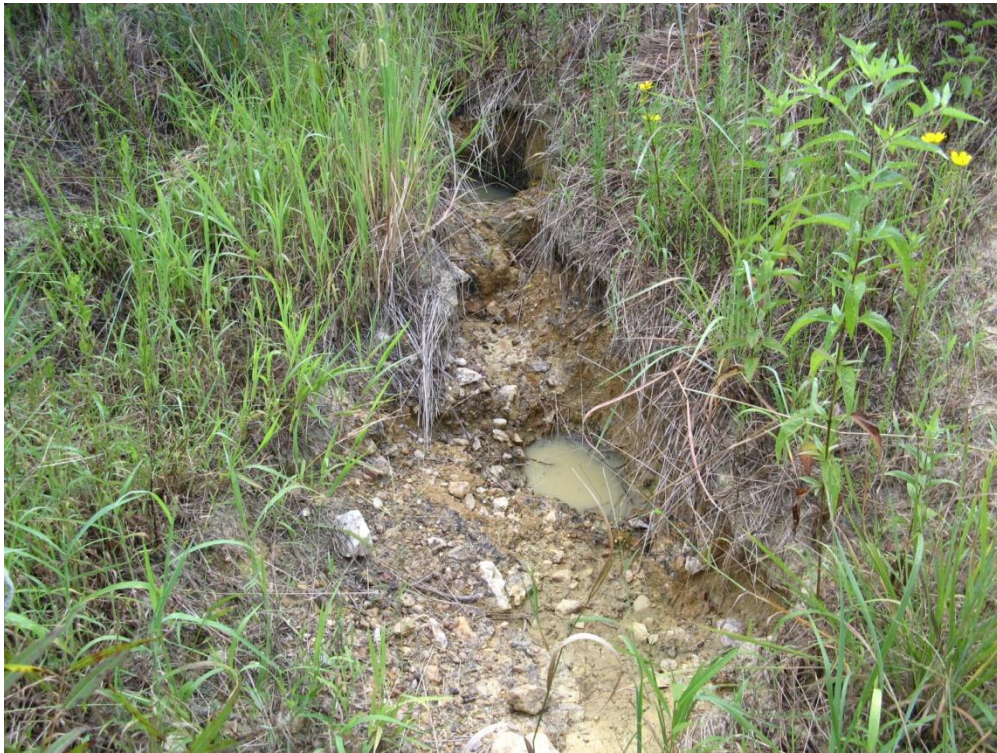
Problem Area MY4 PA-1

The heavy growth of cattails (*Typha latifolia*) within the stream bed in Reach 2 as well as backwater from the culvert within the reach has provided a stop to the sediment movement and a flattening of the stream bed with the resultant loss of riffle habitat. This is the natural response of a stream to changes in its watershed and bed vegetation and is listed as general problem area MY4 PA-1 that occurs in at least 10 places from station 100+43 to 113+46 in Reach 2.

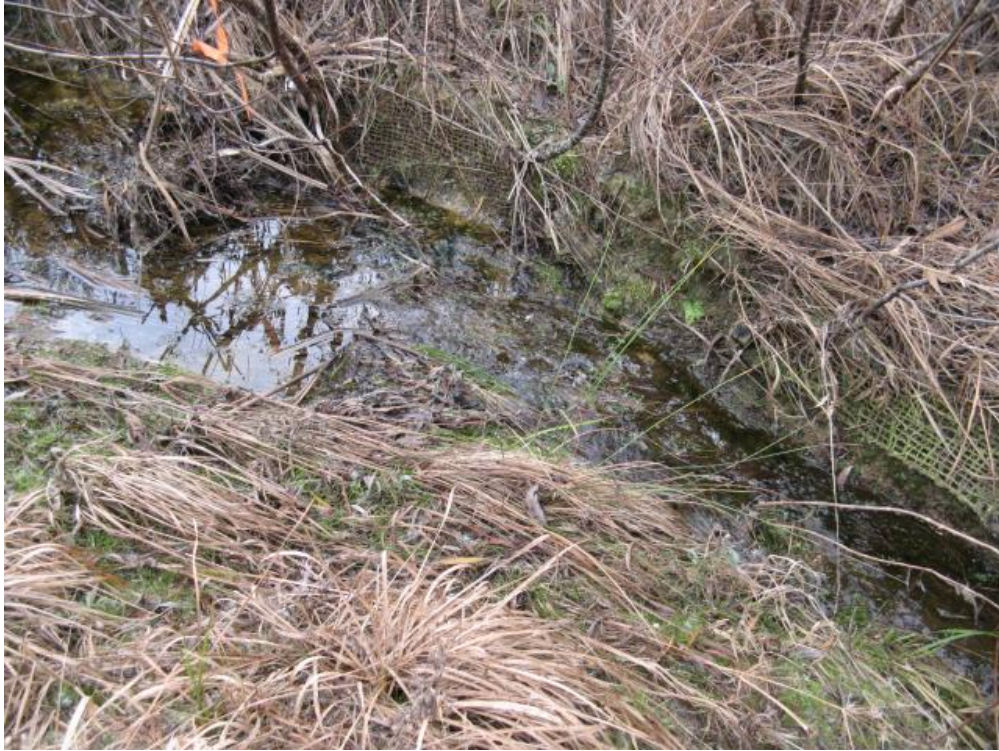
Problem Area MY4 PA-2

A second factor affecting the stability of the stream occurs outside of the riparian buffer on Reaches 2 and 3 where farming practices are causing an increase in sediment load throughout both reaches and impacting the morphology of the stream. The grading of the adjacent field in winter of 2010 increased the concentration of flows through swales into the reach causing erosion in a swale transecting the buffer (See photo 3.1.3-1 below). This was identified as problem area MY4 PA-2 located at station 3+29 in Reach 2.

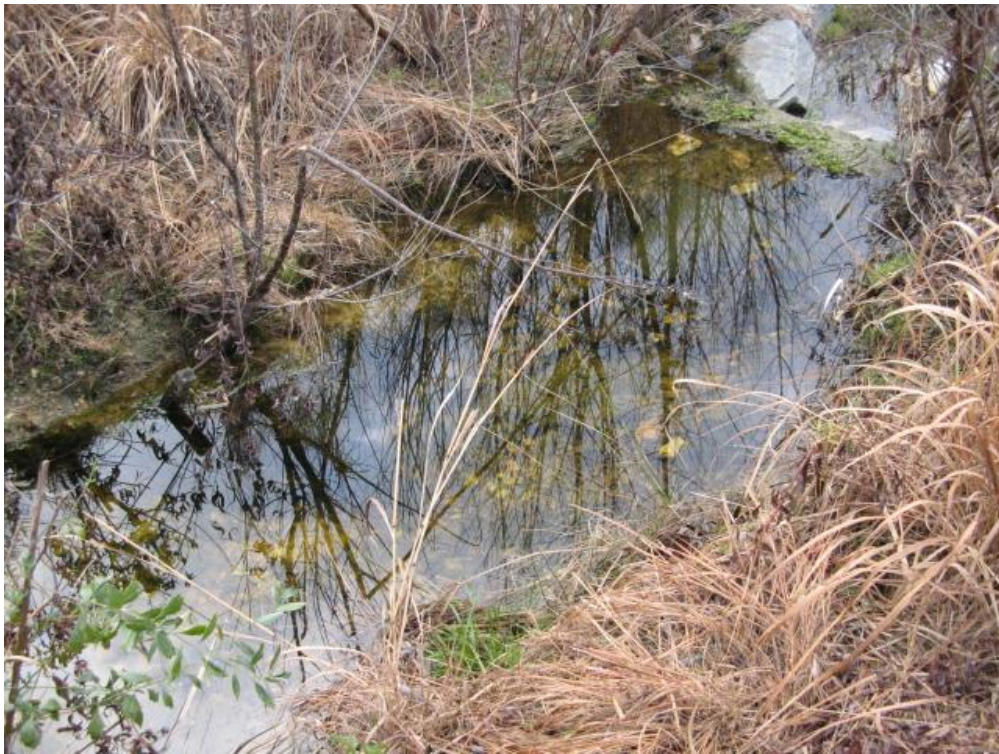
Problem Area MY4 PA-3

The changes in flow regime have created a headcut along with scour from station 107+97 to station 108+08 in Reach 2 which is listed as problem area MY4 PA-3.

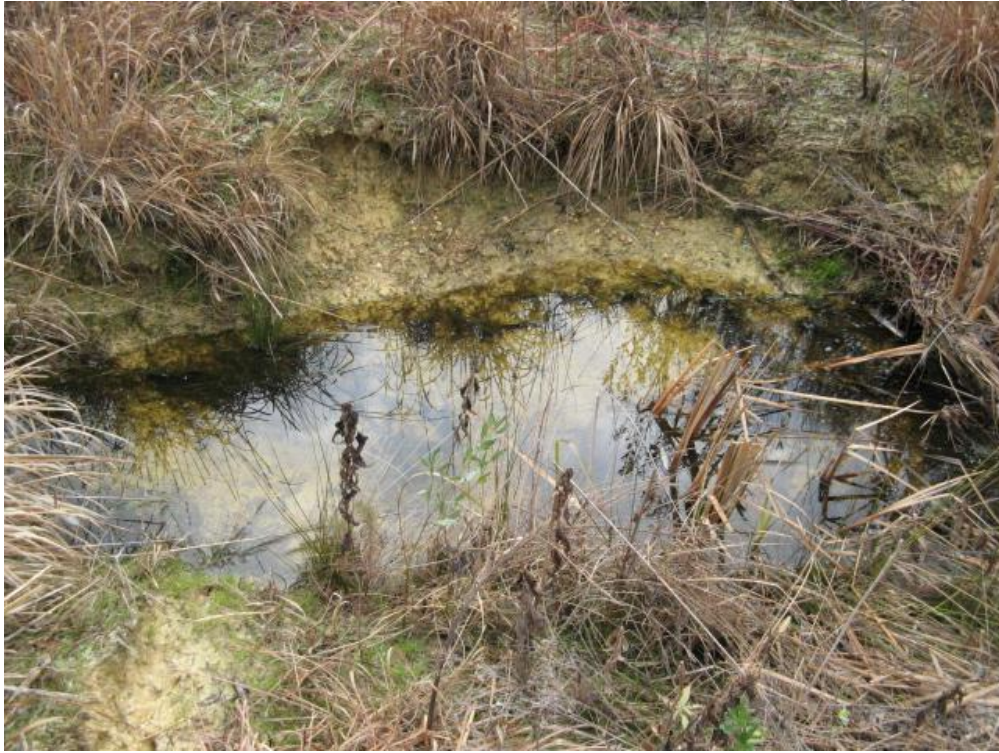
Problem Area MY4 PA-4

Problem area MY4 PA-4 is a scour pool above a stone cross vane which occurs at station 109+08 in Reach 2. It is caused by the cattail growth that has filled the pool below the cross vane causing water to back up at high flows and the resulting turbulence and bypass flows.

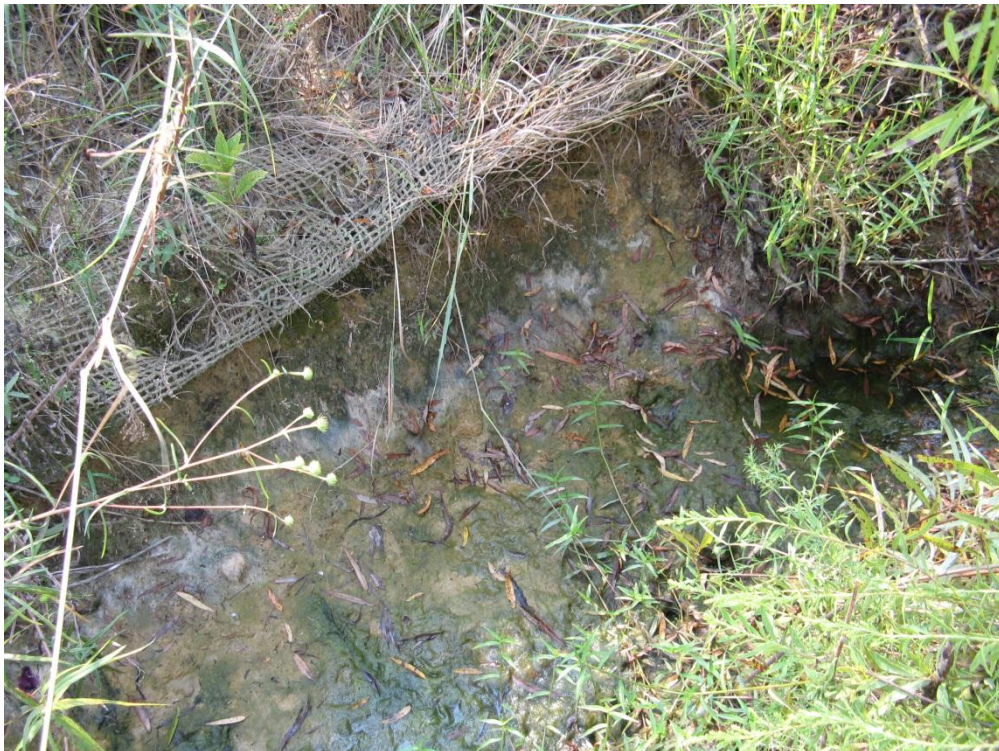
Problem Area MY4 PA-5

Problem area MY4 PA-5 is bank scour on the outside of a bend that occurs at station 108+09 in Reach 2 and can be attributed to a steep point bar on the inside of a tight radius bend. Evidence of the bank issue can be seen by the changes in WP R2 PXS-1 left bank cross section as well which is as station 108+12.
