Table of Contents

1.0 Executive Summary

*Wolf Pond Mitigation Site
Annual Monitoring Report for 2012 (Year 5)*

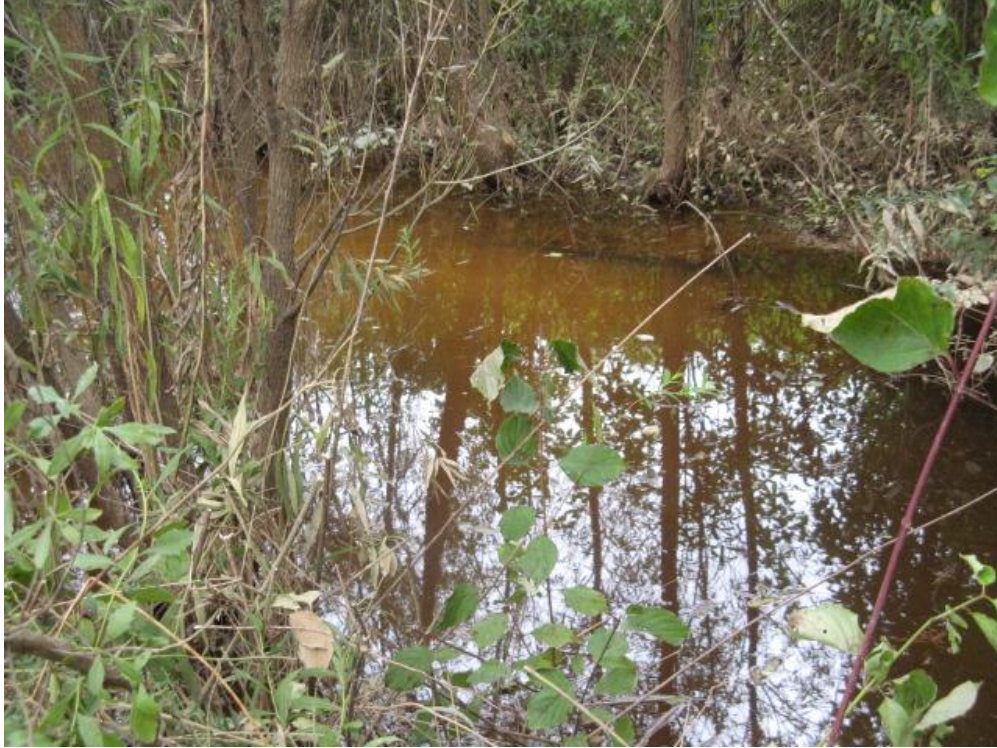
Photo Point 17 (Vane flooded by backwater)

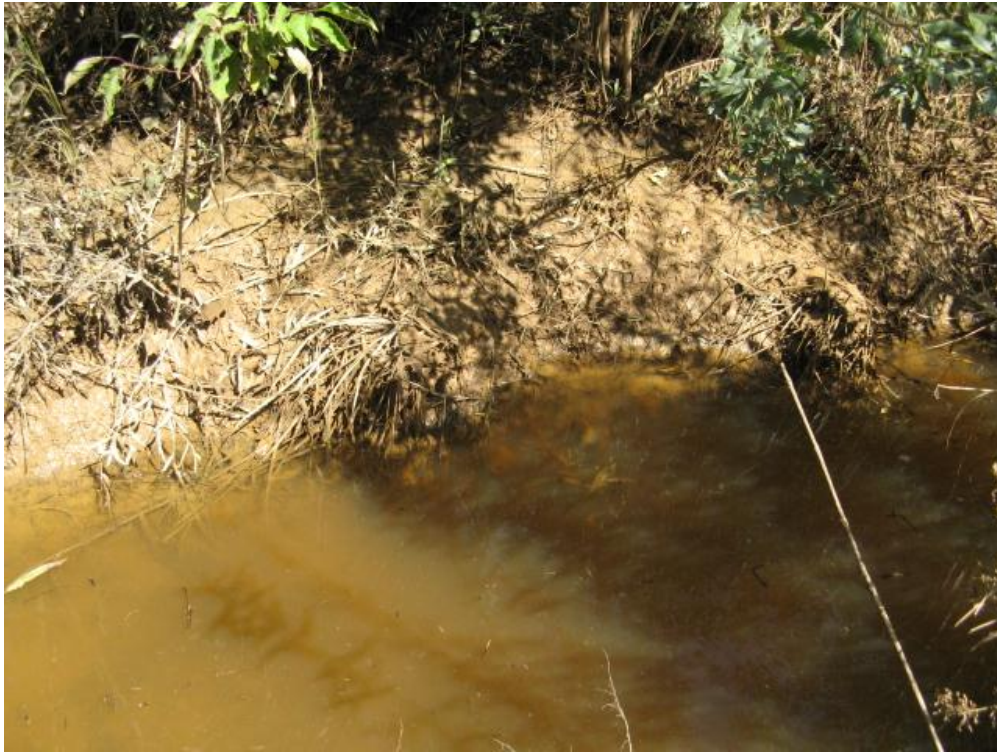
Problem Area MY4 PA-6

Problem Area MY4-PA6 was a preexisting left bank scour in Reach 1 caused by in-stream vegetation and debris back up. The problem was eliminated when backwater killed the in-stream vegetation. It is bare earth and will need replanting.

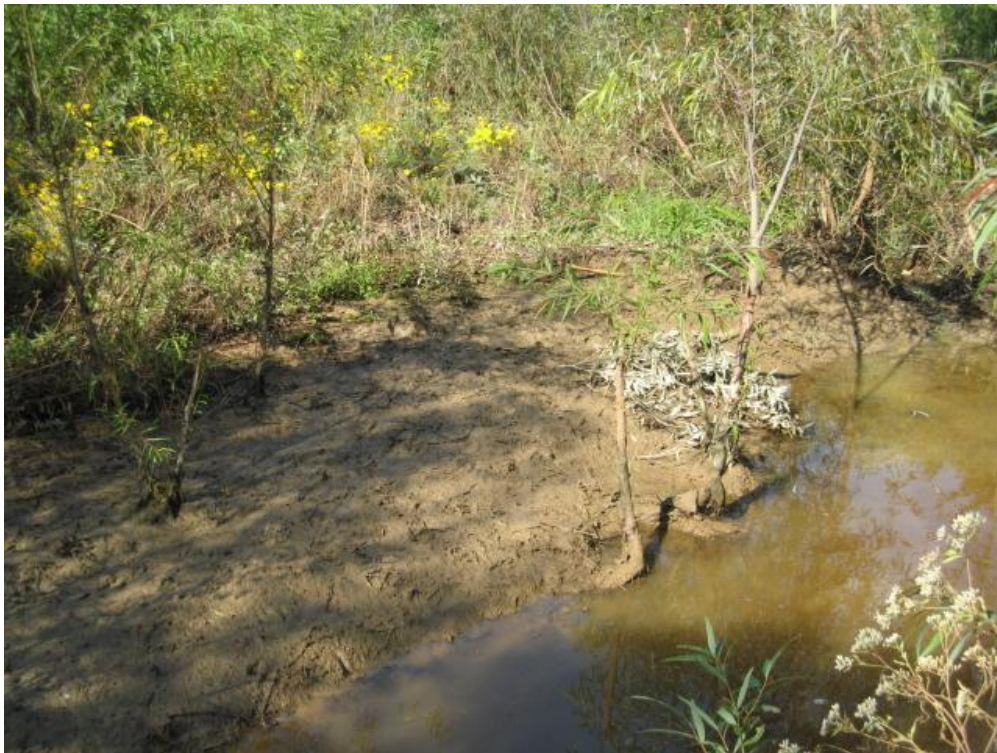
Problem Area MY4 PA-8

MY4-PA8 and MY4-PA7 are both a preexisting left bank cutoff channel that being created by willow vegetation in Reach 1. The beavers have removed the willows and both problems have disappeared but the vegetation must be replaced to assure a stable stream bank.

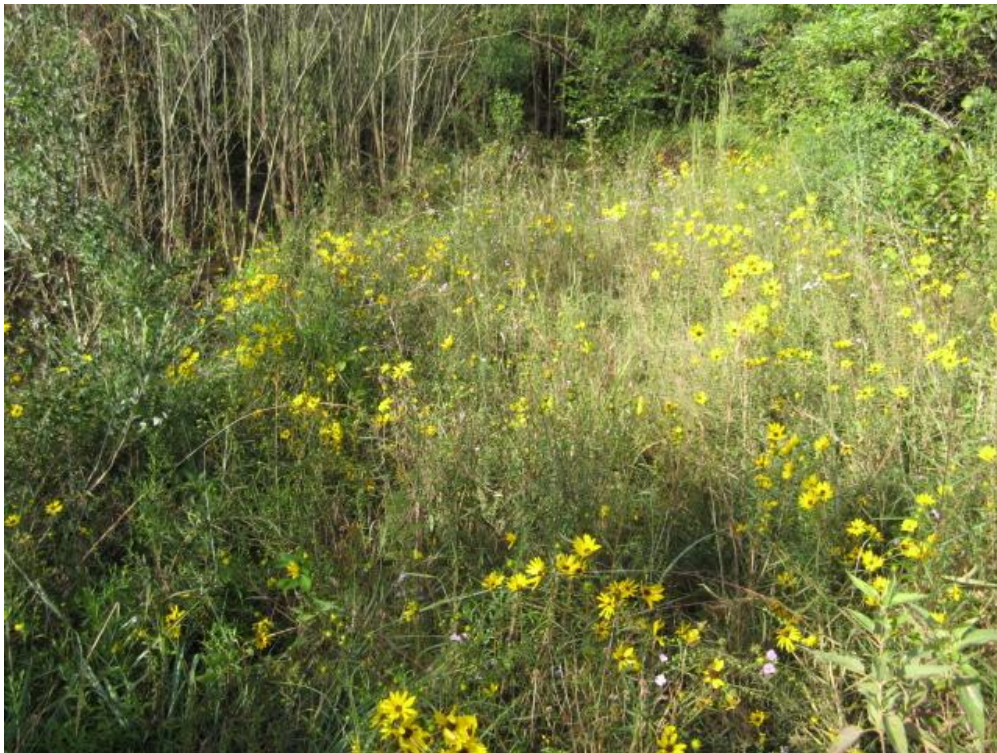
Problem Area MY3 PA-4 Healed
