MONITORING YEAR 3 ANNUAL REPORT FINAL

WYANT LANDS MITIGATION SITE

WYANT LANDS MITIGATION SITE
Monitoring Year 3 Annual Report

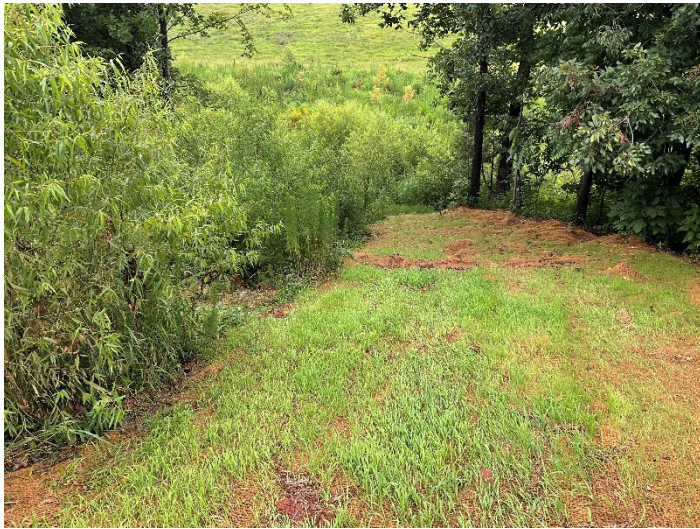
A few isolated areas of concern were present during MY2. There was a gully, approximately 60 linear feet (LF) and 6 inches in depth that formed adjacent to BMP 3 on UT2 R1. The gully was repaired in June 2023 by redirecting overland flow towards the BMP, filling in the gully, placing coir matting and seeding disturbed areas. The log sill on UT2 Reach 3 at station 322+00 was found to be stable and has not changed since the previous monitoring year. The structure is still separated from the streambank; however, the piping is isolated to the structure's tie-in and not affecting the stability of the channel. During MY2, rock was added to the livestock crossing beneath Wyant Road and seeded during the dormant season and vegetation has become established, significantly reducing sediment input. Wildlands has worked with the landowner to reduce livestock use of this area to reduce impact. If stream banks become unstable during the monitoring period, Wildlands will assess and implement best methods to reduce sediment load. These areas will continue to be monitored annually.

UT2 R1 – Repaired Gully looking downslope (6/23/2023)

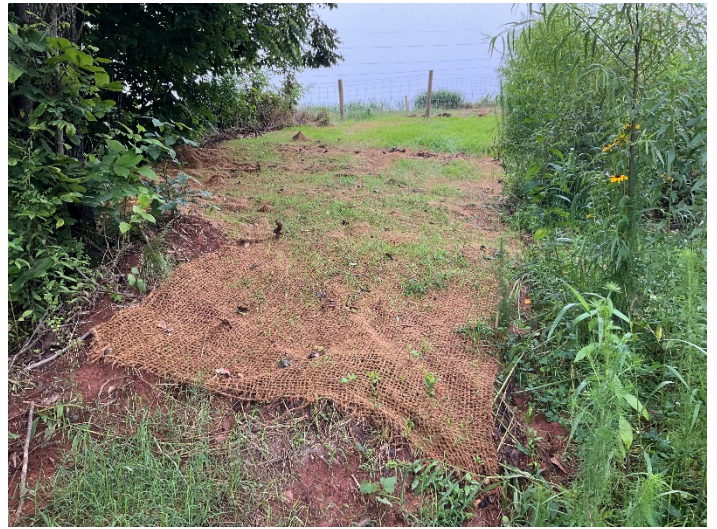
UT2 R1 – Repaired Gully looking upslope (6/23/2023)

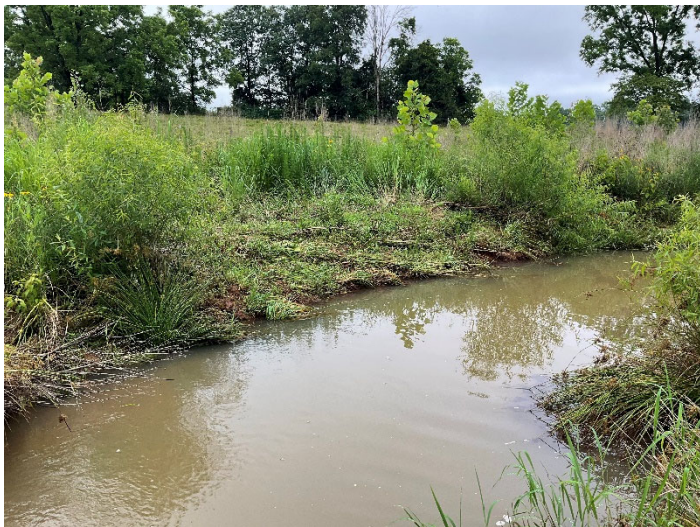
During MY3, approximately 25 feet of the left bank of Wyant Creek Reach 4 near station 128+75 (at cross-section 15) slumped and was eroding. The bank was successfully repaired in June 2023 (see Resolved Areas of Concern Photographs in Appendix A) and will be live staked during the dormant season. Three small beaver dams were removed on Wyant Reach 4 near station 136+00, 139+50, and 141+00 in the fall of 2023. One beaver dam was removed during the winter of 2023 on Wyant Creek Reach 1 near 102+50. A beaver dam was discovered on the upstream extent of Wyant Creek R1 during the November 29 site visit. This new dam will be removed during MY4 and documented in the monitoring report. Planted trees were damaged by beaver activity, but most of the damage was to willows which will grow back and not be permanent. These areas of concern are noted on the CCPV maps and will continue to be monitored for signs of instability. Refer to Appendix A for the Visual Stream Morphology Stability Assessment Table and Areas of Concern Photographs.

Wyant Creek R4 – STA:128+75 (XS15) Bank Repair (6/23/2023)

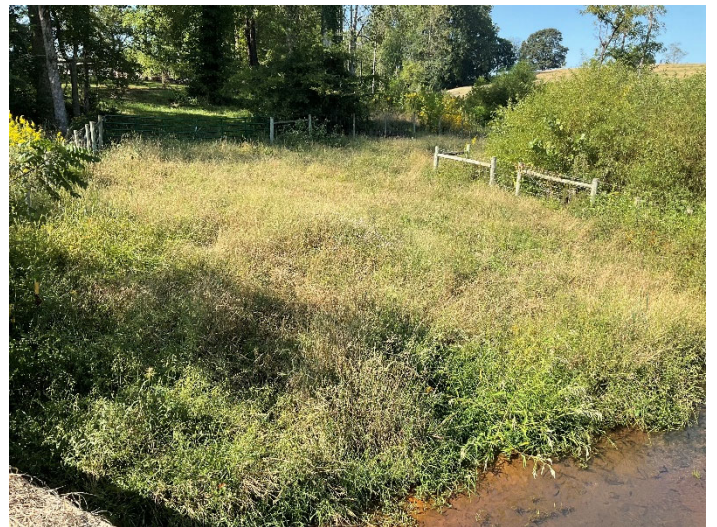
Wyant Creek R2 – Ford Crossing Vegetation Cover (9/19/2023)

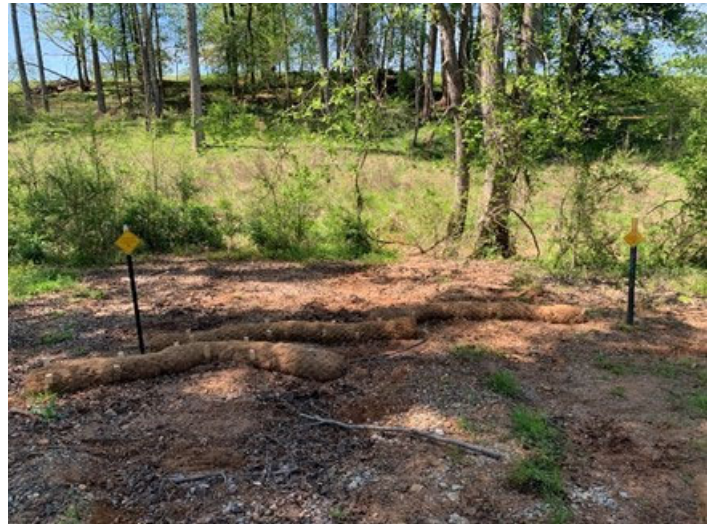
UT2 R3 – Off-Site Sediment Repair (5/2/2023)

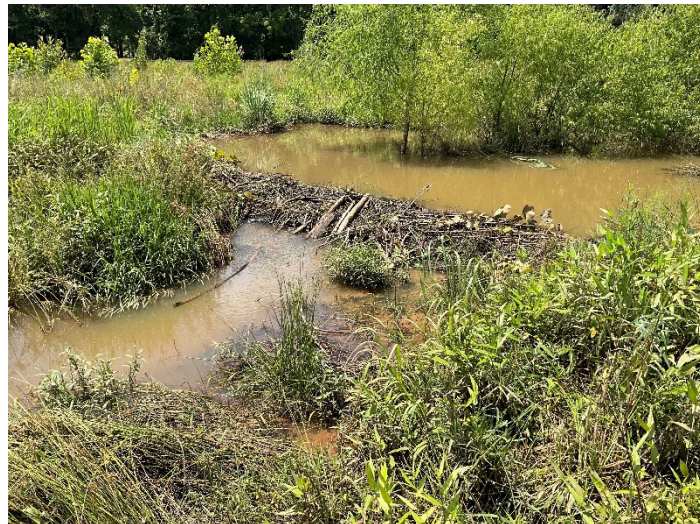
Wyant Creek R4 – STA:139+50 Beaver Dam Pre-Removal (6/23/2023)
