**MITIGATION REPORT
FOR
ZACKS' FORK CREEK STREAM RESTORATION**

**LENOIR, CALDWELL COUNTY, NORTH CAROLINA
CONTRACT # AW03003-A**

Revised: February 14, 2008

ZACKS FORK CREEK
November 29, 2006 Site Inspection

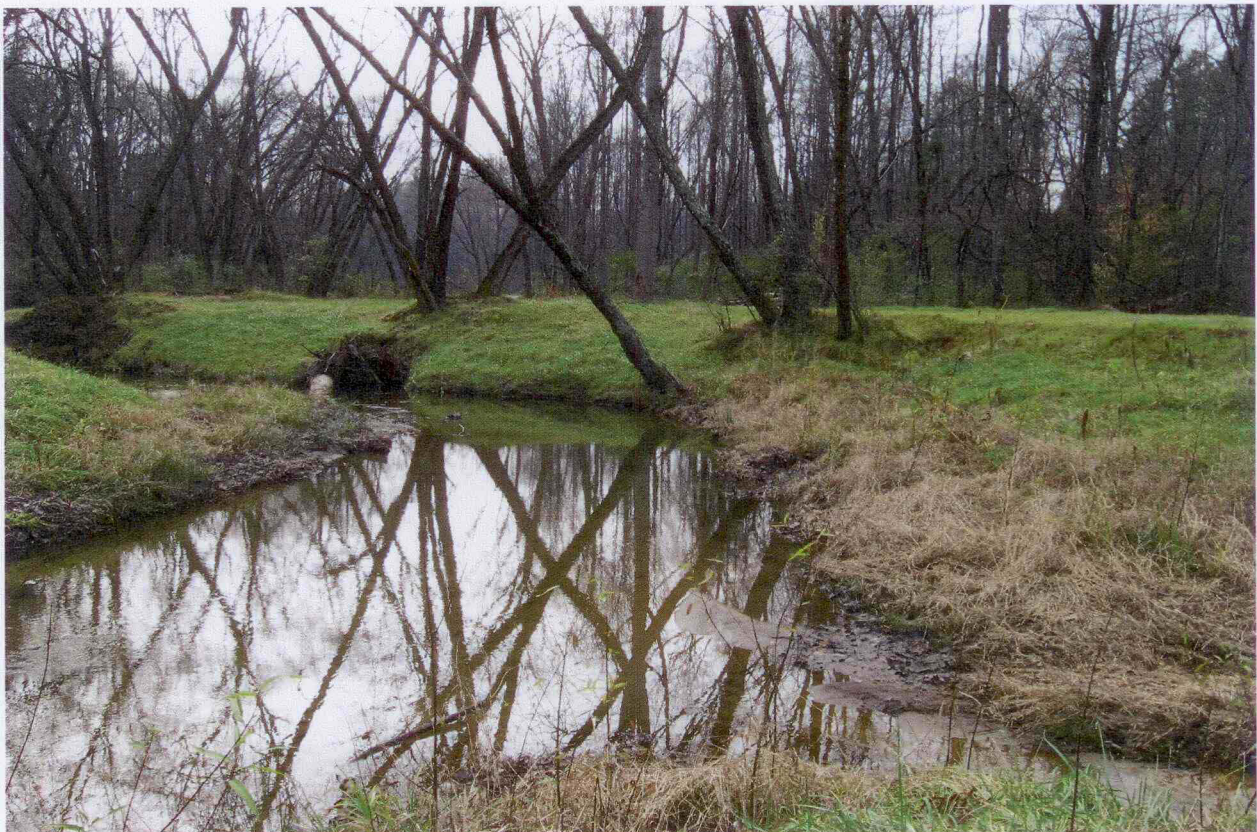
Picture 765

765	Looking downstream @ Station 37+00
767	Looking downstream @ Station 38+50
772	Looking upstream @ Station 45+50
774	Looking downstream @ Station 47+50 (last structure – Cross Vane) (Erosion at connection to bank to be addressed in Dec. 2006 Monitoring Report)
780	Looking downstream @ Station 49+00 (existing channel)
