# Zacks Fork Creek Stream Restoration Monitoring Report

Monitoring Year: 2006  
Measurement Year: 1  
As-Built Date: 2005  
NCEEP Project #: AW03003A

**Prepared by:** Environmental Services, Inc.  
3661 Alamance Road  
Burlington, NC 27215

# Zacks Fork Creek Year 1 (2006) Monitoring Report

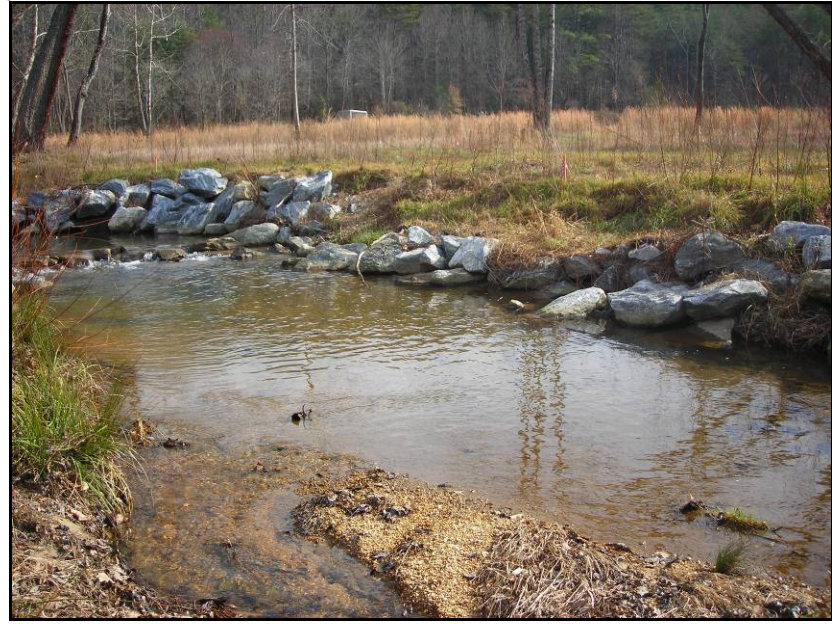
Photo Station 6

<b>Table 6. Stream Problem Areas</b>			
<b>Feature Issue</b>	<b>Station #</b>	<b>Suspected Cause</b>	<b>Photo #</b>
Aggradation/Bar Formation	13+50	Mid-stream bar	6
	16+50	Mid-stream bar	
Bank Scour	23+00	Water velocity	29
	26+50	Thalweg migration	
	33+50	Water velocity	
	34+25	Water velocity	
Structure Scour/Piping	36+00	Inadequate EC matting	44, 45

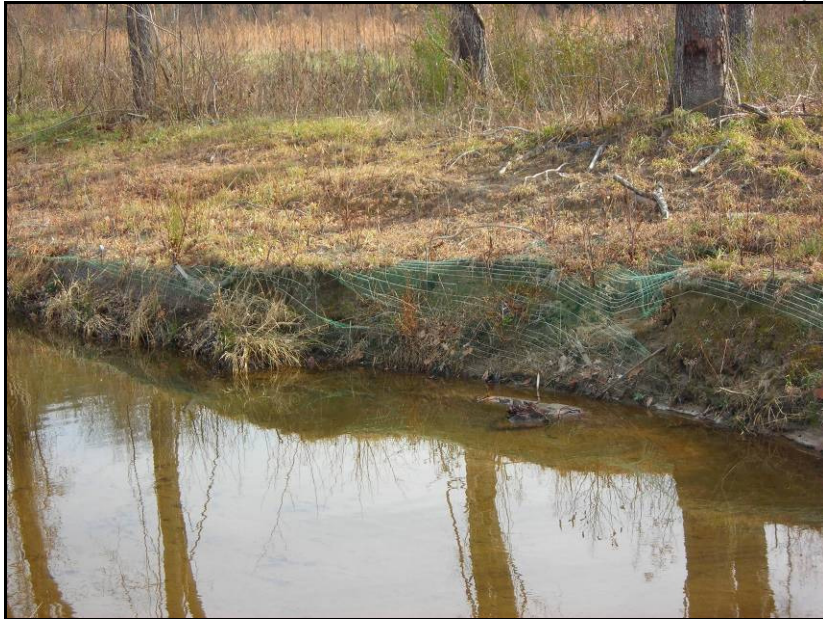
Photo Station 17

Table 4. Vegetative Problem Areas			
Feature/Issue	Station#/Range	Probable Cause	Photo #
Bare Bank	21+00 – 21+50	Needs additional live stakes	24
	23+00 – 21+75	Needs additional live stakes	
Displaced EC Matting	17+50 – 17+80	Not adequately secured.	17
	20+50 – 21+00	Not adequately secured.	
	27+00 – 27+25	Not adequately secured.

Several problem areas have been identified (Table 4, Figure 3) where erosion control matting is inadequately re-vegetated, undercut on outer bends, and/or displaced into the streambed. In these areas, the primary recommendation is to re-secure or replace the matting. Additional planting of willow live-stakes in these areas would help to establish longer-term bank stabilization.
