Zacks Fork Creek Stream Restoration Monitoring Report

Monitoring Year: 2007
Measurement Year: 2
As-Built Date: 2005
NCEEP Project #: AW03003A

Prepared by: Environmental Services, Inc.
3661 Alamance Road
Burlington, NC 27215

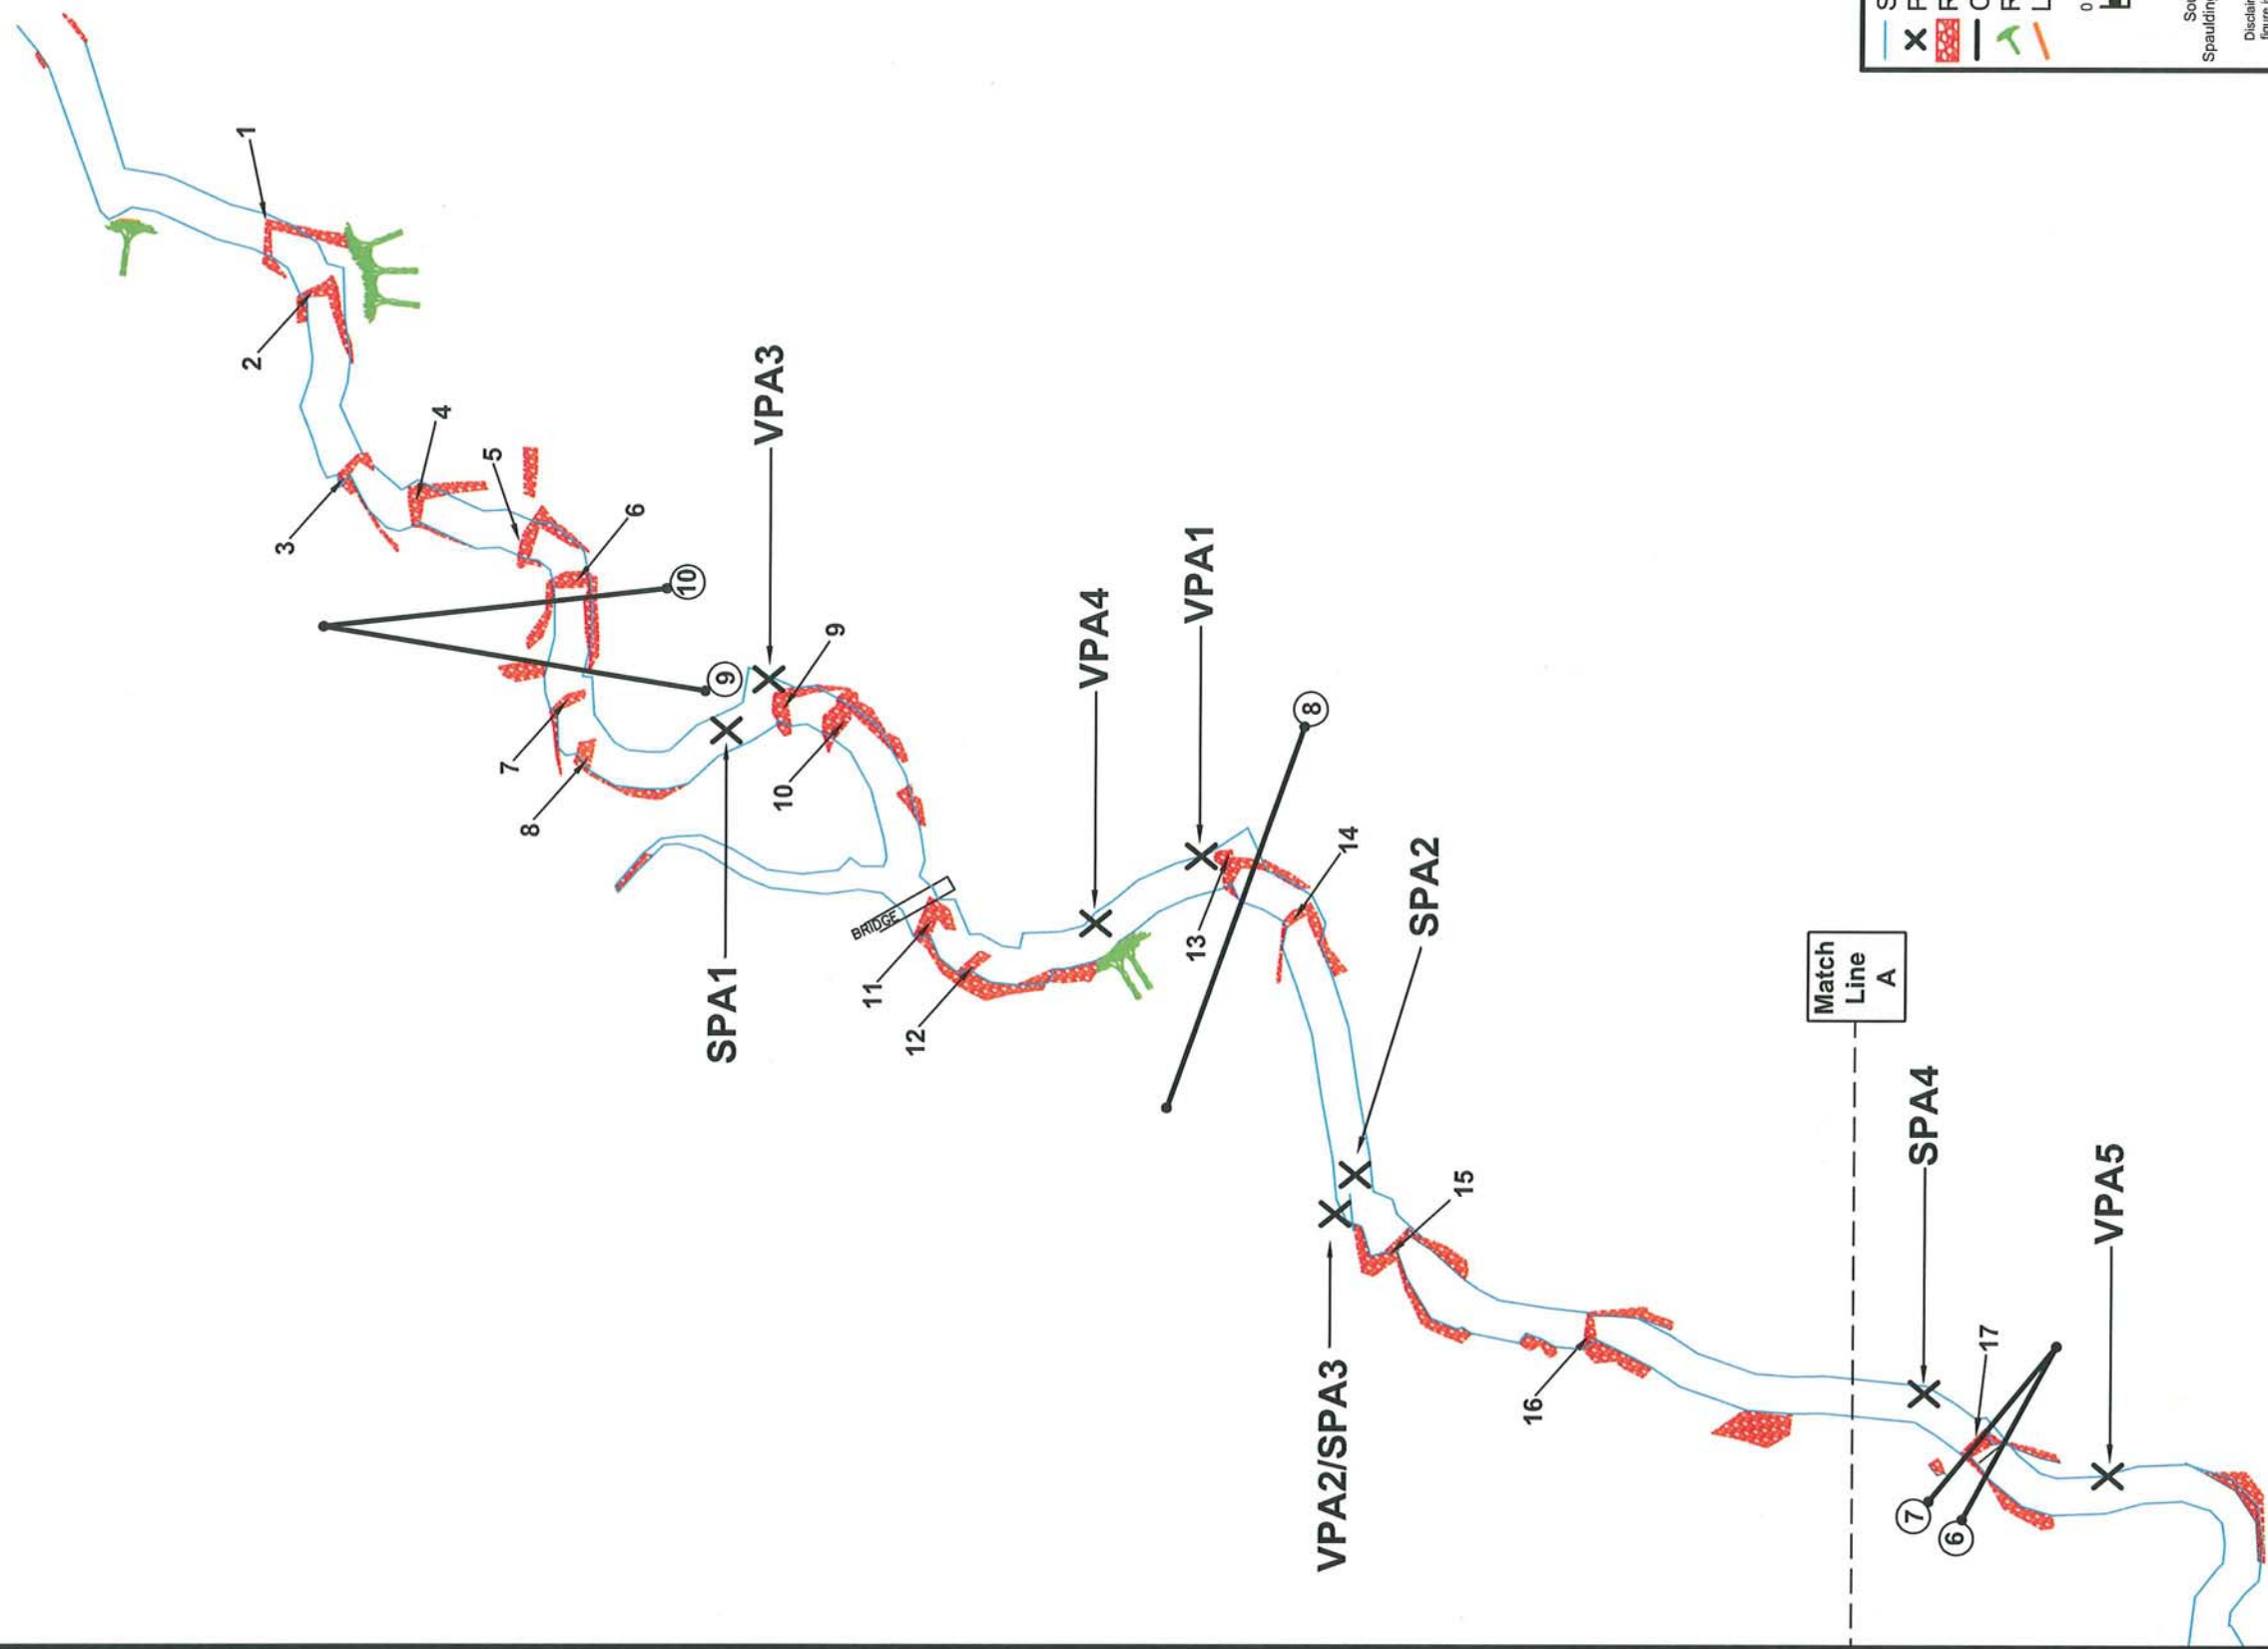
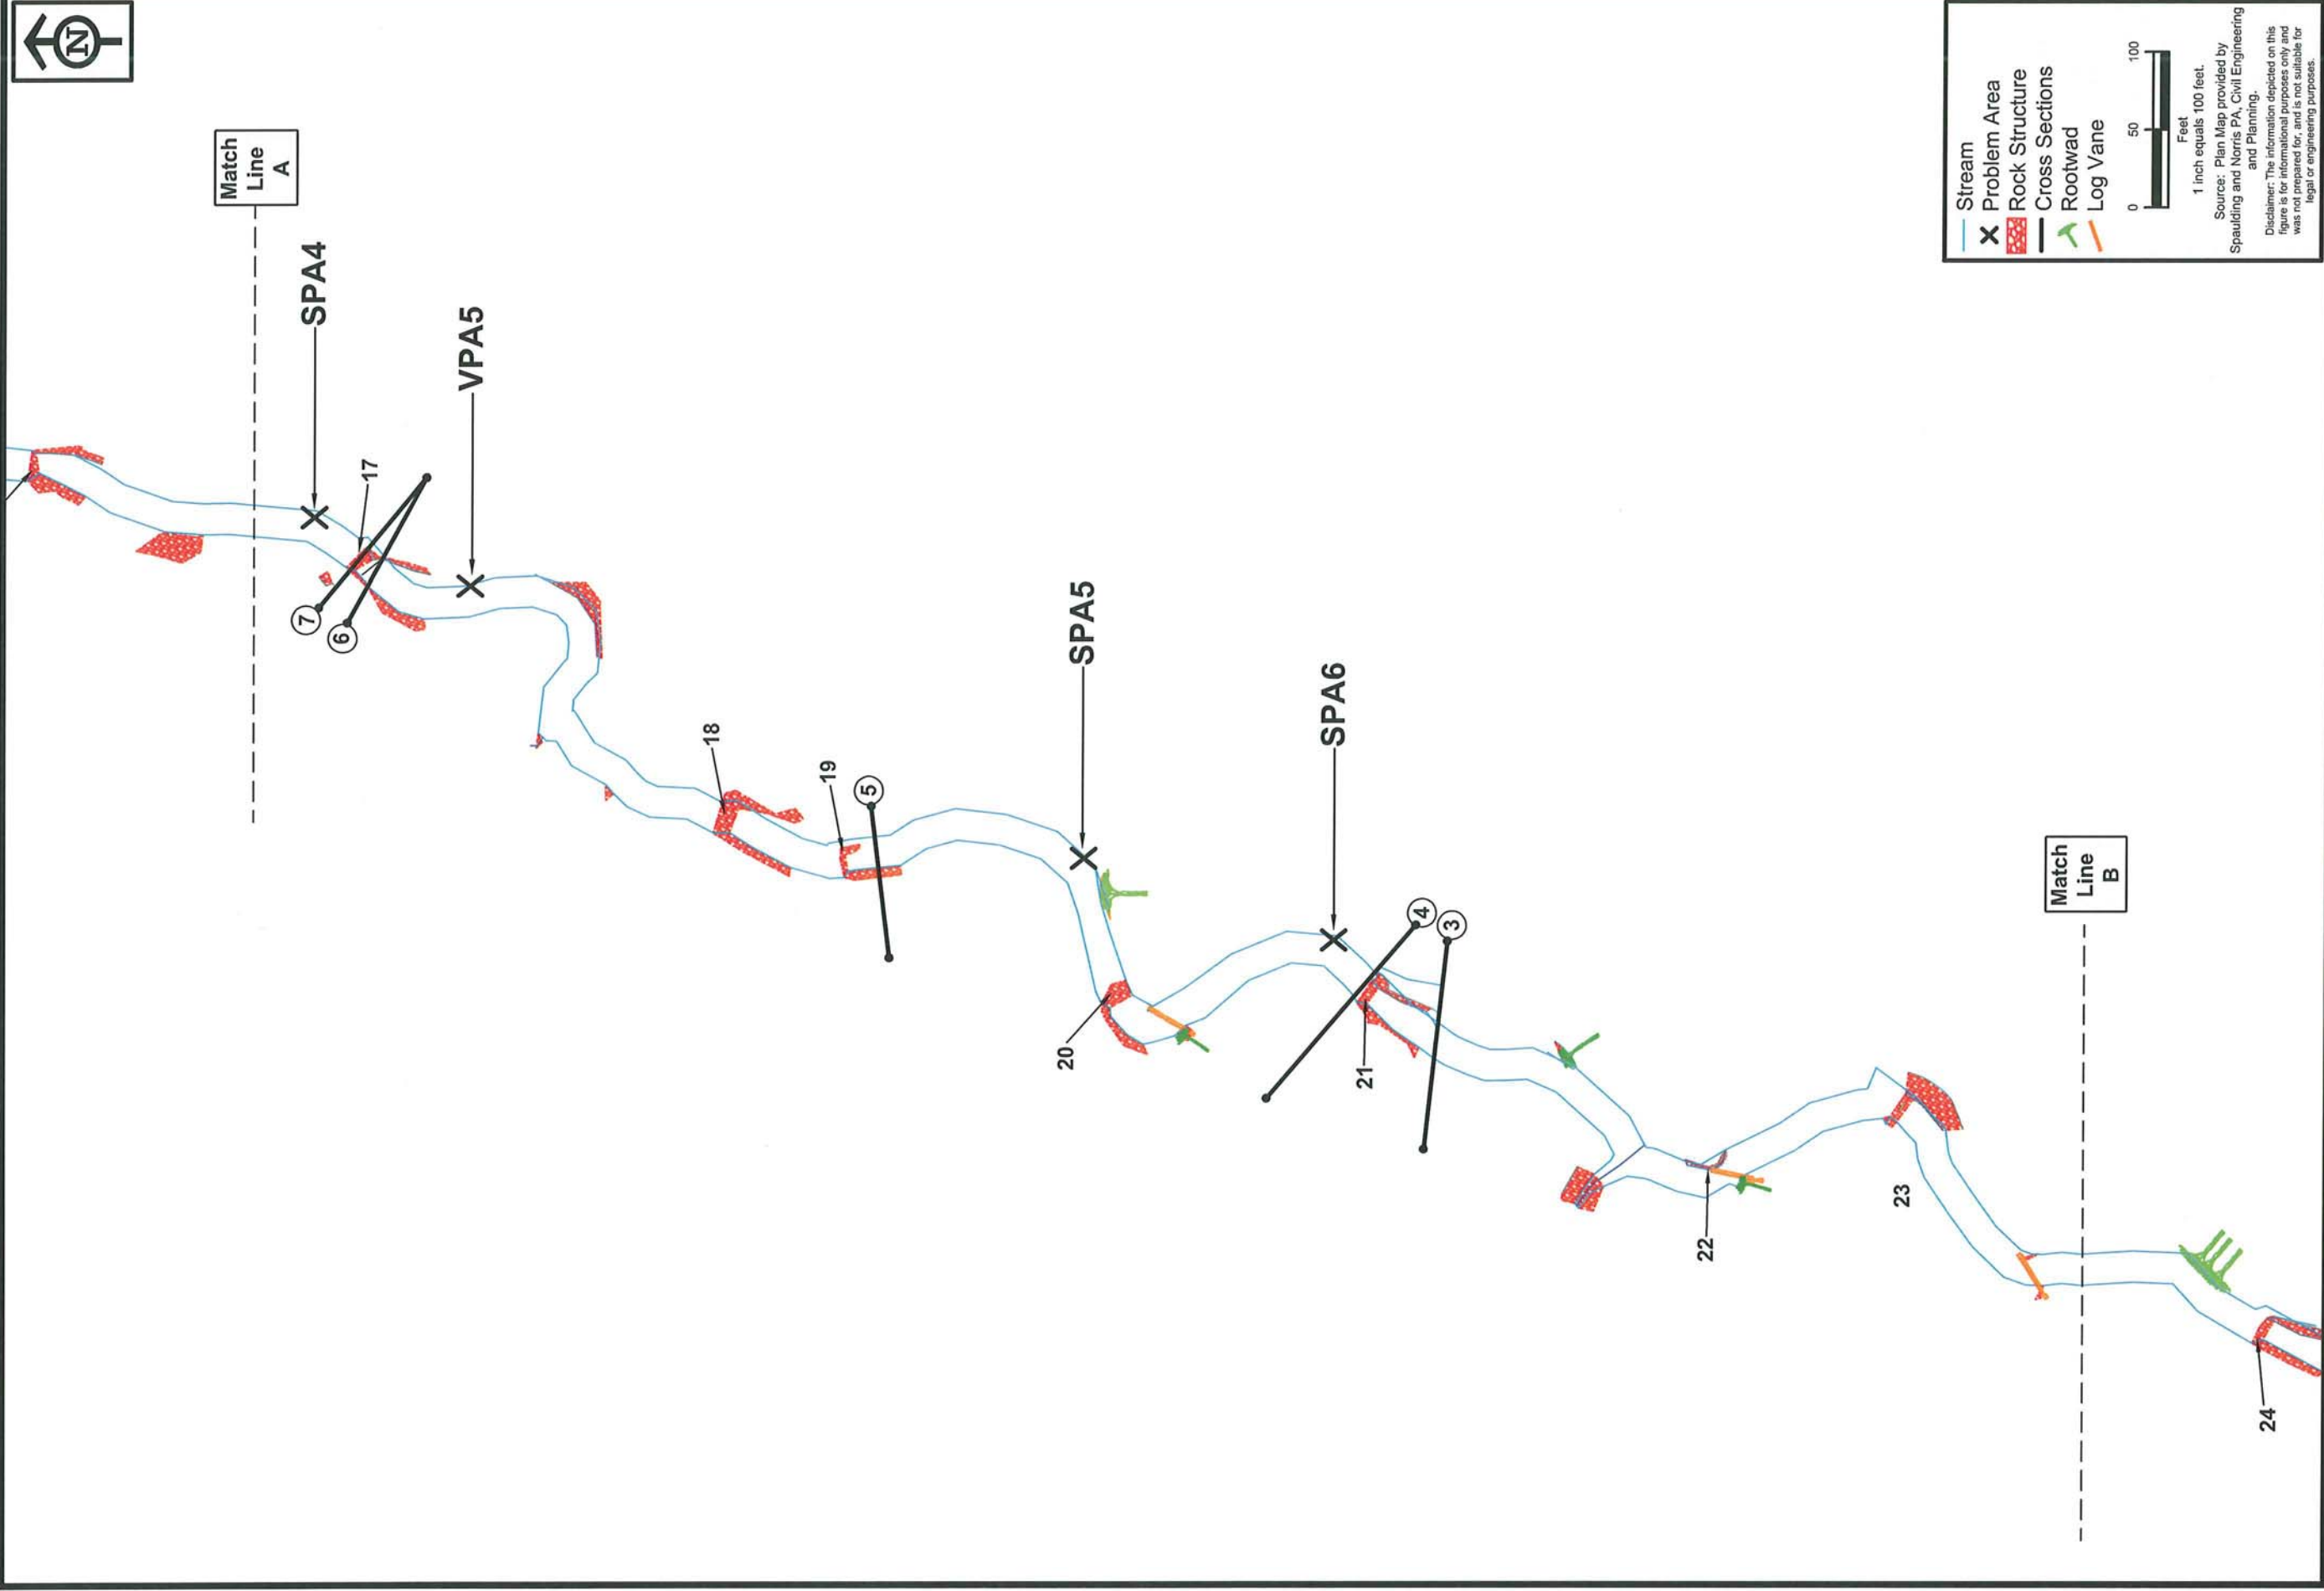
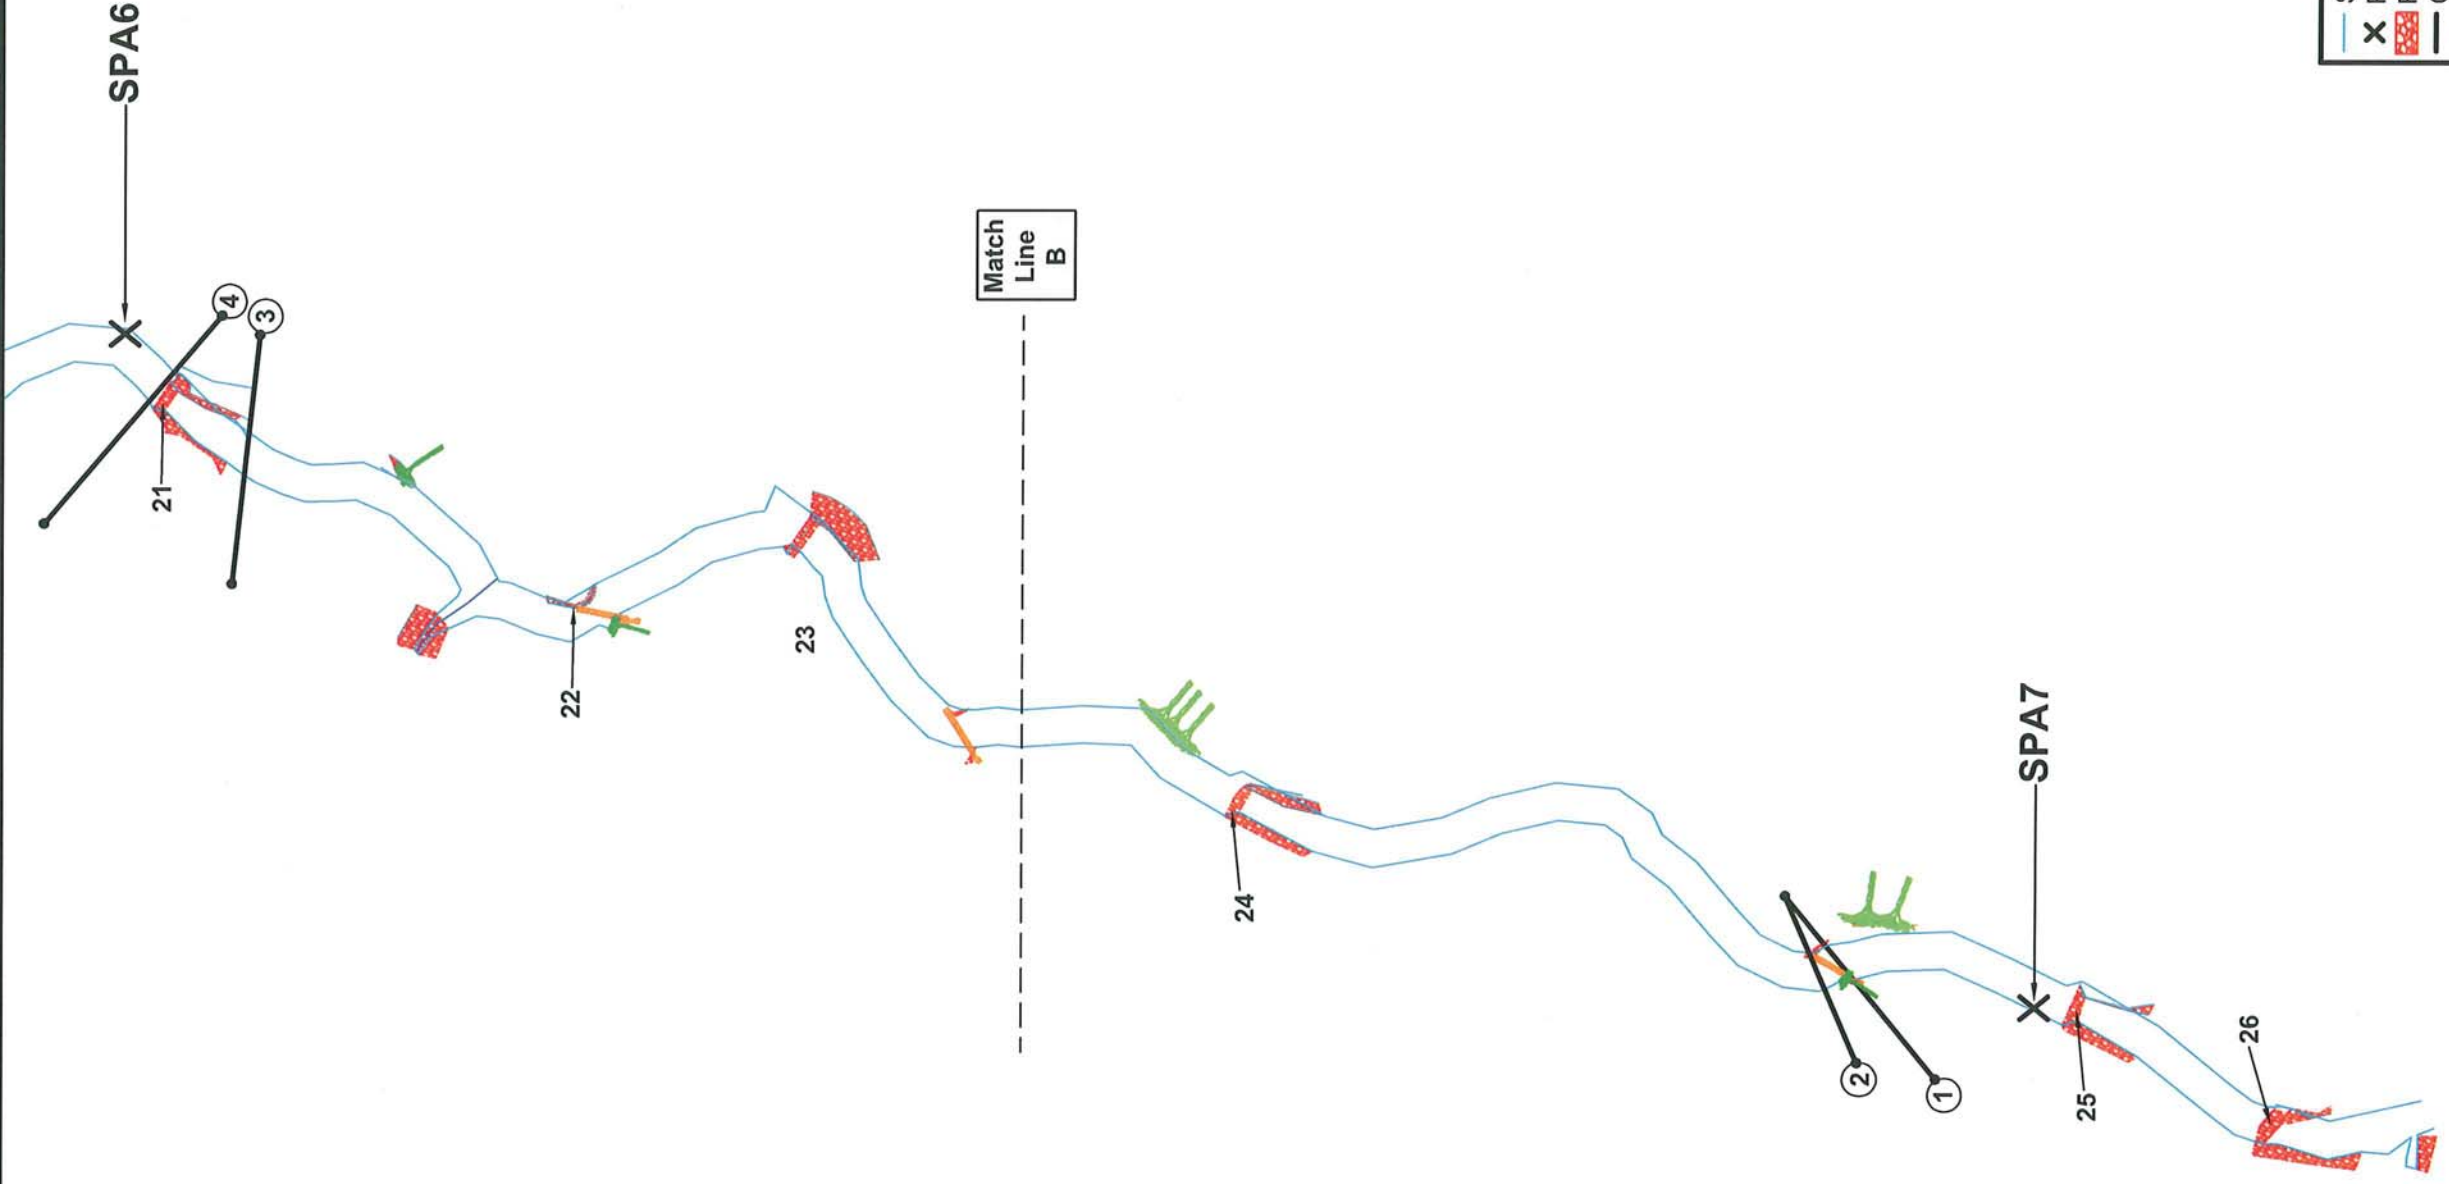
Few problem areas were identified (Table 4, Figure 3) where erosion control matting is inadequately re-vegetated, undercut on outer bends, and/or displaced into the streambed. In these areas, the primary recommendation is to replace the matting. Additional planting of willow live-stakes in these areas would help to establish longer-term bank stabilization. Vegetation plots 6, 8, and 10 had notably low stem counts, possibly due to past mowing activities. "No mowing" signs could be placed in these areas to prohibit these activities while enhancing native plant seed set and growth.

Feature Issue	Station #	Suspected Cause	Photo #
Aggradation/Bar Formation	13+50	Mid-stream bar has naturalized	21
	16+50	Mid-stream bar	
Bank Scour	23+00	Water velocity	33,34
	26+50	Thalweg migration	
	33+50	Water velocity	
	34+25	Water velocity	
Structure Scour/Piping	36+00	Inadequate EC matting	43,45
