Zacks Fork Creek Stream Restoration Monitoring Report

Monitoring Year: 2008
Measurement Year: 3
As-Built Date: 2005
NCEEP Project #: AW03003A

Submitted on December 17, 2008
Revised on February 4, 2009

Prepared by: Environmental Services, Inc.
524 S. New Hope Road
Raleigh, NC 27610

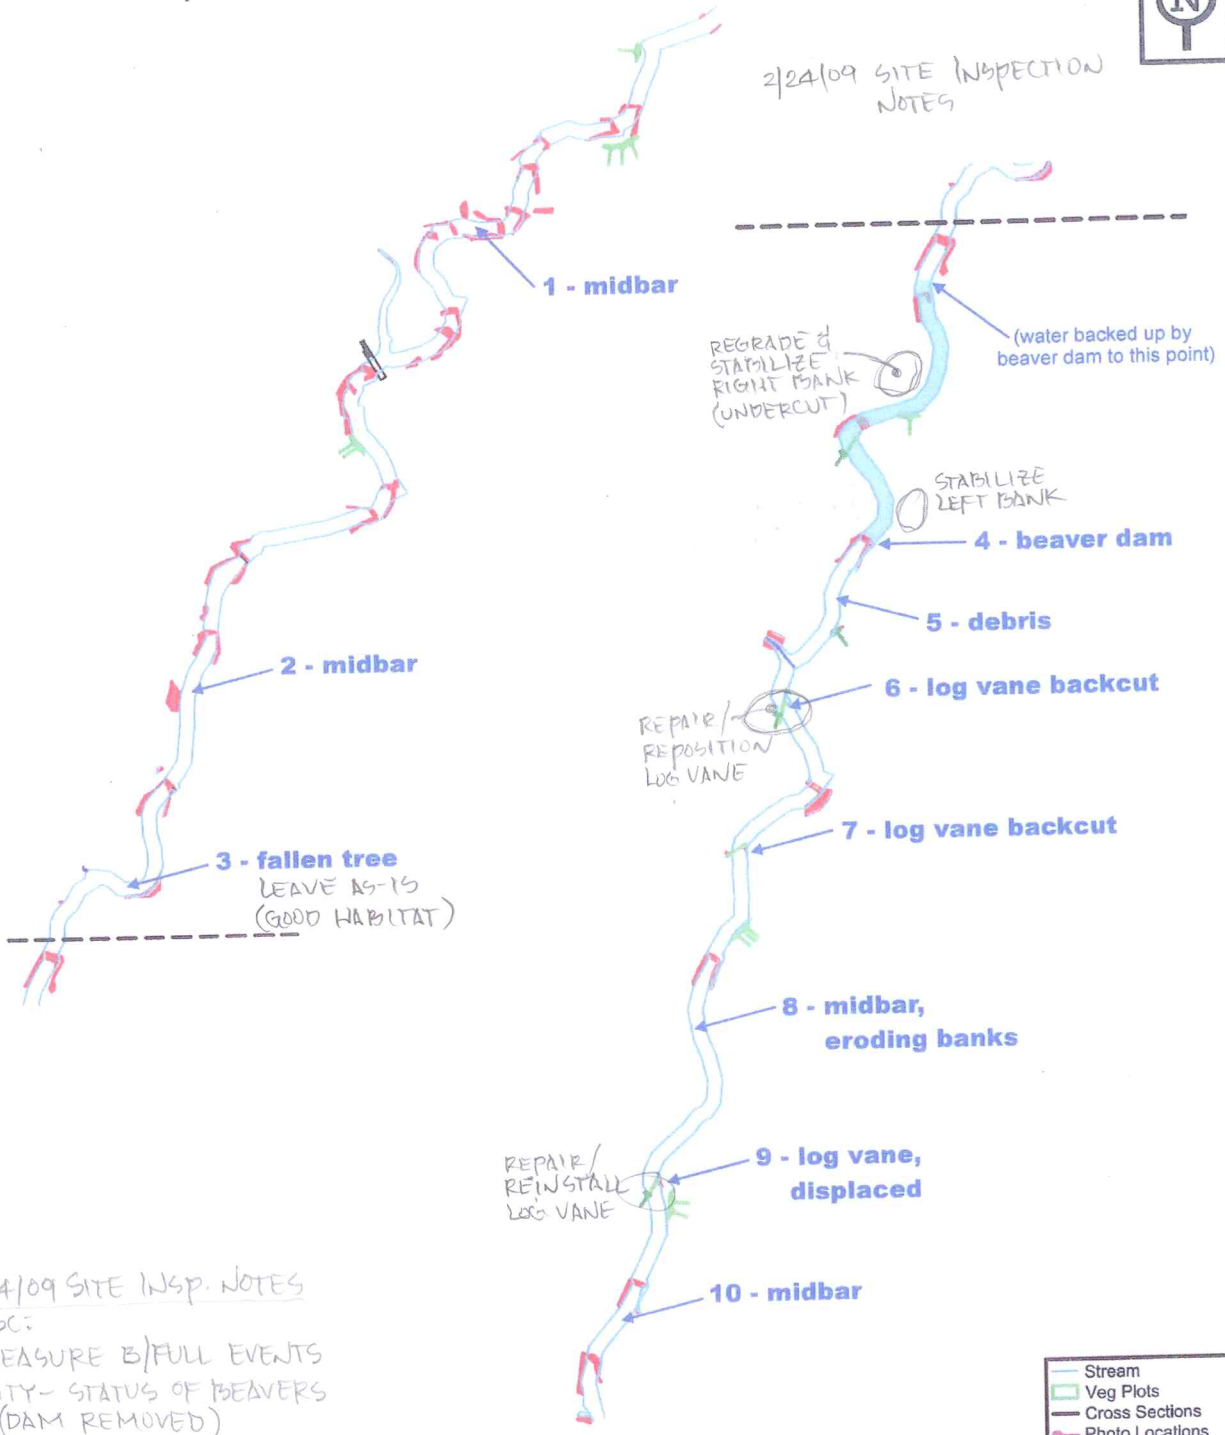
Stream Problem Areas
Zack's Fork, Year 3 Monitoring Report
 Lenoir, Caldwell County, North Carolina

- 1) MEASURE B/FULL EVENTS
- 2) CITY - STATUS OF BEAVERS (DAM REMOVED)
- 3) REPAIR RT. BANK @ REACH 26
- 4) PROVIDE LTR TO DESCRIBE REPAIRS
 - VERIFY DATA W/ESI
 - AMEND TR-3 REPORT??

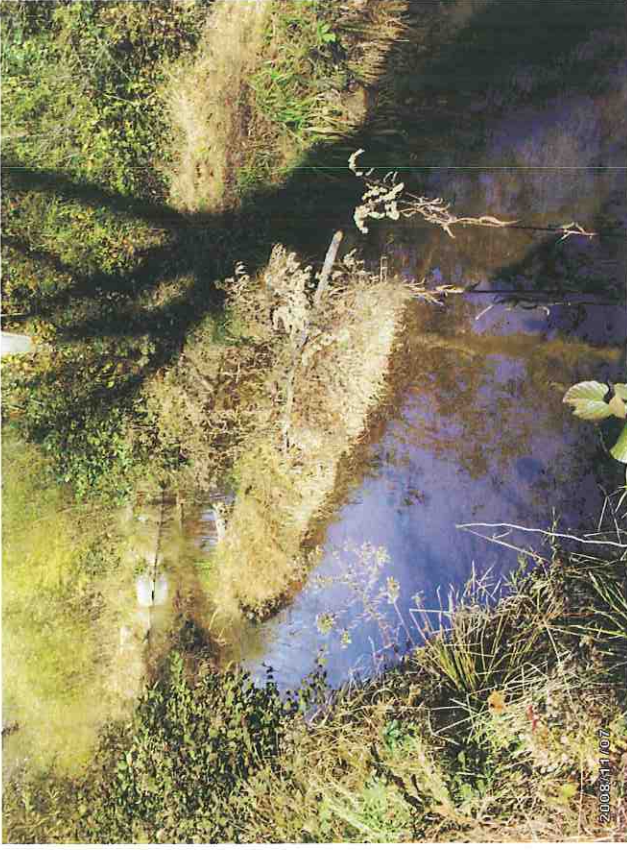
Problem Area 2 - vegetated mid-bar

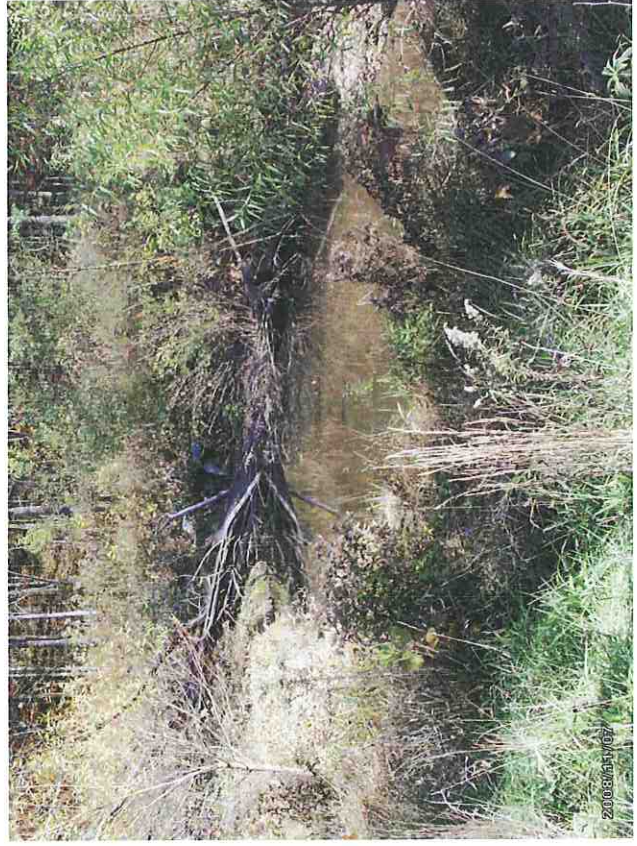
Problem Area 3 - fallen tree across channel

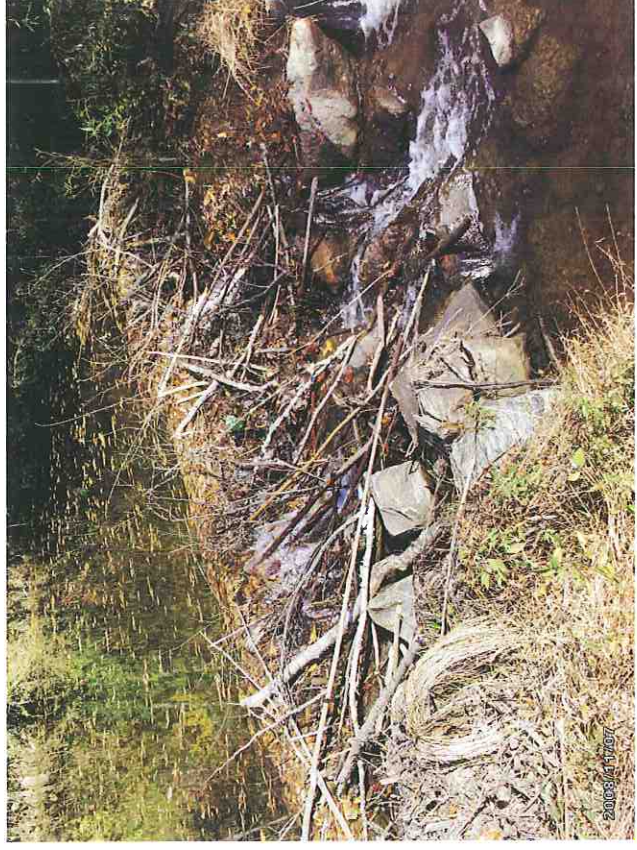
Problem Area 4 - beaver dam

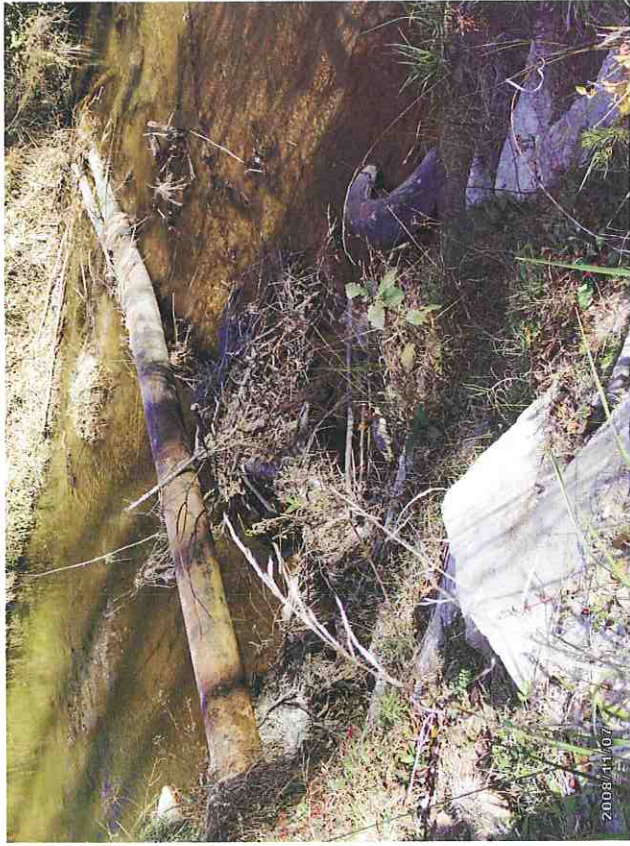
Problem Area 5 - pipe and debris, partial occlusion

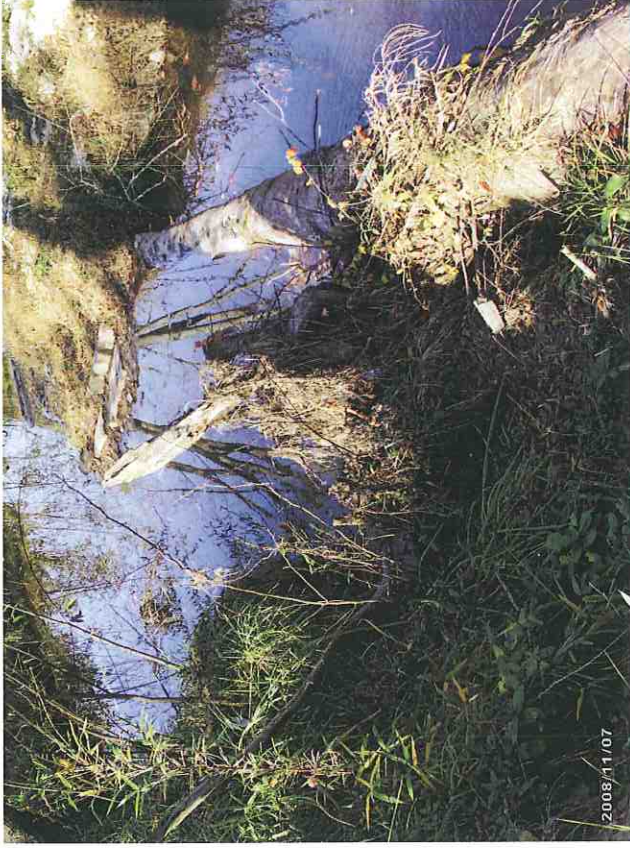
Problem Area 6 - log vane beginning to backcut

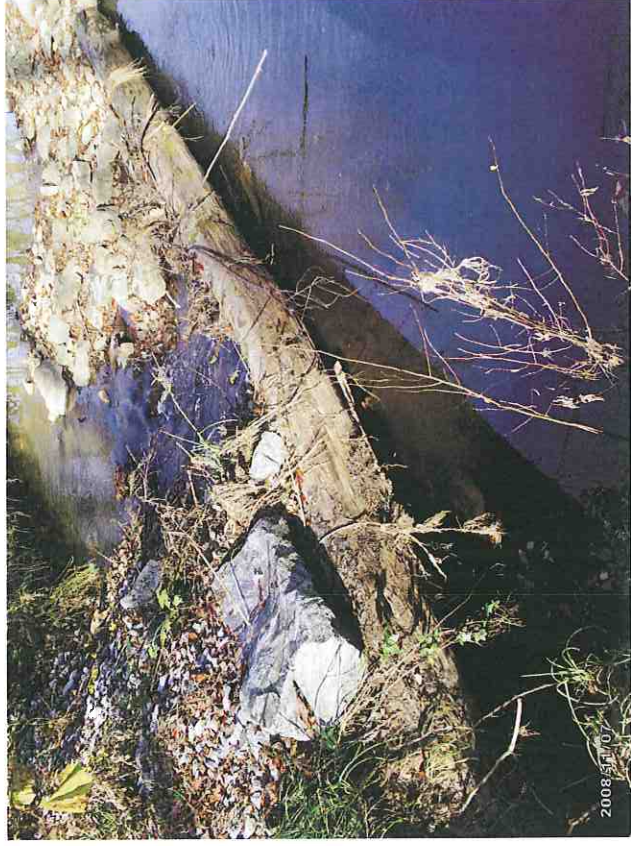
Problem Area 7 - log vane backcut
