Zacks Fork Creek Stream Restoration Monitoring Report

Monitoring Year: 2009
Measurement Year: 4
As-Built Date: 2005
NCEEP Project #: AW03003A

Zacks Fork Creek Year 4 (2009) Monitoring Report

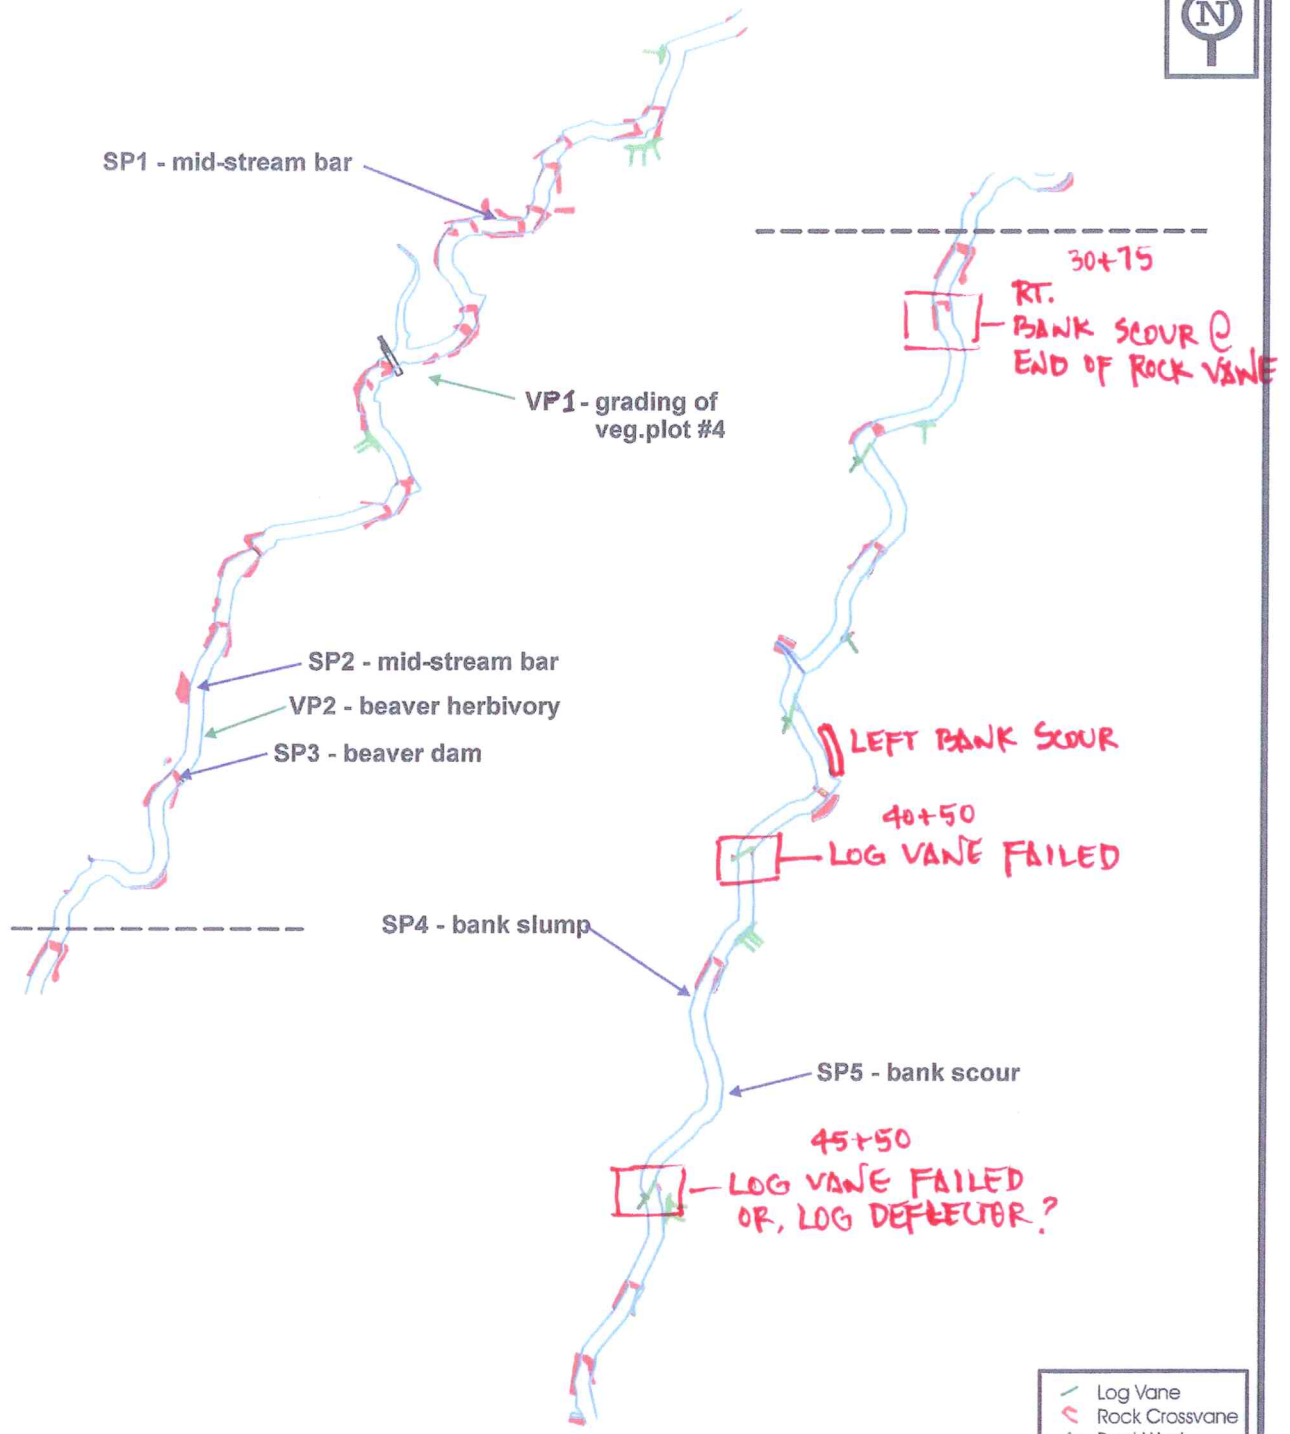
Stream Problem Areas
Zack's Fork, Year 4 Monitoring Report
 Lenoir, Caldwell County, North Carolina

This year's evaluation records no problems with any grade-control structures. There are five other areas with minor issues (Table 6 and Figure 4). Two mid-channel bars have formed; both bars as well as the adjacent banks are fully vegetated and appear stable at this time. There is a beaver dam which spans one crossvane and is causing the water level to be raised for several hundred feet upstream. A minor bank slump (approximately 15 LF) is largely re-vegetated and appears to have a stable geometry. Lastly, there is an area of bank scour (approximately 50 LF) on the outer (right) bank of one mid-reach meander. Representative photographs are given in Appendix E. Of note, the rock crossvane near the downstream end of the project which had shown backcutting and piping through the vane arms was repaired in March 2009 by repositioning of rock and placement of erosion control matting. This year's evaluation shows this structure to be stable and functioning properly.

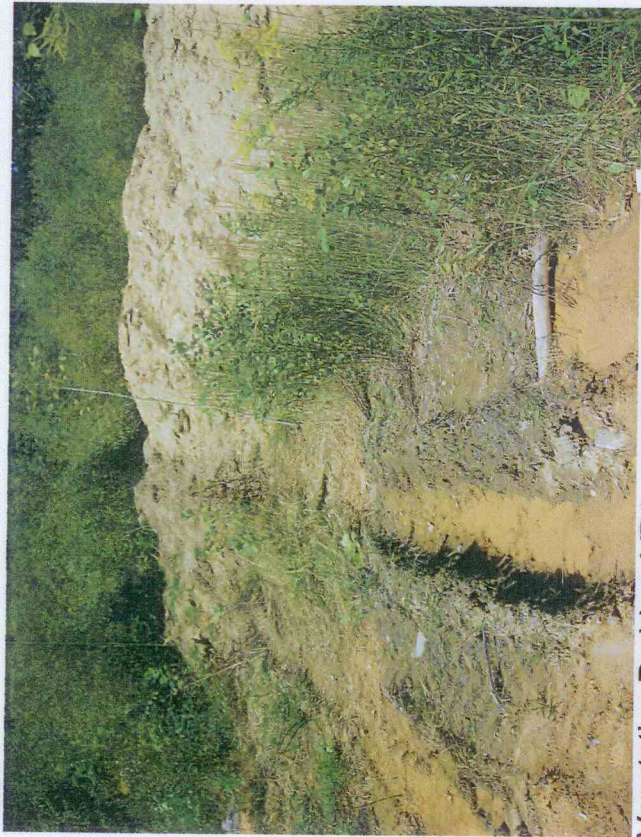
Feature/Issue	Station#	Probable Cause	Photo #
Herbivory	26+00	Beaver activity	VP2
Grading	18+00	Vegetation Plot 4 partially graded	VP1

Vegetative Problem VP1 - grading of VegPlot #4

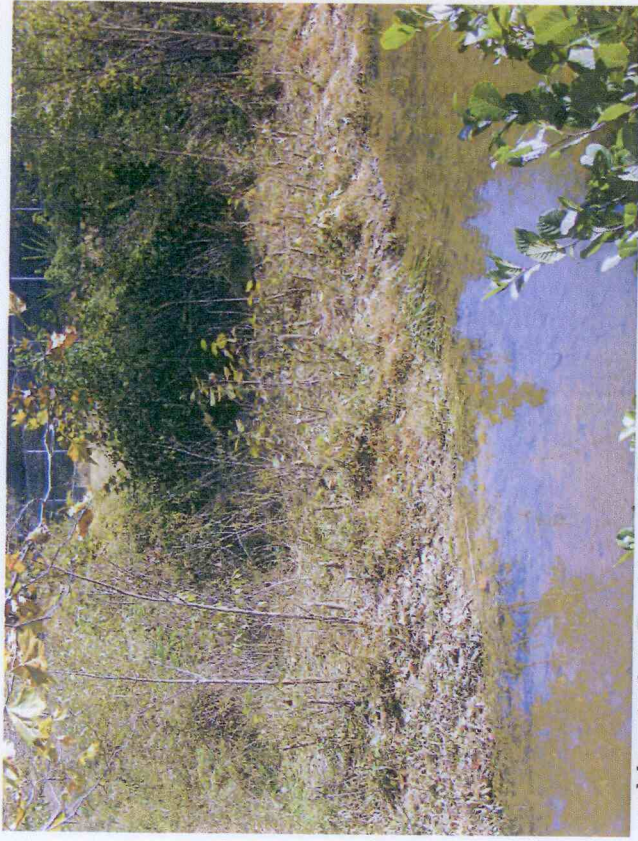
Two vegetative problem areas were identified in the Year 4 assessment (Table 4). There is one area of extreme beaver herbivory where virtually all the trees, primarily willows, have been gnawed off at 1'-2' above the ground. This is likely a scenario which will recur unless the beavers are removed or eliminated; however, it is also likely that this area will revegetate naturally from sprouting of the gnawed stumps and/or natural seed recruitment from the surrounding upper canopy. The other area is Vegetation Plot #4 which has been partially re-graded by heavy equipment, apparently to improve drainage or stormwater flow near the bridge and walking trail. This grading extends to within 10' of the stream bank; however the remaining riparian vegetation is vigorous and appears at this point to be sufficient to maintain bank integrity. S&N contacted the City Public Works Staff to discuss their activities and re-vegetation of the area. This is the second time at which the City Staff has encroached into the project area and S&N has discussed this with them. The City has indicated that they may be willing re-vegetate as recommended using appropriate year-class specimen.

Vegetative Problem VP2 - beaver herbivory

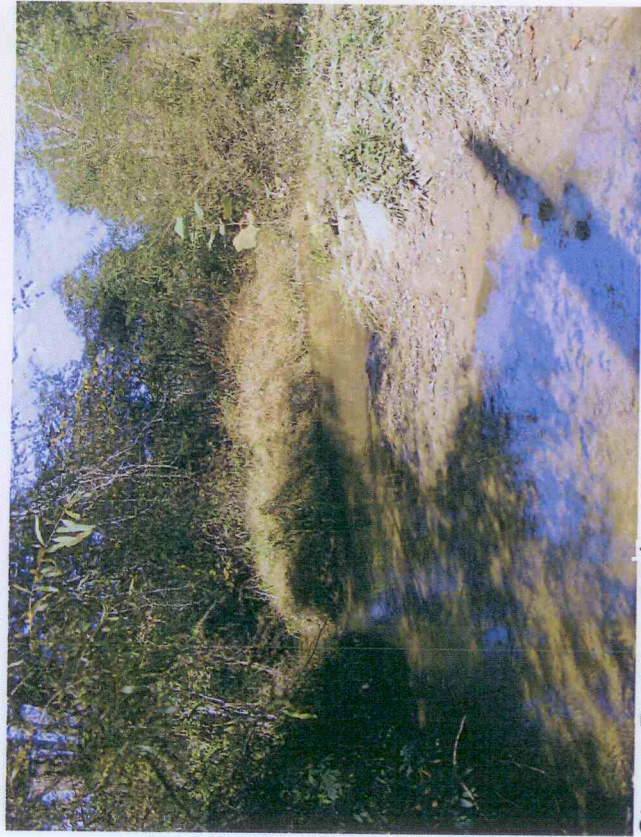
Feature Issue	Station #	Suspected Cause	SP #	Photo #
Bar Formation	15+50	Mid-stream bar	1	SP1
	25+25	Mid-stream bar	2	SP2
Flow Occlusion	26+50	Beaver dam	3	SP3
Bank Slump	43+25	Water velocity	4	SP4
Bank Scour	44+50	Water velocity	5	SP5

Stream Problem SP1 - mid-stream bar (in background)

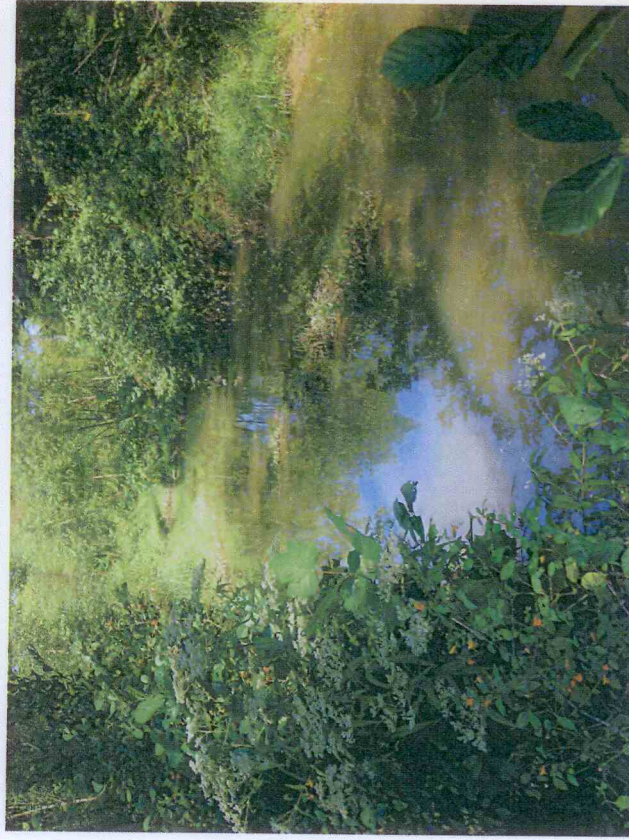
Stream Problem SP2 - mid-stream bar (partially submerged)

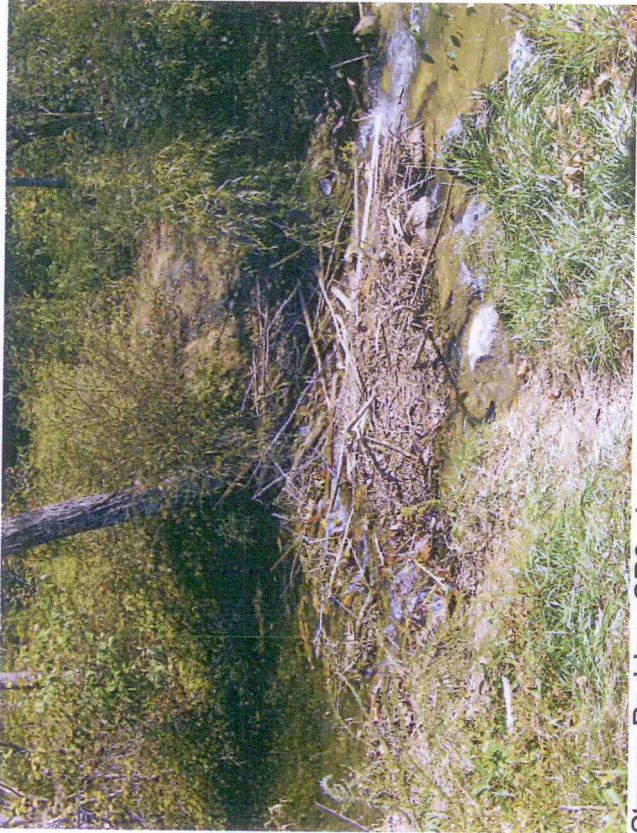
Stream Problem SP3 - beaver dam

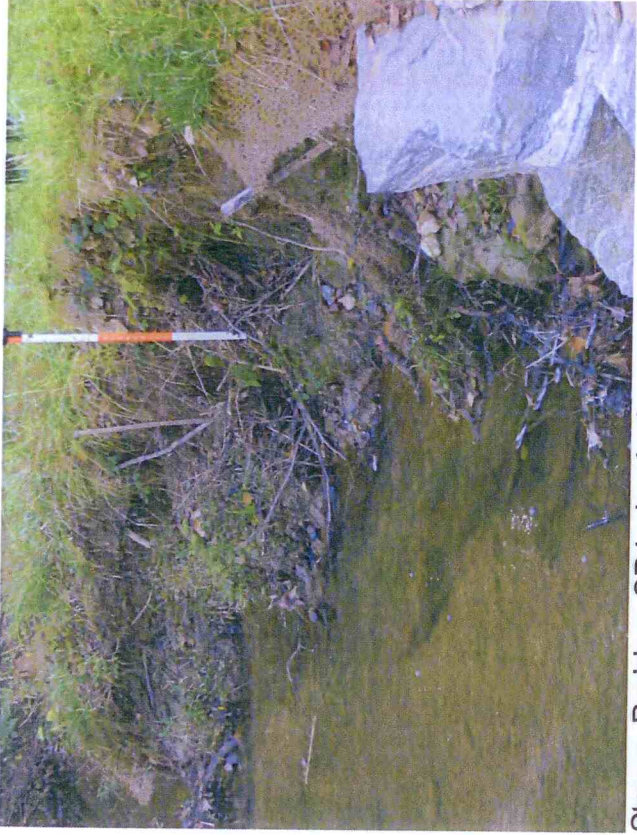
Stream Problem SP4 - bank slump

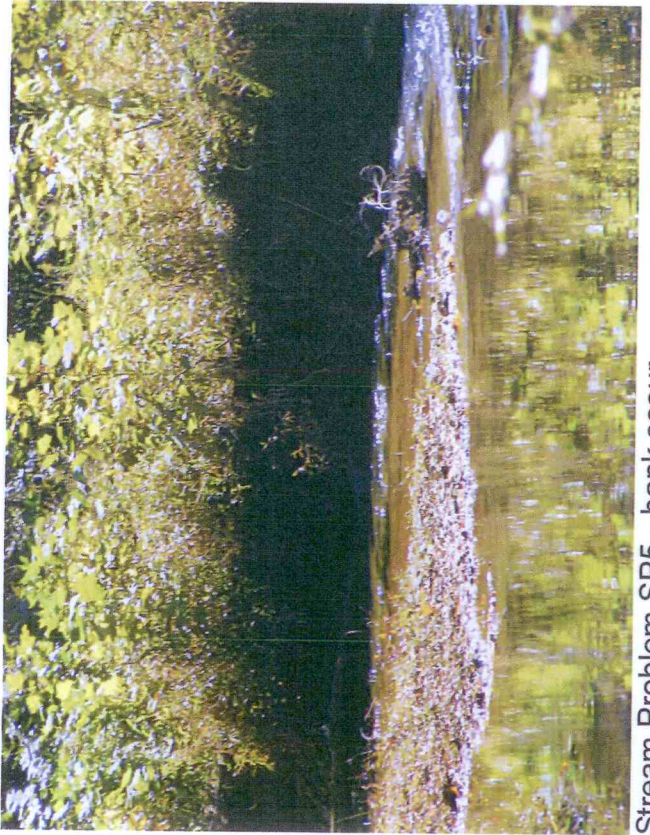
Stream Problem SP5 - bank scour
