# Zacks Fork Creek Stream Restoration Monitoring Report

Monitoring Year: 2010  
Measurement Year: 5  
As-Built Date: 2005  
NCEEP Project #: AW03003A

# Zacks Fork Creek Year 5 (2010) Monitoring Report

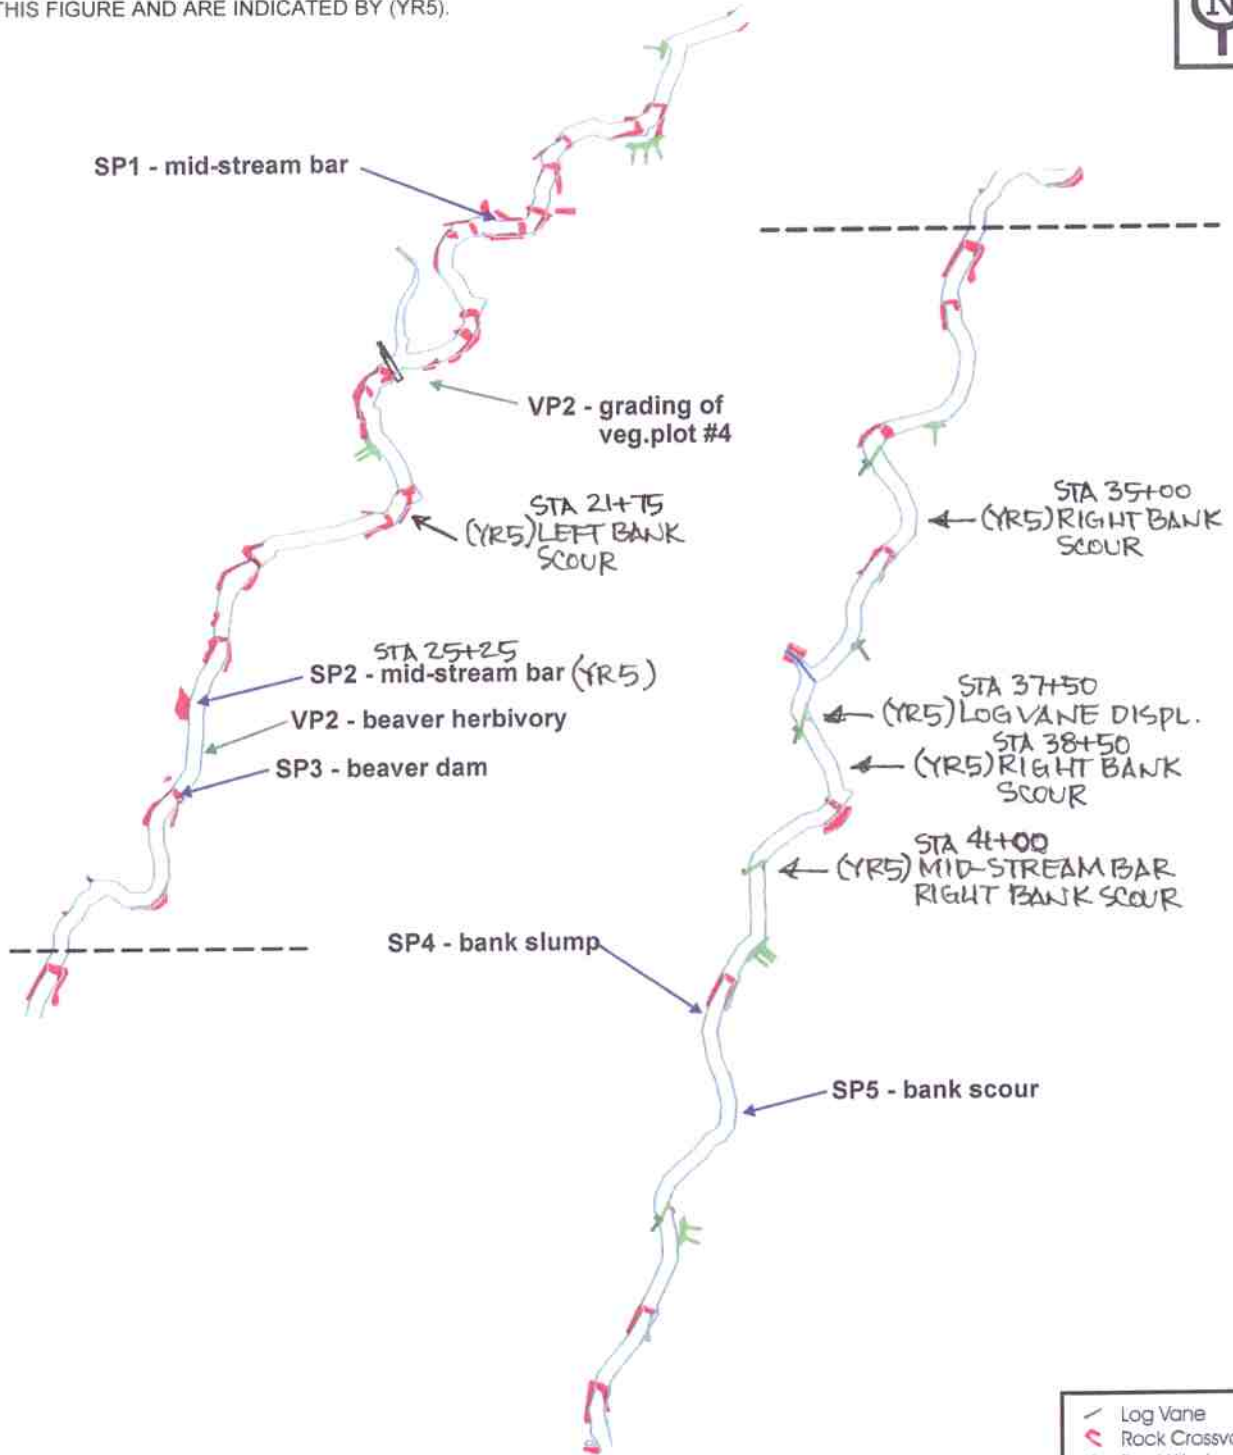
Stream Problem Areas  
**Zack's Fork, Year 4 Monitoring Report**  
 Lenoir, Caldwell County, North Carolina

NOTE: STREAM PROBLEM AREAS REFERENCED IN THE YEAR 5 MONITORING REPORT HAVE BEEN ADDED TO THIS FIGURE AND ARE INDICATED BY (YR5).

Feature Issue	Station #	Suspected Cause	Location #	Photo #
Aggradation / Bar Formation	25+25	Mid-stream bar	2	2
	41+00	Mid-stream bar	6	6
Bank Scour	21+75	Water velocity	1	1
	35+00	Water velocity	3	3
	38+50	Lack of vegetation	5	5
	41+50	Water velocity	7	7
Structure Change	37+50	Log vane displaced	4	4

As previously referenced in the Executive Summary, repairs to the stream problem areas noted above, in particular bank stabilization, were successfully completed in April 2011. Photographs of these areas are also included in Appendix D.

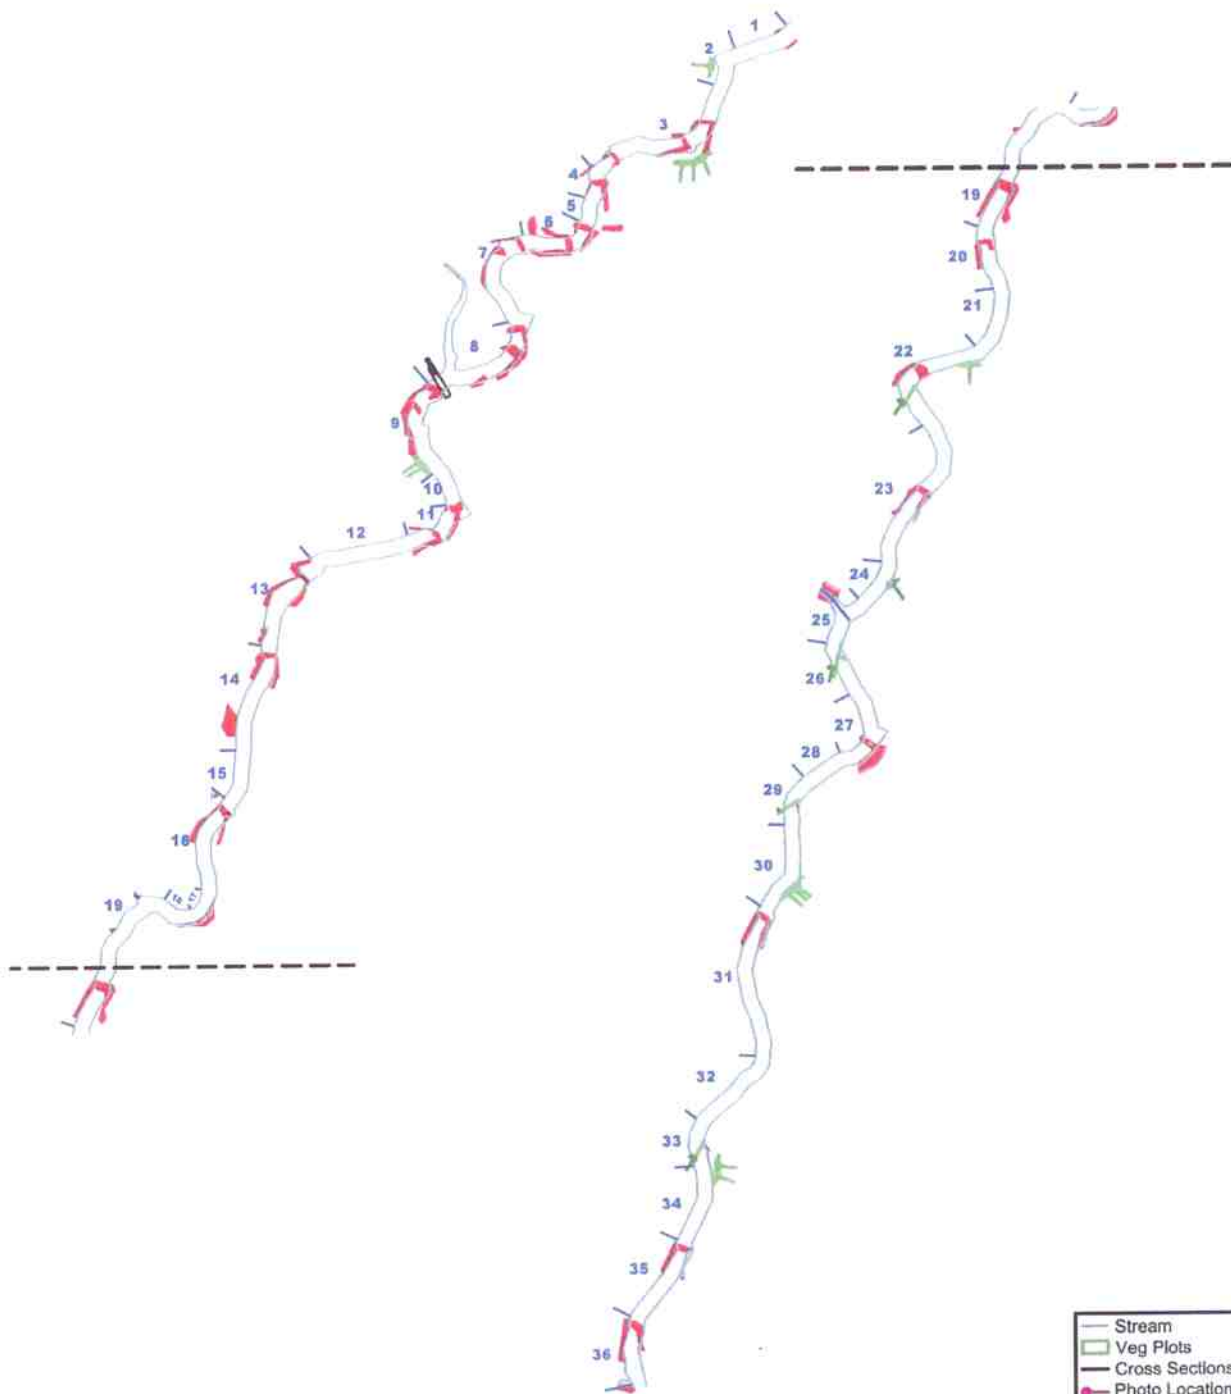
BEHI/NBS Reaches, Right Bank  
**Zack's Fork, Year 3 Monitoring Report**  
Lenoir, Caldwell County, North Carolina

**Table 6R. Bank Erosion Hazardous Index (BEHI) and Near-Bank Stress (NBS) Assessments**

<i>Reach</i>	<i>BEHI Adjective Rating</i>	<i>NBS Adjective Rating</i>	<i>Study Bank Height</i>	<i>Length</i>
Right Bank 1	Low	Low	2.5	68
Right Bank 2	Low	Low	2.0	77
Right Bank 3	Very Low	Low	2.5	220
Right Bank 4	Very Low	Very Low	2.5	35
Right Bank 5	Low	Moderate	3.0	37
Right Bank 6	Low	Moderate	2.5	94
Right Bank 7	Low	Moderate	3.0	153
Right Bank 8	Low	Very Low	3.0	128
Right Bank 9	Very Low	Very Low	3.0	171
Right Bank 10	Low	Low	3.0	43
Right Bank 11	Very Low	Low	3.0	77
Right Bank 12	Very Low	Very Low	3.5	126
Right Bank 13	Low	Low	3.0	153
Right Bank 14	Low	Very Low	3.5	157
Right Bank 15	Very Low	Low	3.0	65
Right Bank 16	Low	Low	3.0	139
Right Bank 17	Moderate	High	3.5	24
Right Bank 18	Moderate	Low	3.5	71
Right Bank 19	Low	Low	3.0	225
Right Bank 20	Moderate	Moderate	4.0	100
Right Bank 21	Low	Very Low	2.5	70
Right Bank 22	Low	Moderate	3.5	190
Right Bank 23	Very Low	Low	3.0	195
Right Bank 24	Very Low	Low	3.0	73
Right Bank 25	Low	Very Low	4.0	65

Right Bank 26	Very High	Very High	5.5	70
Right Bank 27	Moderate	Moderate	4.5	118
Right Bank 28	Low	Moderate	3.0	56
Right Bank 29	Moderate	Very High	4.0	69
Right Bank 30	Low	Very Low	3.5	136
Right Bank 31	Very High	Extreme	5.0	197
Right Bank 32	Moderate	Moderate	4.0	105
Right Bank 33	Very High	Very High	5.0	105
Right Bank 34	Moderate	Moderate	3.0	88
Right Bank 35	Low	High	3.0	107
Right Bank 36	Low	High	3.5	93
			<i>total...</i>	<b>3900</b>

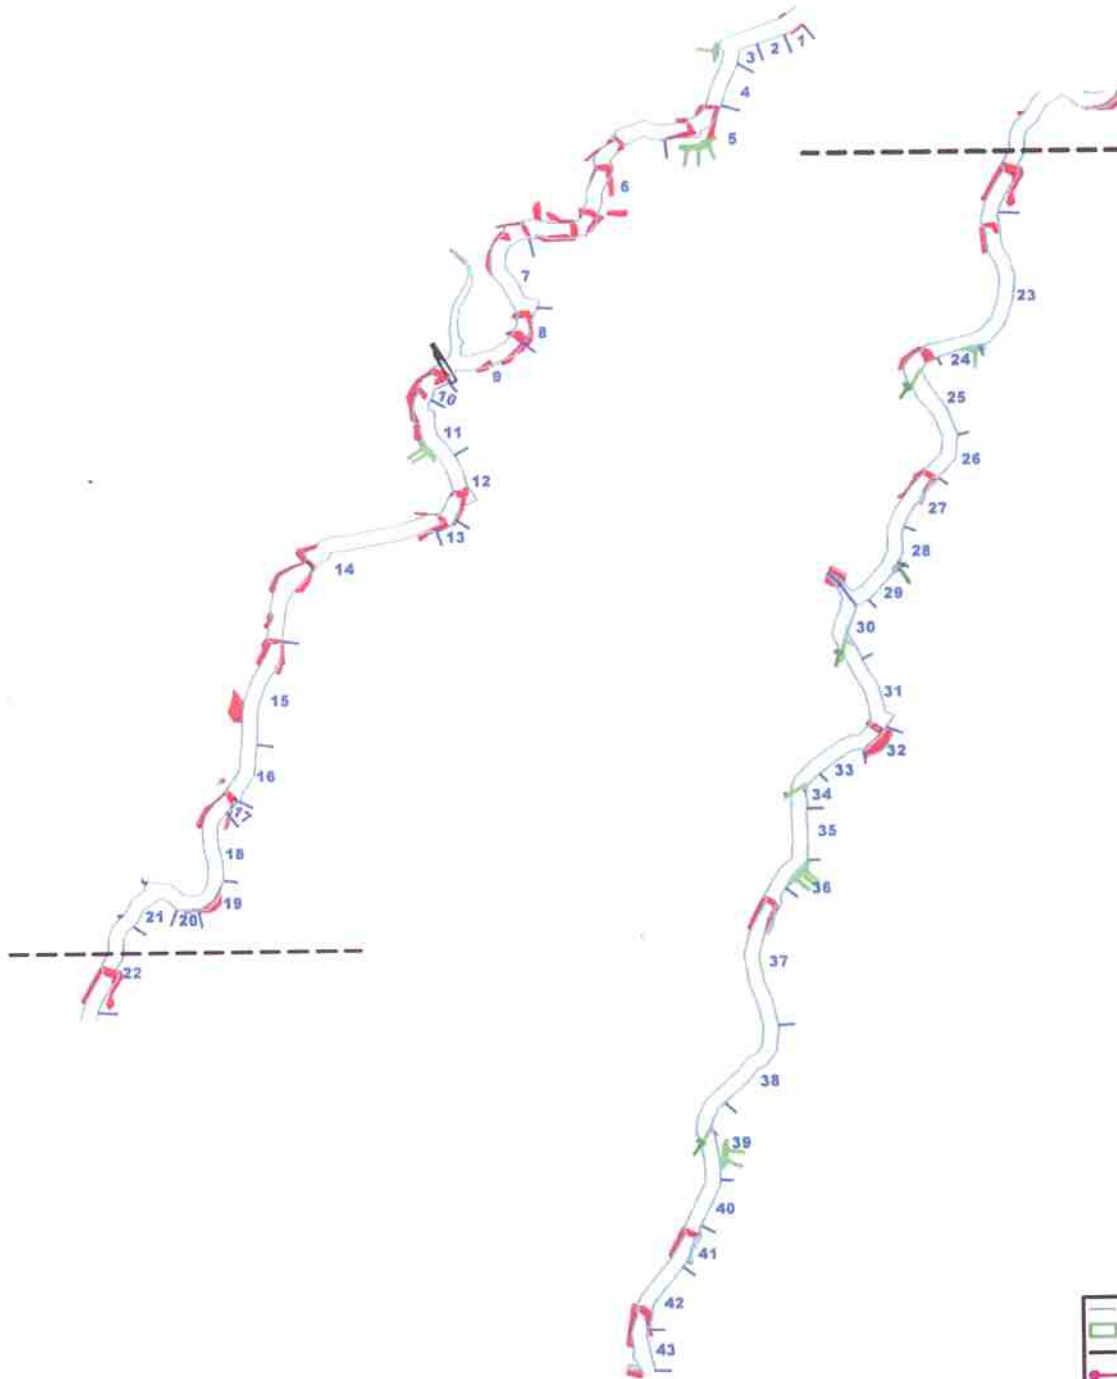
BEHI/NBS Reaches, Left Bank  
**Zack's Fork, Year 3 Monitoring Report**  
Lenoir, Caldwell County, North Carolina

**Table 6L. Bank Erosion Hazardous Index (BEHI) and Near-Bank Stress (NBS) Assessments**

<i>Reach</i>	<i>BEHI Adjective Rating</i>	<i>NBS Adjective Rating</i>	<i>Study Bank Height</i>	<i>Length</i>
Left Bank 1	Low	Moderate	3.0	25
Left Bank 2	Low	Moderate	3.0	45
Left Bank 3	Low	Very Low	2.5	58
Left Bank 4	Low	Low	2.0	60
Left Bank 5	Low	Low	3.0	101
Left Bank 6	Low	Low	3.0	217
Left Bank 7	Very Low	Very Low	2.0	143
Left Bank 8	Low	Low	2.5	43
Left Bank 9	Low	Moderate	2.5	114
Left Bank 10	Moderate	Moderate	3.0	41
Left Bank 11	Very Low	Low	3.0	97
Left Bank 12	Low	Low	3.0	103
Left Bank 13	Moderate	Moderate	4.5	27
Left Bank 14	Very Low	Low	2.0	288
Left Bank 15	Very Low	Very Low	2.5	150
Left Bank 16	Moderate	Low	4.5	82
Left Bank 17	High	High	5.0	21
Left Bank 18	Low	Very Low	2.0	104
Left Bank 19	Low	Low	2.5	57
Left Bank 20	Very High	Extreme	5.0	24
Left Bank 21	Low	Low	2.5	91
Left Bank 22	Low	Low	3.0	132
Left Bank 23	High	High	5.0	193
Left Bank 24	Moderate	Moderate	4.0	64
Left Bank 25	Low	Low	4.0	129
Left Bank 26	Very High	Extreme	6.0	67

Left Bank 27	Moderate	Moderate	4.5	94
Left Bank 28	Low	Low	3.0	43
Left Bank 29	Moderate	Moderate	3.0	64
Left Bank 30	Low	Moderate	3.0	105
Left Bank 31	Very High	Very High	6.5	109
Left Bank 32	Moderate	Moderate	3.5	45
Left Bank 33	Very High	Extreme	5.0	62
Left Bank 34	Low	Moderate	3.0	54
Left Bank 35	Moderate	Moderate	4.5	56
Left Bank 36	Low	Low	3.0	52
Left Bank 37	Low	Low	3.0	196
Left Bank 38	High	Moderate	4.5	127
Left Bank 39	Low	Moderate	3.0	114
Left Bank 40	High	High	7.0	67
Left Bank 41	Low	Low	3.0	68
Left Bank 42	Very High	High	7.0	102
Left Bank 43	Low	Low	3.5	66
			<b>total...</b>	<b>3900</b>

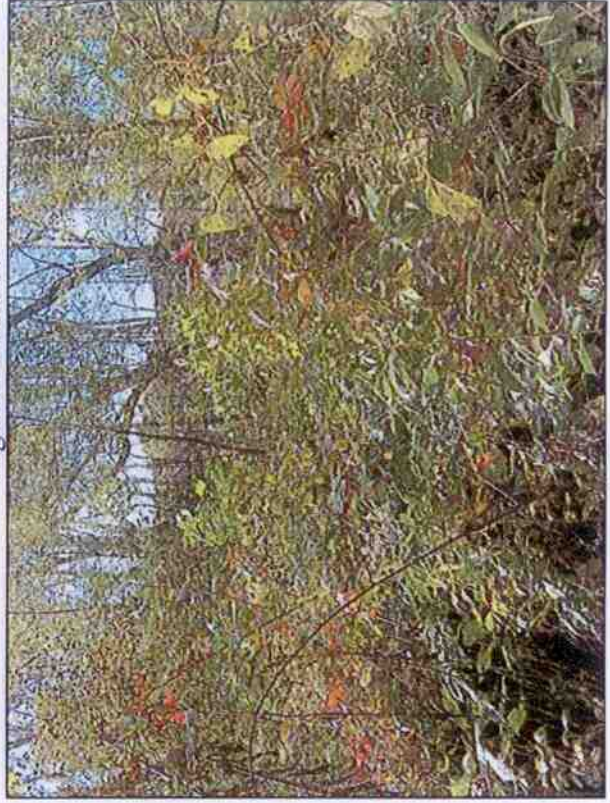
VPA

The second vegetative problem area consists of the wild rose (*Rosa multiflora*) growth within the riparian zone. In June 2008, selective spot-spraying using a glyphosphate-based herbicide was conducted. Evaluation in November 2008 showed this treatment to be partially effective as evidenced by leaf/stem kill of treated plants. It was apparent, however, that the wild rose growth is not limited to the restoration corridor and that re-colonization from mature plants in adjacent areas and any existing *insitu* seed bank was likely. The Year-5 evaluation shows this re-growth to have occurred, as wild rose is still prevalent, though not dominant. However, as tree growth continues, it is expected that the canopy will begin to limit the sunlight into the herbaceous layer, which should inhibit the wild rose growth in these areas.

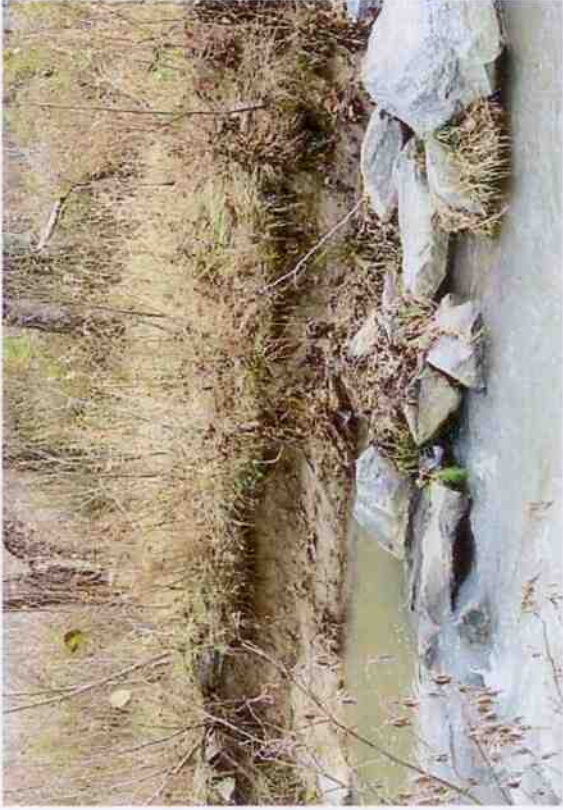
Problem Area 1 - Left Bank Scour

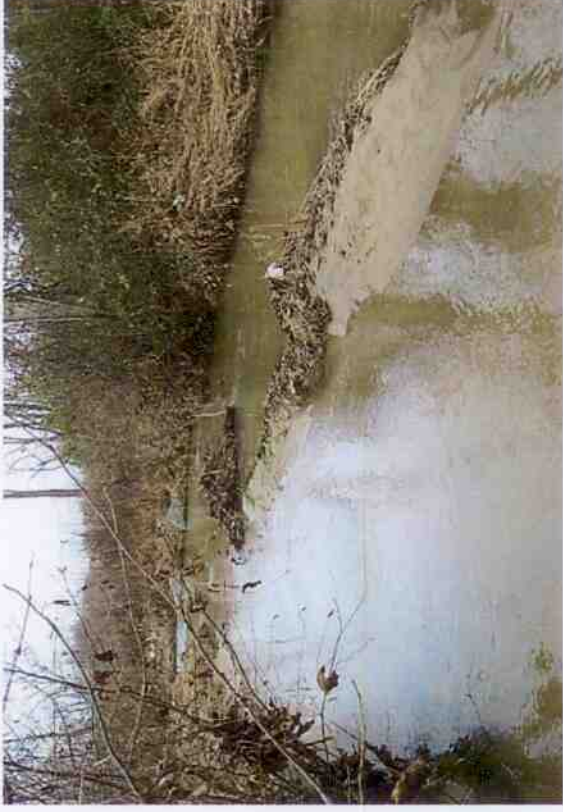
Problem Area 2 - Mid Channel Bar

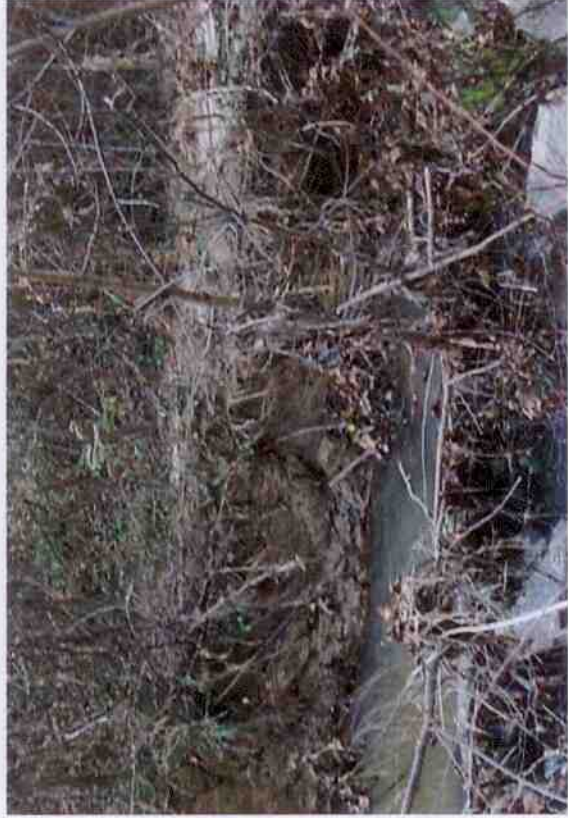
Problem Area 3 - Left Bank Scour

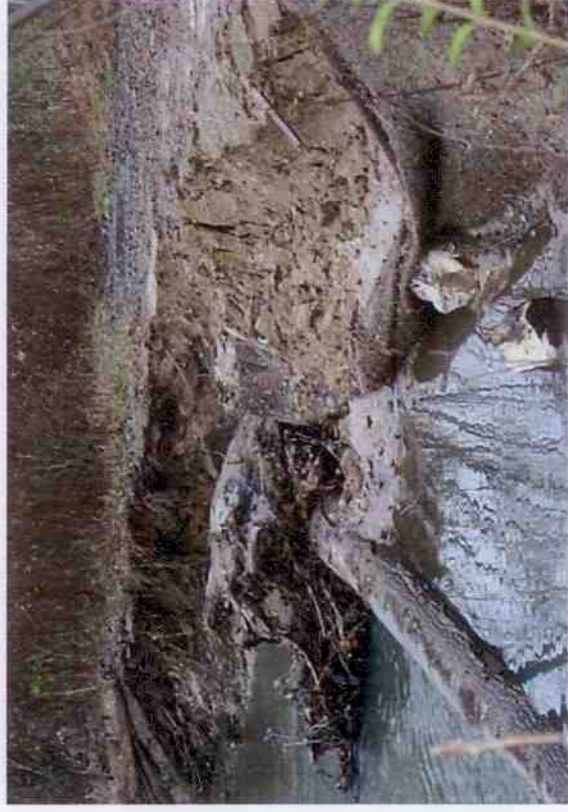
Problem Area 4 - Log vane displacement

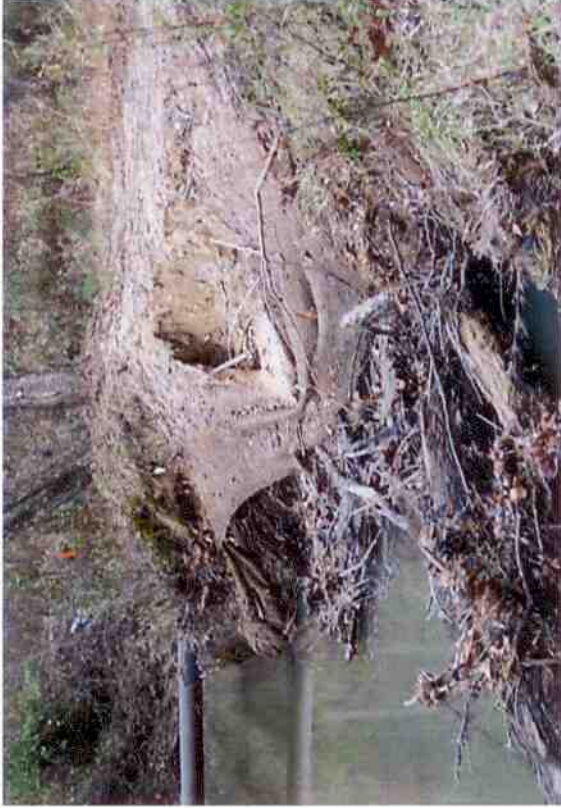
Problem Area 5 - Right Bank Failure

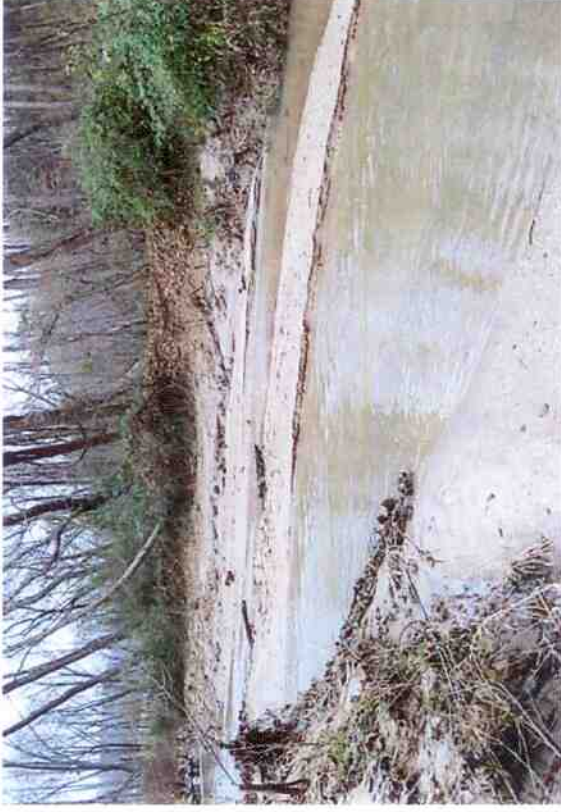
Problem Area 6 – Mid Channel Bar

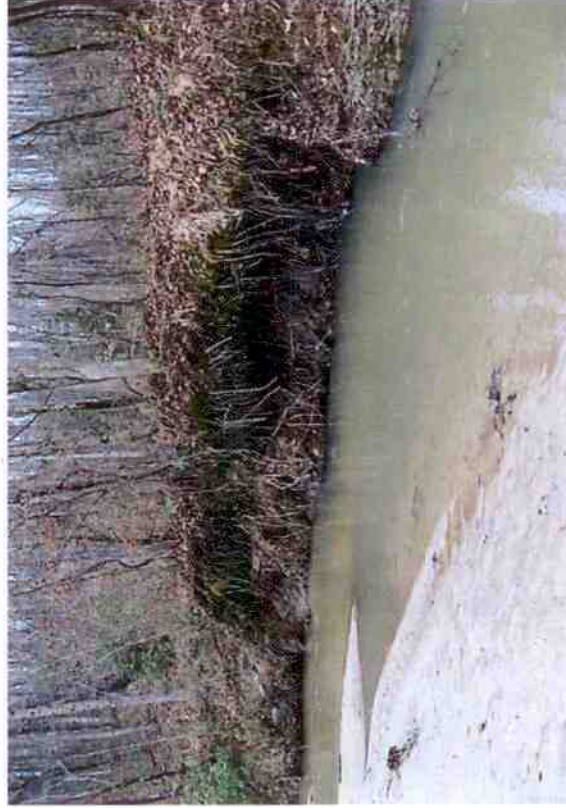
Problem Area 7 - Left Bank Scour

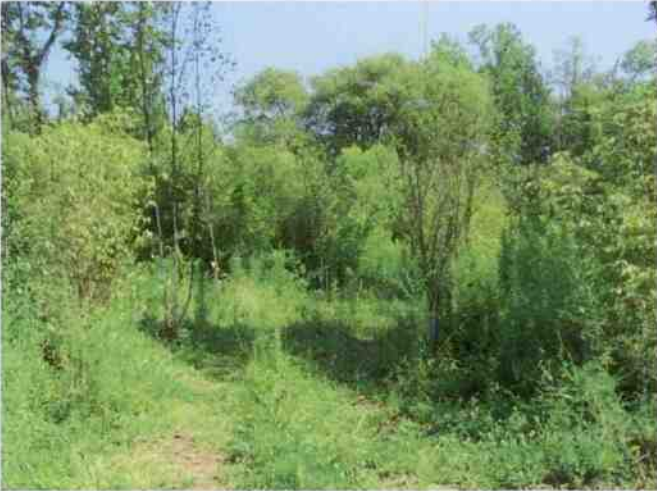
VEGETATION PLOT 4

The partially re-graded area near the bridge and walking trail at Plot 4 is a vegetative problem area that was noted in the Year 4 monitoring report. The grading extended to within approximately 10 feet of the stream bank. The remaining sapling vegetation along the stream

bank is vigorous and appears at to be sufficient to maintain bank integrity. The graded area has regenerated and a stable groundcover of various grasses and young saplings was noted. In June 2011, the City installed approximately 20 trees (verigated dogwood, sycamore and birch) throughout the disturbed area, which included Plot 4. These trees have a minimum of 5 years of growth. The added trees are not included in the Year 5 Stem counts provided in Table 5 below.
