As-built report for the Phillips/Willis Mitigation Site, Middle Fork Creek and tributaries, Madison County

North Carolina Wildlife Resources Commission
Micky Clemmons and Brent Burgess
January 6, 2005

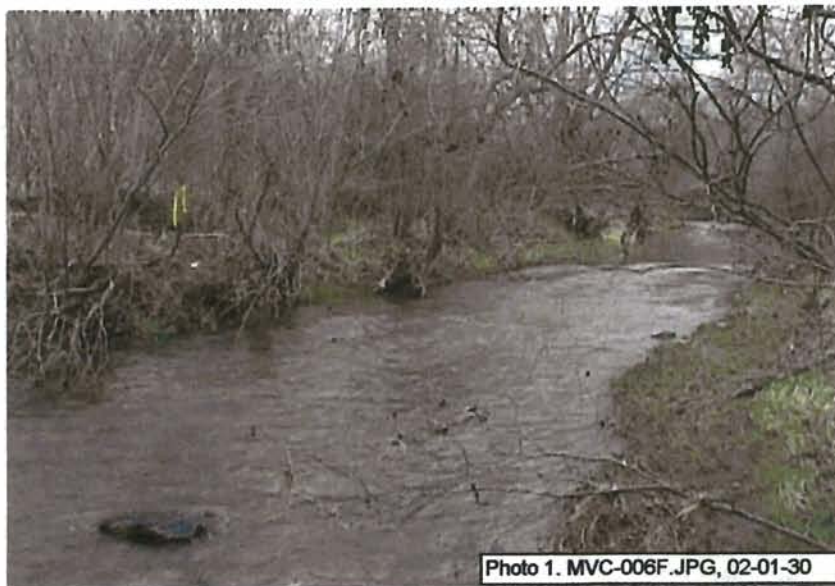
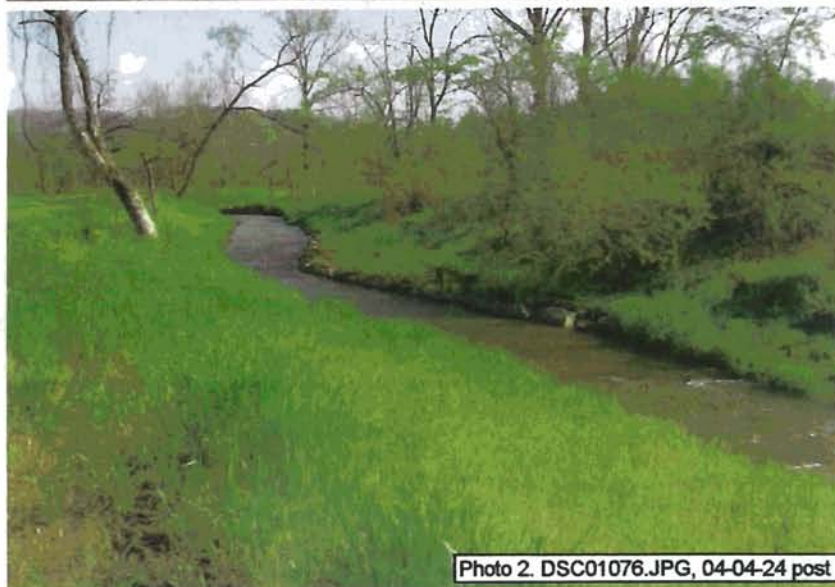
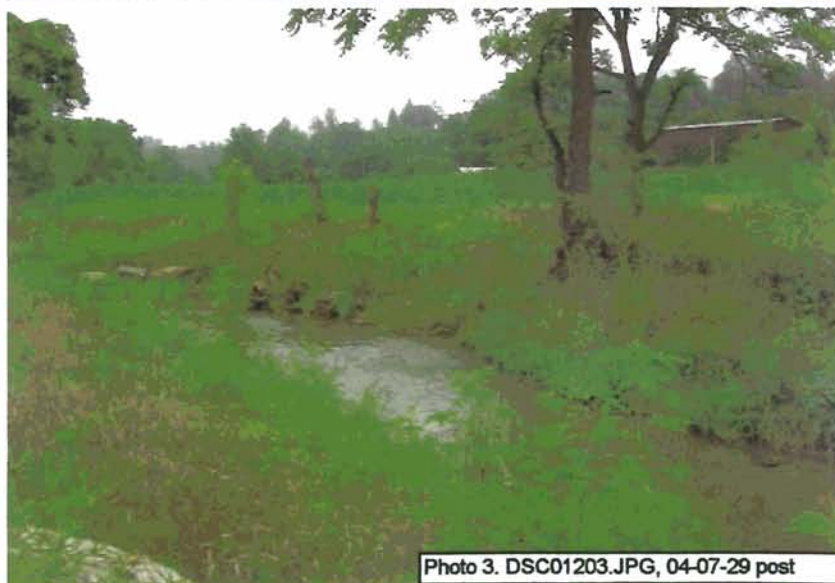
Series 1. These photos show the area between the McKinney Branch confluence and the ford. Photo 1 shows preconstruction conditions in this reach, photo 2 shows the narrowed channel and cover crop, and photo 3 shows area one year later with perennials starting to come up.

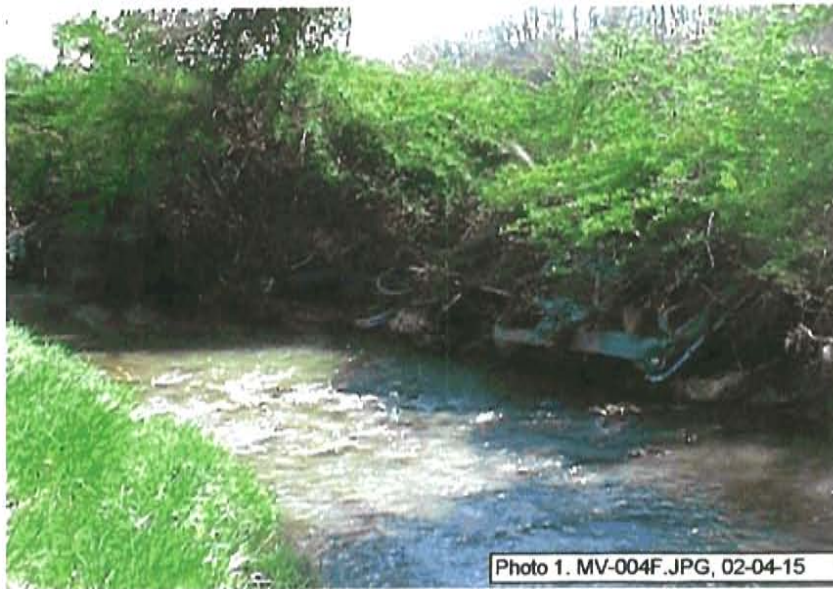
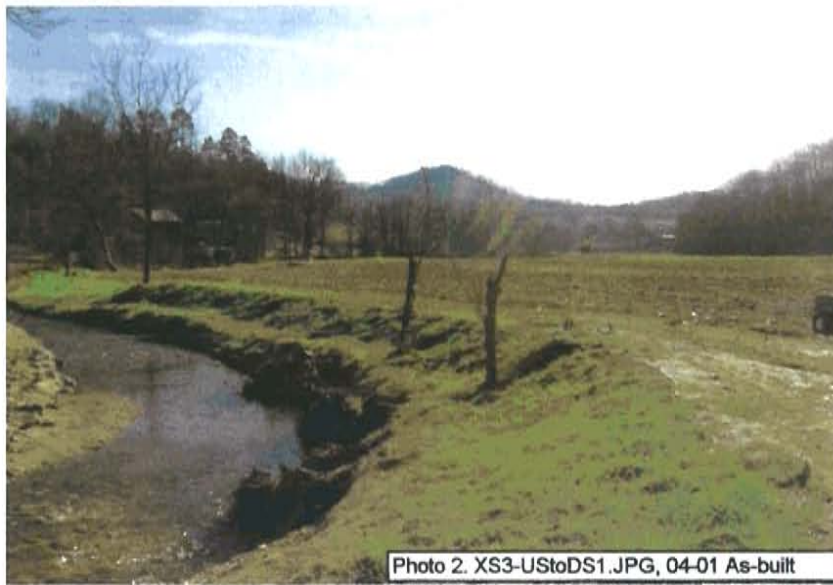
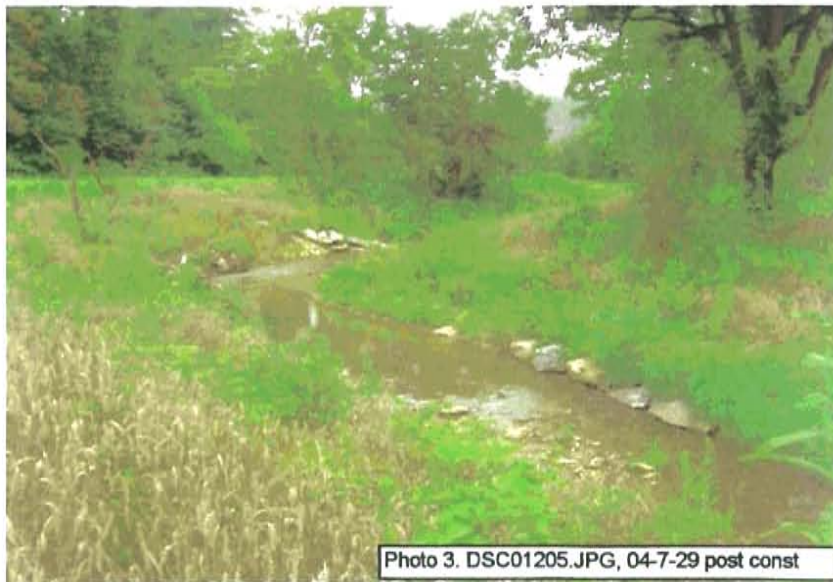
Series 2. These photos show the area at the lower end of the S-curve where properties meet. Photo 1 shows preconstruction conditions in this area, photo 2 shows the modified channel moved off vertical bank and rootwads installed, and photo 3 shows area one year later.

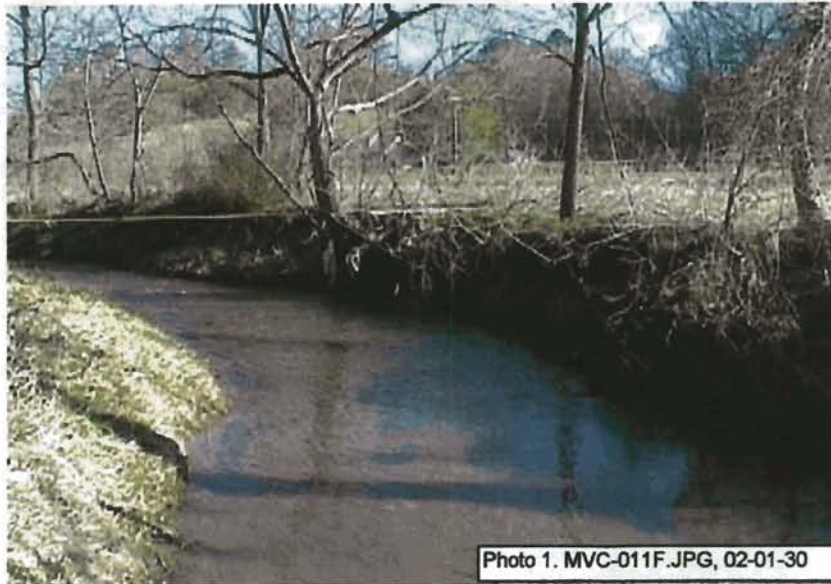
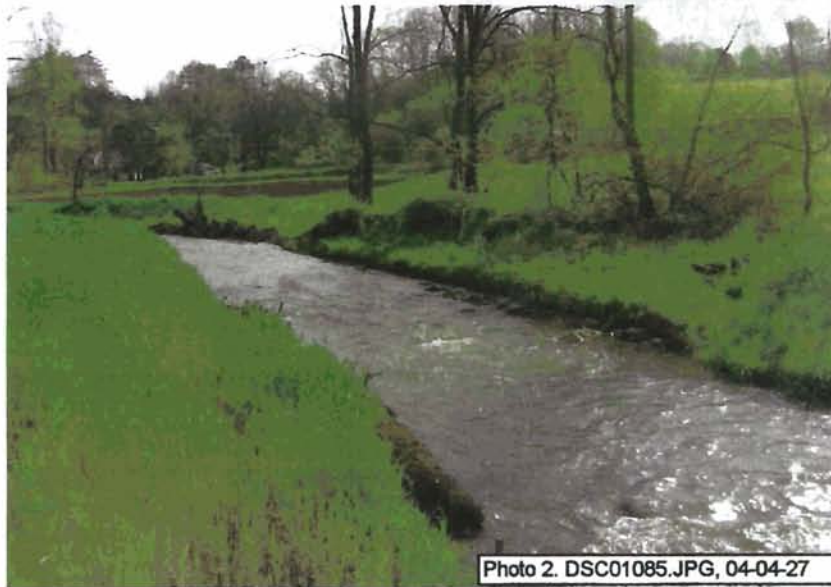
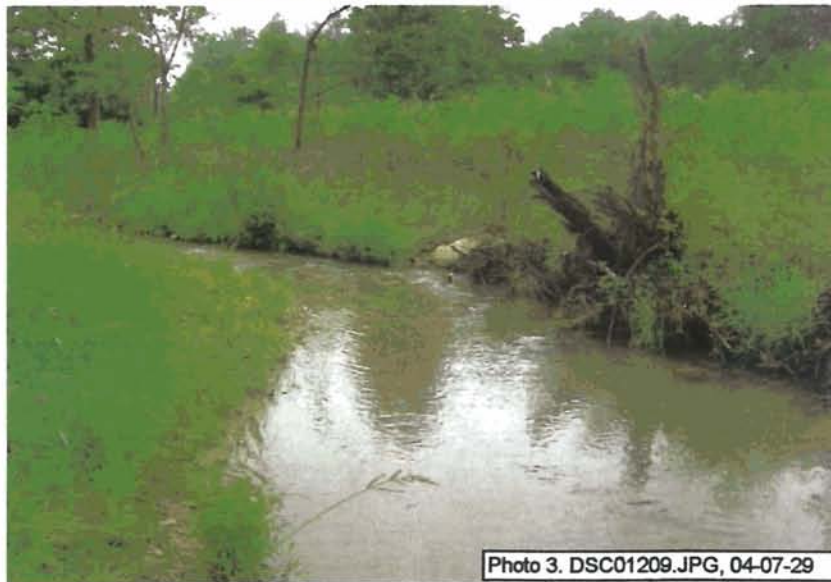
Series 3. These photos show the area at the lower end of the S-curve where properties meet. Photo 1 shows preconstruction conditions in this area, photo 2 shows the modified channel moved off vertical bank and rootwads installed, and photo 3 shows area one year later.

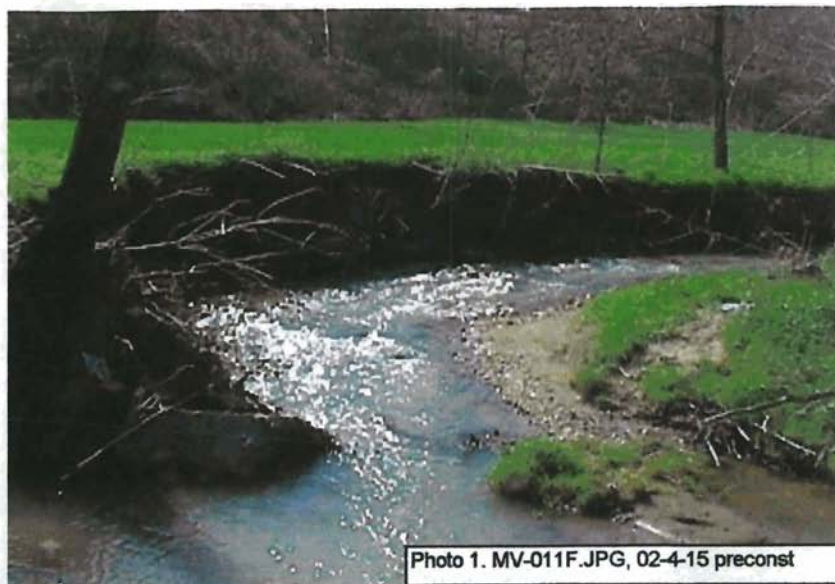
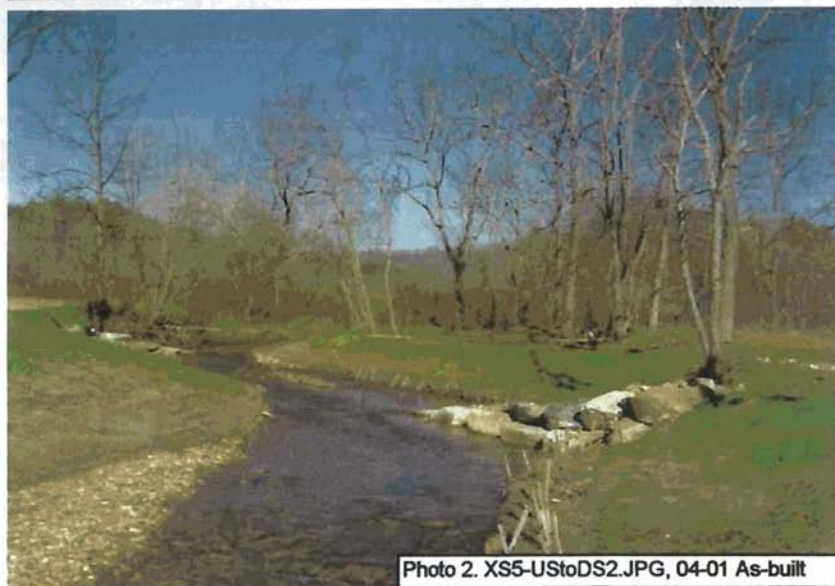
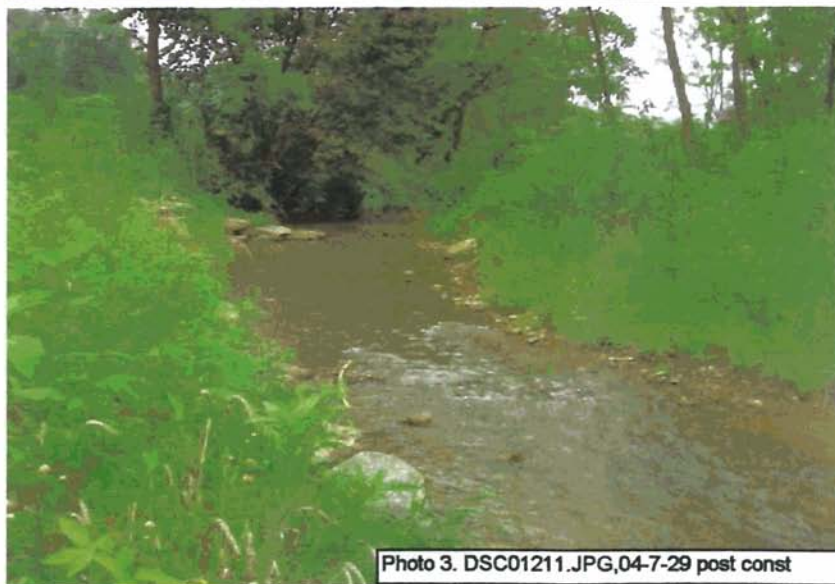
Series 4. These photos show the area at the upper end of the S-curve just below the confluence with Willis Branch. Photo 1 shows preconstruction conditions, photo 2 shows entire area with both meanders and vanes, and photo 3 shows the upper meander and upper vane just below confluence.

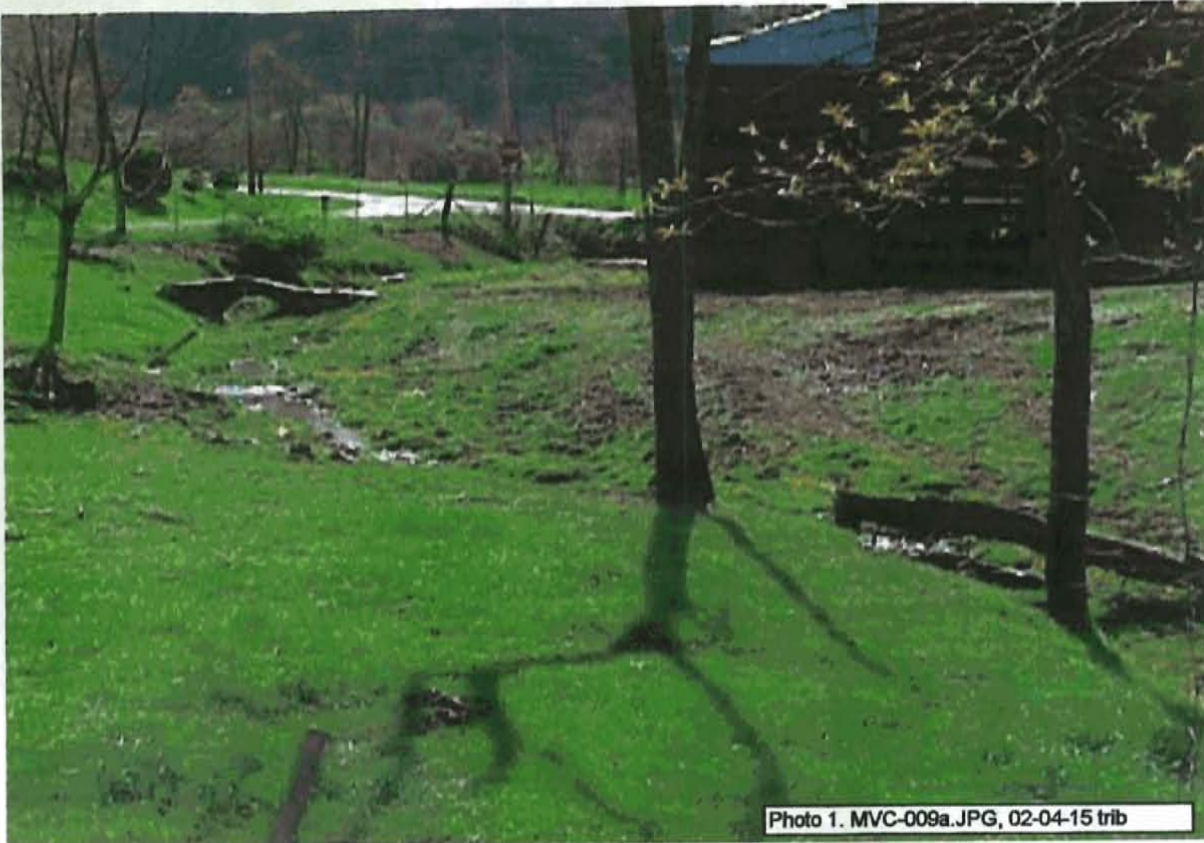
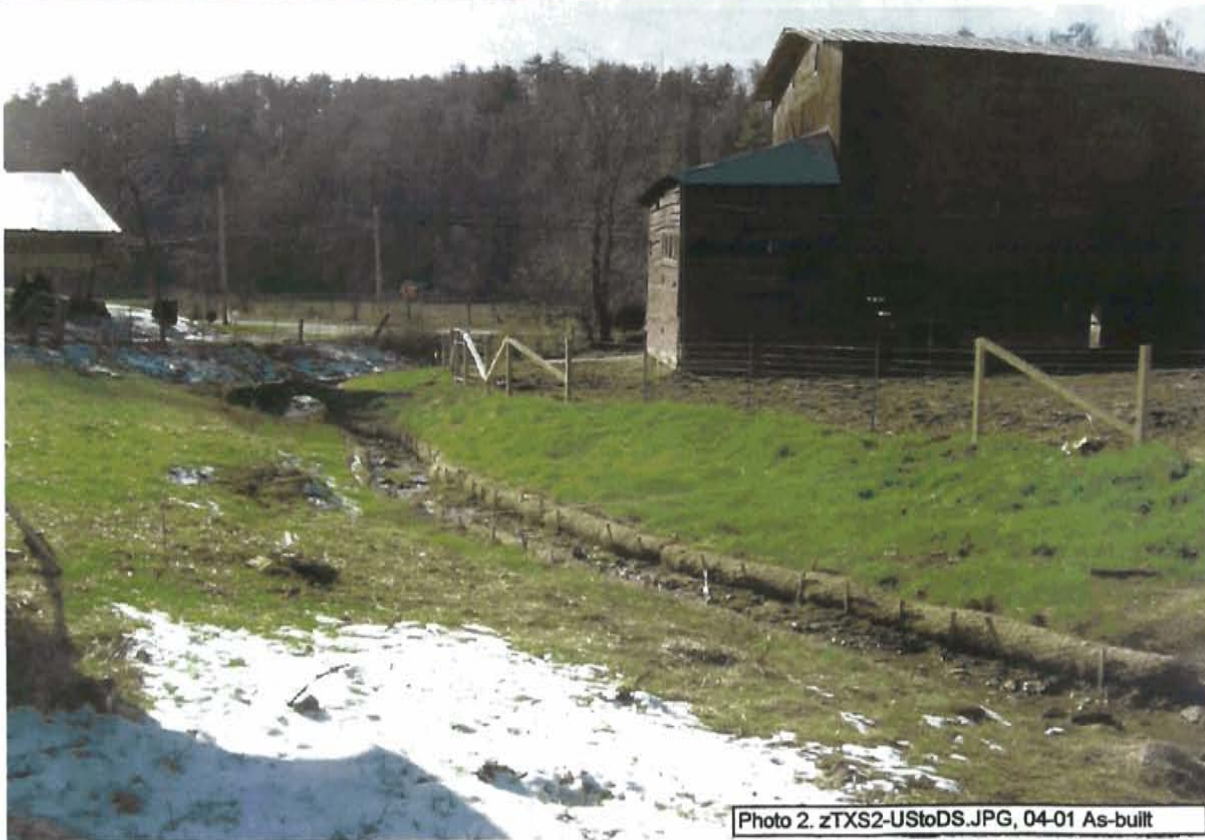
Series 5. These photos show the area within the barn yard just upstream of Middle Fork Road. Photo 1 shows preconstruction conditions where livestock had access to the channel and photo 2 shows the same area after livestock were excluded and the channel defined using coir logs. The tape on XS-2MB is shown.

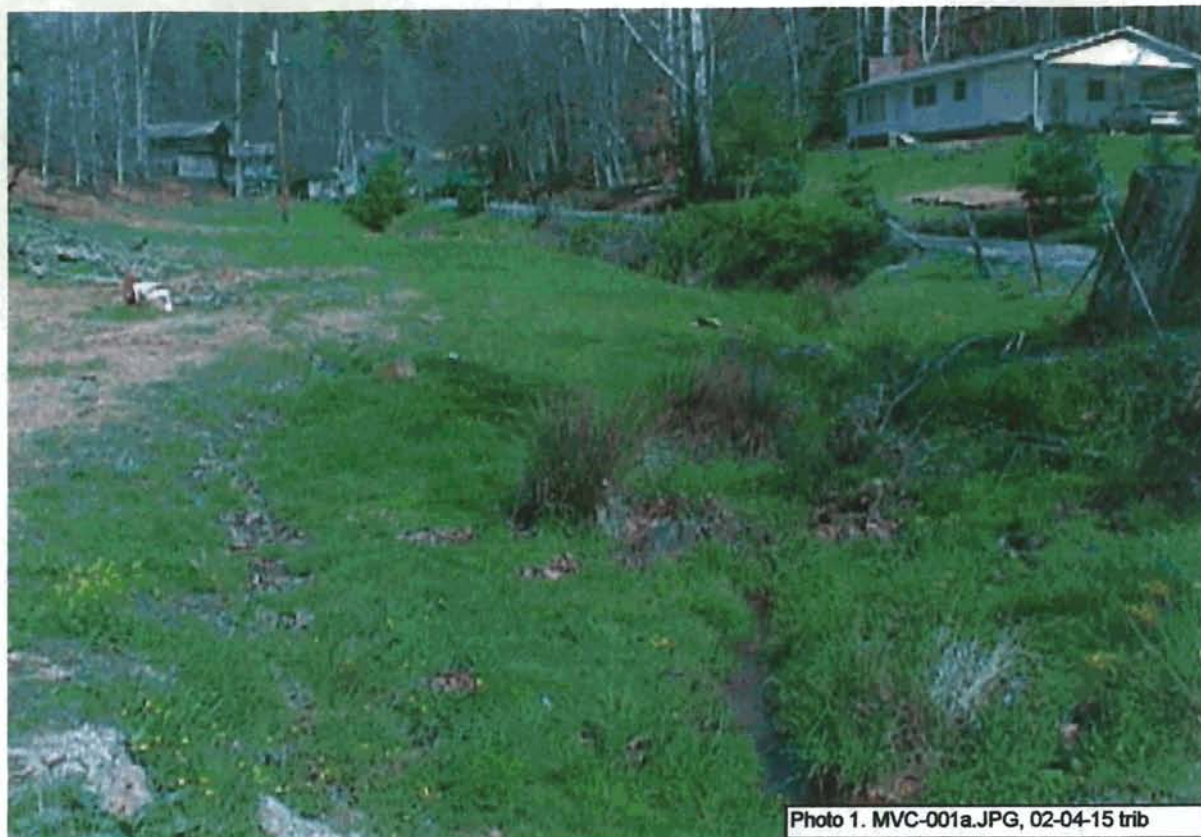
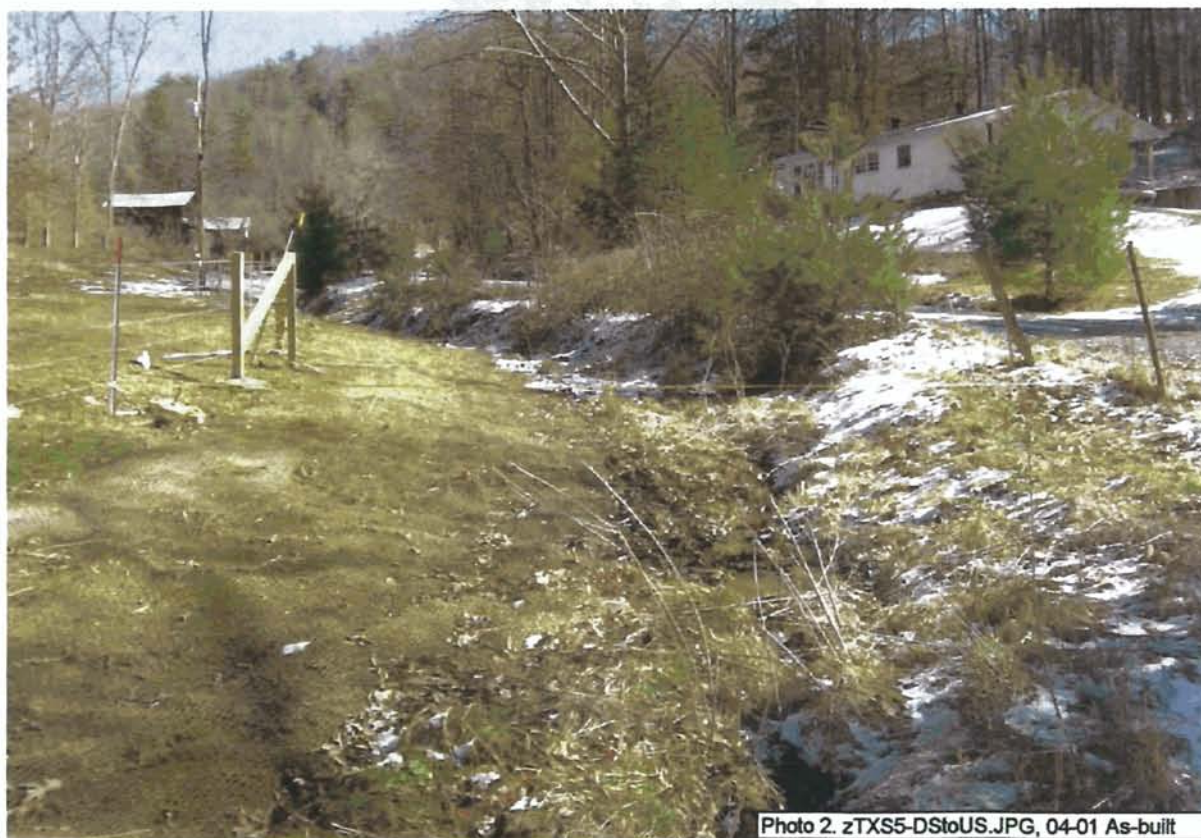
Series 6. These photos show the upstream most reach on McKinney Branch in the upper pasture. Photo 1 shows preconstruction conditions where livestock had access to the channel and photo 2 shows the same area after livestock were excluded and the right bank (left in the photo) has been lowered to develop a floodplain. The tape on XS-5MB is shown.
