Pond Haven Buffer Restoration Site

**Year 2 Monitoring Report
Granville County, North Carolina
Tar-Pamlico River Basin - 03020101**

**DMS Contract 7873
DMS Project Number 100118
DWR Project Number 20190646**

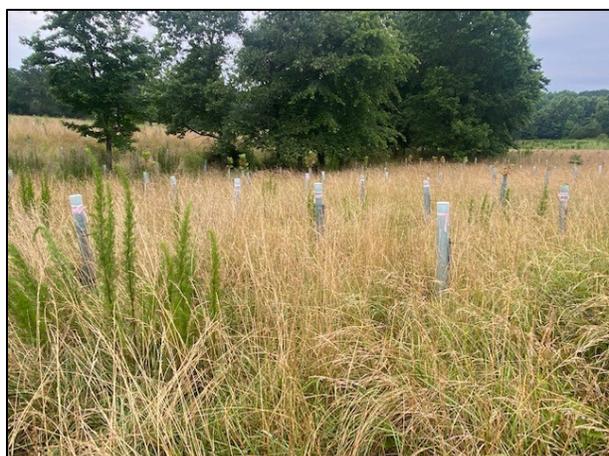
Plot 6 MY02 – 6/29/2022

Monitoring Year 2 vegetation data was collected on June 27th and 29th of 2022. 14 of the 15 vegetation monitoring plots had greater than 260 stems/acre, with only Plot 6F (243 stems/acre) below the density requirement. Plot 6F (3 species) was also the only plot with less than four native hardwood species. Overall, the site is well vegetated with extensive herbaceous coverage and many diverse volunteer woody species.

- Suggest adding a random plot or two next to fix plot #6 to demonstrate if this is an isolated area of lower density.
KCI Response: Plot R4 will be placed near Plot F6 in MY03 to check the density and species composition of this area.
