Aluminum Box Culverts with Bottoms Review

North Carolina Department of Environment and Natural Resources

Division of Water Quality

February 2012

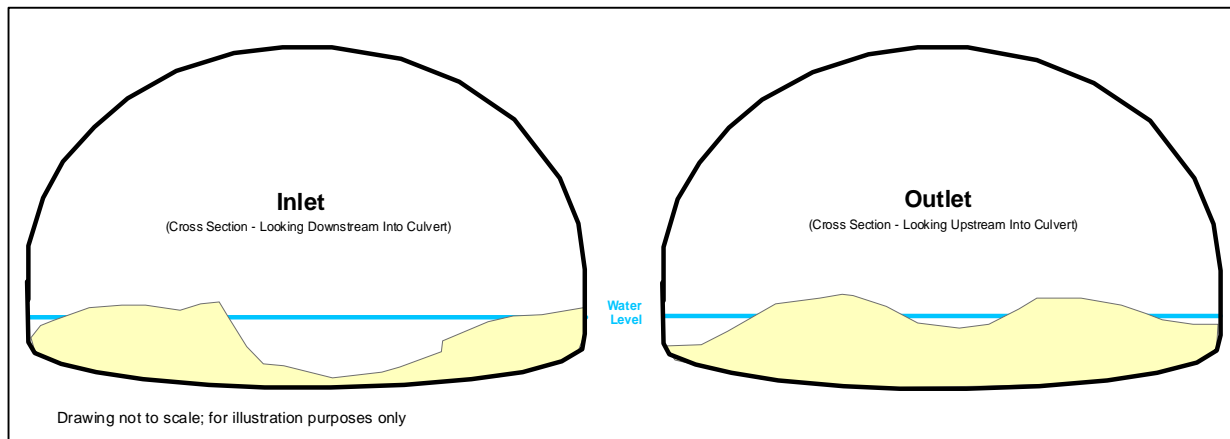
Figure 3: General Sediment Profile for Bridge No. 580156, McDowell County

There was no material placed within the structure during installation, and a portion of the structure bottom could be seen at the inlet side. However, sediment had begun to settle out in the structure and the water was starting to form its own channel within the deposited sediment. Native sediment is very fine and appears to settle out fairly quickly. This is evident by the amount of sediment that has settled out in the few months the structure had been in place. On the upstream side of the structure inlet, there was approximately thirteen to fourteen-inches of sediment that had been deposited. The channel at the inlet was in the middle of the structure, no doubt guided by the riprap fields discussed earlier. At the outlet there was approximately sixteen to seventeen-inches of sediment that had been deposited. The main channel on the outlet side was on the right side of the structure (looking downstream). It is expected that sediment will continue to be deposited in the structure as weather events allow.

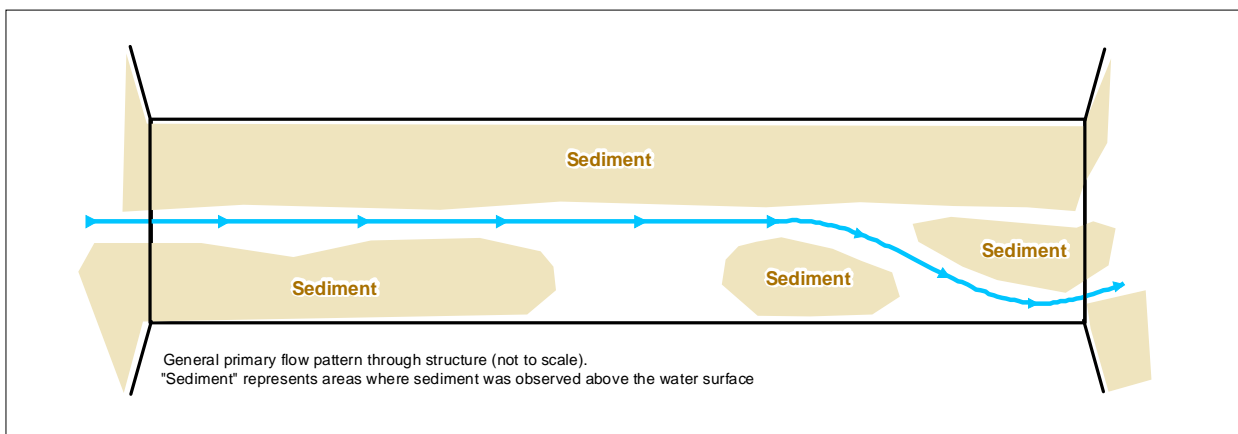
Figure 4: General Flow Profile for Bridge No. 580156, McDowell County

During the review, it was observed that water in the culvert was about twelve-inches deep and was flowing several feet per second. In the thirty days prior to the site visit the site had received 2.70 inches of rain, including 1.34 inches in the five days prior to the review (MPE estimates). Even though installation was only several months prior to the review, at least two bankfull events are believed to have occurred prior to the review.

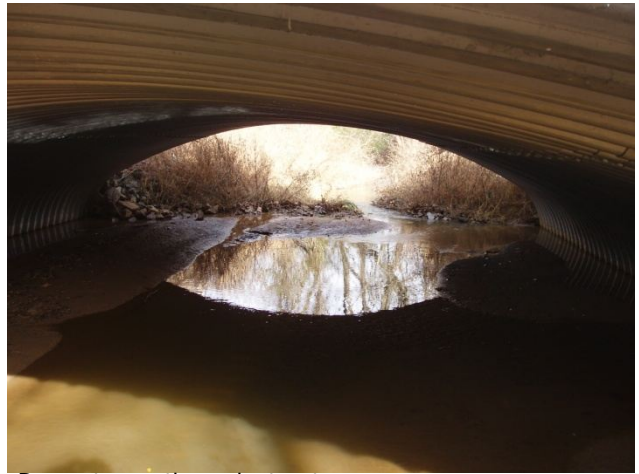
Downstream side of structure

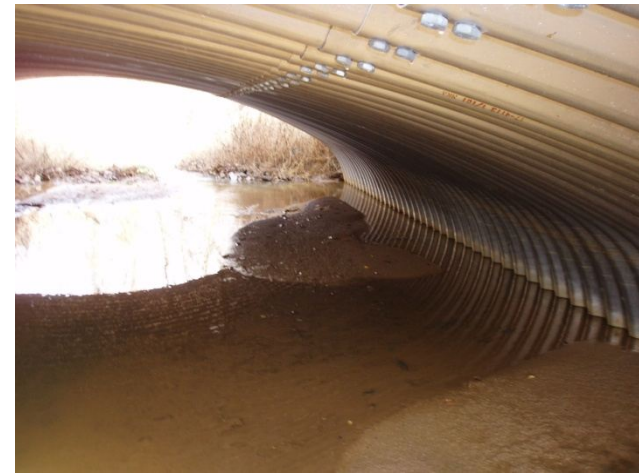
Downstream through structure

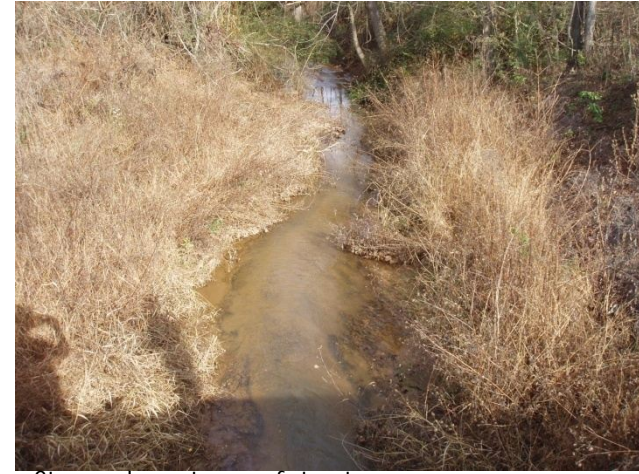
Stream upstream of structure

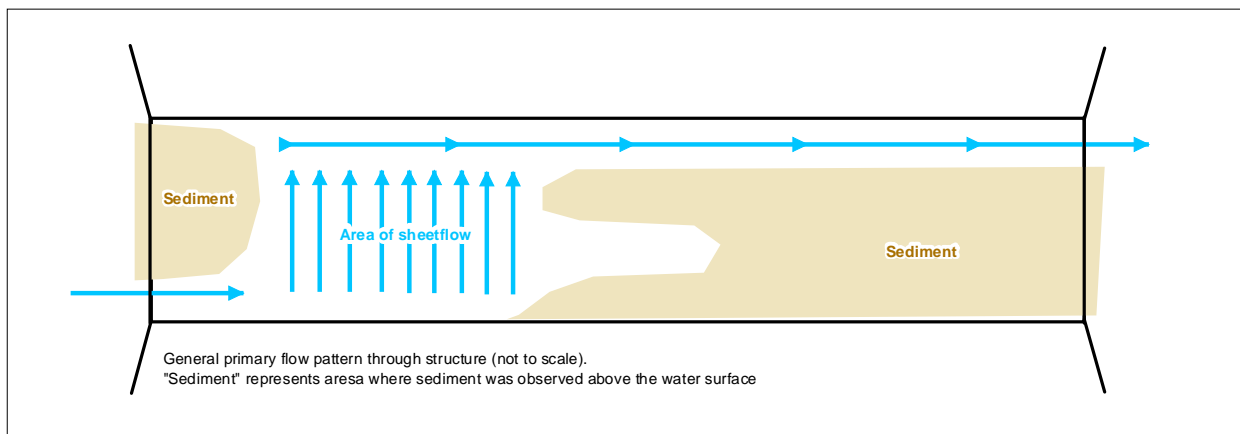
Figure 14: General Flow Profile for Bridge No. 100716, Buncombe County

The natural channel width is approximately four feet. The stream widens out to approximately 14 feet in the area excavated at the inlet. The flow enters the culvert on the right side against the wall. Within the first few feet of the inlet of the culvert, the water becomes very shallow (approximately two-inches) and sheet flows down a shallow slope to the left side of the culvert against the wall where it reconcentrates and continues to flow against the wall until exiting the structure.

Aquatic passage during low flow conditions could be an issue. The water depth in the sheetflow area was only a few inches, and may present a passage issue for larger organisms now, but if the water level drops much it could be an issue for nearly all organisms.

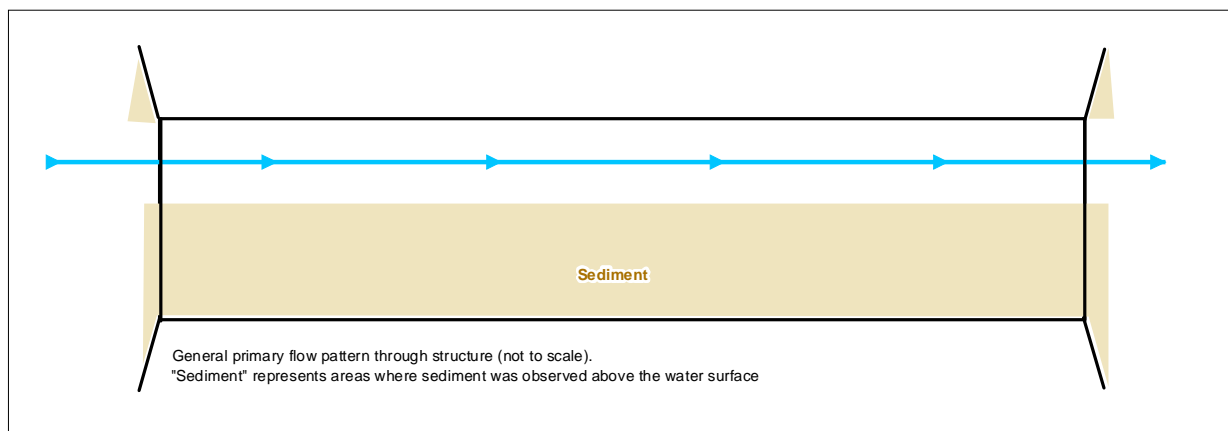
Figure 19: General Flow Profile for Bridge No. 610129, Montgomery County

The width of the natural channel is approximately five feet. The stream widens to about twelve feet in the culvert. When looking downstream, the water enters and exits the culvert on the left side, with the main channel of flow remaining against the left wall, utilizing approximately half of the width of the structure.

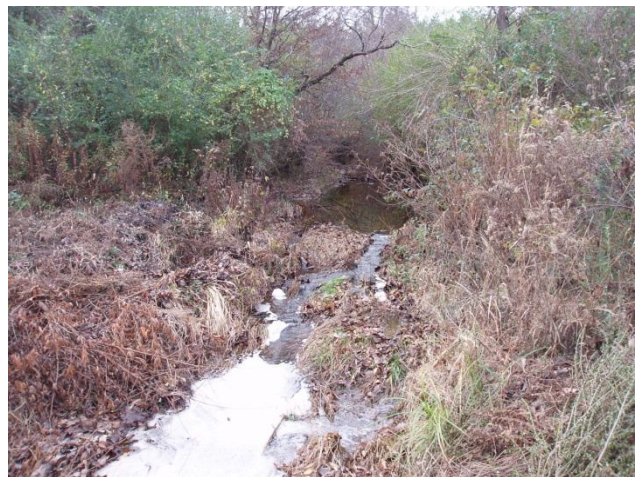
It should be noted that a headcut was seen approximately twenty feet upstream of the culvert inlet. It is unclear if this is directly related to the structure. The drop associated with the headcut is approximately eight-inches.

Upstream of structure (headcut located above white foam)
