Whittier Creek Mitigation Project

Year 1 (2022) Monitoring Report

Surry County, North Carolina

DMS Project ID No. 100020

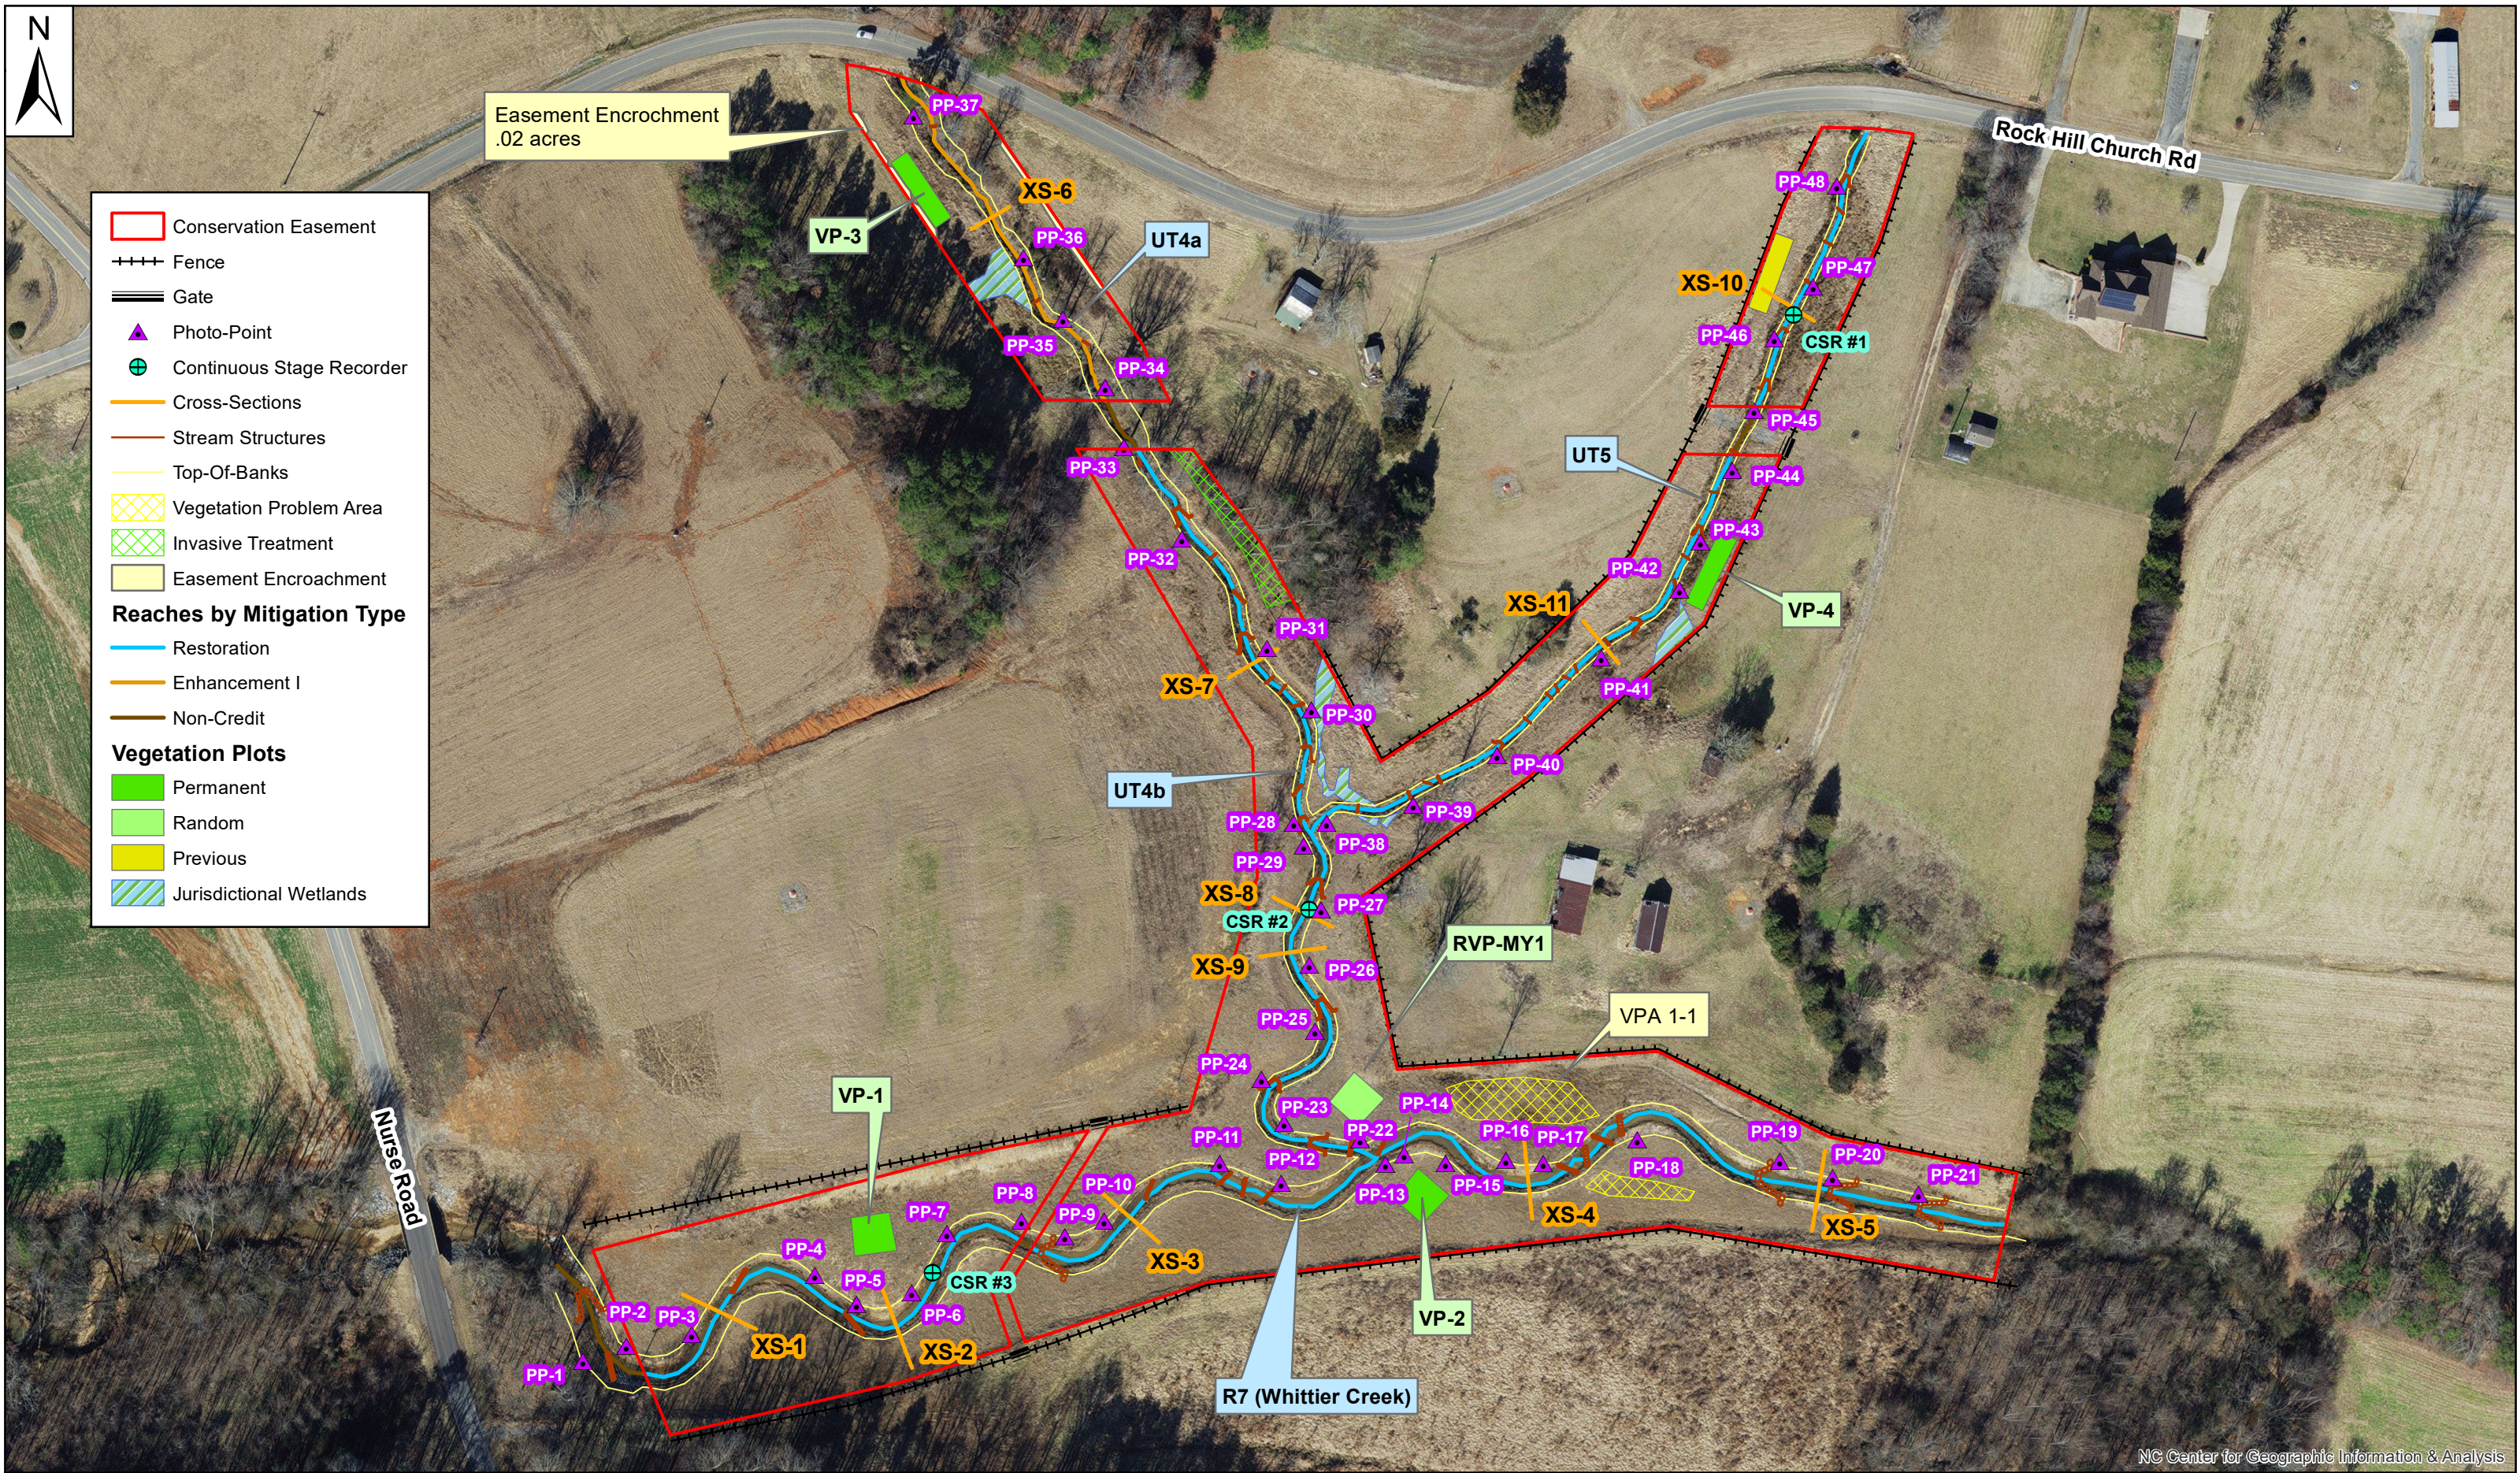
**Figure 3. Current Conditions Plan View
Monitoring Year 1
Whittier Creek Mitigation Project (#100020)
Surry County, NC**

There were however, three Vegetation Problem Areas (VPAs) identified during the Year 1 monitoring (Table 6 in Appendix B). The first VPA consists of low stem density and low vigor totaling 0.22 acres observed along the left and right bank of R7 close to station 20+75. These are areas that are impacted by compacted soils and overbank events after the confluence of UT5 and R7. Michael Baker plans to supplementally plant these areas and put out soil amendments this winter. The second VPA is a minor boundary encroachment on the left and right bank easement line on UT4a. These were areas accidentally mowed by the landowner before it was clear to delineate the easement boundary in the pasture. Michael Baker plans to install horse tape to ensure the boundary line until buffer vegetation establishes a clear line. Finally, the third VPA consists of a small area of observed privet (*Ligustrum sinense*) totaling about 0.05 acres. These areas have been treated during monitoring year 1 but will be treated again in 2023. The exact locations of each of these VPAs is shown in the Current Condition Plan View (CCPV) found in Appendix B.

Easement Encroachment
.02 acres

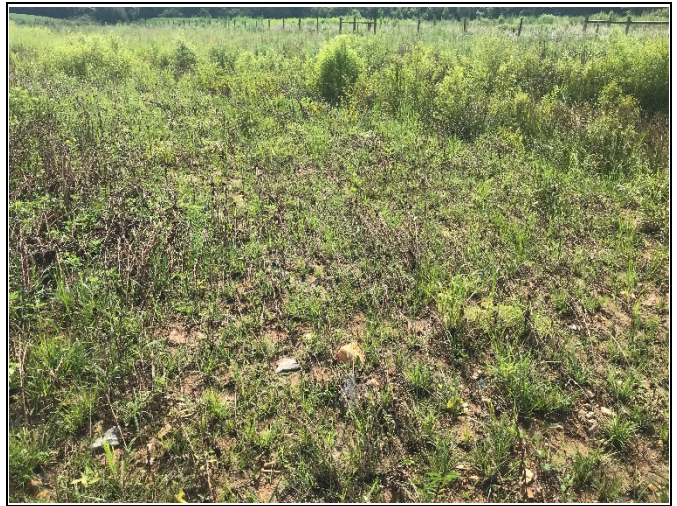
During Year 1 monitoring, one post-construction bankfull event were observed at 0.43” along Reach 7 (see Table 10 in Appendix E and Figure 5 in Appendix E). The event occurred on 7/9/22 as documented through continuous stage recorders along with photographs found in the additional photolog in Appendix B.

R7 Overbank Event Evidence (7/27/22)

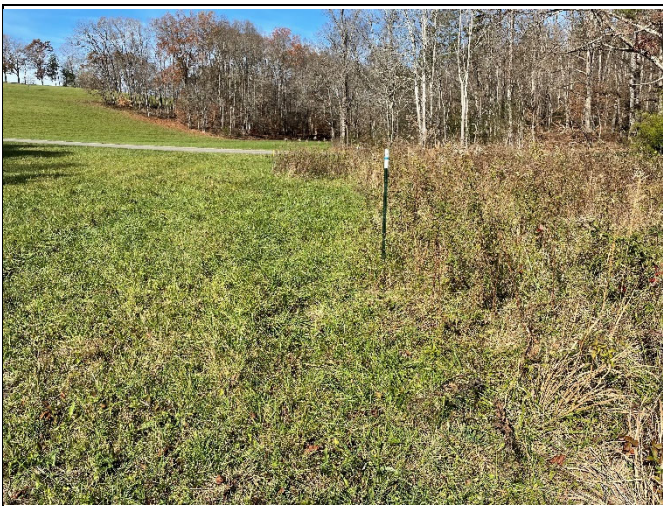
Encroachment to the CE on UT4a (11/16/22)

- Encroachments were identified on UT4a. DMS observed the small encroachment on a monitoring site visit and the solution proposed by Baker should rectify the problem. Please provide photos in the MY2 report of the additional posts and horse tape used to correct mowing encroachment.

Response: Michael Baker plans to address the situation and document the solution in the MY2 report.

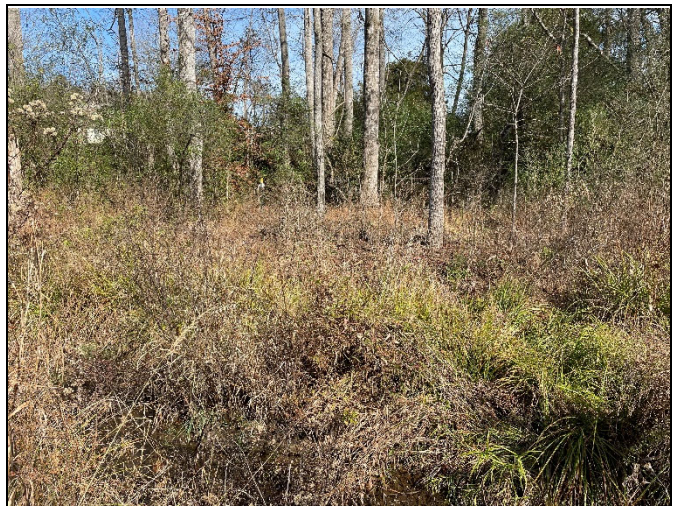
Invasive treatment along UT4a (11/19/2022)

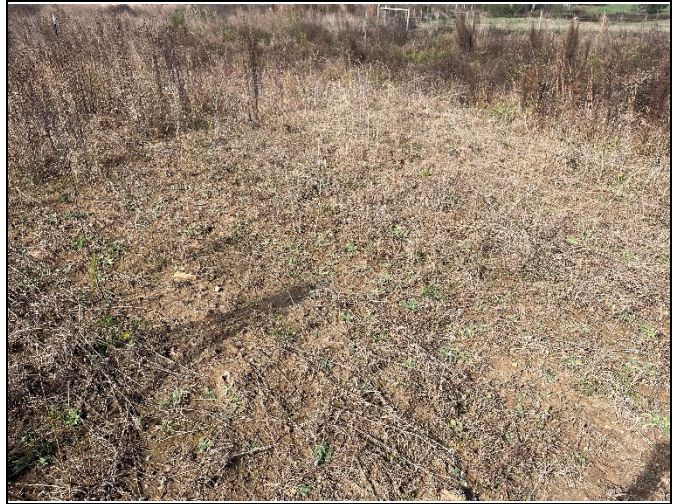
Vegetation Problem Area – R7 left bank (11/16/22)

- Supplemental planting is planned for bare areas along R7 this winter. Please use species from the approved Mitigation Plan planting list and update the MY2 report with species list, quantities, and type (bare root, gallon, etc.).

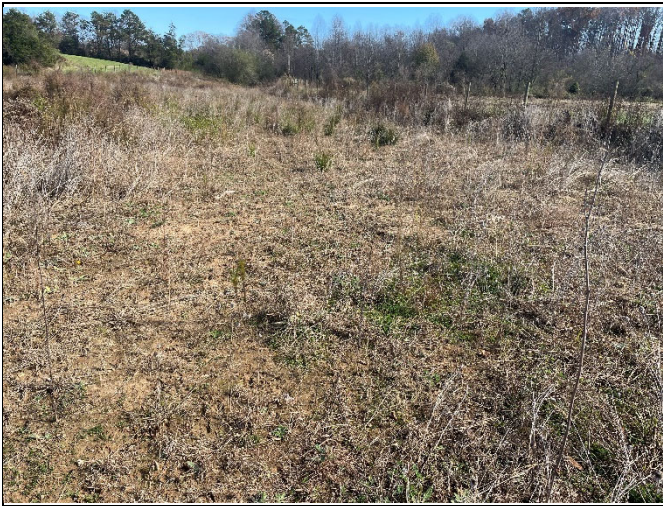
Vegetation Problem Area – R7 left bank (11/16/22)

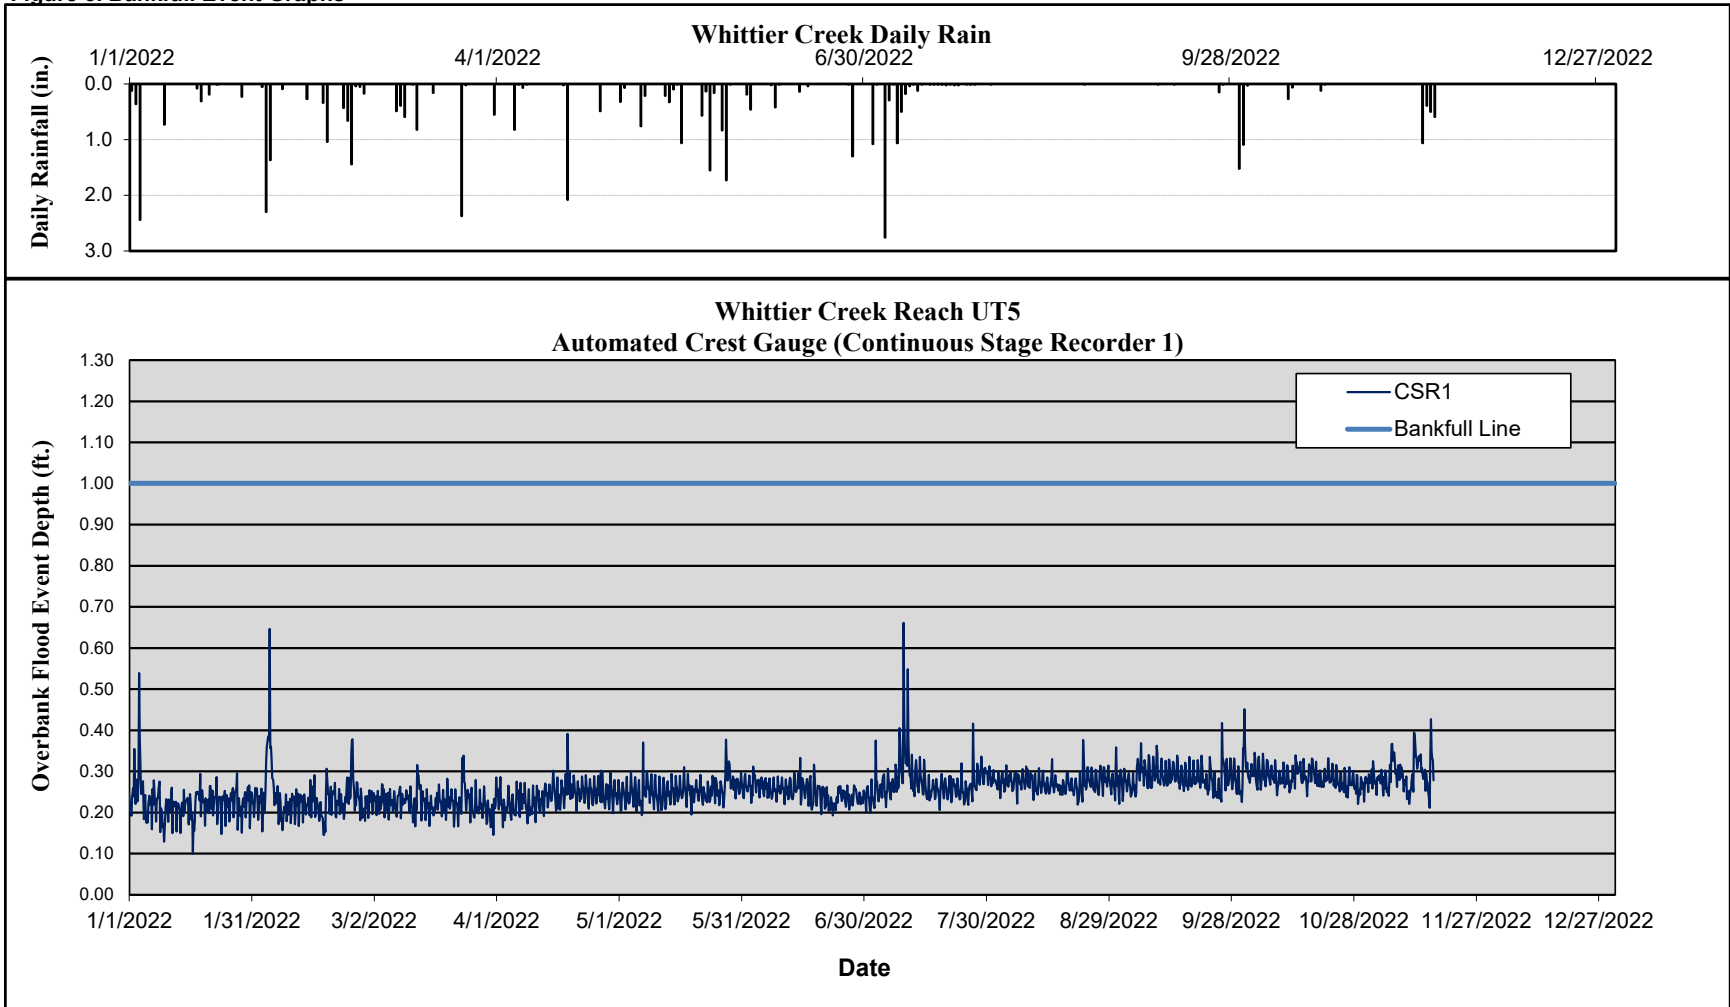
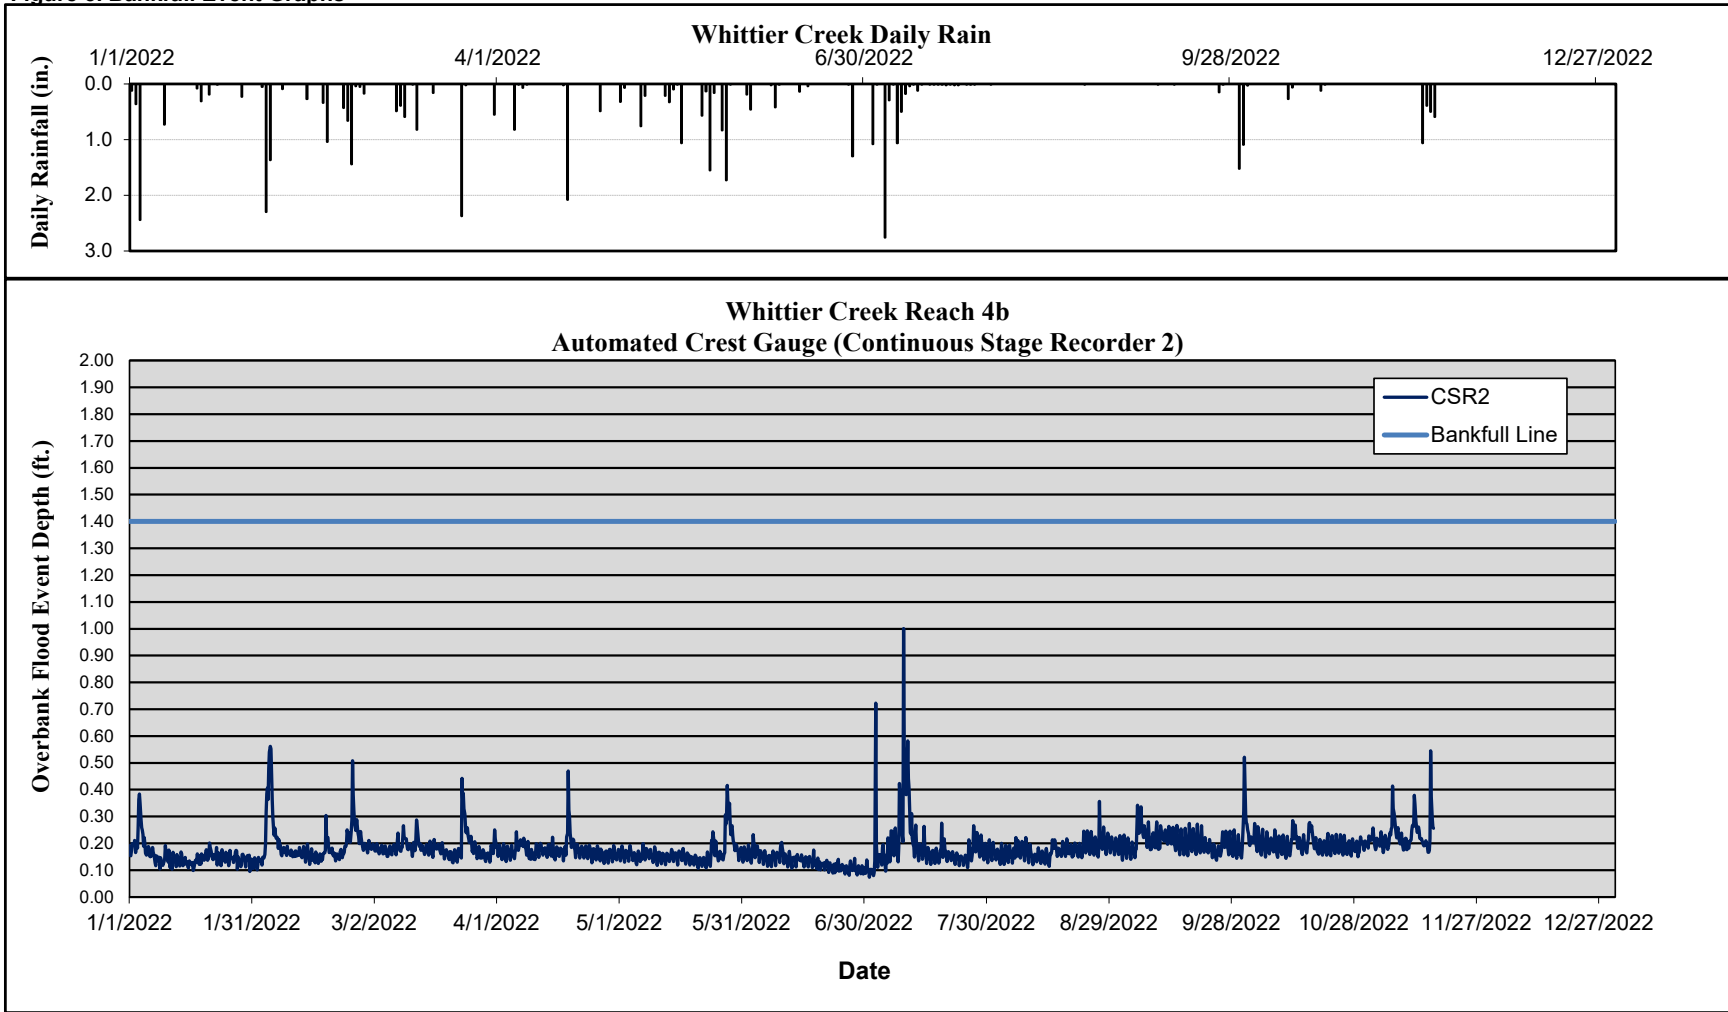
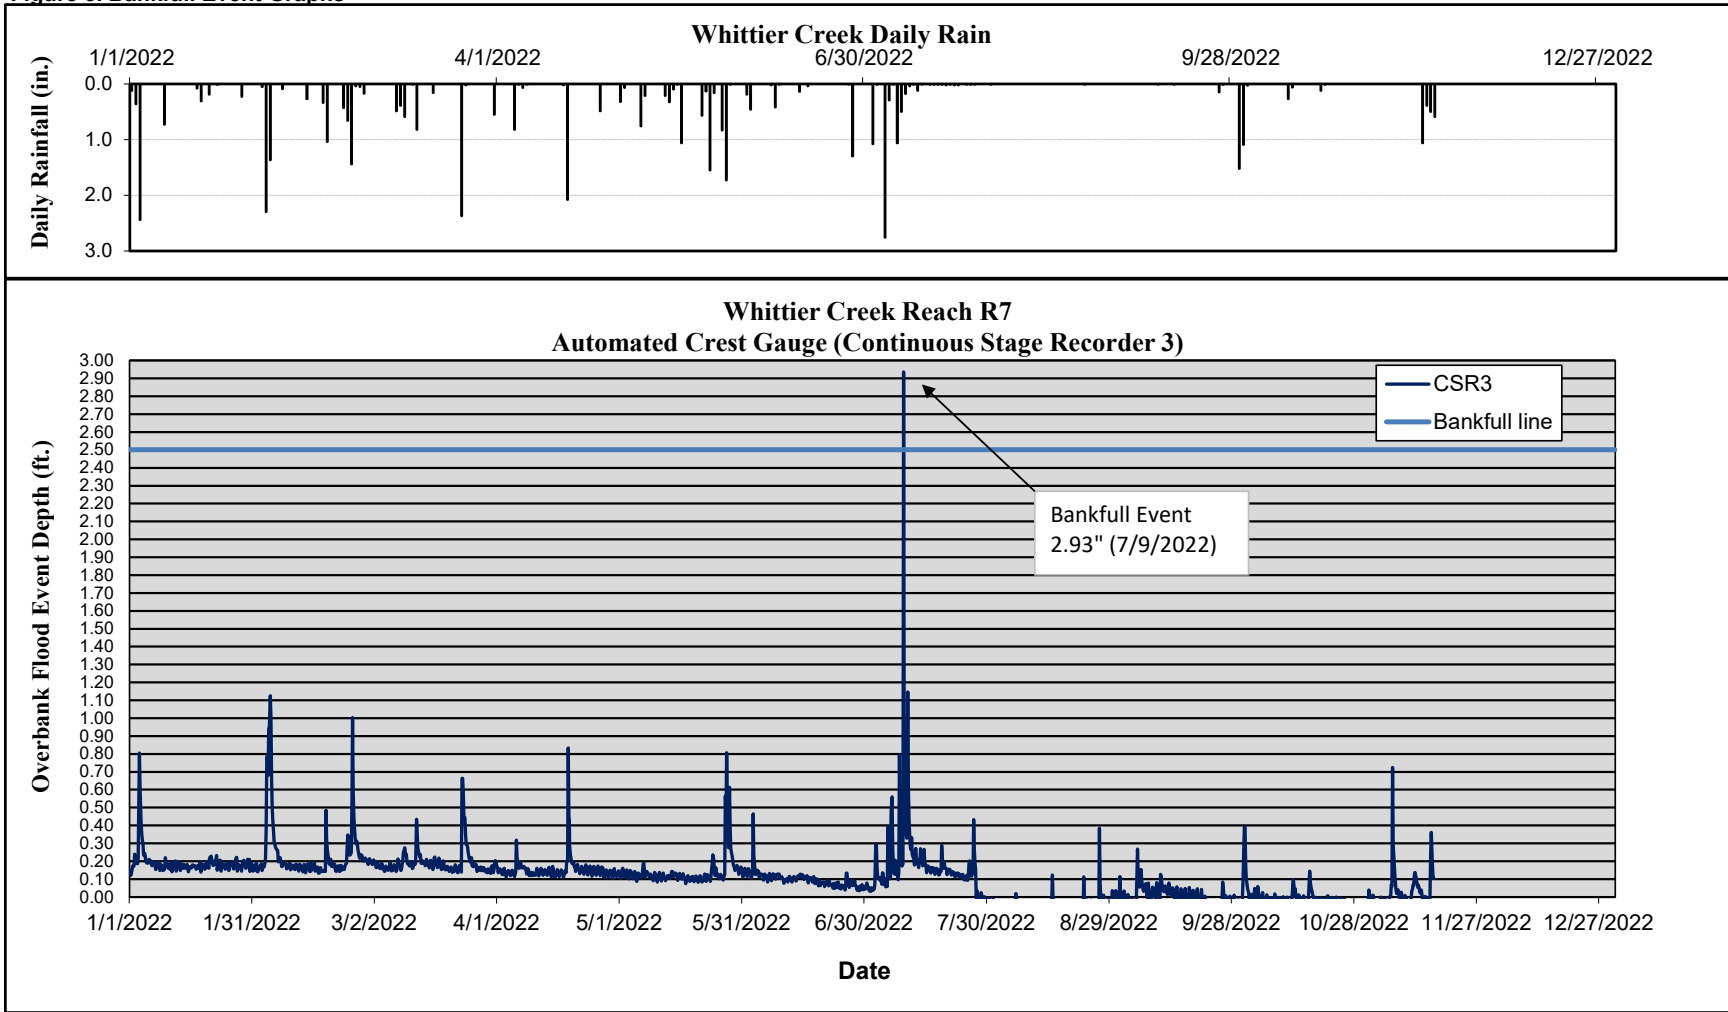
Figure 5. Bankfull Event Graphs

Data presented here is from 1/1/22 thru 11/16/22
Thalweg elevation 0.00'
