7300–Facilities
January 2012
1273–2805P–MTDC
FEMA P–911

Pocket Safety Guide for Dams and Impoundments

0E02L32 Impoundment/Dam Safety Pocket Guide
January 2012

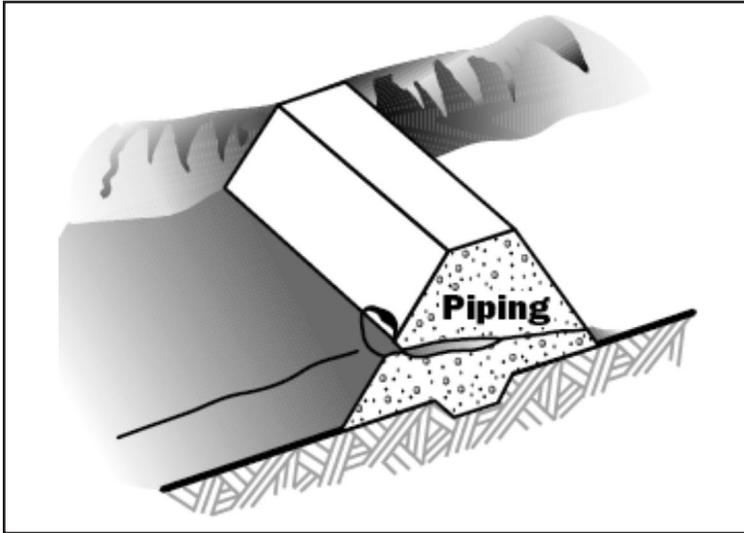
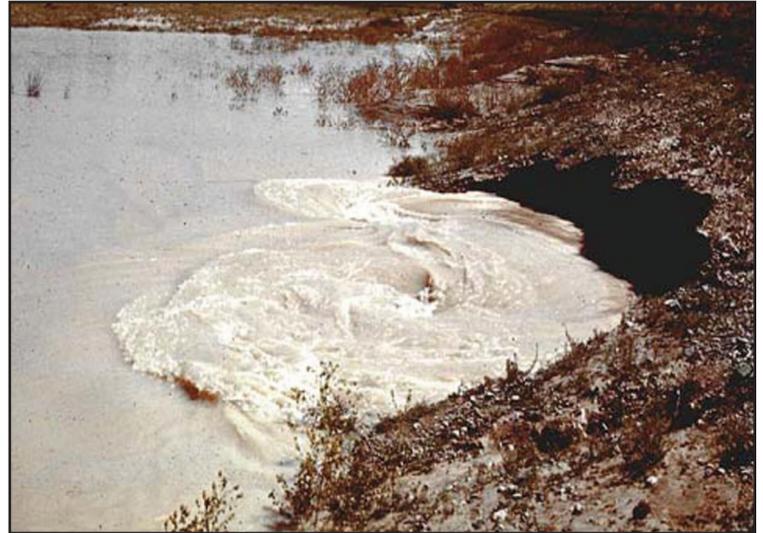
- Internal erosion of embankment materials or the foundation (piping) can cause a sinkhole.
- An eroded cavern (cave-in) can result in a sinkhole.
- A small hole in the wall of an outlet pipe can develop into a sinkhole.
- Water with sediment at the exit indicates erosion of the dam.
- Piping can empty a reservoir through a small hole in the wall. It also can lead to dam failure as soil pipes develop and erode through the foundation or a pervious part of the dam.

Figure 5—Sinkholes.

Figure 6—Whirlpool action is an indication of advanced piping.

Report the suspected problem to the appropriate Federal or State agency official immediately.

- Inspect other parts of the dam that may be susceptible to seepage or more sinkholes.
- Check seepage and leakage outflows for muddy water.
- Have a qualified engineer inspect the conditions, identify the exact cause of sinkholes, and recommend further actions.
- Depending on the location of the sinkhole in the embankment, have the reservoir drawn down as necessary.

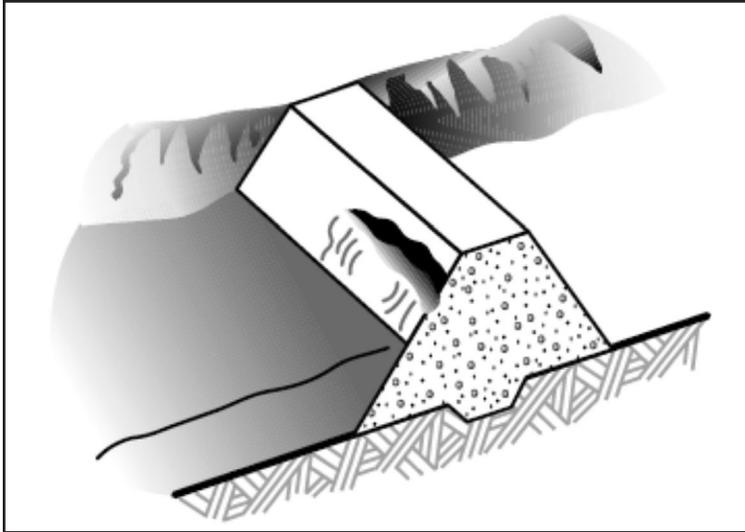
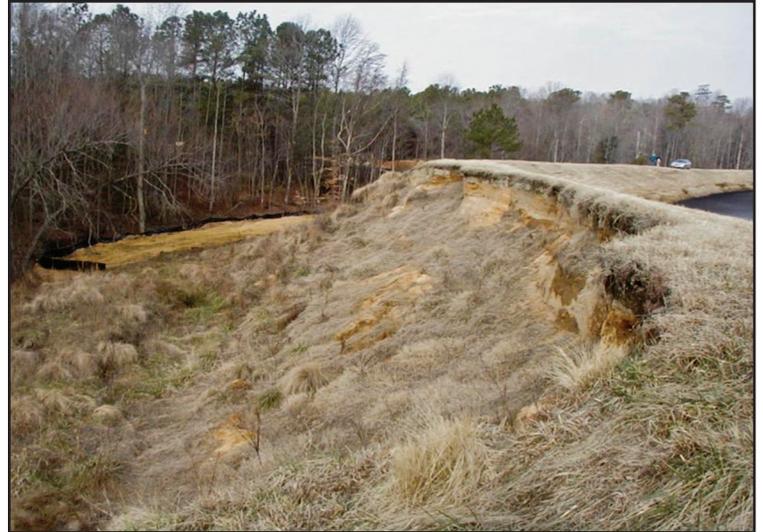
- Foundation movement or a too steep slope can cause earth or rocks to move along a slip plane which can lead to a slump of the embankment.
- Slide movements in the reservoir basin can lead to inlet obstruction or dam failure.

Figure 7—Slide, slump, or slip.

Figure 8—Slumping on the downstream face of a dam.

Report the suspected problem to the appropriate Federal or State agency official immediately.

- Evaluate the extent of the slide.
- Monitor the slide.
- Draw down the reservoir level if the safety of the dam is threatened.
- Have a qualified engineer inspect the conditions and recommend further actions.

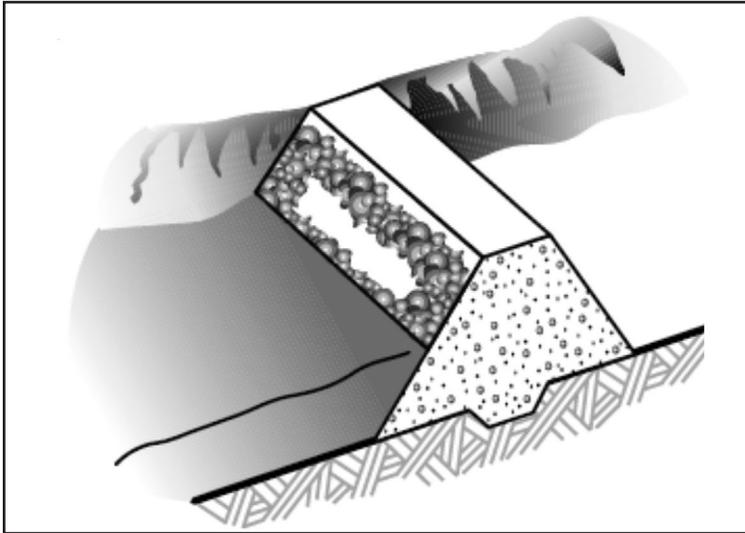
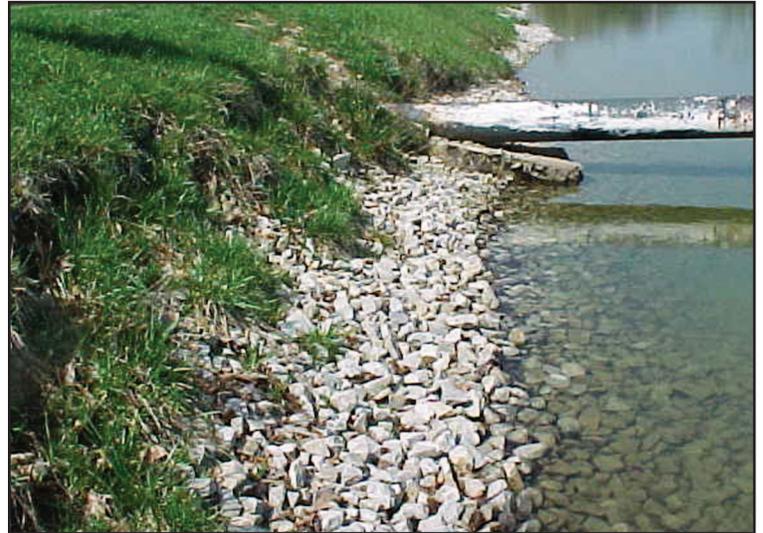
- Poor-quality riprap deteriorates and does not protect the slope.
- Wave or ice action can displace riprap allowing erosion of the bank.
- Similar-sized round rocks may roll downhill and expose the slope.
- Wave action against these unprotected areas decreases the embankment width.

Figure 9—Broken down or missing riprap.

Figure 10—Wave erosion on the unprotected face of a dam.

- Reestablish the normal slope.
- Place bedding material and properly sized riprap to protect against wave action.

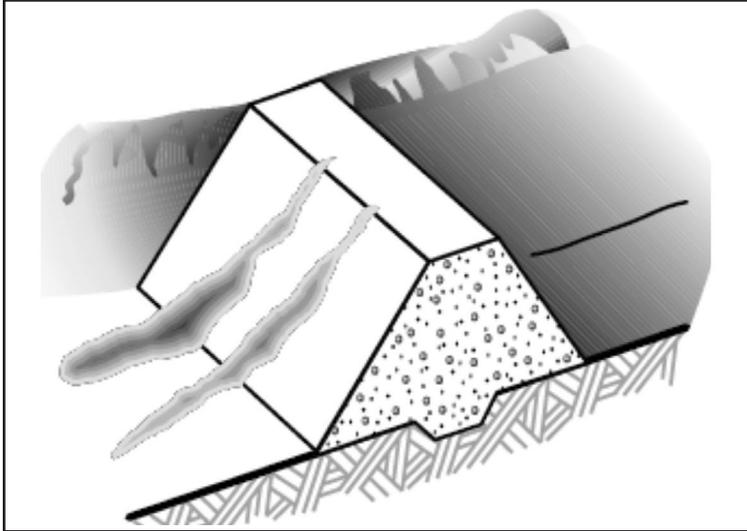
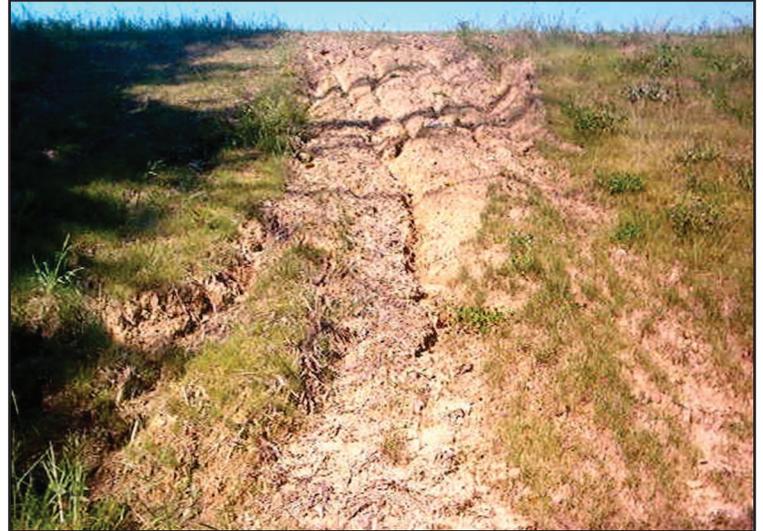
- Water from intense rainstorms or snowmelt carries surface materials down the slope and results in continuous troughs, which can be hazardous if allowed to continue.
- Erosion can lead to deterioration of the downstream slope and failure of the structure.

Figure 11—Erosion.

Figure 12—Erosion on the downstream face of a dam.

- If erosion is detected early, add protective grasses that may resolve the problem.
- Protect eroded areas; add rock or riprap, which is the preferred method.

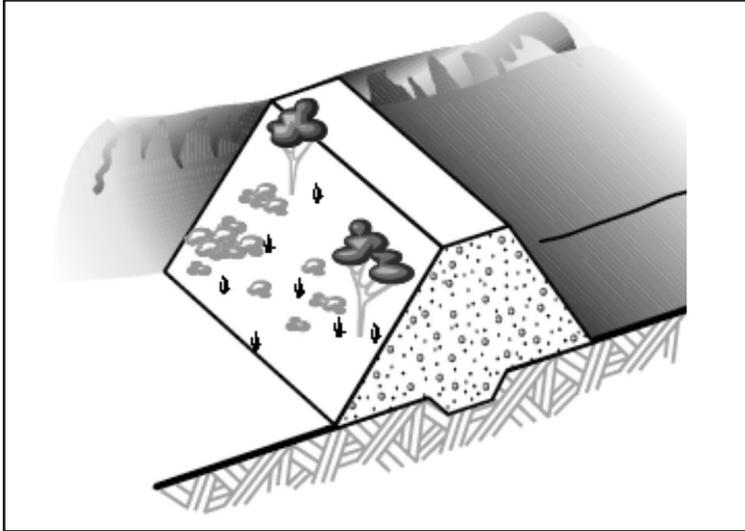
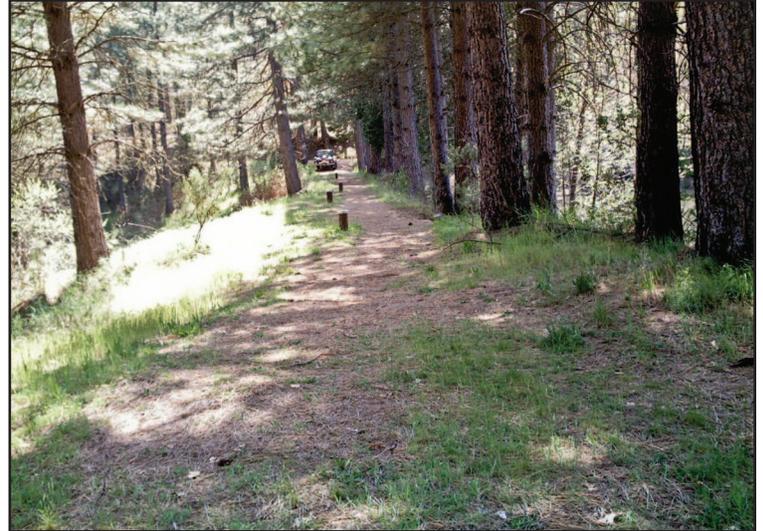
- Natural vegetation (bushes) obscures visual inspection and harbors rodents.
- Large tree roots can create seepage paths.
- Large trees can blow over during a storm and damage the dam, which may cause a breach.

Figure 13—Trees or obscuring vegetation.

Figure 14—Trees growing on the crest and the faces of a dam.

- Control vegetation that obscures visual inspection of the embankment.
- Remove all large, deep-rooted trees and shrubs on or near the embankment.
- Backfill voids properly.
- Remove trees at the toe of the dam to provide a 25-foot buffer.

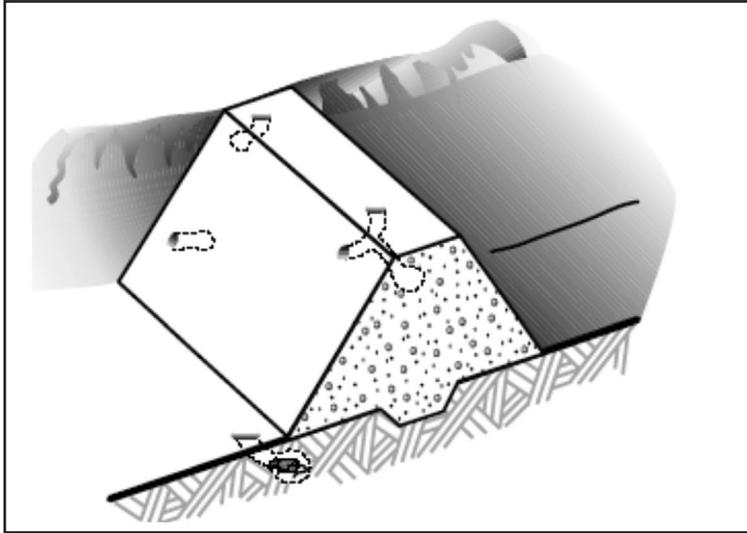
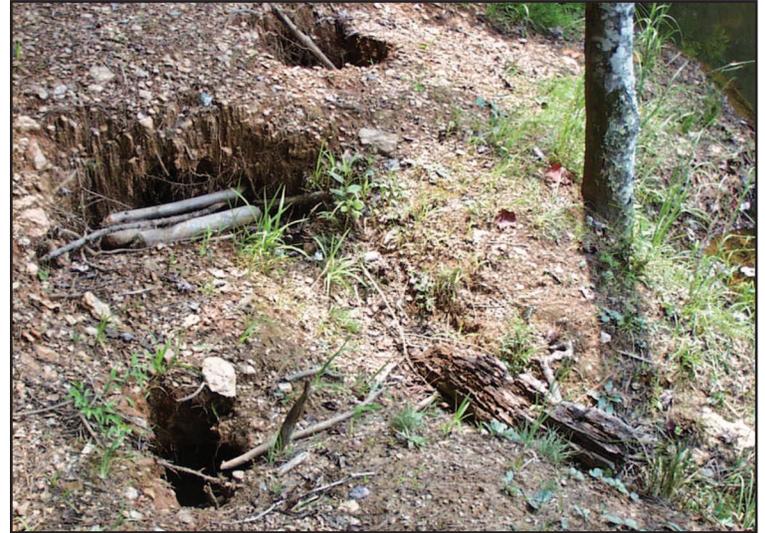
- Cattail-filled areas and areas where trees are close to the reservoir provide ideal habitat and foraging areas for animals.
- An overabundance of rodents increases the chance of animal burrowing, which creates holes, tunnels, and caverns.
- Tunnels may reduce the required length of the seepage path, which could cause a piping problem.
- Tunnels can lead to the collapse of the dam crest and may cause dam failure.

Figure 15—Rodent activity

Figure 16—Rodent holes in the dam face can cause dam failure.

- Start a rodent control program to reduce the population and prevent future damage to the dam.
- Determine the exact location and extent of tunneling.
- Backfill existing rodent holes with suitable well-compacted material to repair damages.

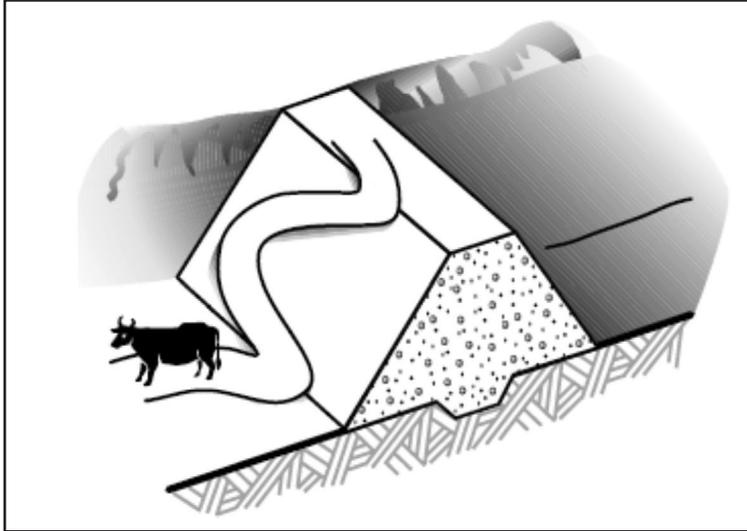
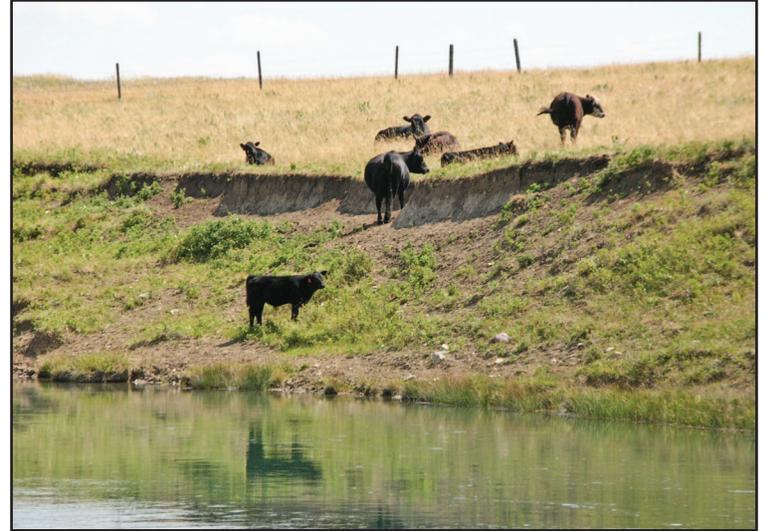
- Livestock paths and activities on the downstream dam face can damage slopes, especially when wet.
- Livestock activities may reduce erosion protection and cause erosion channels.
- Bare areas may allow water to stand and be susceptible to drying cracks.

Figure 17—Livestock and cattle traffic.

Figure 18—Livestock paths on dam faces can lead to dam erosion.

- Fence the embankment area to keep out livestock.
- Repair erosion protection by reestablishing grasses or by placing riprap.

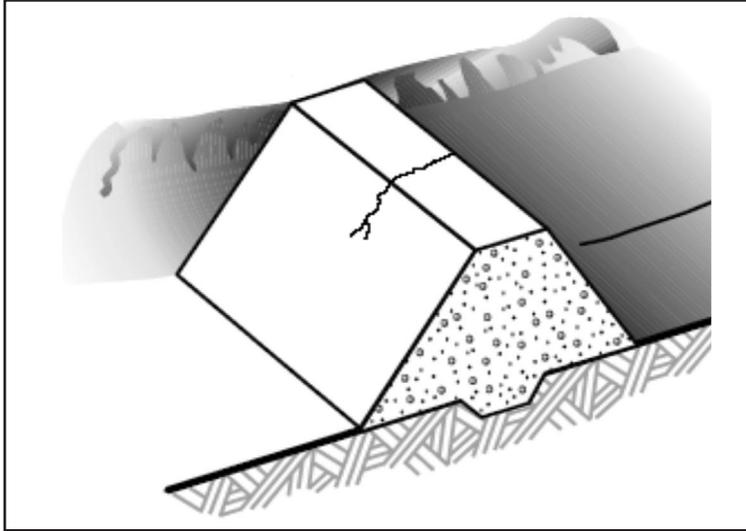
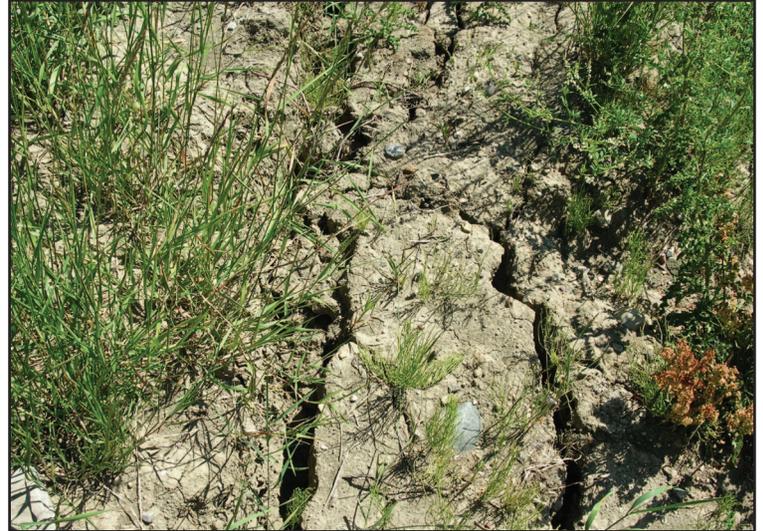
- Uneven movement between adjacent segments of the embankment may cause transverse cracking.
- Deformation caused by structural stress or instability may provide a path for seepage through the embankment cross section.
- If not corrected, cracking creates an area of low strength within the embankment that may lead to future structural movement, deformation, or failure.
- Cracks create a point for water to enter the embankment. Saturation of the adjacent embankment area may occur and could lead to localized failure.

Figure 19—Transverse cracking.

Figure 20—Transverse cracks can be an indication of dam instability.

Report the suspected problem to the appropriate Federal or State agency official immediately.

- Inspect the crack and carefully record its location, length, depth, width, and other pertinent physical features. Stake out the crack limits.
- Have a qualified engineer determine the cause of cracking and supervise all steps necessary to reduce danger to the dam and correct the condition.
- Excavate the crest along the crack to a point below the bottom of the crack. Backfill the excavation using suitable material and correct construction techniques. This seals the cracks at the crest surface to prevent surface water infiltration. Monitor the crest routinely for evidence of future cracking.

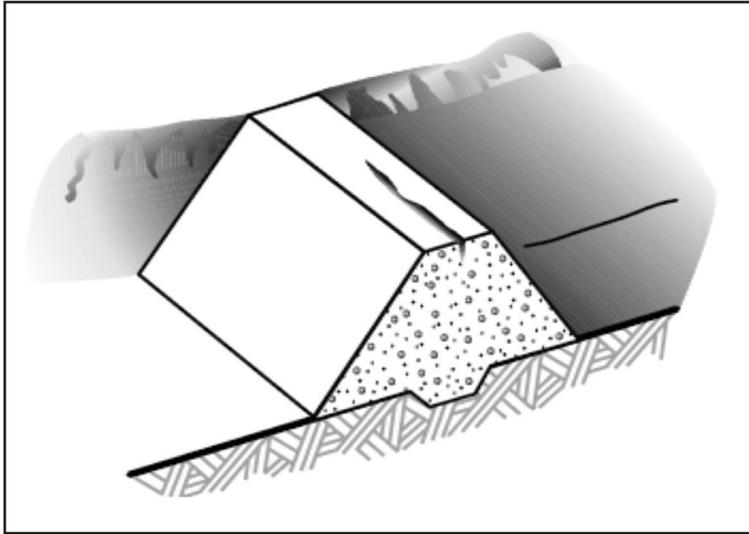
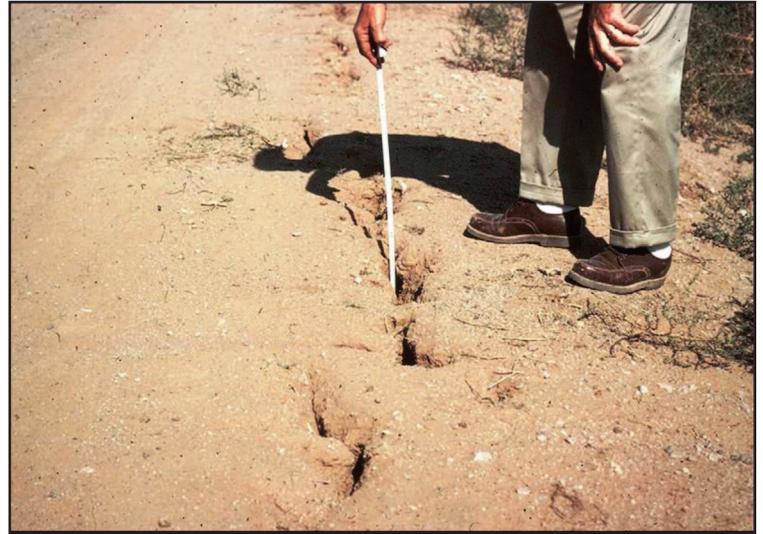
- Uneven settlement between adjacent sections or zones within the embankment may cause longitudinal cracking.
- Foundation failure causes loss of embankment support, which can result in embankment slide.
- Settlement creates an area of low strength within an embankment, which may lead to future structural movement, deformation, or failure.
- Cracks create a point for water to enter the embankment. Saturation of the adjacent embankment area may occur and could lead to localized failure.

Figure 21—Longitudinal crack.

Figure 22—Longitudinal cracks can be an indication of dam instability.

Report the suspected problem to the appropriate Federal or State agency official immediately.

- Inspect the crack and carefully record the location, length, depth, width, alignment, and other pertinent physical features. Immediately stake out the crack limits and monitor frequently.
- Have a qualified engineer determine the cause of cracking and supervise the steps necessary to reduce danger to the dam and correct the condition.
- Effectively seal the cracks at the crest surface to prevent surface water infiltration.
- Monitor the crest routinely for evidence of further cracking.

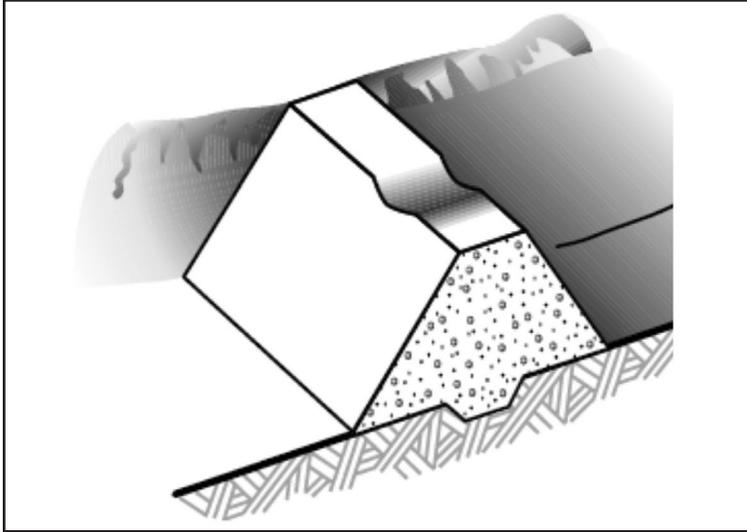
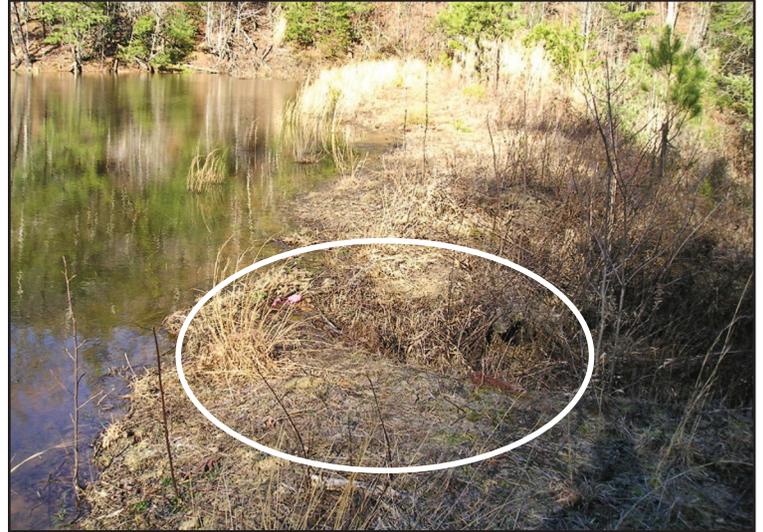
- Excessive settlement of the embankment or internal erosion of embankment material may cause a depression on the top of a dam.
- Foundation spreading upstream and/or downstream, prolonged wind erosion, or improper final grading following construction may cause a low area in the crest of a dam.
- Low areas can reduce the freeboard available to pass flood flows safely through the spillway.

Figure 23—Low area in the crest of a dam.

Figure 24—Low areas in the crest of a dam reduce the freeboard.

Report the suspected problem to the appropriate Federal or State agency official immediately.

- Establish survey monuments along the length of the crest to determine the exact amount, location, and extent of settlement in the crest.
- Have a qualified engineer determine the cause of the low area and supervise all necessary steps to reduce any threat to the dam and correct the condition.
- Use proper construction techniques to fill in the low area and reestablish a uniform elevation over the length of the crest.
- Reestablish and routinely monitor survey monuments to detect any settlement across the crest of the dam.

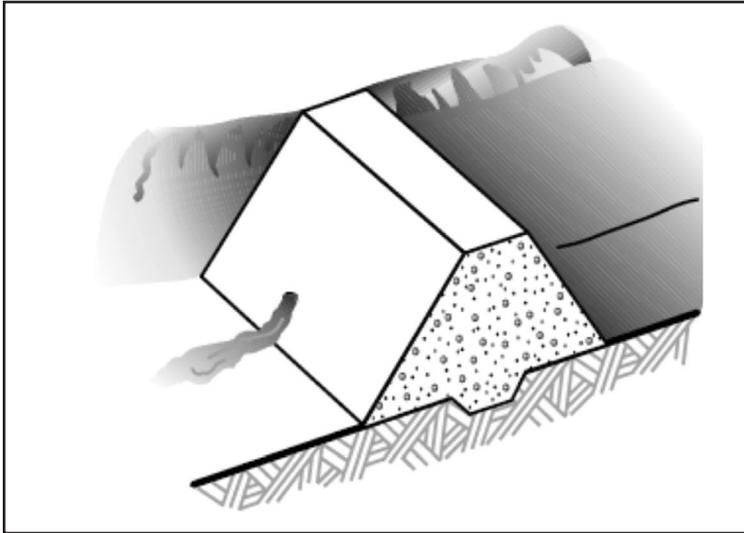
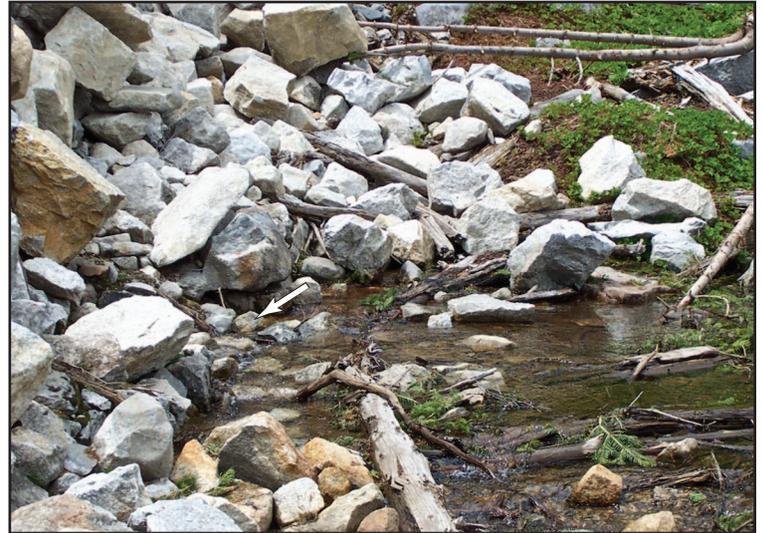
- Water has created an open pathway, channel, or pipe through the dam. The water is eroding and carrying embankment material.
- Surface agitation of water and embankment materials exiting at one point may cause muddy water.
- Rodents, frost action, or poor construction may allow water to create an open pathway or pipe through the embankment.
- Continued flows can saturate parts of the embankment and lead to slides in the area.
- Continued flows can further erode embankment materials and lead to dam failure.

Figure 25—Excessive quantity and/or muddy water exiting from a point.

Figure 26—Excessive water piping through the dam at the toe of the embankment.

Report the suspected problem to the appropriate Federal or State agency official immediately.

- Begin measuring outflow quantity. Determine whether water is getting muddier, staying the same, or clearing up.
- Have a qualified engineer inspect the condition and recommend further actions.
- If the quantity of flow is increasing, lower the water level in the reservoir until the flow stabilizes or stops.
- Search for an opening on the upstream side of the dam. Plug it if possible.

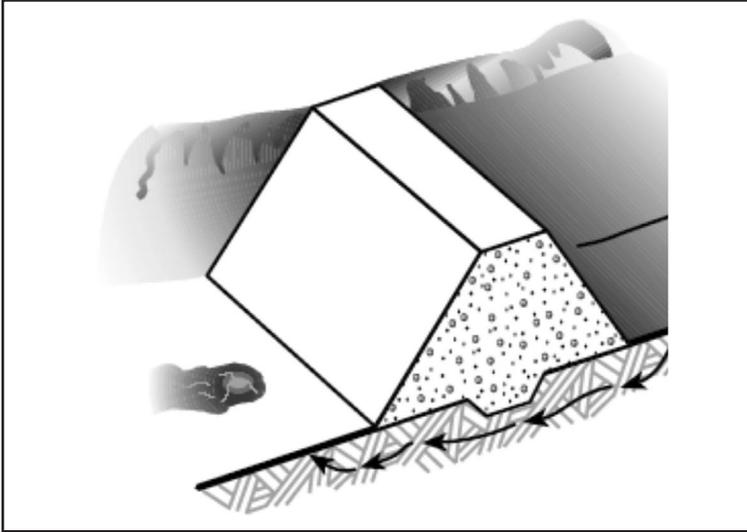
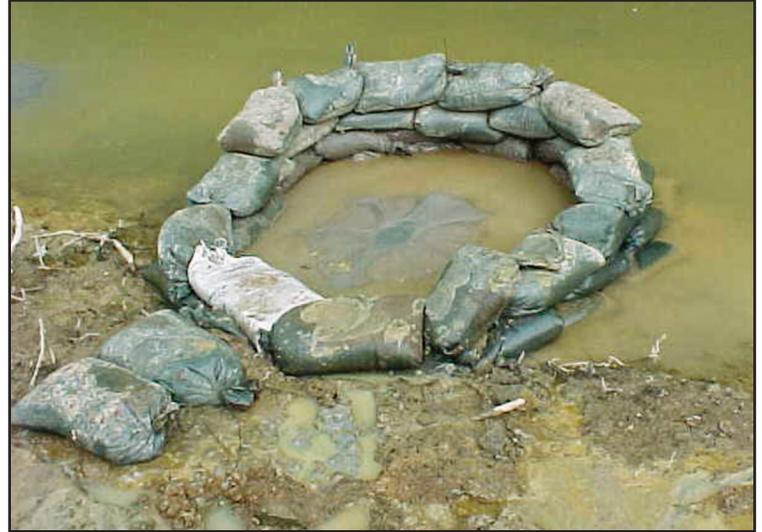
- Some part of the foundation material is supplying a flow path. This could be caused by a sand or gravel layer in the foundation.
- Increased flows can lead to erosion of the foundation and dam failure.

Figure 27—Seepage water exiting as a boil in the foundation.

Figure 28— Sandbags surrounding a boil on the downstream side of the dam.

Report the suspected problem to the appropriate Federal or State agency official immediately.

- Examine the boil to see if foundation materials are being transported.
- Have a qualified engineer inspect the condition and recommend further actions.
- If soil particles are moving downstream, use sandbags or earth to create a dike around the boil. The pressures created by the water level may control flow velocities and temporarily prevent further erosion.
- If erosion is increasing, the reservoir level should be lowered.

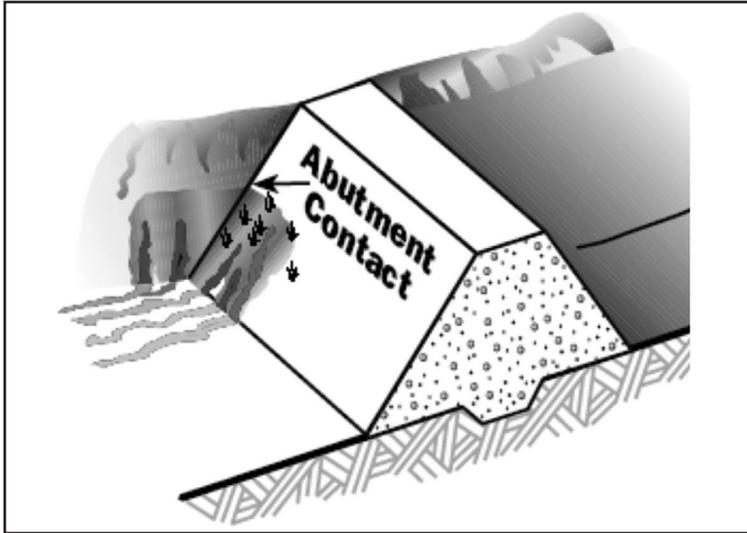
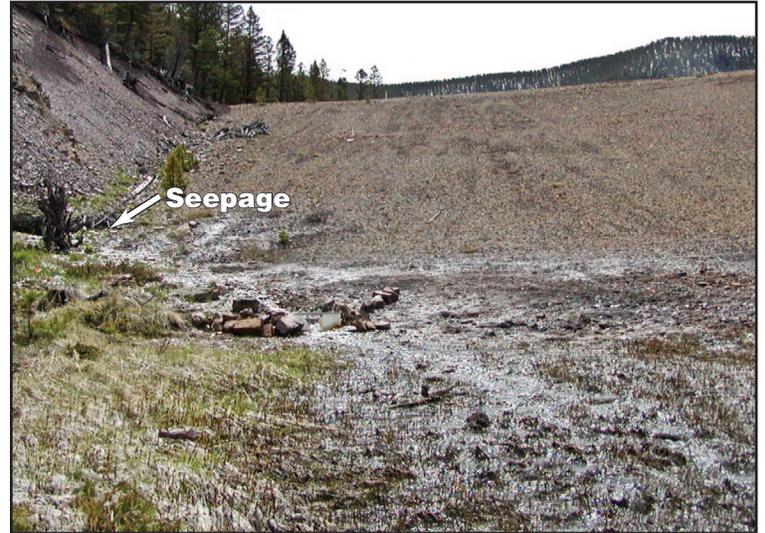
- Water flowing through pathways in the abutment or through the embankment can cause seepage.
- Seepage can lead to erosion of the embankment material and dam failure.

Figure 29—Seepage exiting at the abutment contact (groin).

Figure 30—Seepage at the abutment contact (groin) can lead to dam failure.

Report the suspected problem to the appropriate Federal or State agency official immediately.

- Study the leakage area to determine the quantity of flow and extent of saturation.
- Inspect for developing slides daily.
- Have a qualified engineer inspect the condition and recommend further actions.
- To ensure embankment safety, water level in the reservoir may need to be lowered.

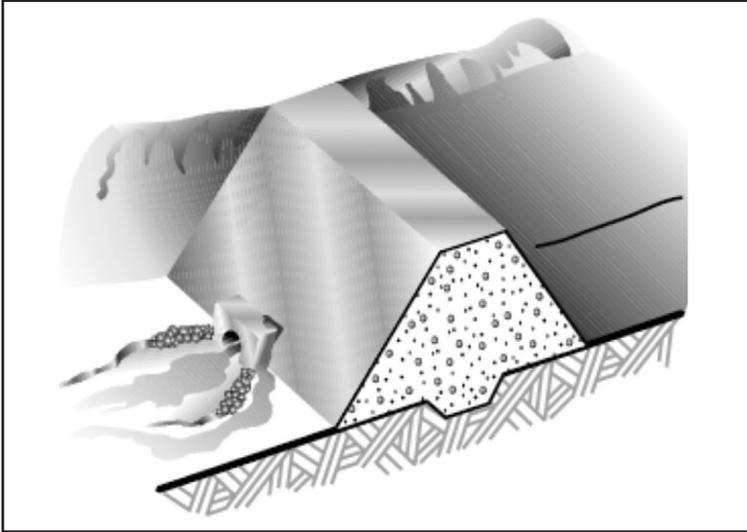
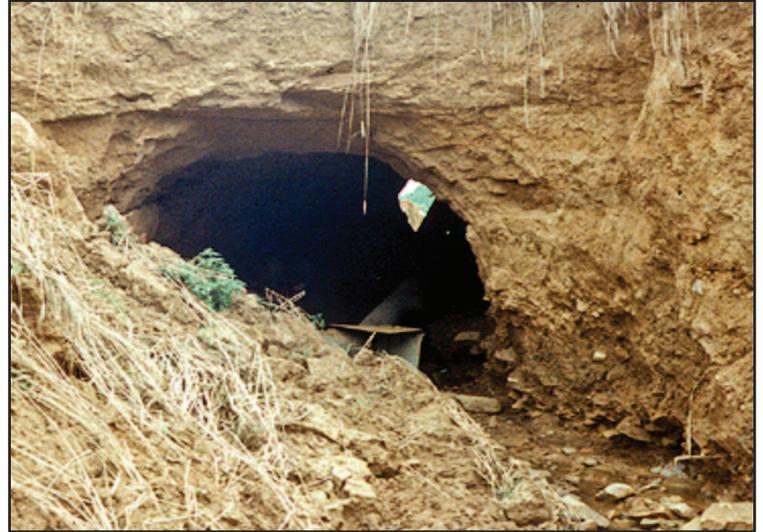
- A break or hole in the outlet pipe or poor compaction around the pipe allows water to flow and creates a pathway along the outside of the outlet pipe.
- Continued flows can lead to embankment material erosion and dam failure.

Figure 31—Seepage water exiting from a point adjacent to the outlet pipe.

Figure 32—Piping of water alongside an outlet pipe.

Report the suspected problem to the appropriate Federal or State agency official immediately.

- Thoroughly investigate the area by probing and/or shoveling to determine cause.
- Determine if seepage is carrying soil particles (muddy water).
- Determine quantity of flow.
- Have a qualified engineer inspect the condition and recommend further actions.
- If flow increases or is carrying embankment material, the reservoir level should be lowered until leakage stops.
- Investigate the embankment along the alignment of the spillway pipe if there are any signs of settlement or sinkholes.

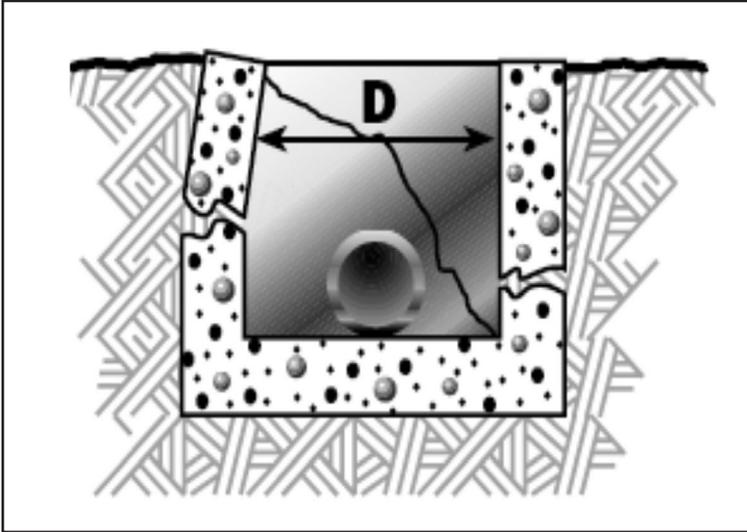
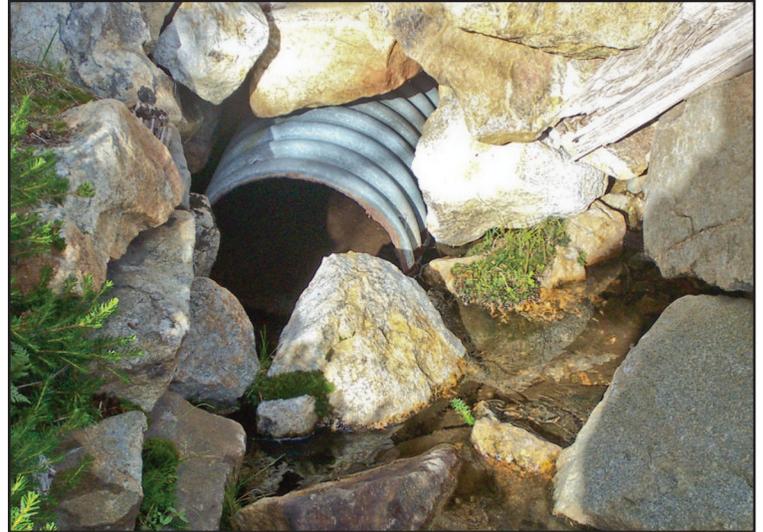
- Excessive side pressures on a nonreinforced concrete structure or poor concrete quality can cause failure of the outfall structure.
- Too steep of a slope can cause rocks to roll down the hill and partially block the outlet.
- The embankment may be exposed to erosion by outlet releases because of loss of an outfall structure.

Figure 33—Failure of a concrete outfall structure.

Figure 34—Rock failure around an outlet pipe.

- Monitor a typical dimension (such as “D” shown in figure 33) to check for progressive failure.
- Repair by patching cracks and supplying drainage around the concrete structure. The entire outfall structure may need to be replaced.
- Repair the slopes and place riprap to stabilize them.

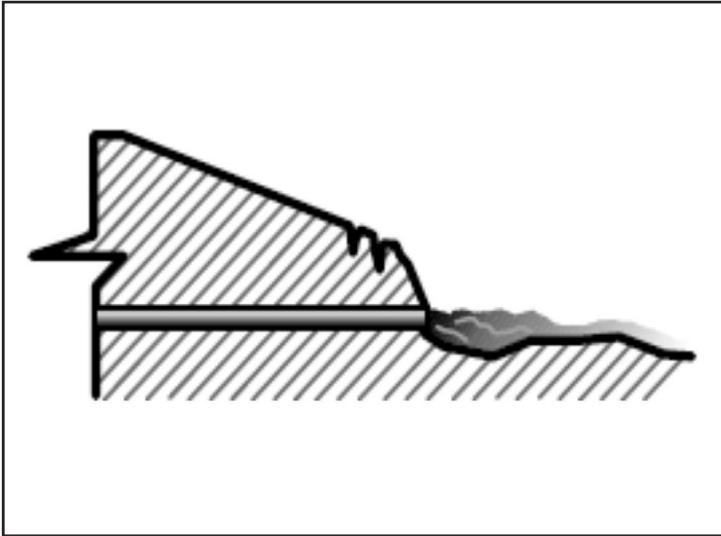
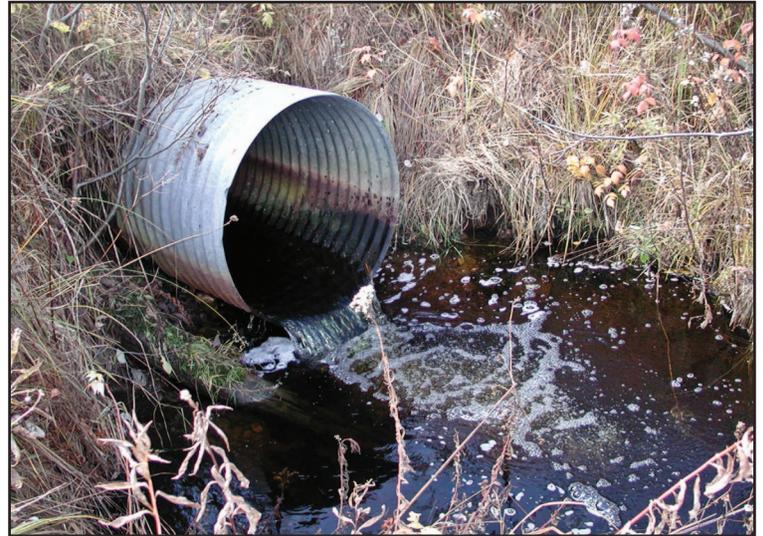
- The outlet pipe may be too short and cause a scour hole.
- No energy-dissipating pool or structure at the downstream end of the conduit can cause a scour hole.
- Erosion of the toe of the dam makes the downstream slope too steep and causes progressive sloughing.

Figure 35—Outlet releases erode the toe of the dam.

Figure 36—A scour hole at an outlet erodes the toe of the slope.

- Extend the outlet pipe beyond the toe (use the same size of pipe and material). Form a watertight connection to the existing conduit.
- Stabilize the slope.
- Use riprap over suitable bedding to protect the embankment.

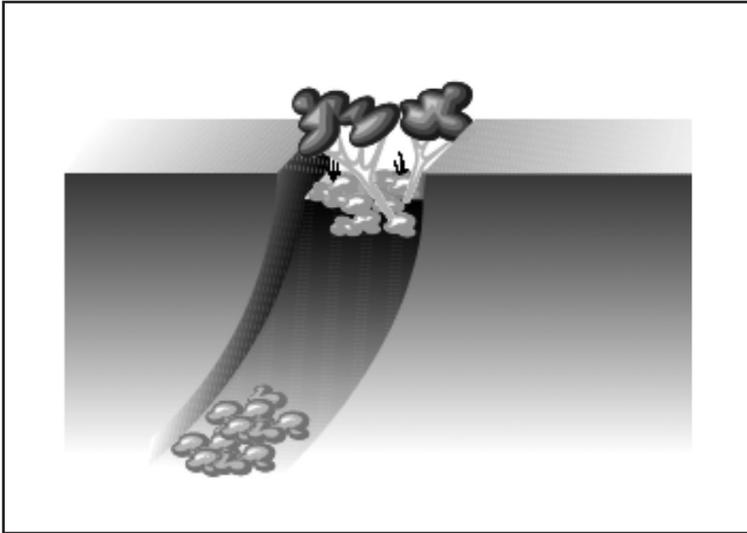
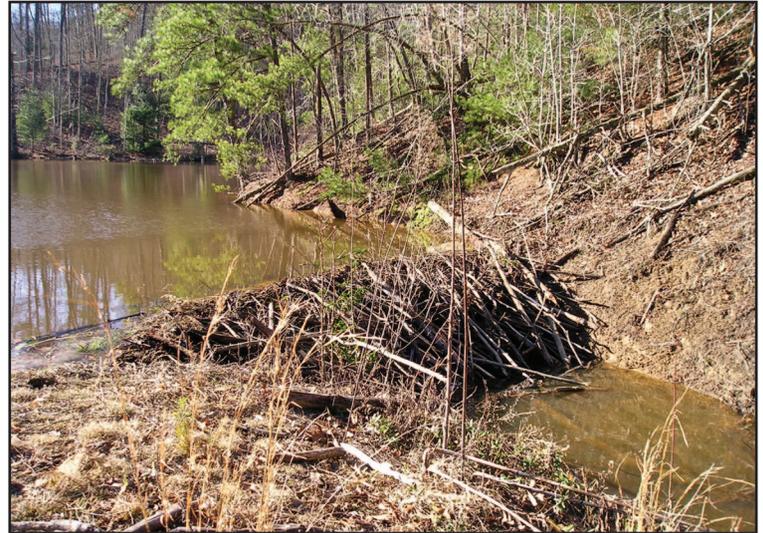
- An accumulation of slide materials, dead trees, excessive vegetative growth, etc., in the spillway channel can reduce waterway capacity.
- Reduced discharge capacity may cause the spillway to overflow and the dam to overtop. Prolonged overtopping can cause dam failure.

Figure 37—Excessive vegetation or debris in a spillway channel.

Figure 38—A blocked spillway channel may cause overtopping of the dam.

- Clean out debris periodically and control vegetative growth in the spillway channel.
- Install a log boom in front of the spillway entrance to intercept debris.

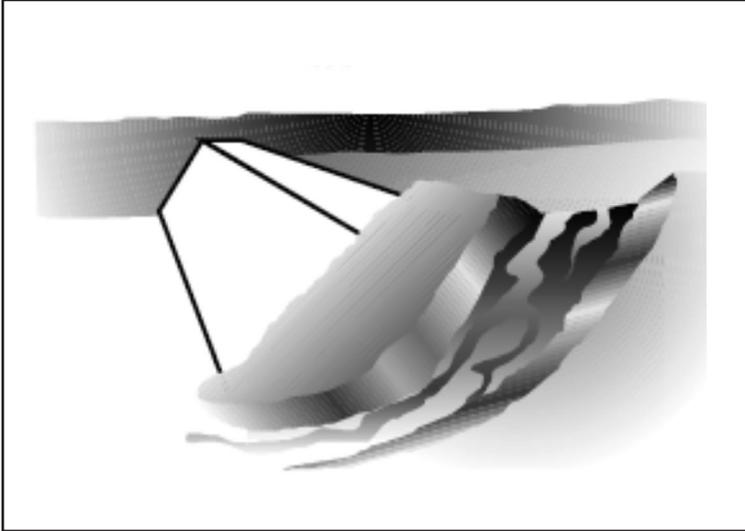
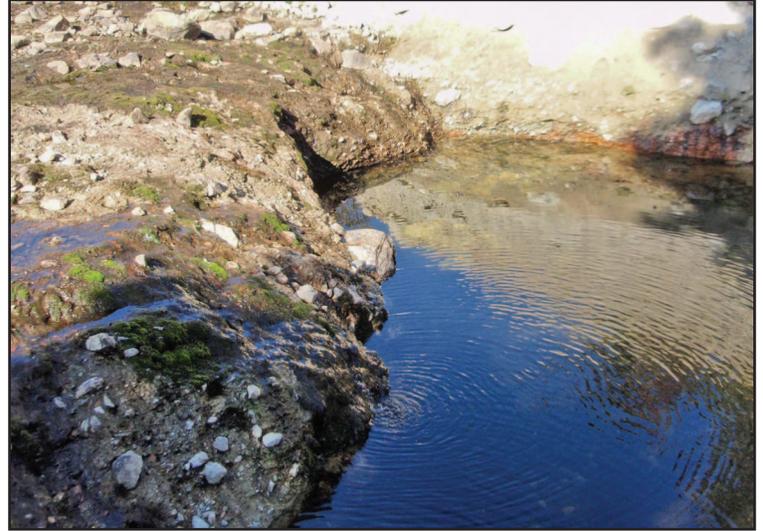
- Surface runoff from intense rainstorms or flow from the spillway carries surface material down the spillway causing continuous troughs.
- Livestock traffic creates gullies where runoff flow can concentrate.
- Unabated erosion can lead to slides, slumps, or slips, which can result in reduced spillway capacity. Inadequate spillway capacity can lead to embankment overtopping and result in dam failure.

Figure 39—Erosion channels.

Figure 40—Erosion of the spillway channel may lead to slumps or slides of the spillway sides.

- Photograph the condition and bring it to the attention of the engineer.
- Replace eroded material with compacted fill to repair damaged areas.
- Revegetate the areas if appropriate.
- Install suitable rock riprap to protect against future erosion.
