BEAMON'S RUN BUFFER AND WETLAND RESTORATION SITE  
(BARNHILL FARM)  
MONITORING REPORT (2011)

Greene County, North Carolina  
EEP Project No. 24

Status of Plan: Final  
Project Planted: 2000  
Data Collected: 2011  
Submission Date: November 2011

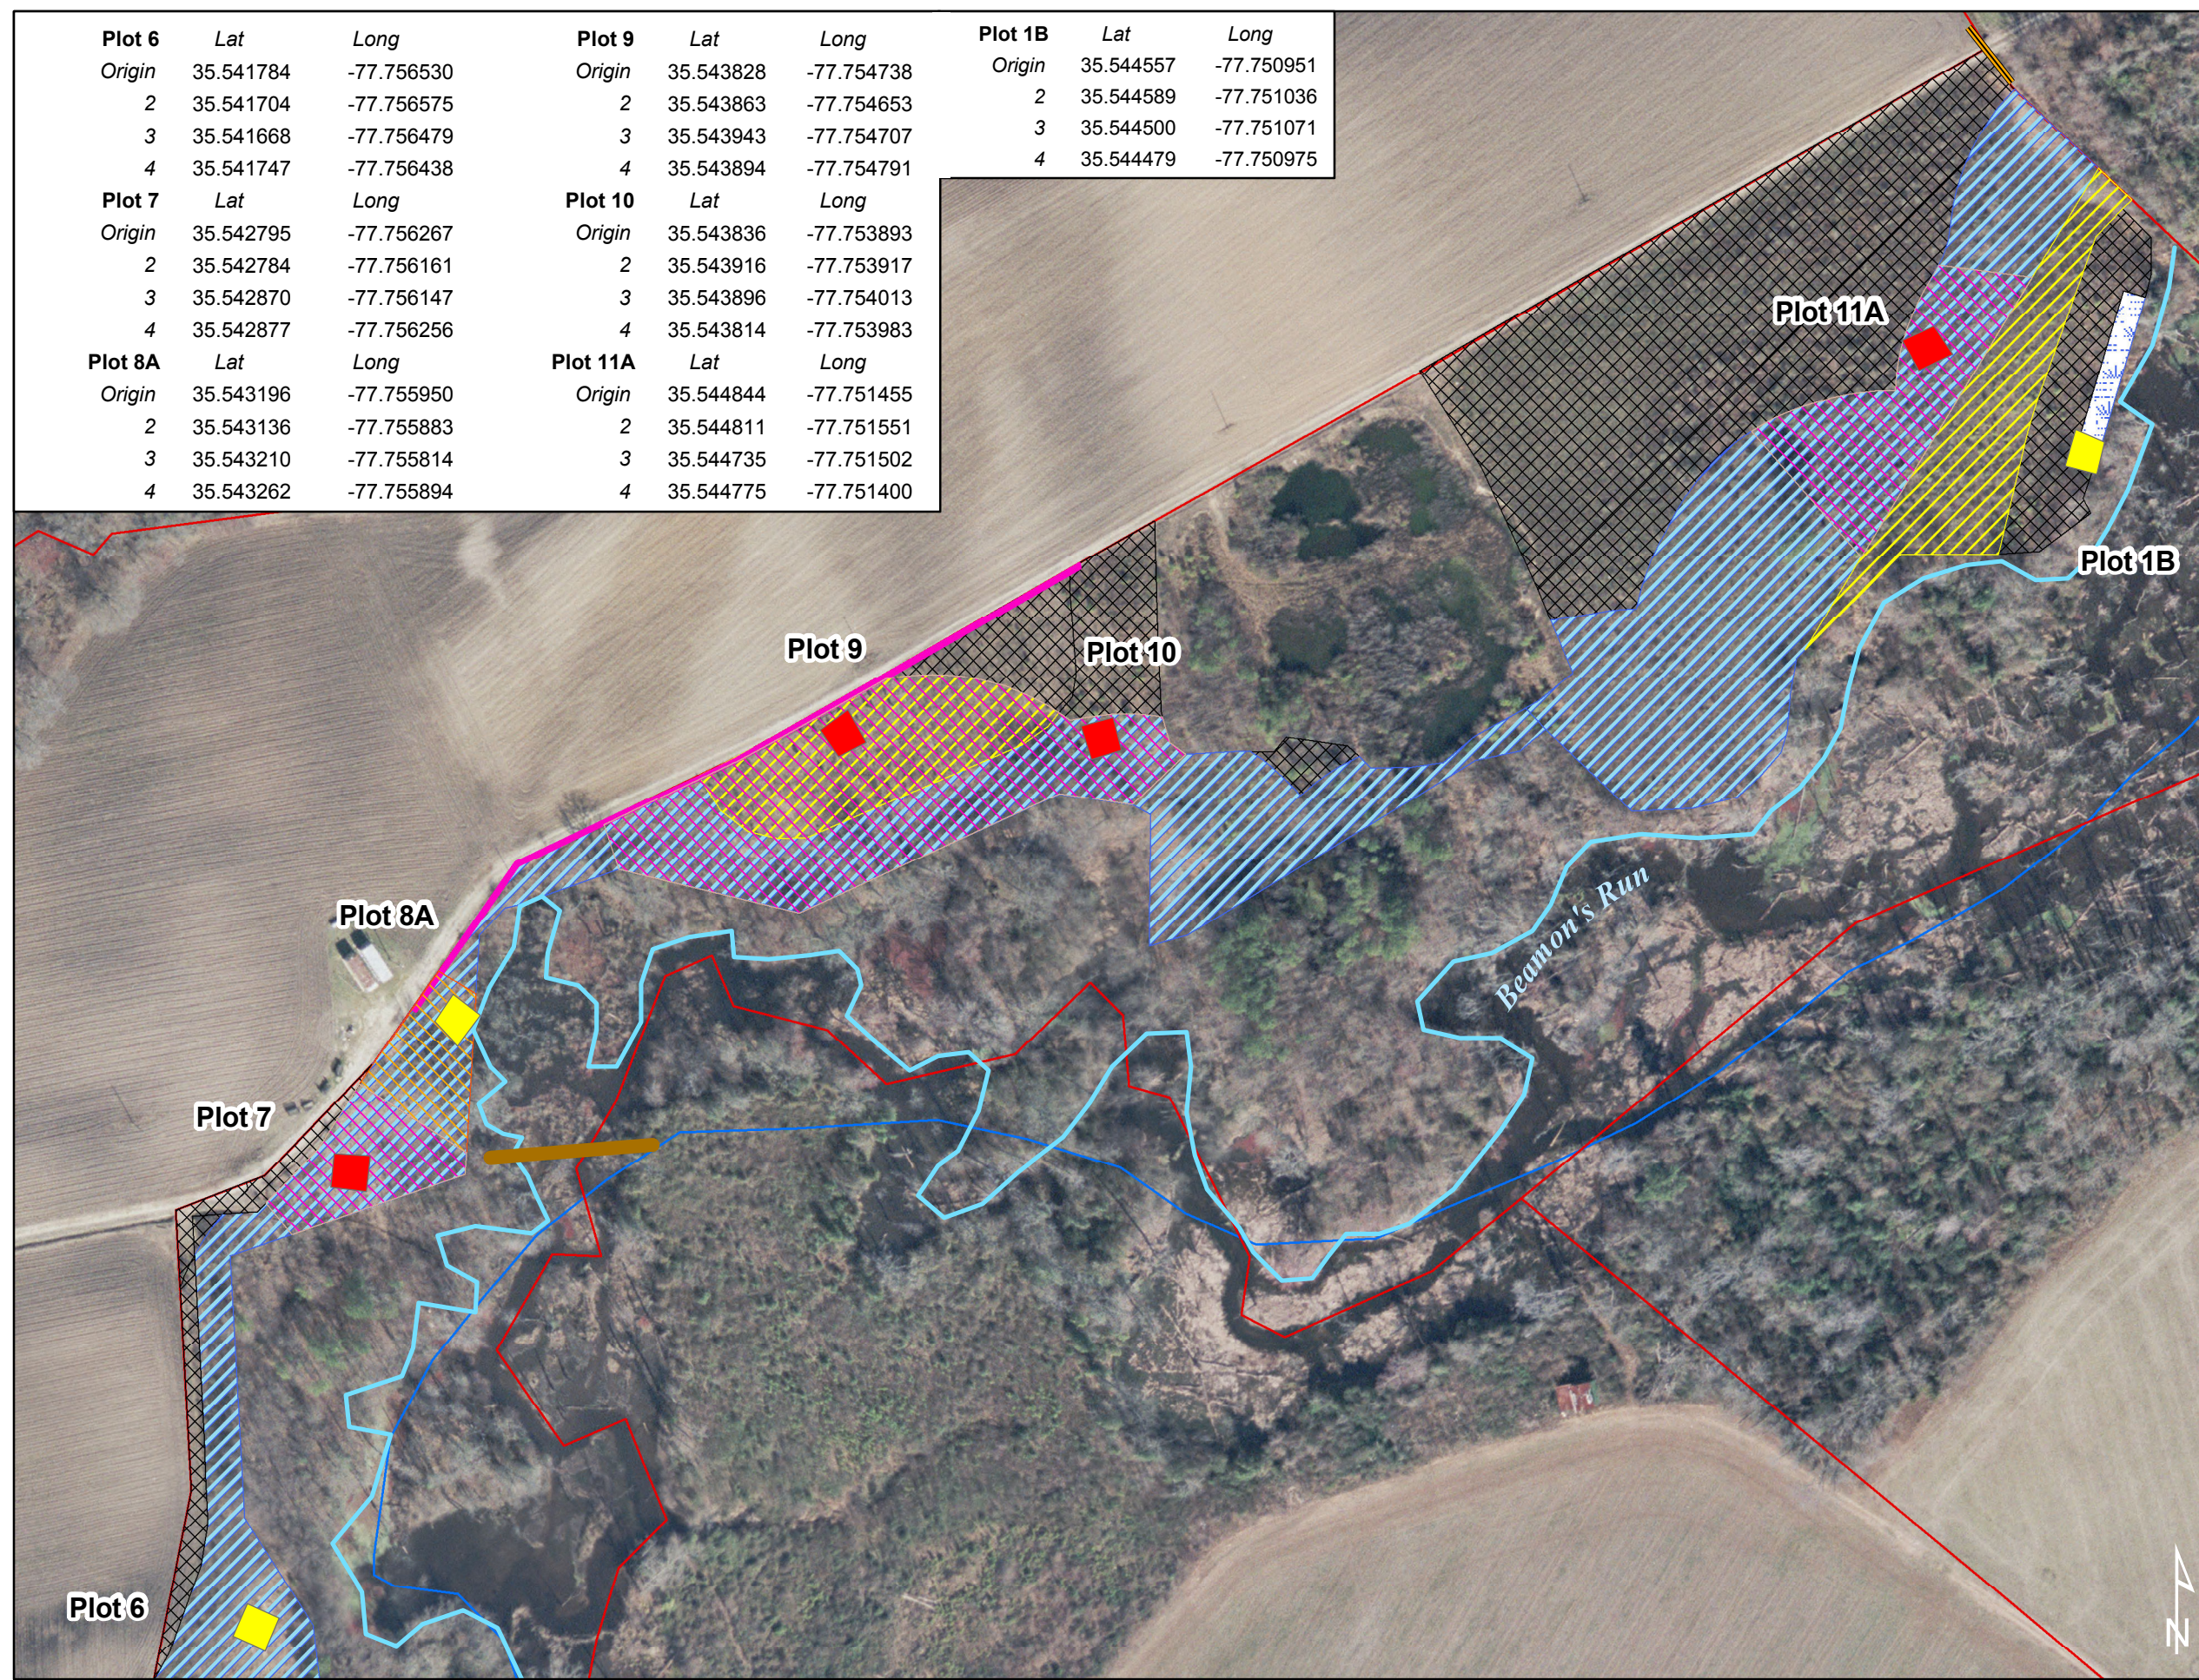
Figure 2 - Sheet 3  
 Current Condition Plan View  
 Beamon's Run Wetland and  
 Buffer Restoration Site  
 EEP Project # 24  
 Greene County, North Carolina

Note:  
 The area on this sheet depicted in the planting plan as river birch is actually bigger than originally shown. The entirety of Plot 1B is planted with River Birch.
