Beaverdam Creek and Unnamed Tributaries Mitigation Plan

Union County
North Carolina
NC EEP Project Number: D06054-C

Submitted: April 28, 2009

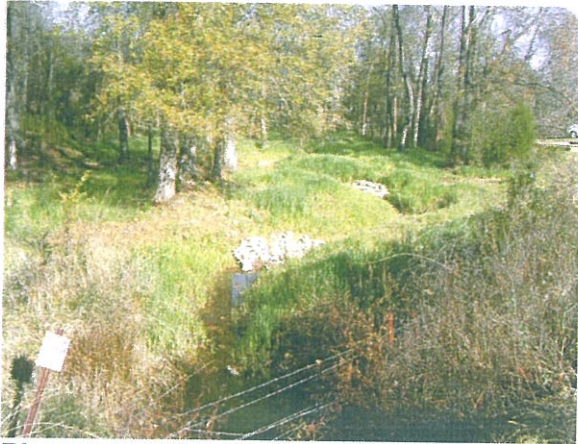
Photograph 1
Fixed Station 1. Overview of Beaverdam Creek, looking downstream.

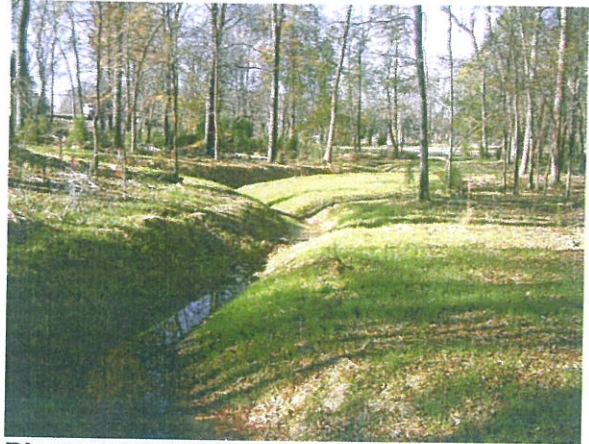
Photograph 2
Fixed Station 2. Overview of UT1, looking upstream near station 19+00.

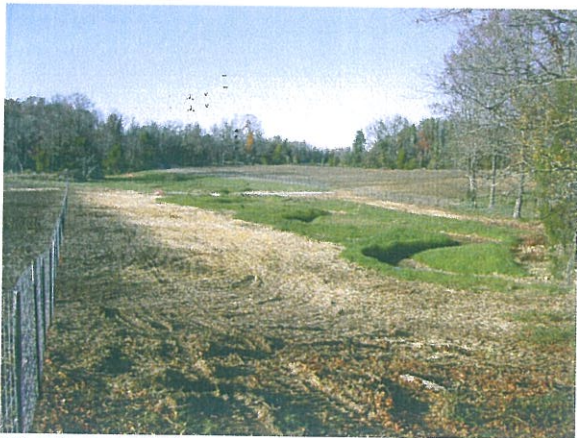
Photograph 3
Fixed Station 3. Overview of valley along UT1, looking upstream near station 13+00.

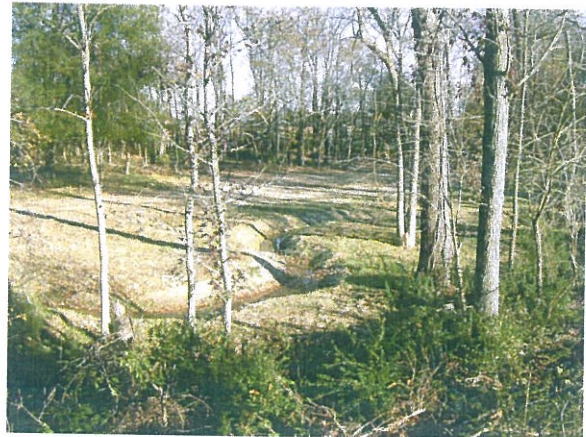
Photograph 4
Fixed Station 4. Overview of valley along UT1, looking downstream near station 13+00.

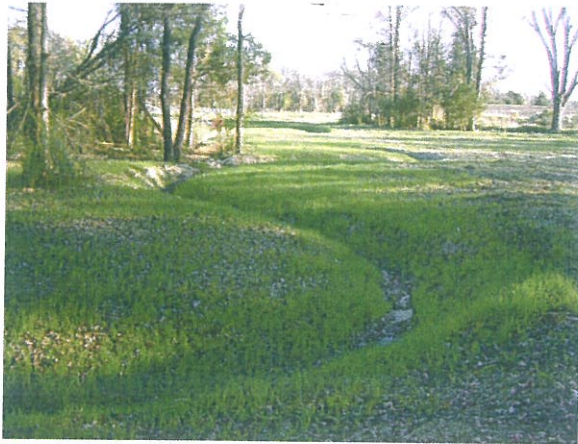
Photograph 5
Fixed Station 5. Overview of UT1, looking downstream from upstream project limits.

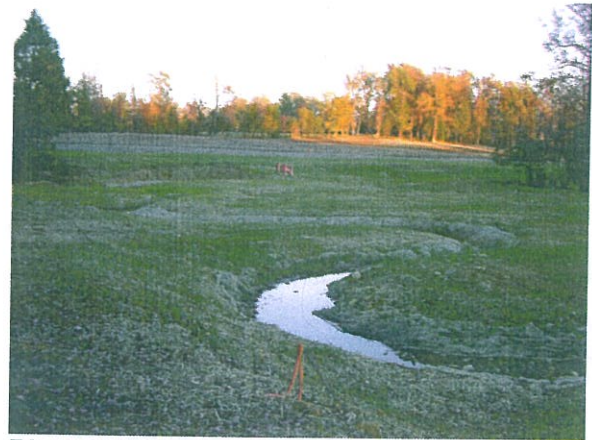
Photograph 6
Fixed Station 6. Overview of UT2, looking downstream.

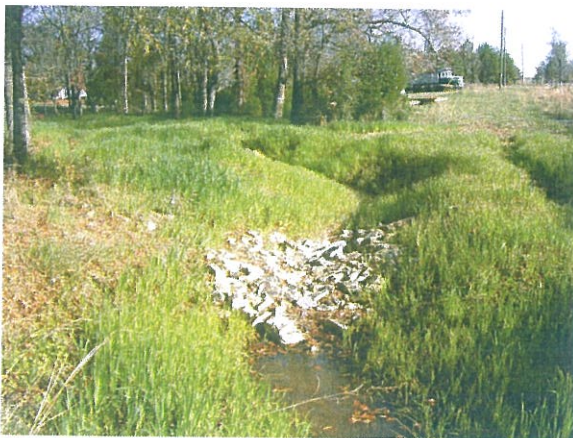
Photograph 7
Example Structure. Riffle at Station 0+32 on Beaverdam Creek, looking downstream.

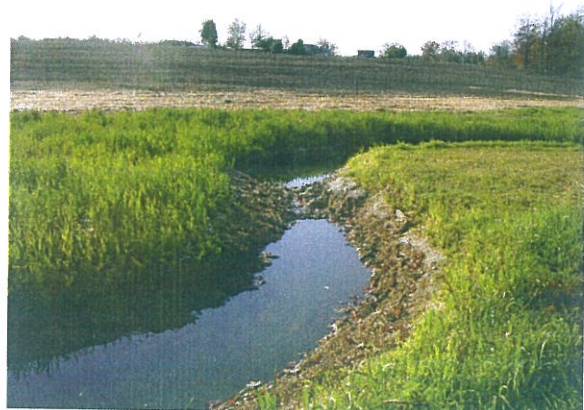
Photograph 8
Example Structure. Riffle at Station 10+73 on UT1, looking upstream.
