Buffalo Creek Watershed Stream Restoration Projects Greensboro, North Carolina

North Carolina Department of Environment and Natural Resources
Wetlands Restoration Program

June 5, 2002

Design Report Prepared By Buck Engineering PC

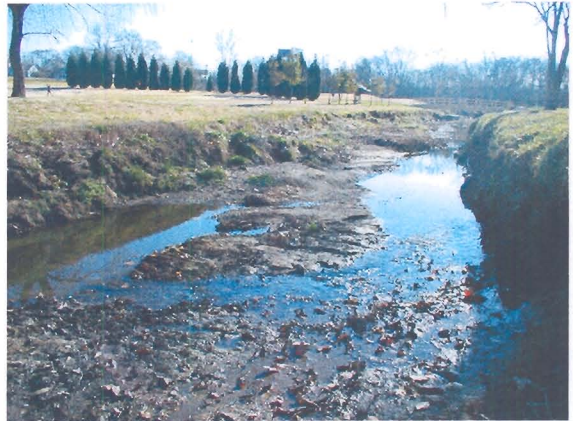
Mid-Channel Bar Forming

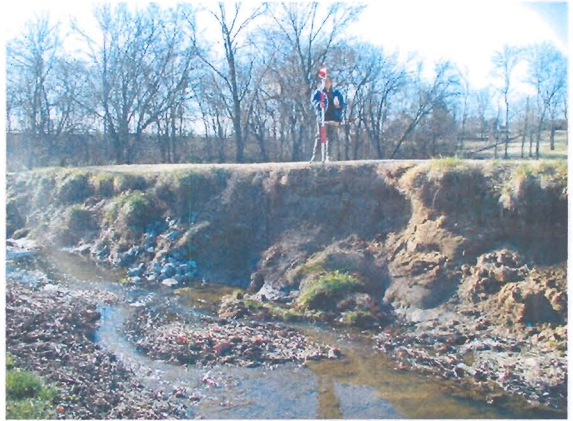
Bank Erosion

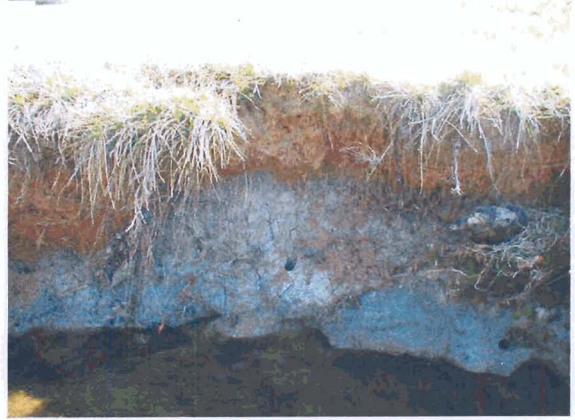
Bank Erosion

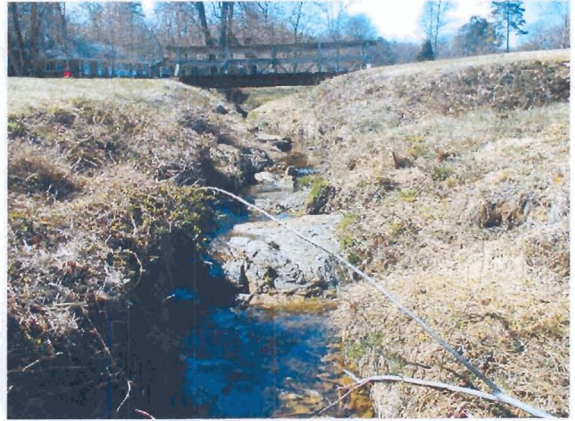
Bedrock Knickpoint

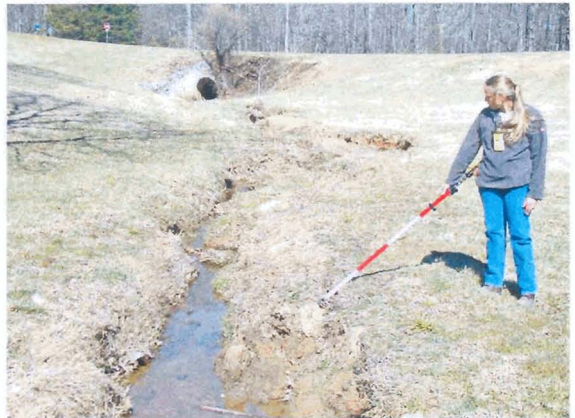
Bank Erosion - Downstream
