MITIGATION PLAN WITH AS-BUILT DRAWINGS

BROWN MARSH SWAMP STREAM AND WETLAND RESTORATION SITE

Robeson County, North Carolina

Contract No. D06038-A

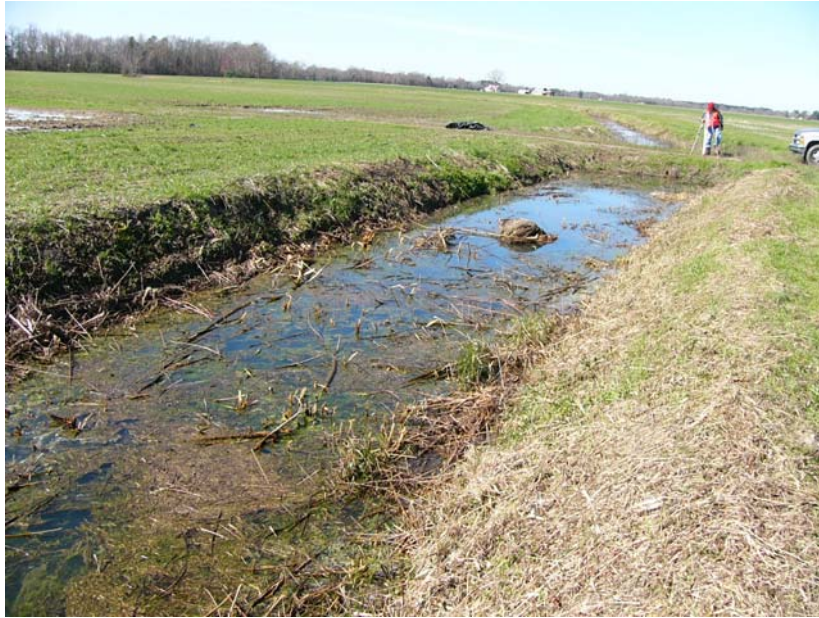
Northern UT looking downstream at recently mowed banks

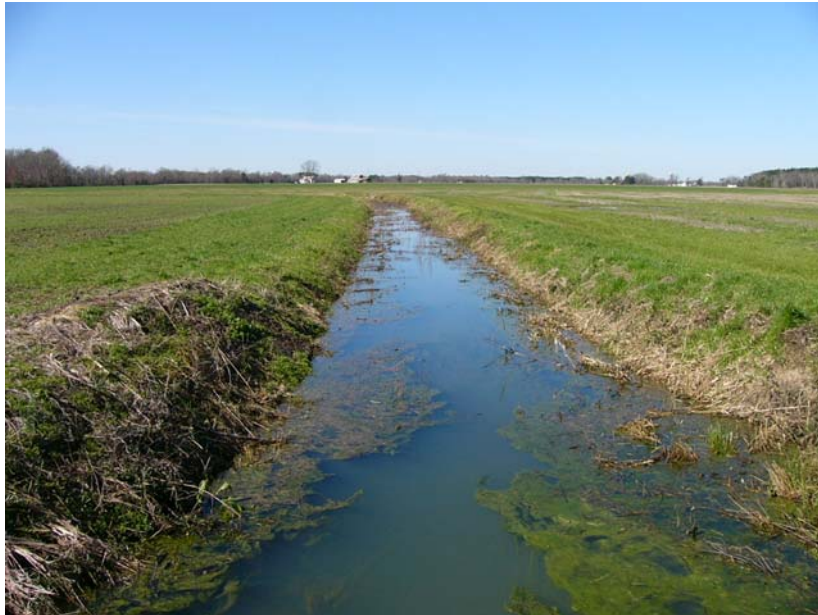
Northern UT looking downstream from crossing

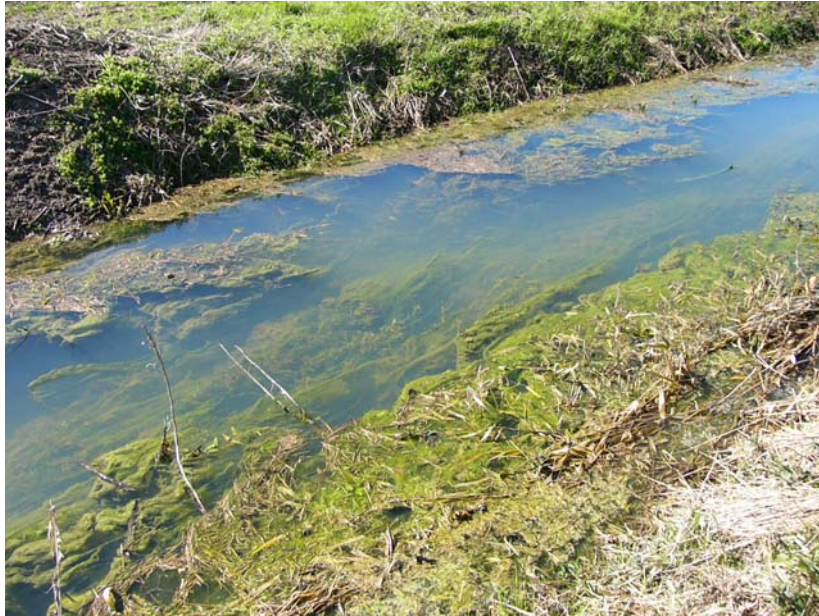
**View of algal blooms growing in
Northern UT from nutrient loading**

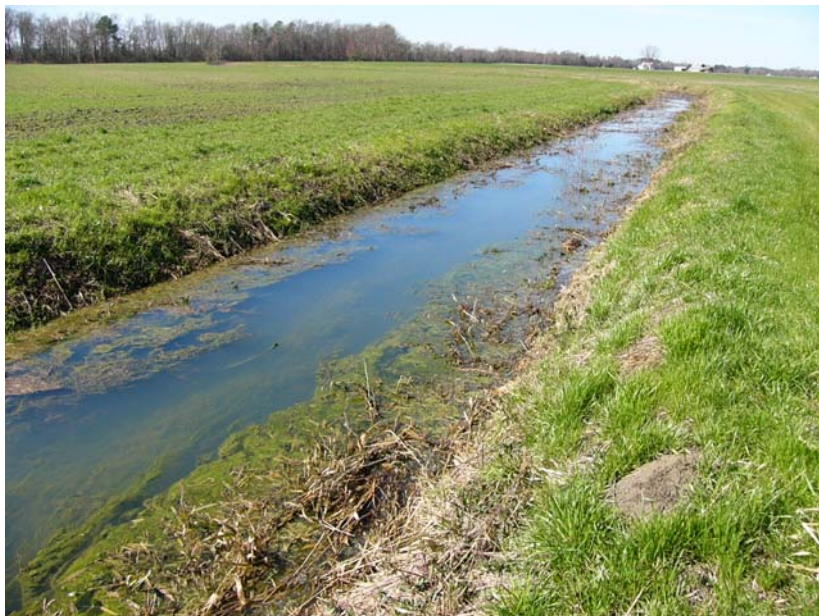
**Northern UT looking downstream at
maintained banks**

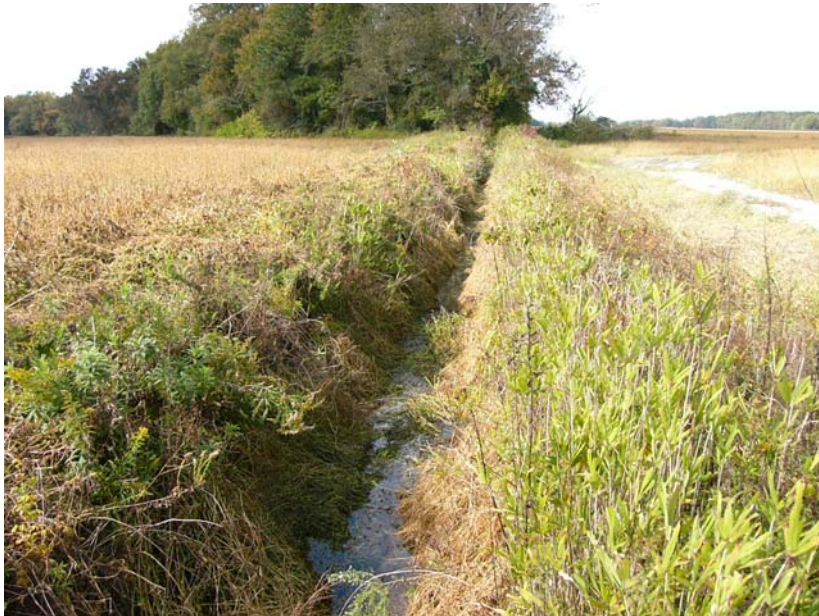
**Southern UT looking downstream
towards convergence with Northern UT**

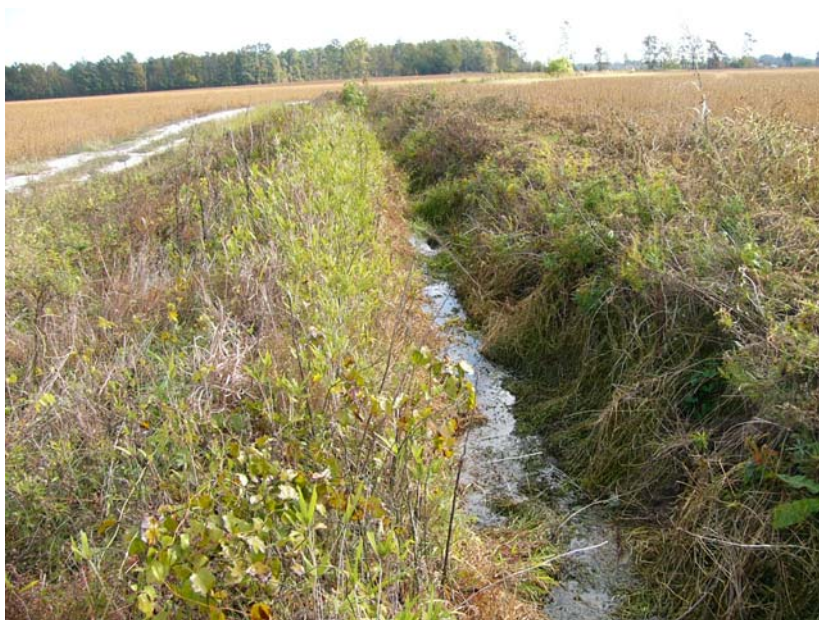
**Southern UT looking upstream towards
start of project**

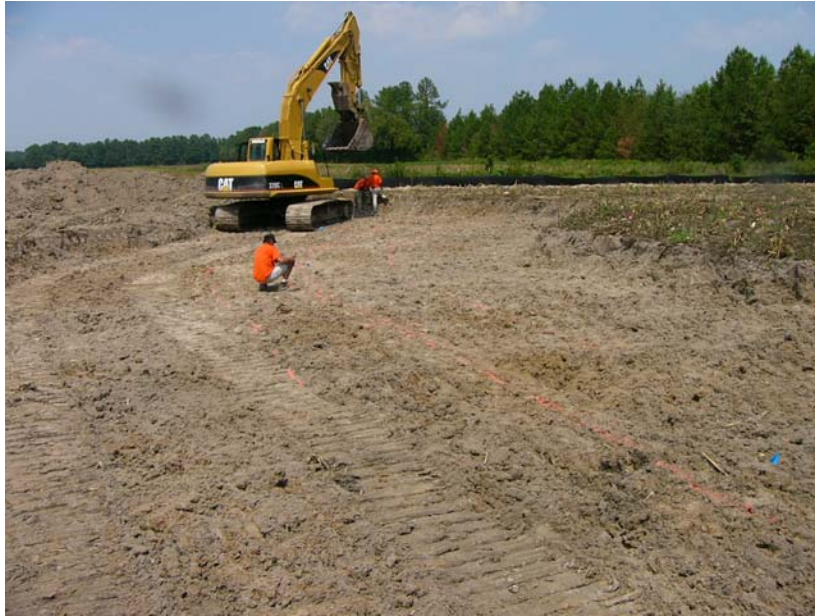
Construction of Northern UT Floodplain

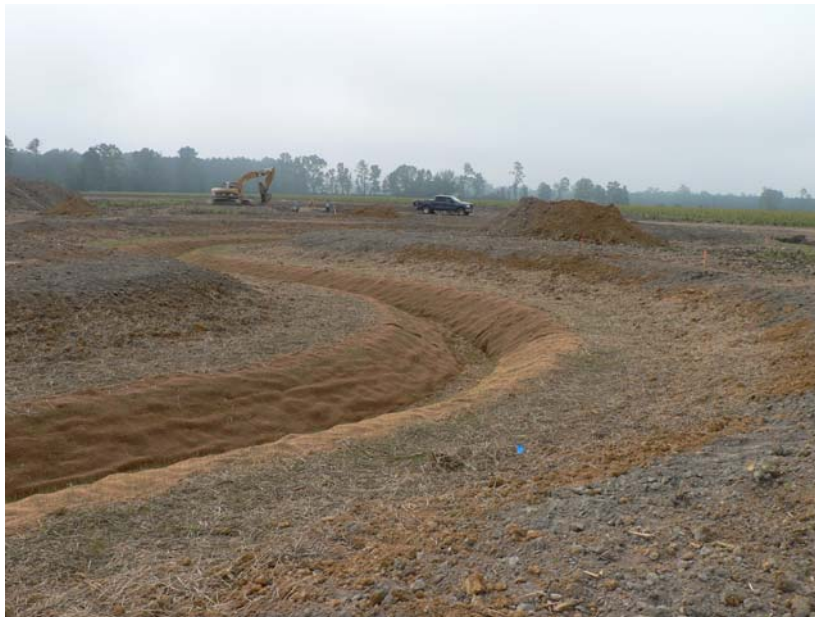
**Construction of Northern UT Channel
and Floodplain**

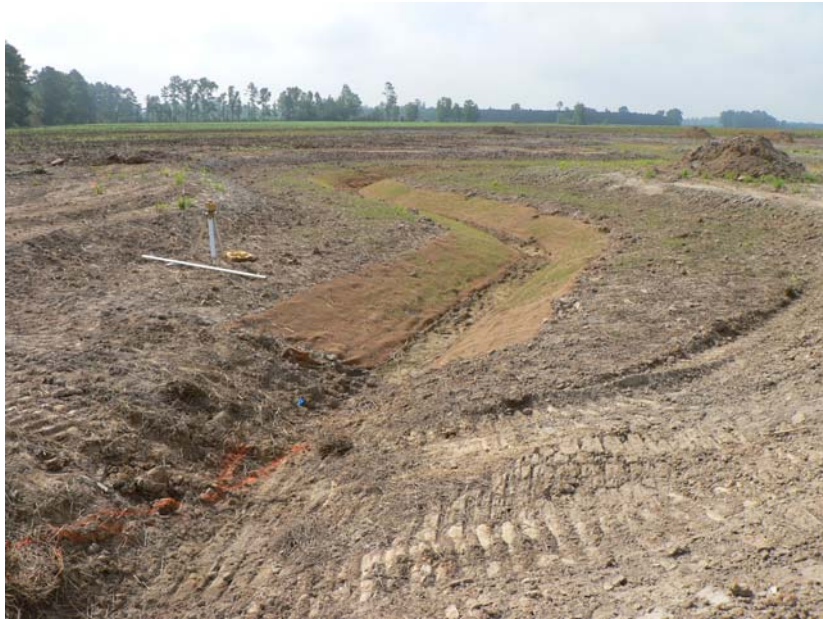
Northern UT at start of project

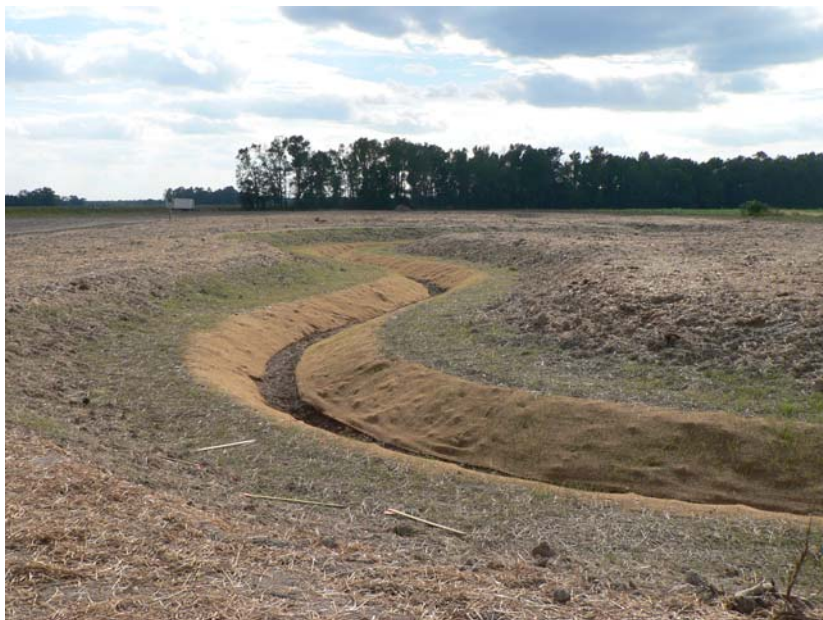
Northern UT looking downstream at meanders and grass establishment

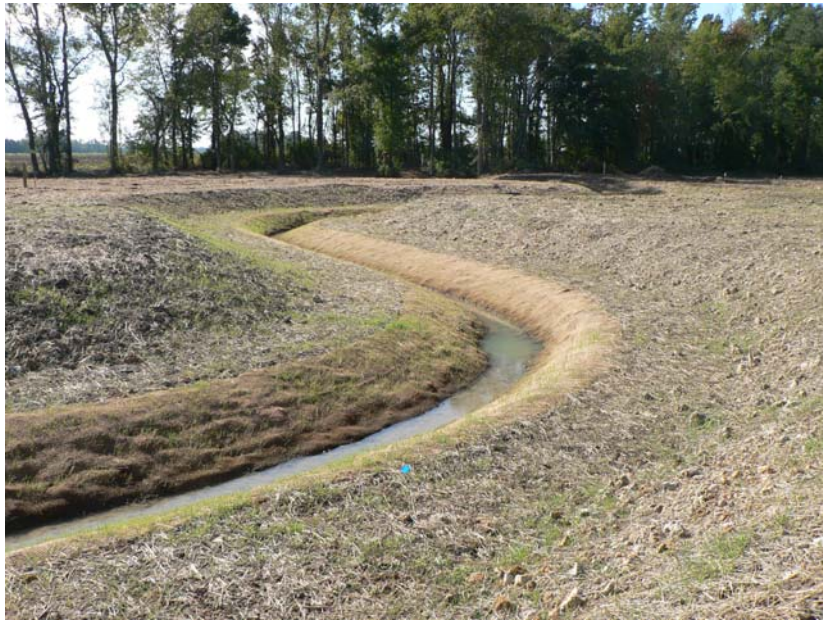
**Northern UT looking downstream
towards confluence with Lower Reach**

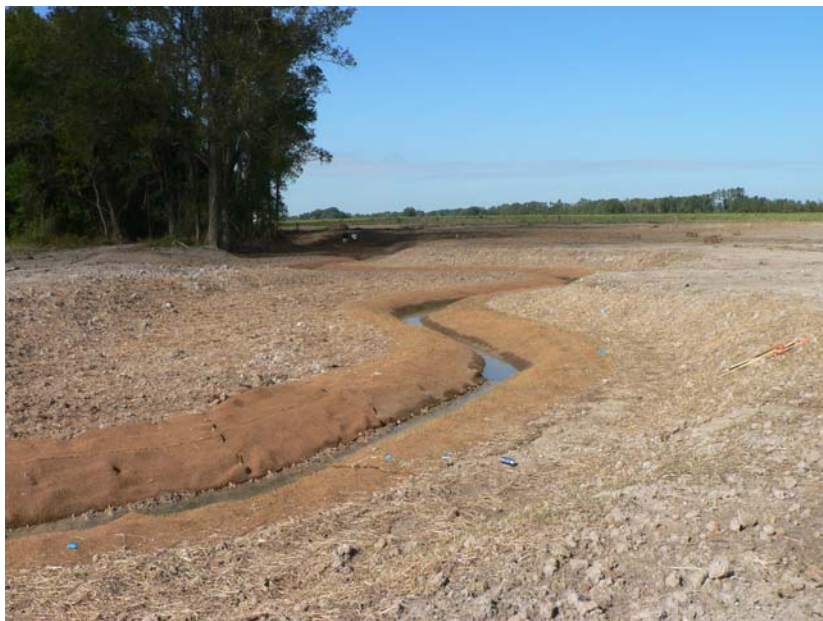
**Southern UT looking downstream
towards confluence with Upper Reach**
