**Year 1 Monitoring Report**

**Bucky's Branch Mitigation Project**

**DMS Project #: 100109 | Contract #: 7861 | DWR # 2019-1404 | RFP: 16-007703**

**January 2021**

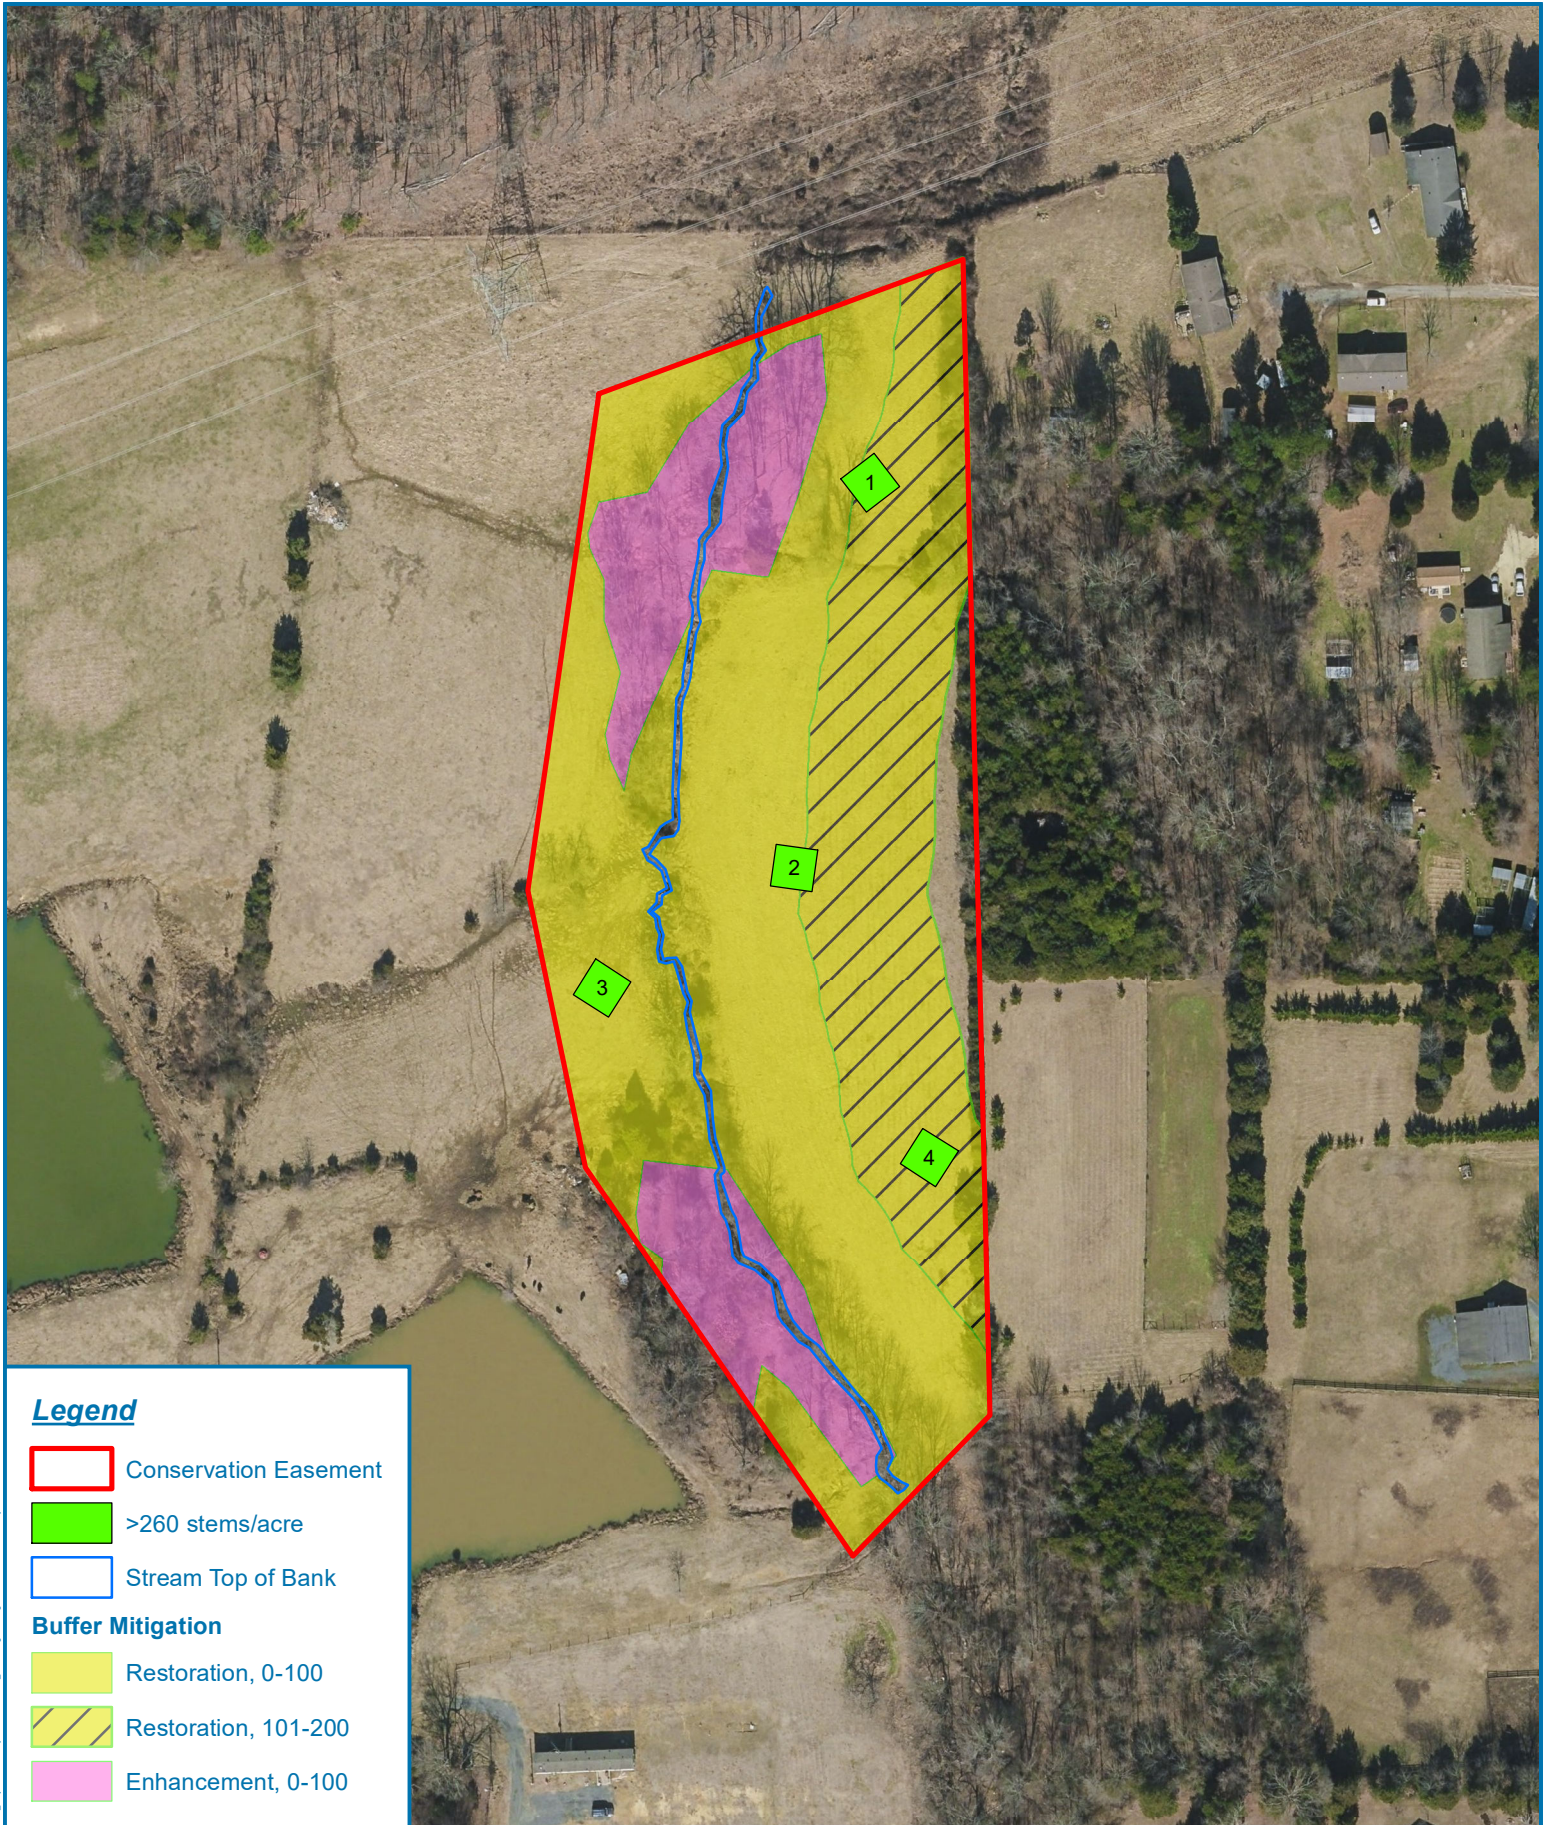
Figure 2 - Current Conditions Plan View

Visual assessment of vegetation outside of the monitoring plots indicates that the herbaceous vegetation is becoming well established throughout the project and no invasive species were observed. The fence has been installed, is in good condition, and is maintaining cattle exclusion. Additionally, there were no signs of encroachment or concentrated flow in the easement area.

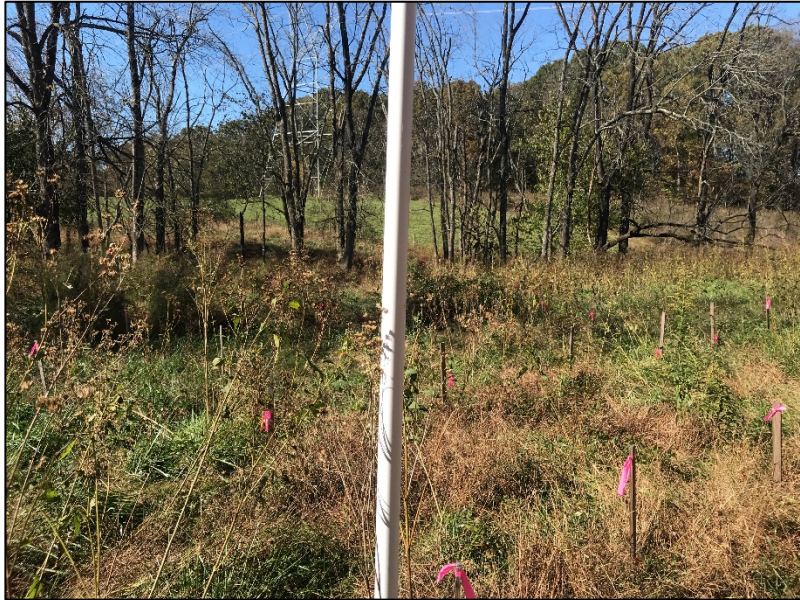
Vegetation Plot 1 (11/04/2020)

| Plot # | Planted Stems/Acre | Volunteer Stems/Acre | Total Stems/Acre | Success Criteria Met? | Average Planted Stem Height (ft) |
|---|---|---|---|---|---|
| 1 | 486 | 162 | 647 | Yes | 1.6 |

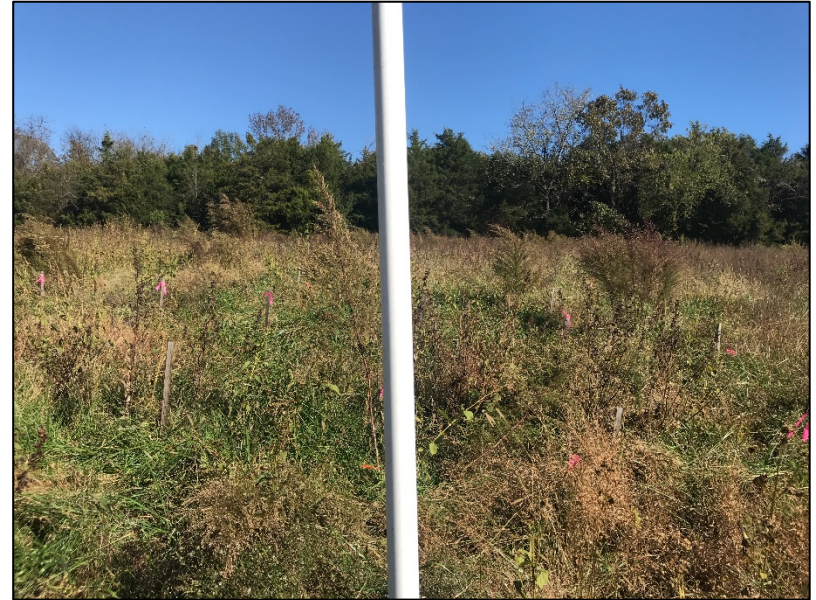
Vegetation Plot 2 (11/04/2020)

| Plot # | Planted Stems/Acre | Volunteer Stems/Acre | Total Stems/Acre | Success Criteria Met? | Average Planted Stem Height (ft) |
|---|---|---|---|---|---|
| 2 | 405 | 40 | 445 | Yes | 1.5 |

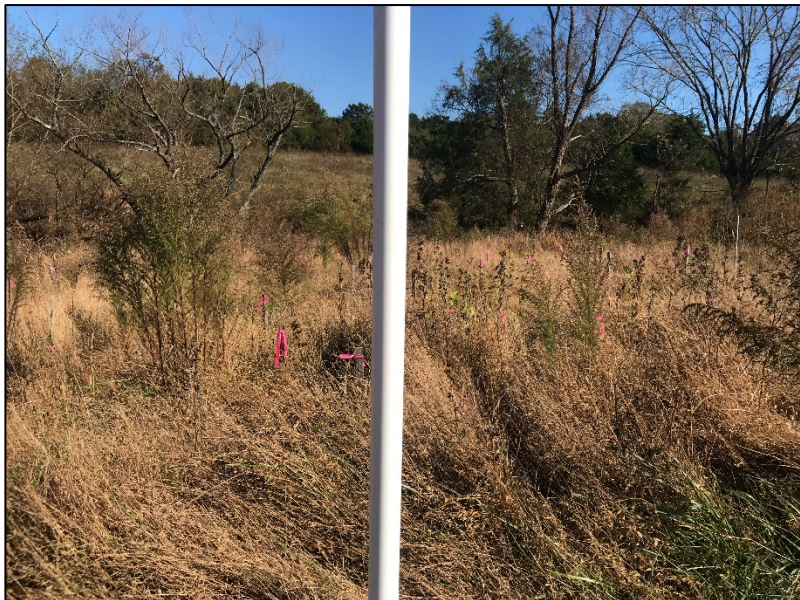
Vegetation Plot 3 (11/04/2020)

| Plot # | Planted Stems/Acre | Volunteer Stems/Acre | Total Stems/Acre | Success Criteria Met? | Average Planted Stem Height (ft) |
|---|---|---|---|---|---|
| 3 | 728 | 0 | 728 | Yes | 1.5 |

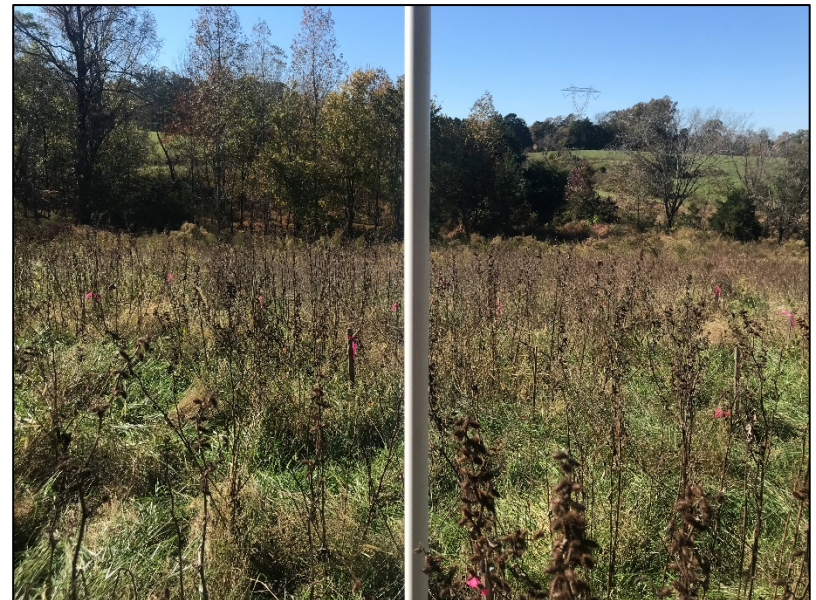
Vegetation Plot 4 (11/04/2020)

| Plot # | Planted Stems/Acre | Volunteer Stems/Acre | Total Stems/Acre | Success Criteria Met? | Average Planted Stem Height (ft) |
|---|---|---|---|---|---|
| 4 | 567 | 0 | 567 | Yes | 1.7 |
