STREAM RESTORATION PLAN

Little Bugaboo Creek Wilkes County, North Carolina

N.C. Wetlands Restoration Program

April 2002

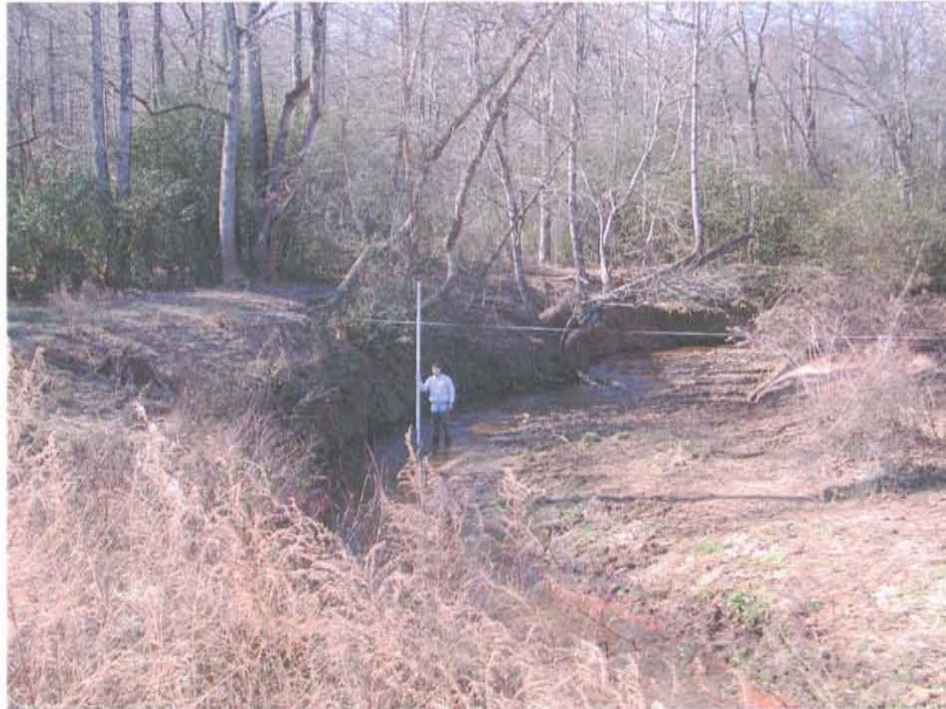
Picture 1. First Cross-section at the upstream end of Little Bugaboo Creek.

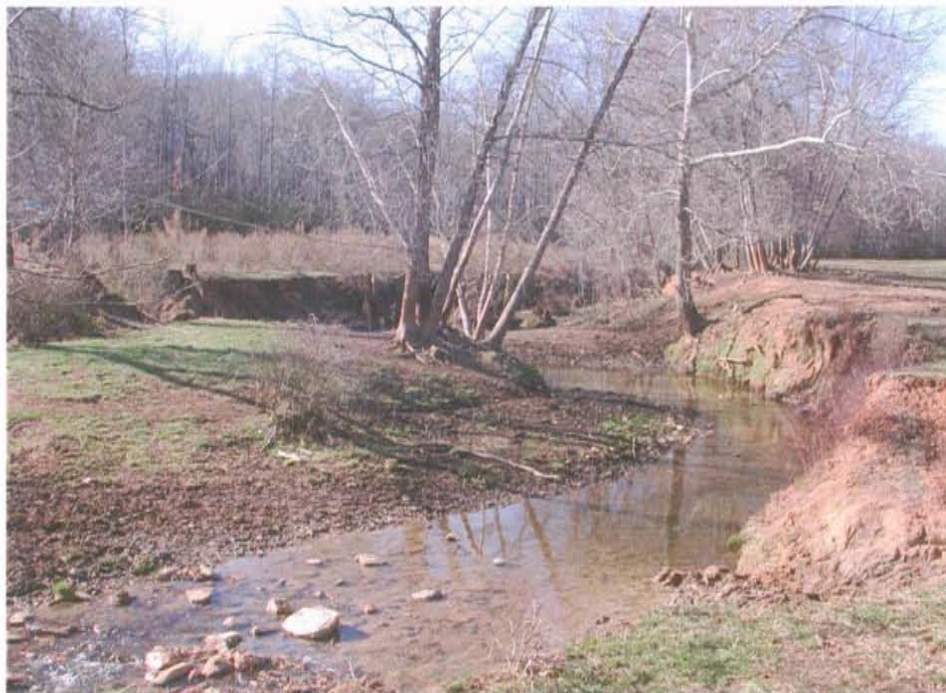
Picture 2. Little Bugaboo Creek upstream of existing crossing.
Bankfull bench forming on left bank.

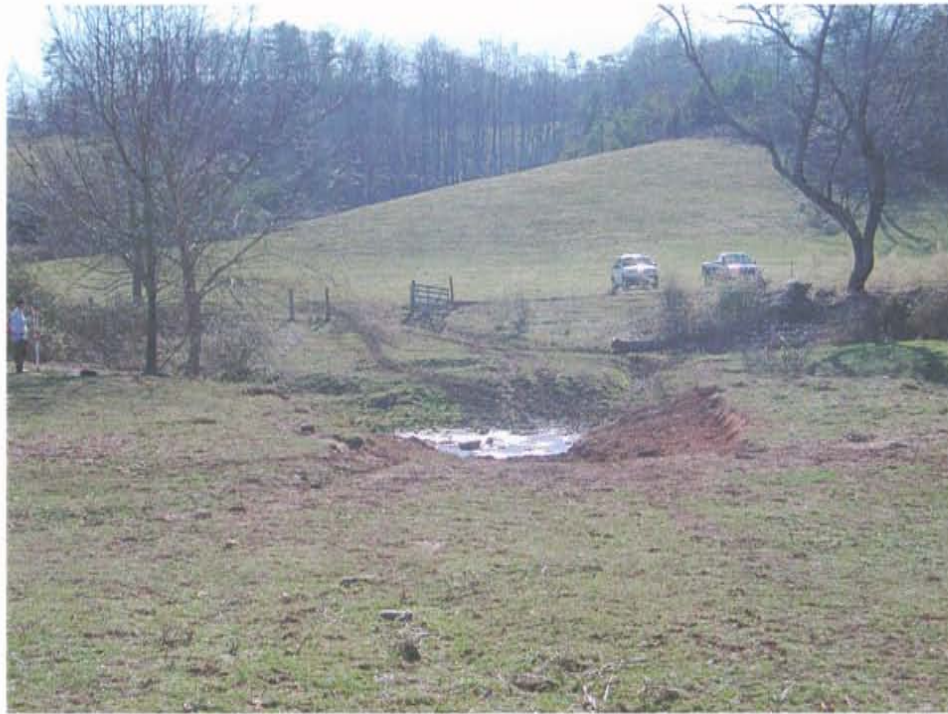
Picture 3. Existing crossing on Little Bugaboo Creek.

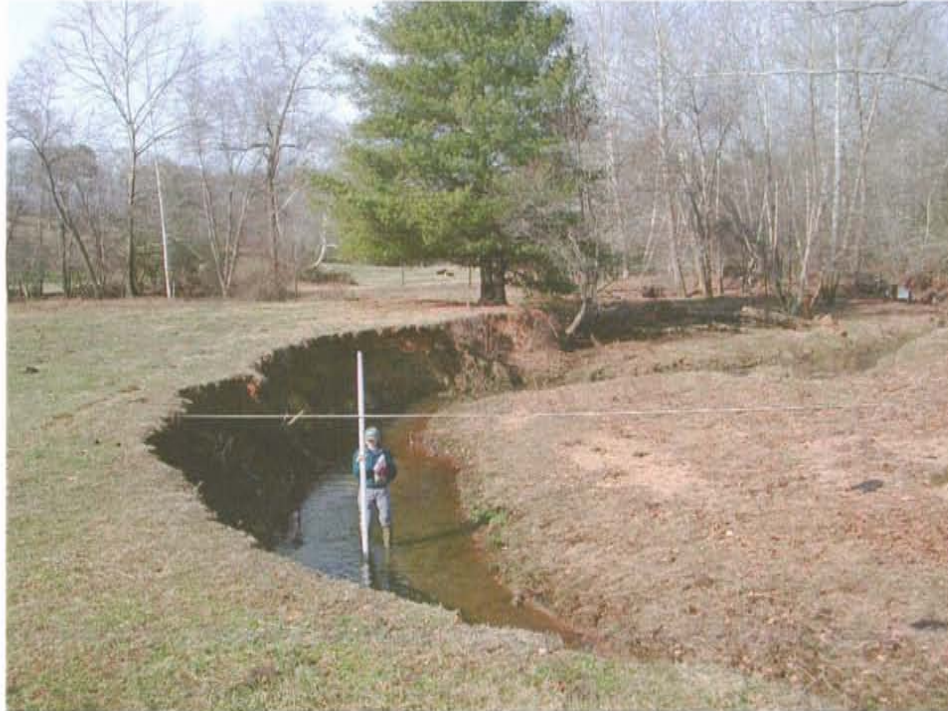
Picture 4. Pool cross-section at severely eroding meander on Little Bugaboo Creek.

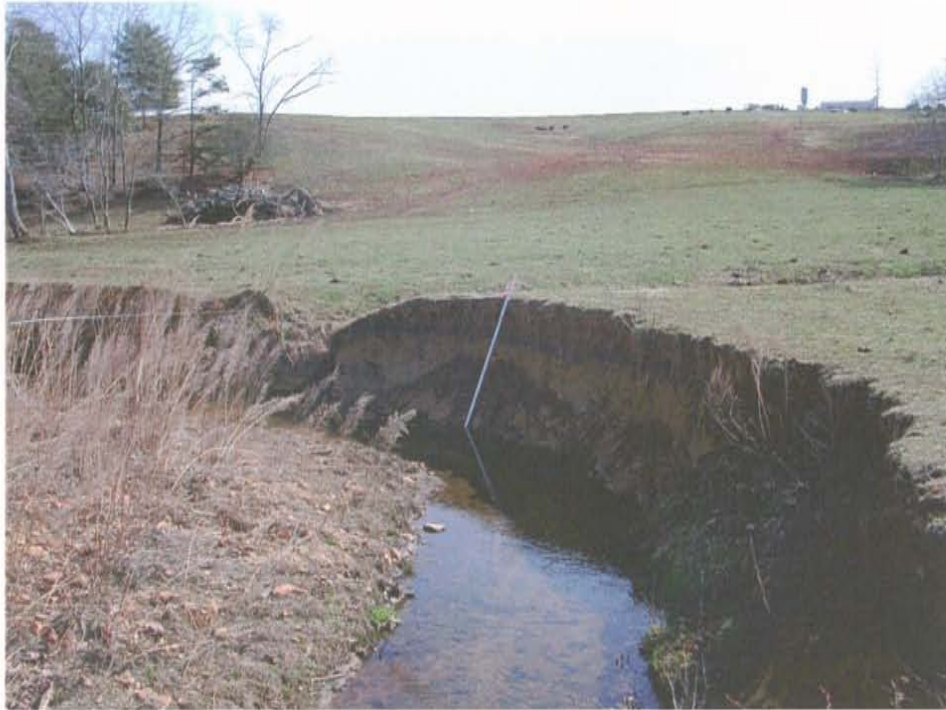
Picture 5. Pool cross-section at severely eroding meander on Little Bugaboo Creek. Looking downstream.

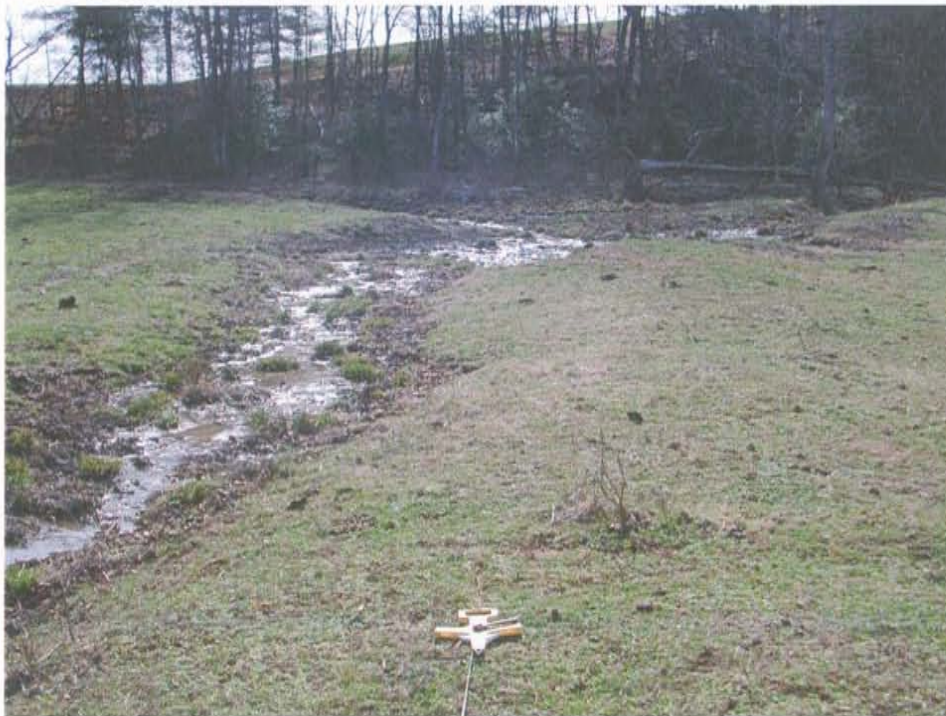
Picture 6. Drainage leaving wet area flowing into Little Bugaboo Creek.

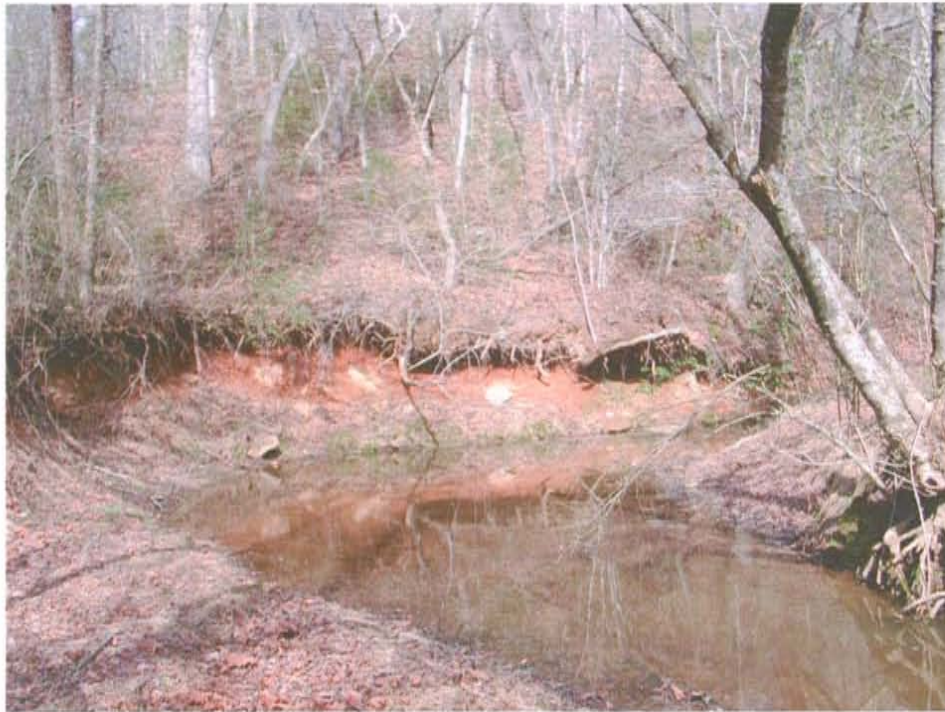
Picture 7. Sharp eroding meander on Little Bugaboo Creek near the middle of the project.

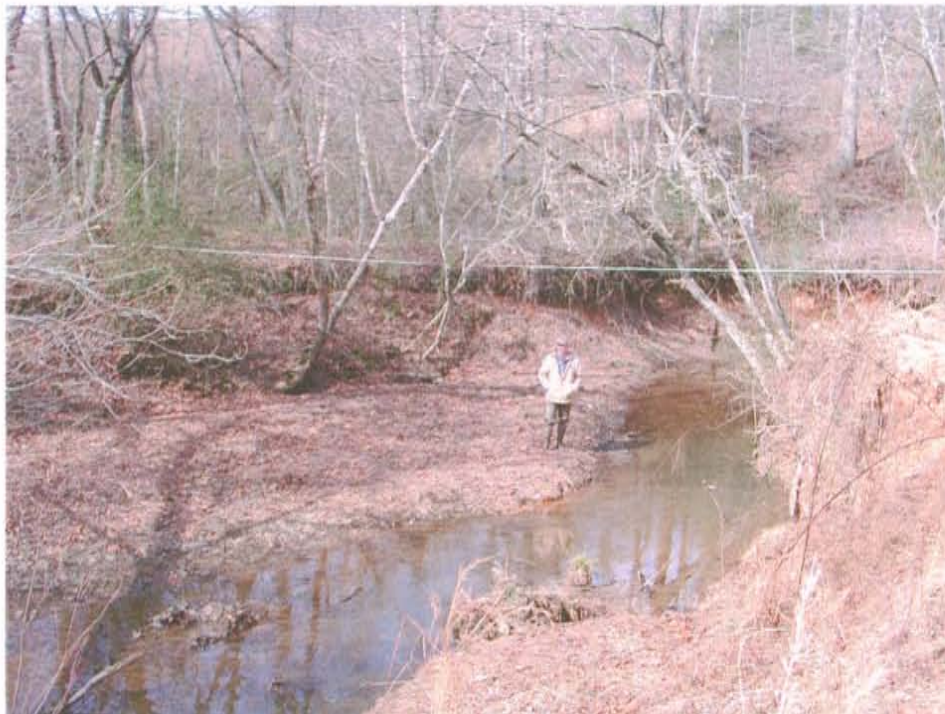
Picture 8. Over widened area along Little Bugaboo Creek.
Floodplain being created on left bank.

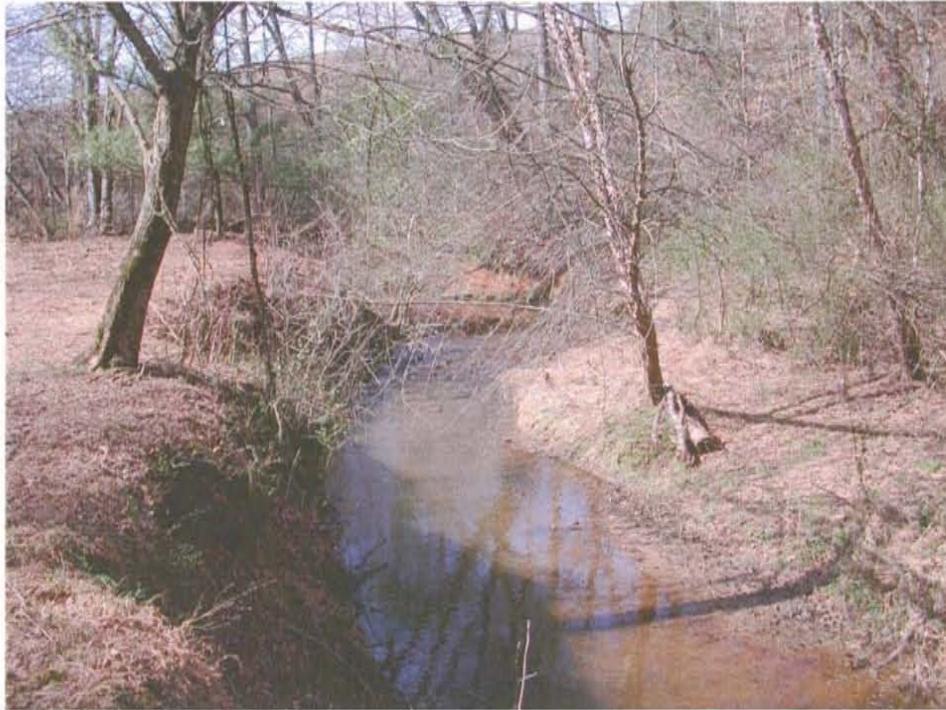
Picture 9. Pool cross-section at station 17+20.

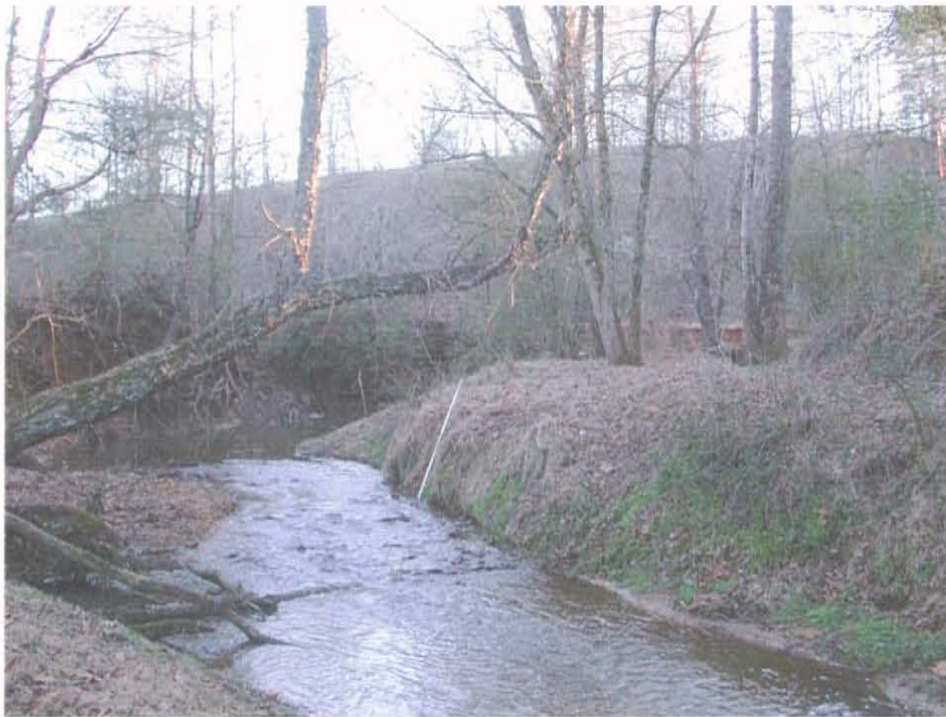
Picture 10. Pool cross-section at station at 13+20.

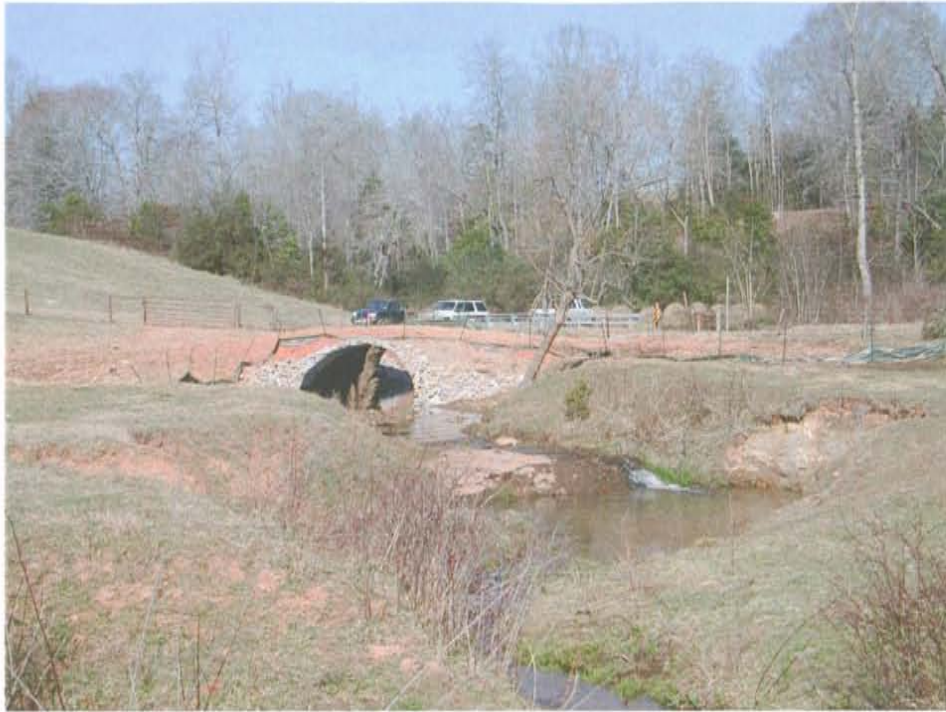
Picture 11. Existing bridge to be replaced.

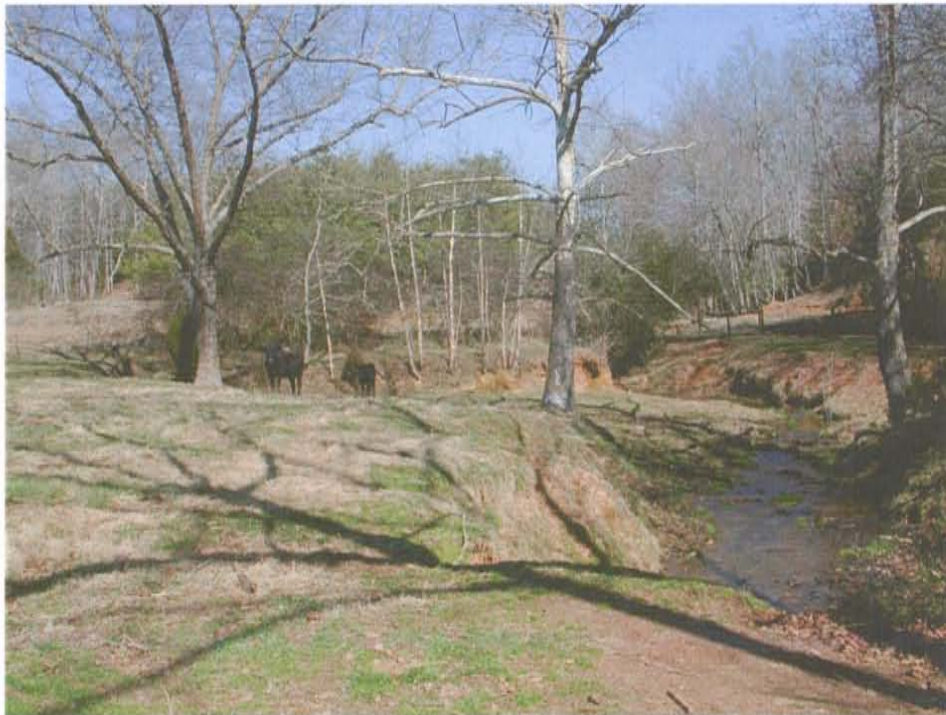
Picture 12. Eroding bank with exposed roots.

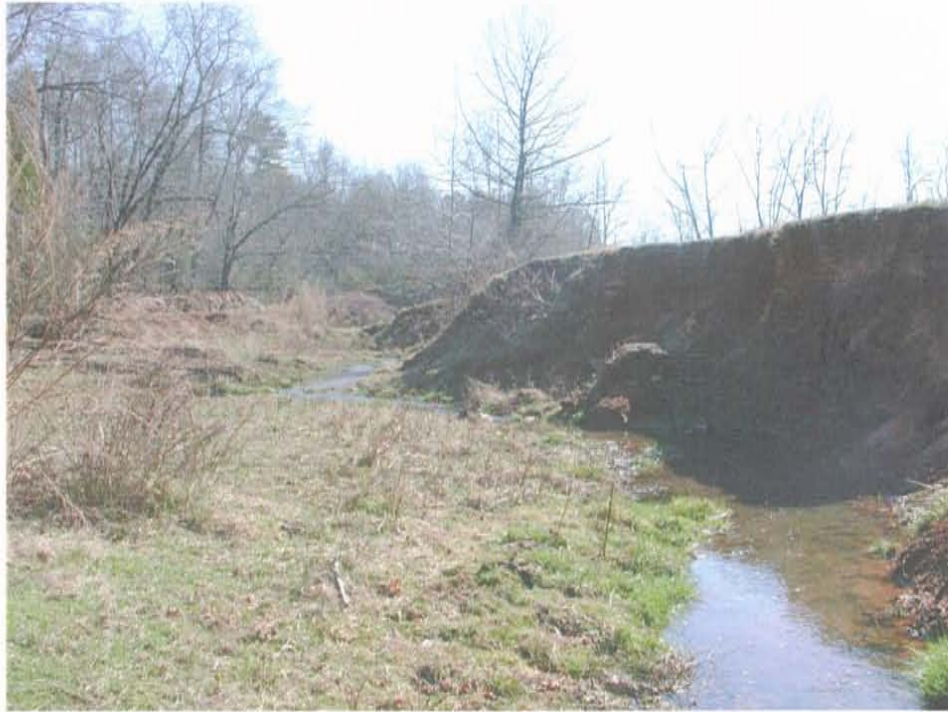
Picture 13. Stream with no vegetation.

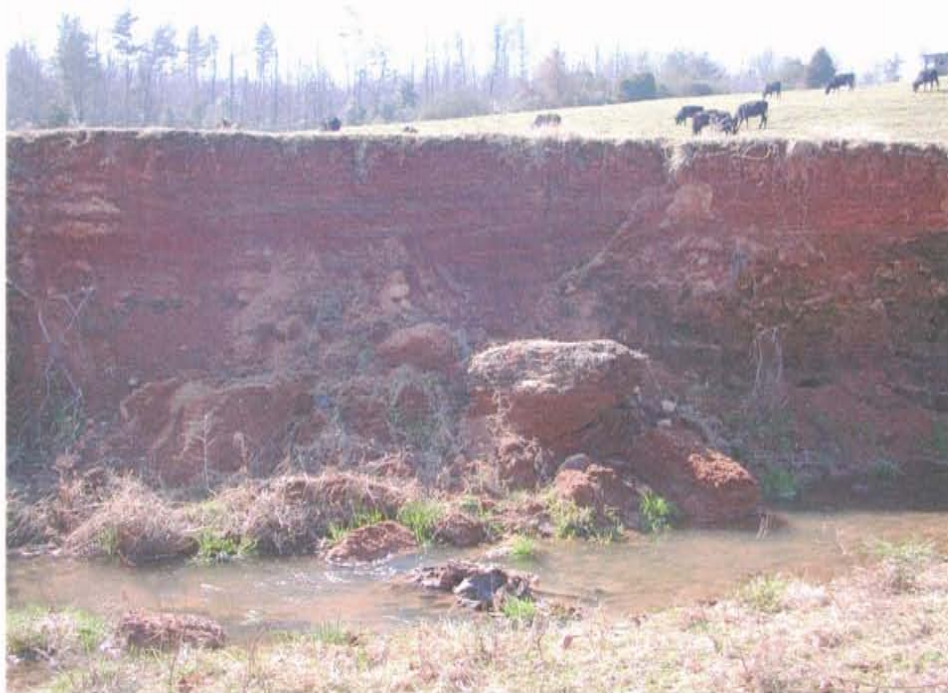
Picture 14. Overwidening channel with debris jam and central bar.

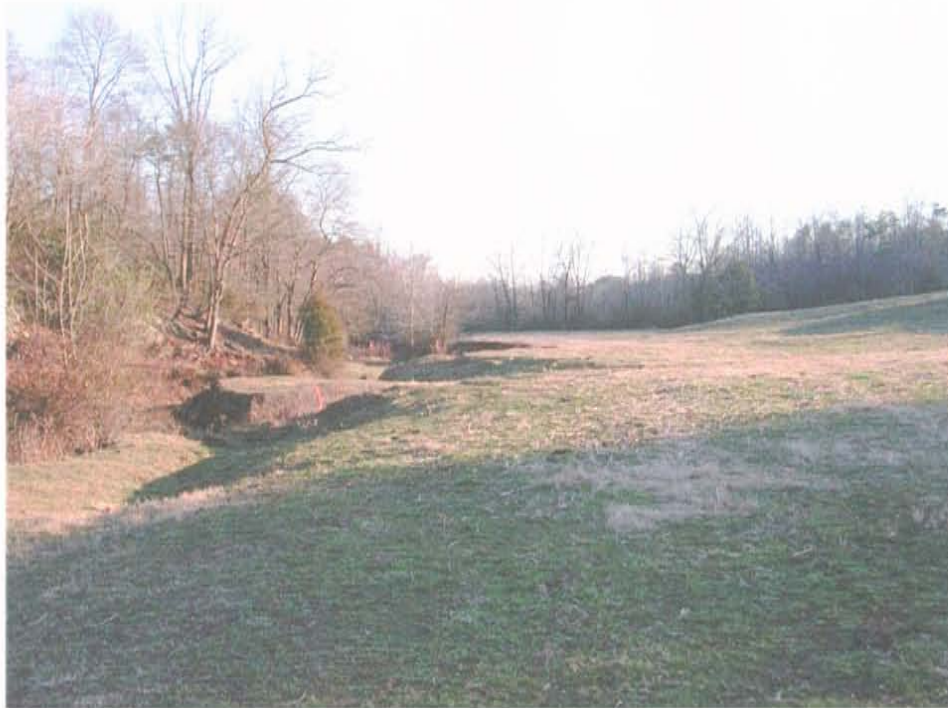
Picture 15. Mass wasting along one side of a central bar.

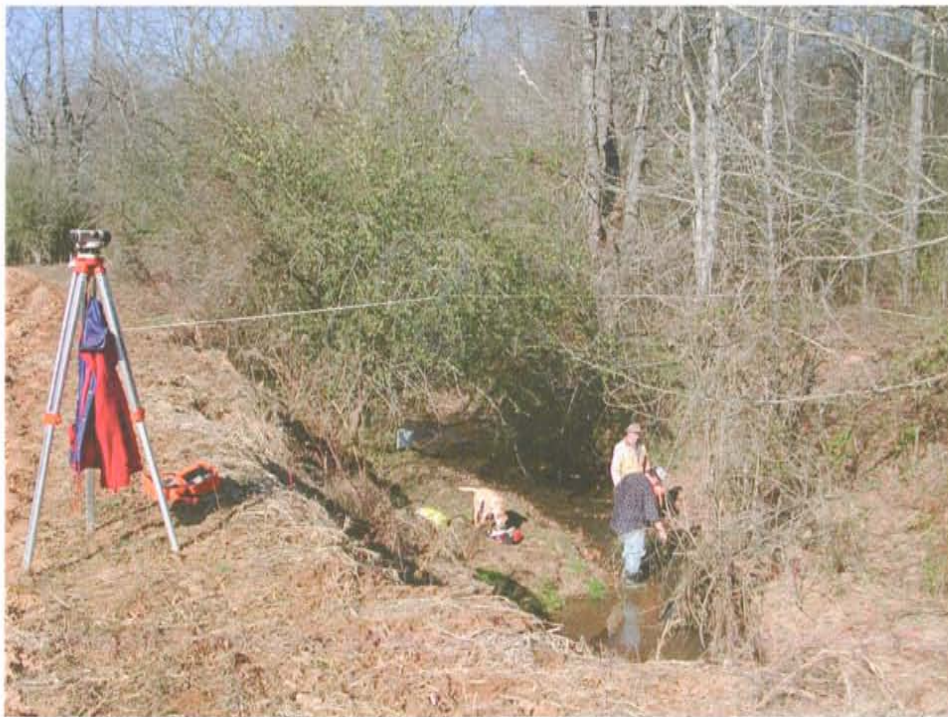
Picture 16. Central bar, typical throughout the mitigation site.
