MONITORING YEAR 5 of 5 ANNUAL REPORT

FINAL

BYRDS CREEK MITIGATION SITE

Person County, NC

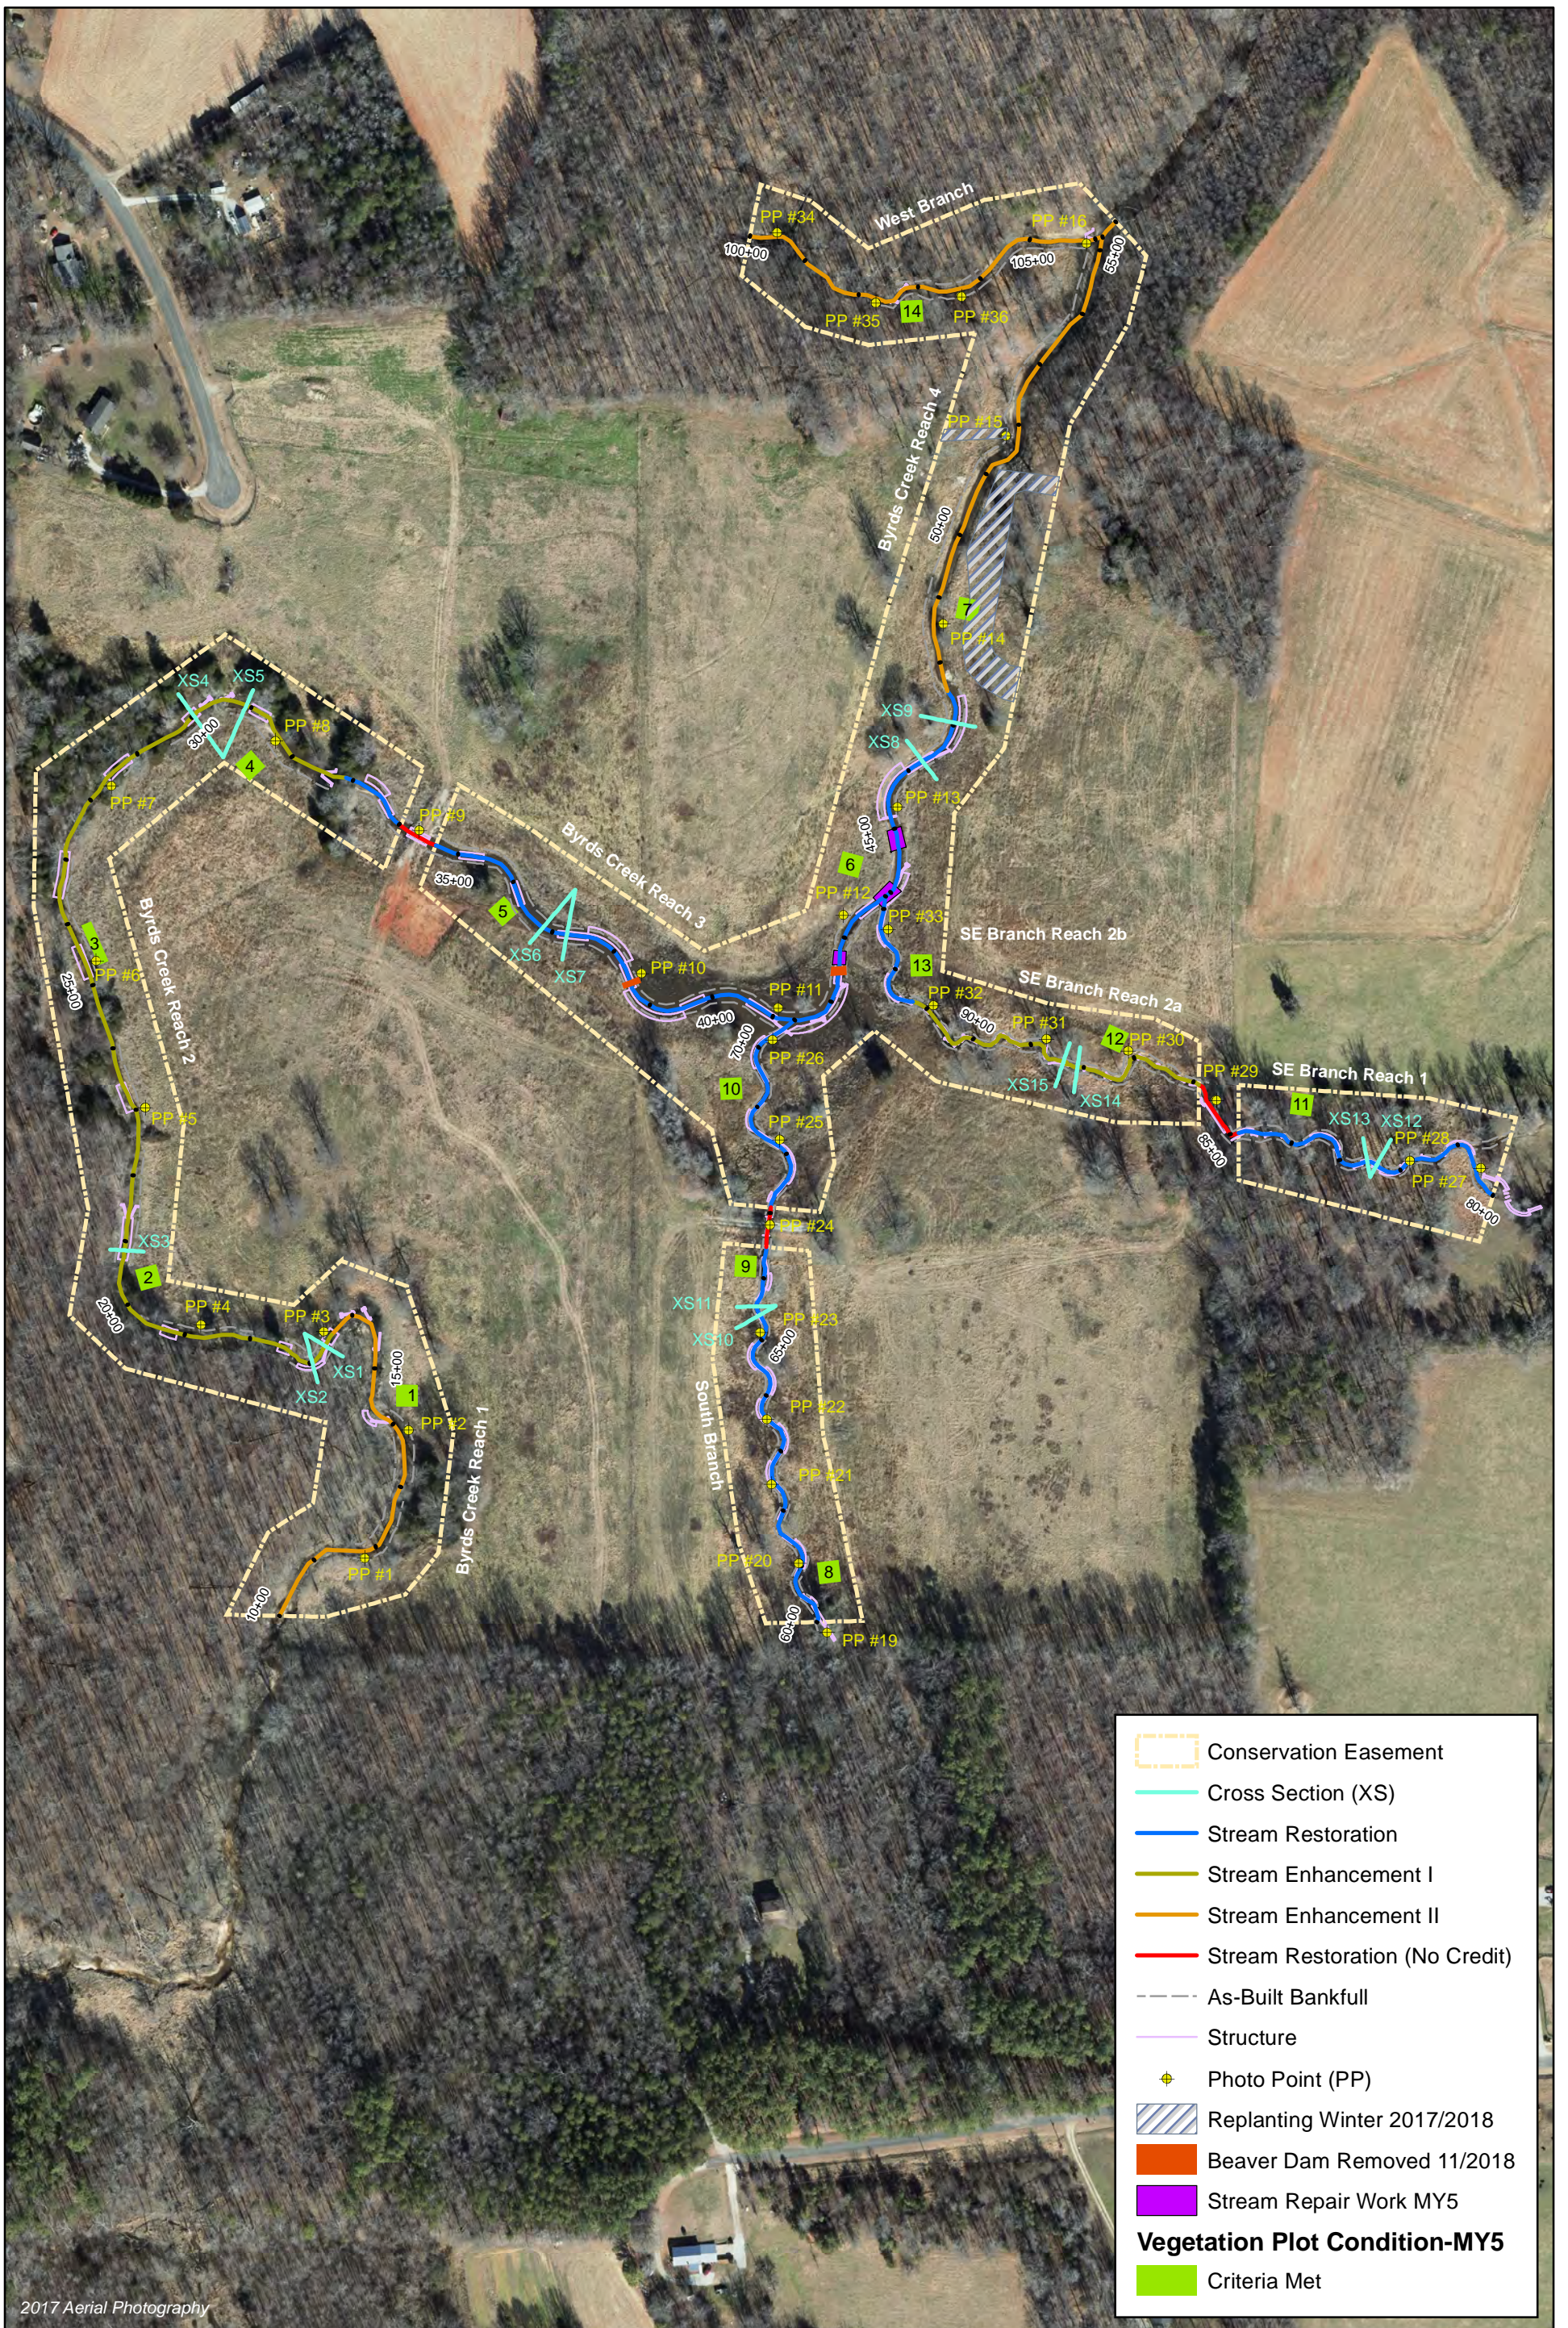
Figure 3 Integrated Current Condition Plan View
 Byrds Creek Stream Restoration Site
 DMS Project No. 95020
 Monitoring Year 5 - 2018
 Person County, NC

Morphological surveys for MY-5 were conducted in June 2018. All streams within the Site are stable with the exception of a few isolated areas of bank erosion. Refer to Appendix 2 for the visual assessment table, integrated current condition plan view (CCPV) map (Figure 3), and reference photographs. Refer to Appendix 4 for the morphological data and plots.

As described in section 1.2.3 above, stream repair work will be performed during the winter of 2018.
